Old Rectory  
Market Bosworth  
Archaeological Monitoring and Recording  
July 2024

Archaeological Monitoring and Recording

Old Rectory, Market Bosworth

RHA22/221

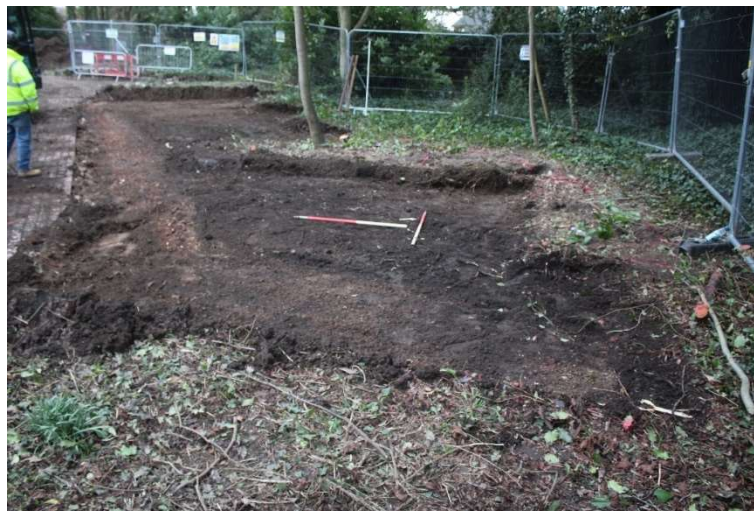
- 6.1.1 Monitoring comprised the excavation of parking spaces to a depth of 0.18m and one trench for a new water main to the site running north-south to the west of the property to a maximum depth of 1.20m (Figure 2, Figure 3). Ground conditions throughout were dry.
- 6.1.2 Natural geology comprising mid-yellow to brown clayey silt (108) was observed at a depth of 0.60m BGL (131.24m aOD). This was sealed by a deposit comprising mid-grey to brown clayey silt subsoil (111) which ranged in thickness from 0.45m in the north to 0.35m in the south. The sequence was completed by topsoil (100) measuring up to 0.20m in thickness.
- 6.1.3 In the north of the area, this sequence was cut by the foundation of the modern paved path. Cut [104] was linear in plan and filled by a mid-pink to grey gravel (103).

*Plate 1. Area 1, north section looking west (2x1m scales)*

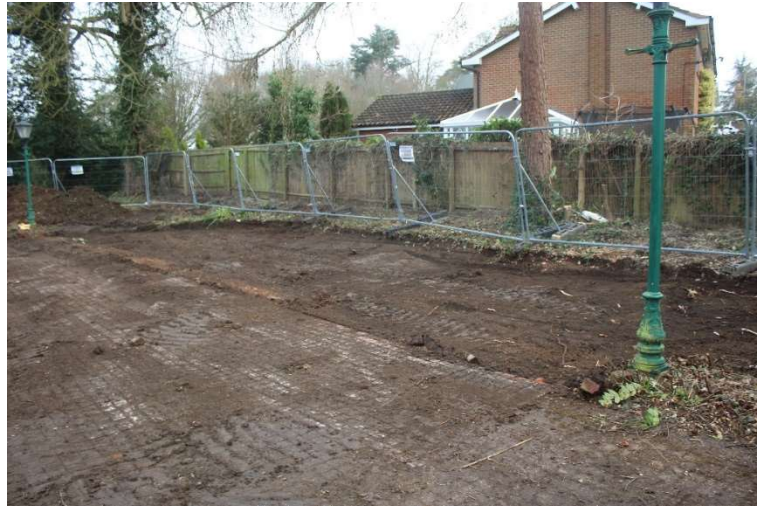
*Plate 2. Area 1, west section looking northeast (no scale)*

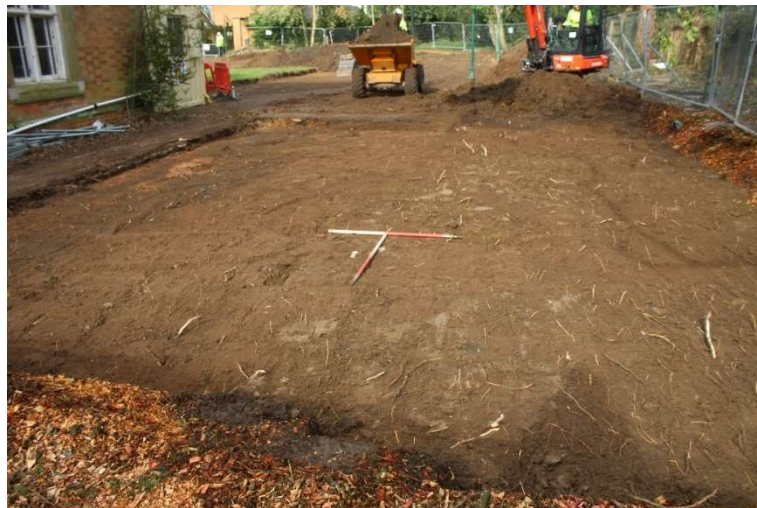
- 6.1.4 In the east of Area 1, a similar sequence of deposits was visible, with path cut [106] filled by (105) a mid-pink to grey gravel.
- 6.1.5 In the southeast of Area 1, made ground (107) was present, comprising firm mid-yellow to grey clayey silt with clay lenses (Plate 3).

*Plate 3. Area 1, west section with made ground (107), looking north (2x1m scales)*

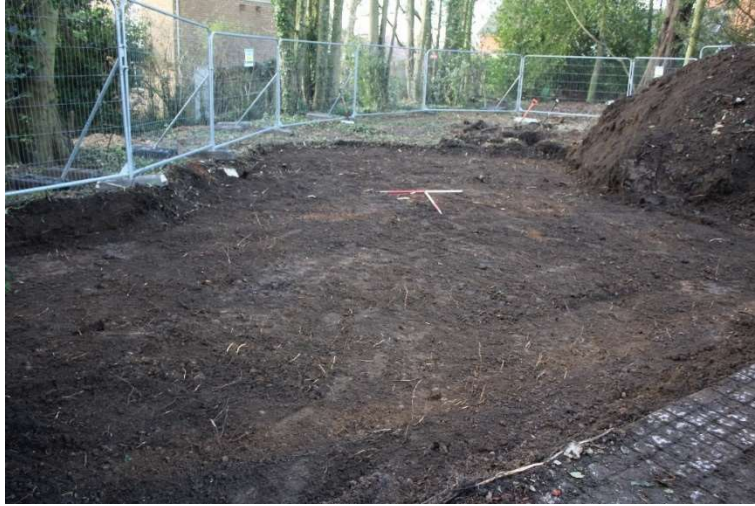
- 6.1.6 A large area was stripped (Plate 4), and a trench running north-south was excavated in the western area. In the southwest of this area, subsoil (111) was cut the construction cut for the paved path, measuring 15m long, 0.60m wide (excavated) and 0.24m thick. The northern side of the cut [110] was visible, comprising a gradual break of slope at the top, vertical sides and a flat base. Fill (109) consisted of a mid-grey brown clayey silt with occasional frogged bricks and frequent small subangular stones.

*Plate 4. Area 1, western area, looking northwest (2x1m scales)*

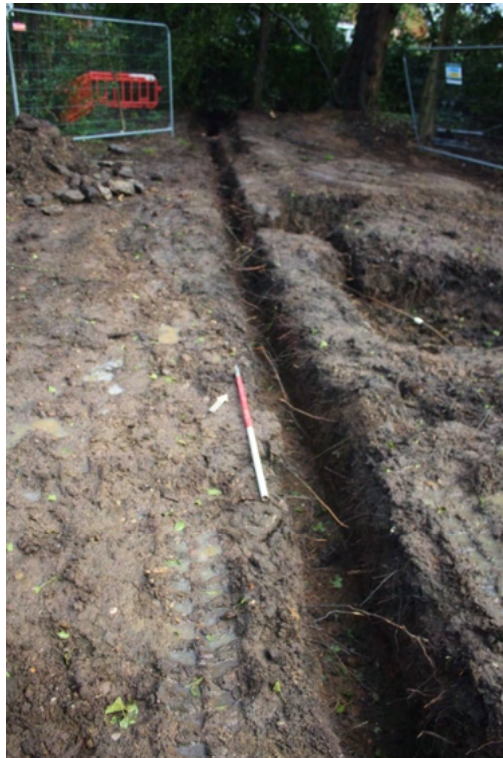
*Plate 5. Trench for new water main excavated in Area 1, looking north (1m scale)*

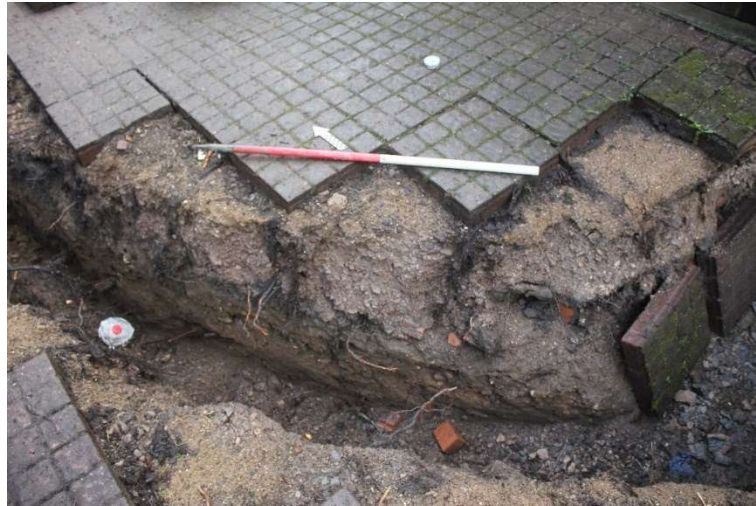
*Plate 6. Southwest section of western trench for new water main, showing (109), looking northeast (1m scale)*

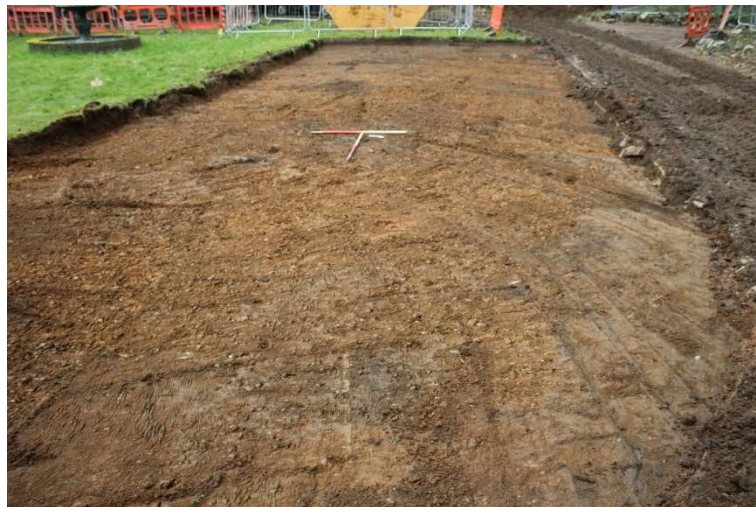
- 6.1.7 To the north of the central area was a modern deposit consisting of redeposited natural geology (101), a mid-yellow to brown clayey silt, with frequent subangular stones, occasional modern pottery and frequent modern glass (not retained) (Plate 7). This was sealed by topsoil (100). Cutting into (101) were a number of tree-throws, which were investigated but were not recorded as the regularity of their spacing (1.40m exactly on a northeast-southwest alignment) and the inclusions found within suggested a very modern date.

*Plate 7. Area 1, northern part of parking area showing deposit (101), looking west (2x1m scales)*

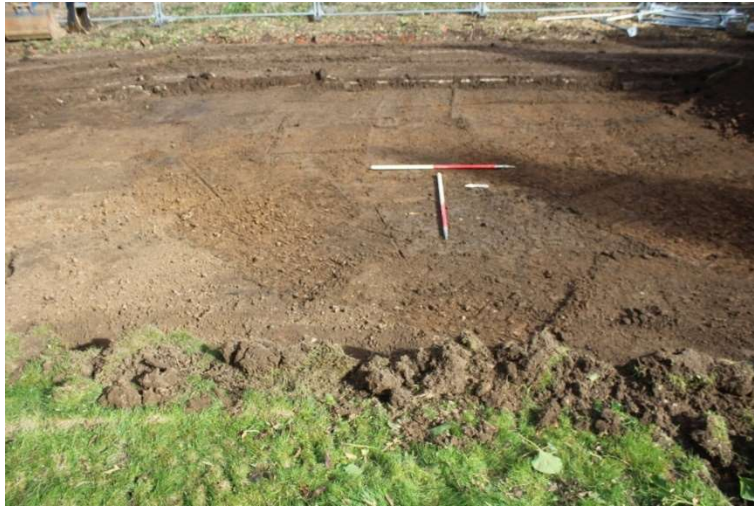
- 6.1.8 To the south of the central area, made ground (102) comprising a mid grey to brown sandy silt with occasional modern pottery (not retained), and frequent small subangular stones was observed under topsoil (100). The relationship between (101) and (102) was unclear (Plate 8).
- 6.1.9 Services, including gas and electricity were observed to the south. All were on a northwest-southeast alignment leading to the existing building.

*Plate 8. Area 1, parking area showing intersection between (101) and (102), looking east (2x1m scales)*

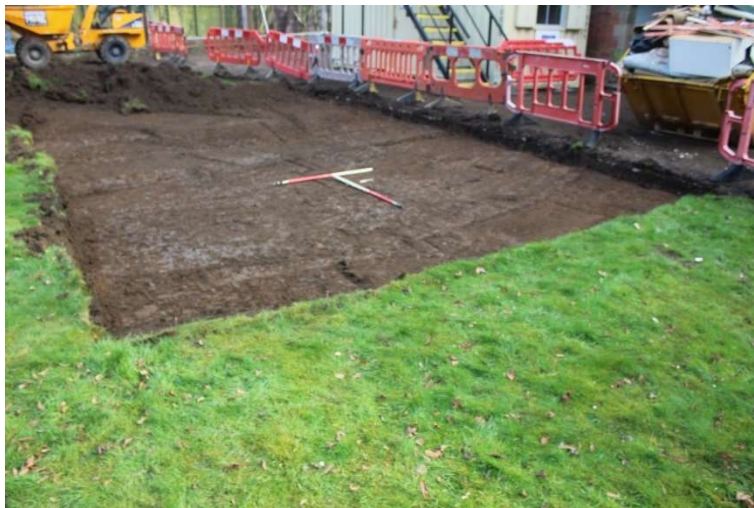
*Plate 9. Area 1, southern part of parking area showing deposit (102), looking southeast (2x1m scales)*

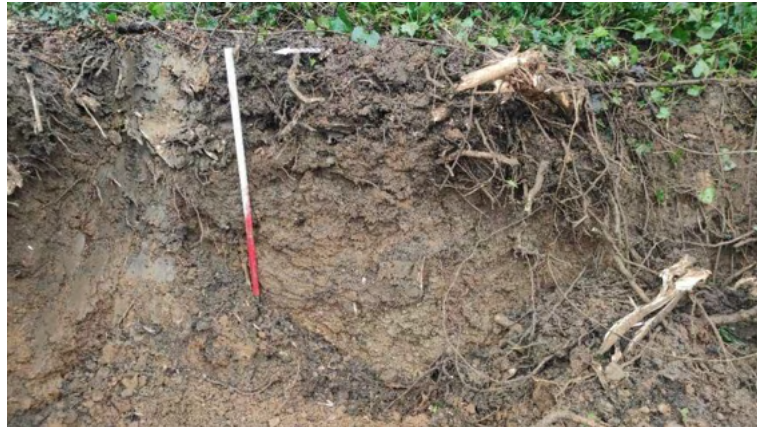
- 6.2.3 To the east of the property, deposit (202) was sealed by a dark orange to brown clayey silt (201), possibly associated with the rooting system of the removed stumps. This was sealed by topsoil (200) measuring up to 0.28m in thickness.

*Plate 10. Area 2, west-facing section of tree stump 3 (1m scale)*

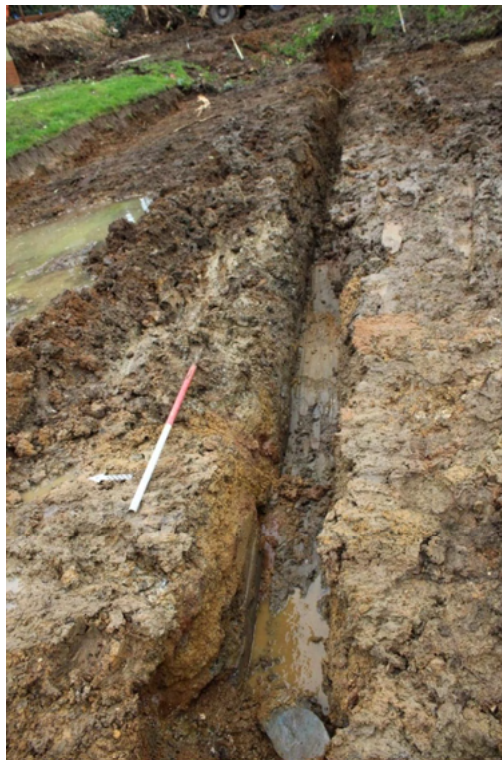
- 6.2.4 In the centre of Area 2, deposit (202) was truncated by a large cut, 25m in length, 13m in width and 0.45 in depth (Figure 6). The cut [206] was rectangular, with a sharp break of slope at the top, concave sides, and a flat base. This was filled by primary fill (205) 0.23m thick, comprised of a mix of mid-blue to grey silty clay and mid-red to brown silty, with occasional small subangular stones, and secondary fill (204), a mid-grey to yellow silty clay measuring 0.18m thick.

*Plate 11. Area 2, Drain 1 [206] (205) (204), looking southeast (1m scale)*

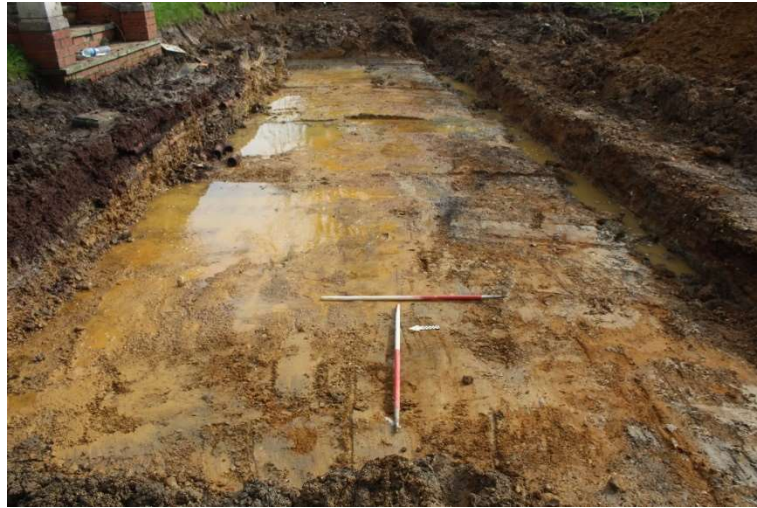
*Plate 12. Area 2, north of tank location showing deposits (206) (205), looking east (2x1m scales)*

- 7.1.3 Made ground (205, 206) correlated to the location of an old tennis court and is most likely a deposit related to its construction, with drains possibly associated with this use.

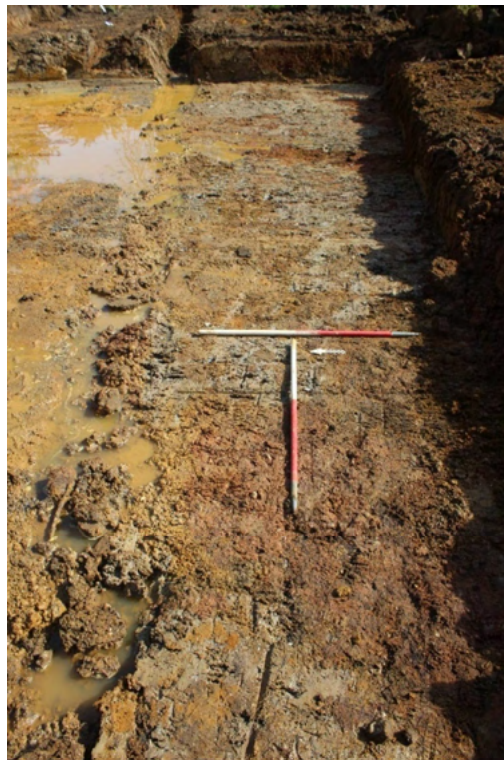
*Plate 13. Area 2, south of tank location showing (205), looking east (2x1m scales)*

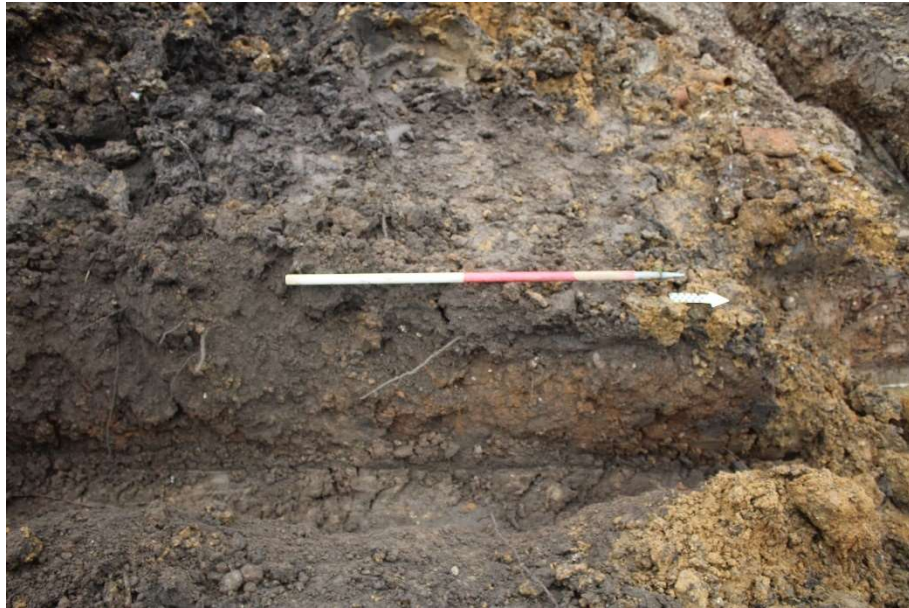
*Plate 14. Area 2, east-facing section of Drain 7 (1m scale)*

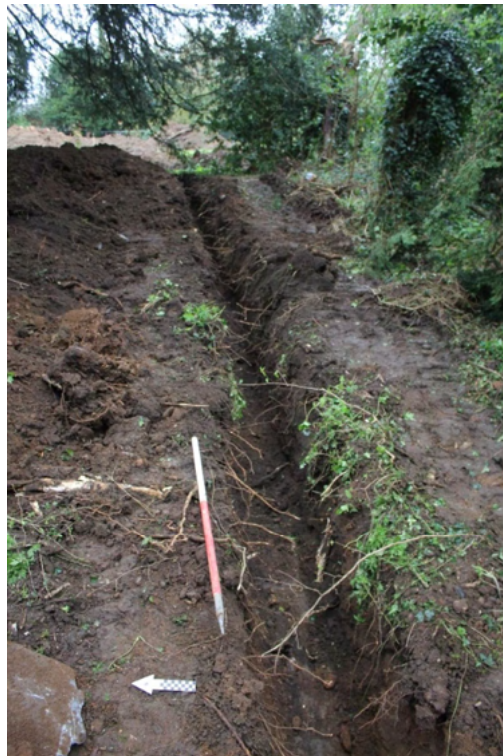
- 6.2.5 Deposit (202) was also cut by a possible cess pit [214], measuring 50m long, 0.60m wide (excavated) and 0.60m deep. Cut [214] was only visible at the southern end of Drain 2 and was filled by (213), a mid-yellow to brown silty clay with occasional small subrounded stones, and modern glass bottles (not retained).

*Plate 15. Area 2, Drain 3b showing (200) and fill (213), looking west (1m scale)*

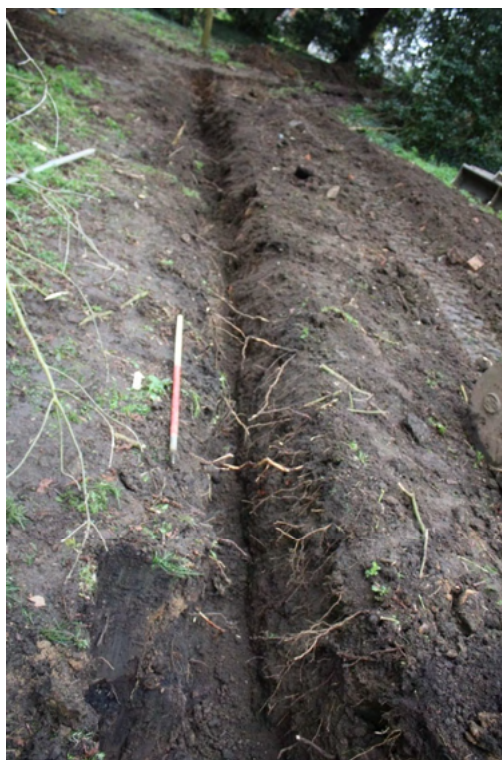
- 6.2.6 Fill (213) was cut by another cess pit [217], measuring 35m long, 0.60m wide (excavated), and 0.50m deep. This cut was only visible on one side, within Drain 3,

with concave sides and a flat base. It was filled by (216), a dark grey to brown clayey silt with occasional animal bones (cattle), glass bottles, slate, and modern plastic (not retained).

*Plate 16. Area 2, Drain 3b showing (216), looking north-northwest (1m scale)*

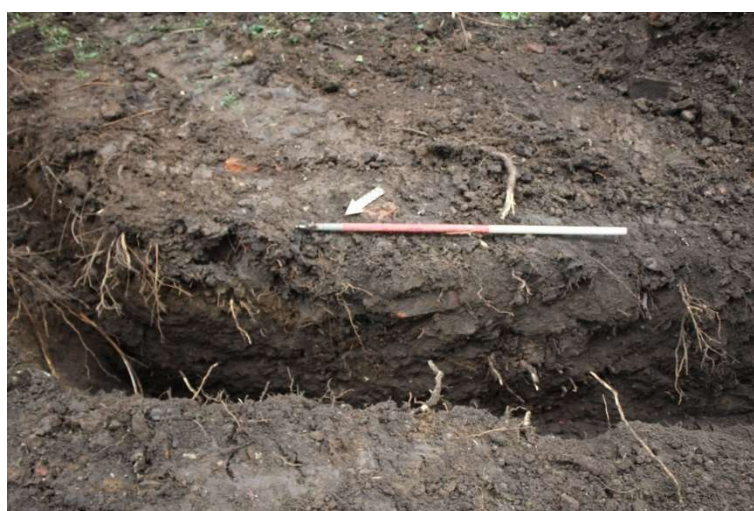
*Plate 17. Northwest facing section of the corner of Drain 3b showing (200) (216) - Looking southeast (1m scale)*

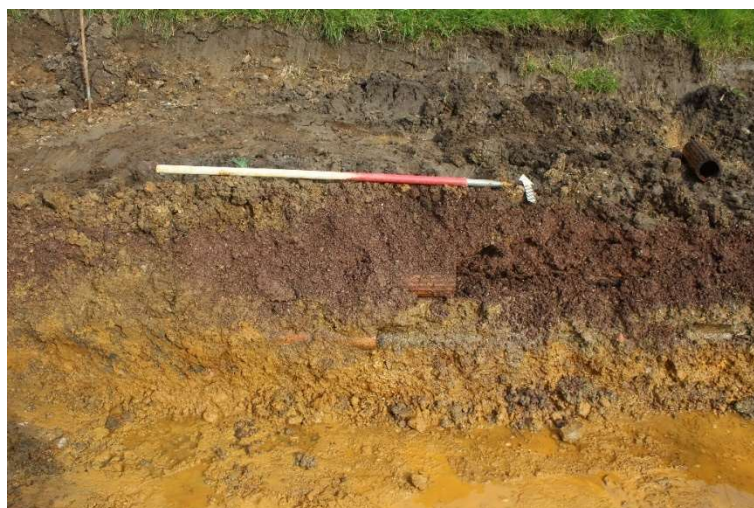
6.2.8 Several post-medieval drains were observed in Area 2 (Figure 3). Most were on a north-south alignment leading to the existing building. Two ran east to west.

*Plate 18. Area 2, post-medieval drain running east-west in south facing section of tank excavation (1m scale)*
