# **Phase 1 Land Contamination Risk Assessment**

## **Proposed Demolition of Existing Dwelling and Outbuildings and Erection of a Replacement Dwelling and Detached Garage**

**Little Moat, Newbold Road,  
Kirkby Mallory, Leicester  
LE9 7QG**

**Date: August 2022**

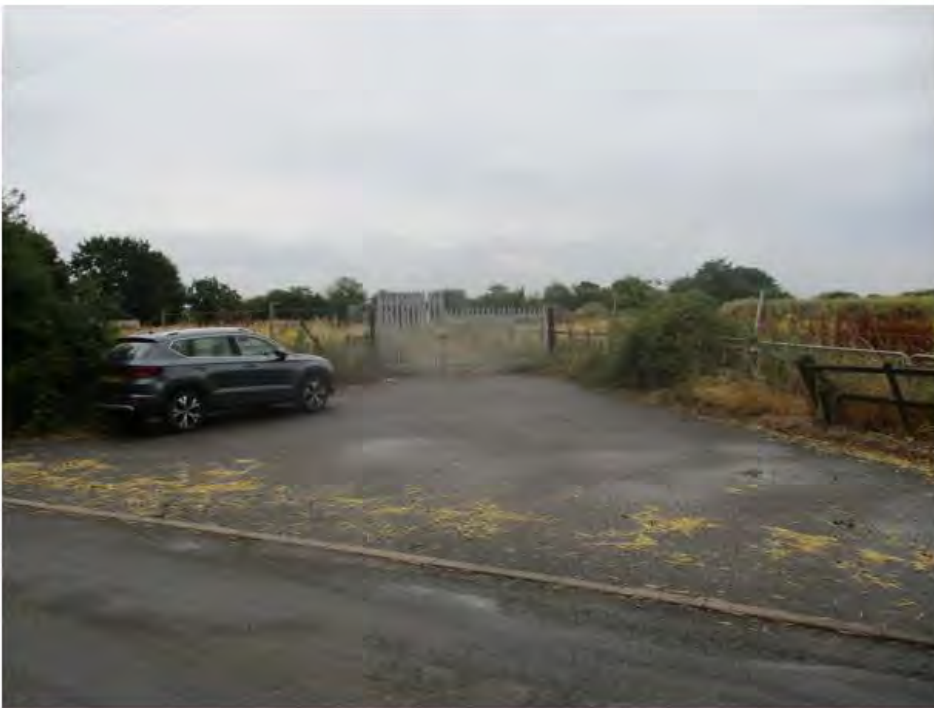
**Photo No.1: Facing NE off Newbold Road showing the gated site access**

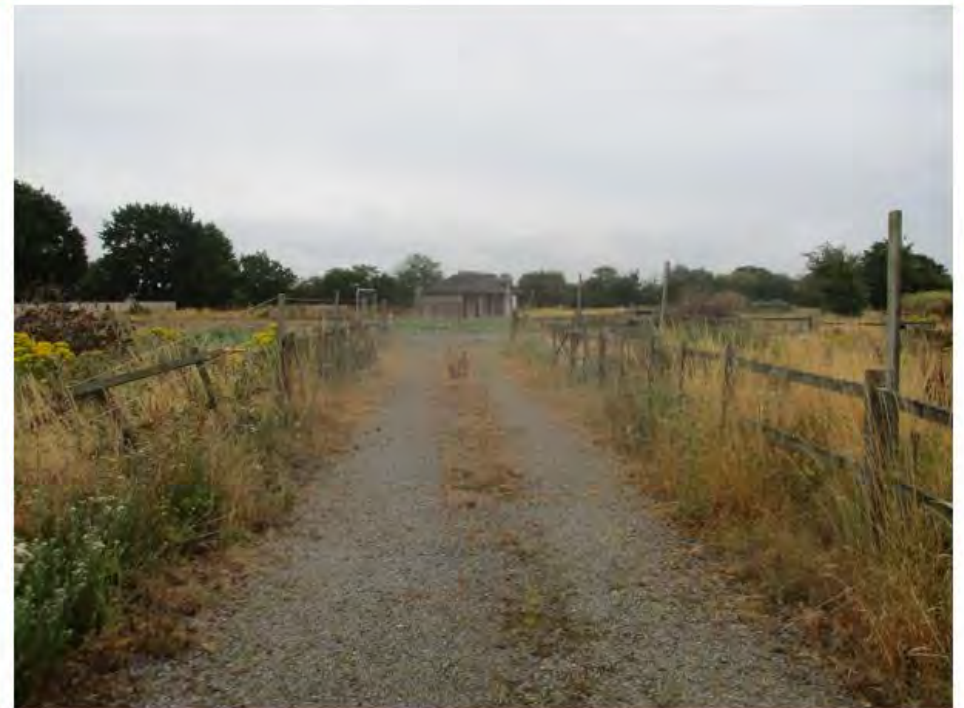
**Photo No.2: Facing NE showing the site access track leading to the main site area**

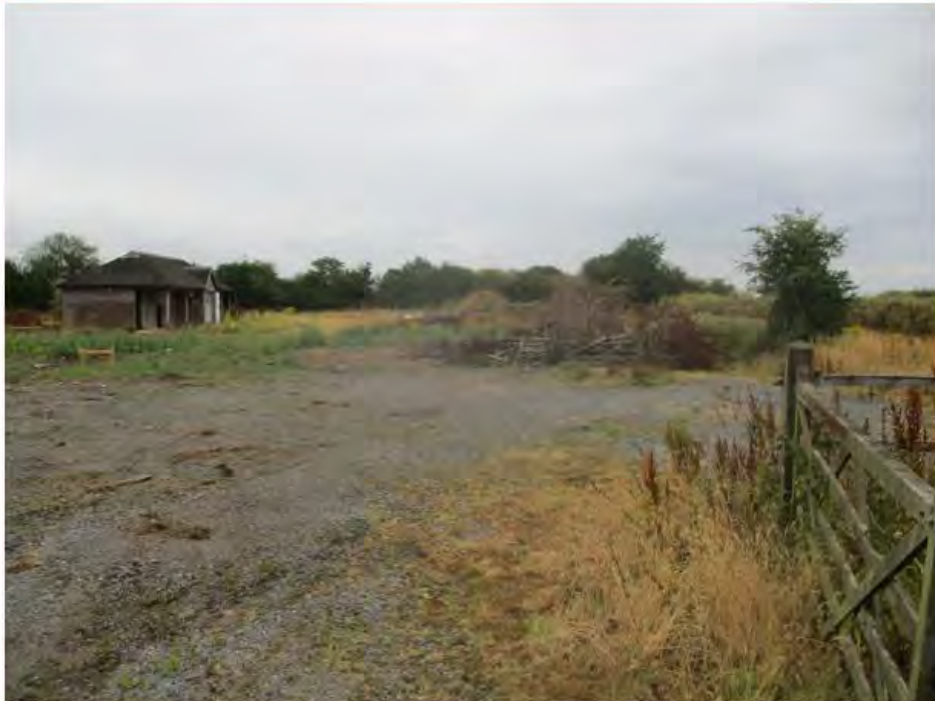
**Photo No.3: Facing slightly NE from the western extent of the main site area showing a timber heap and the stables (left)**

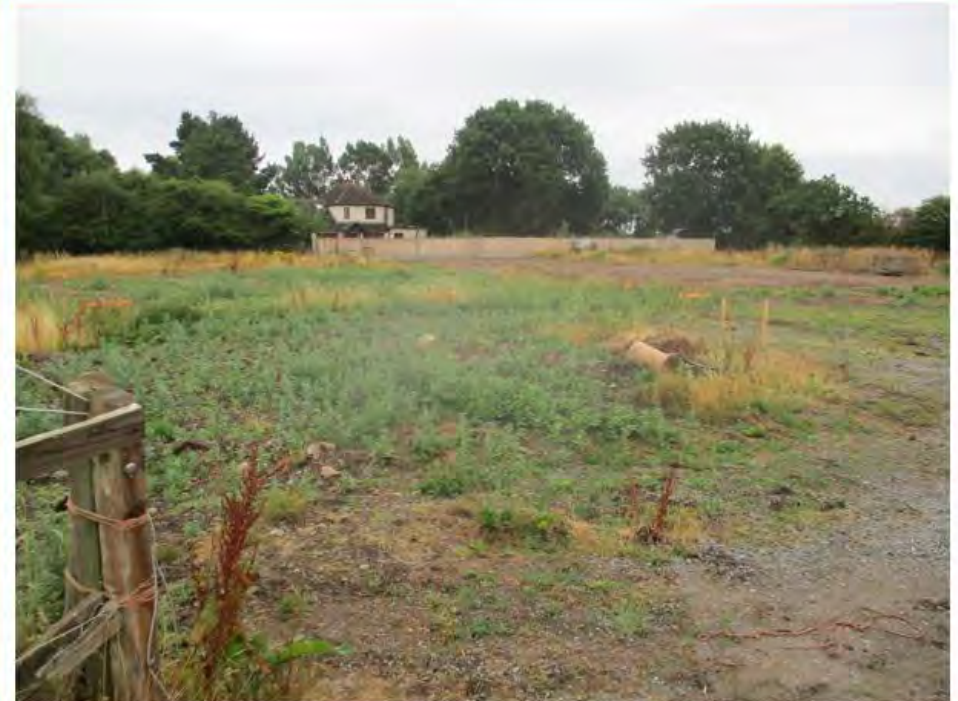
**Photo No.4: Facing north showing the northern extent of site**

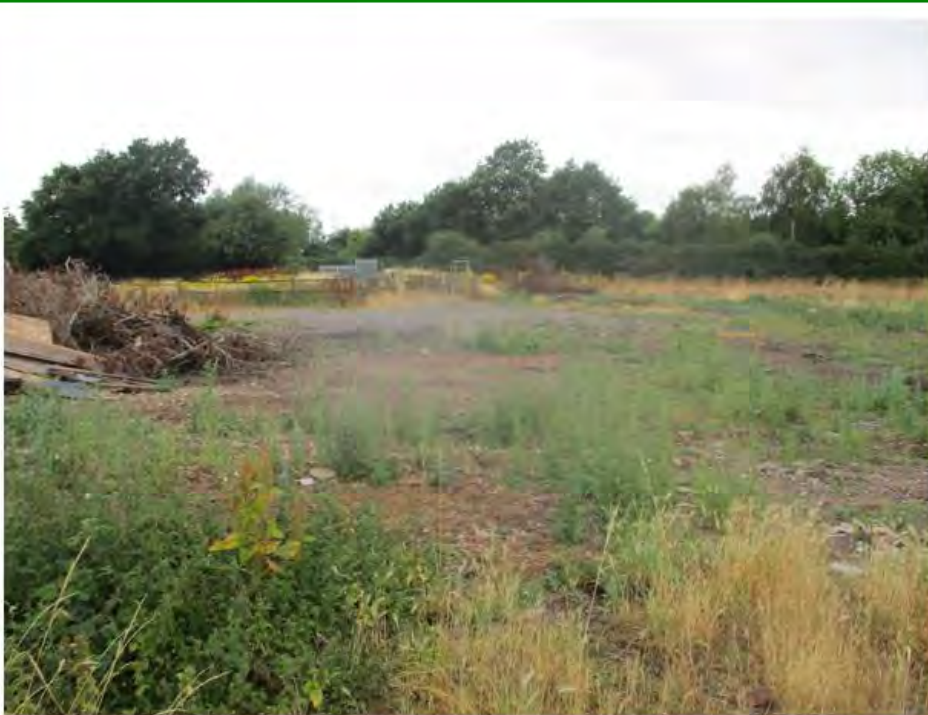
**Photo No.5: Facing west from the central southern extent of site back towards the site access and Newbold Road**

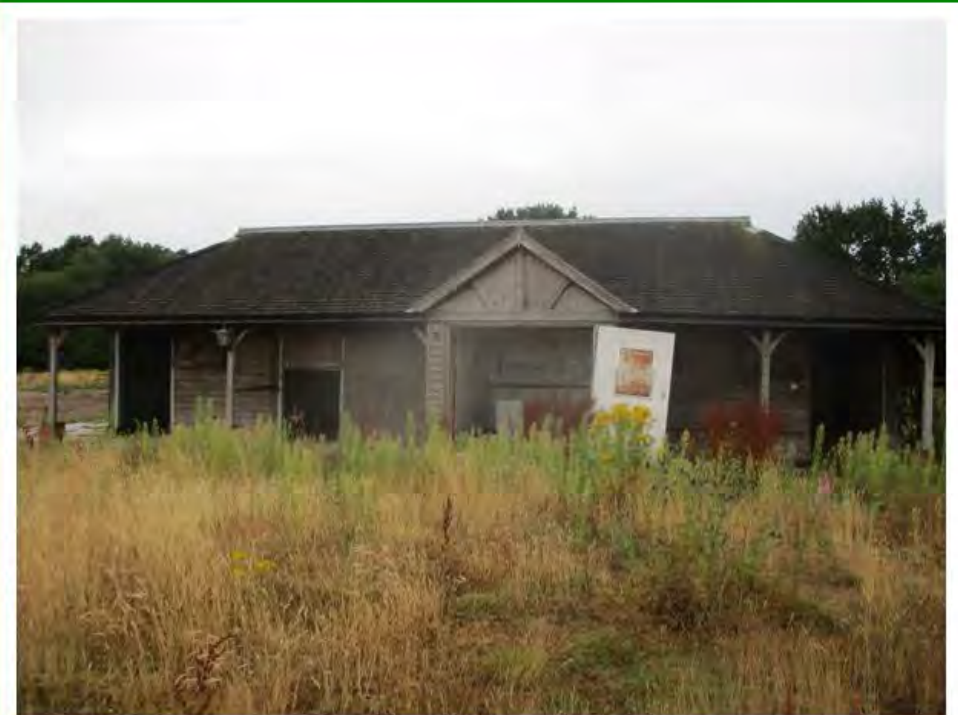
**Photo No.6: Facing north from south of the centrally located former stables showing stables with central refrigeration unit**

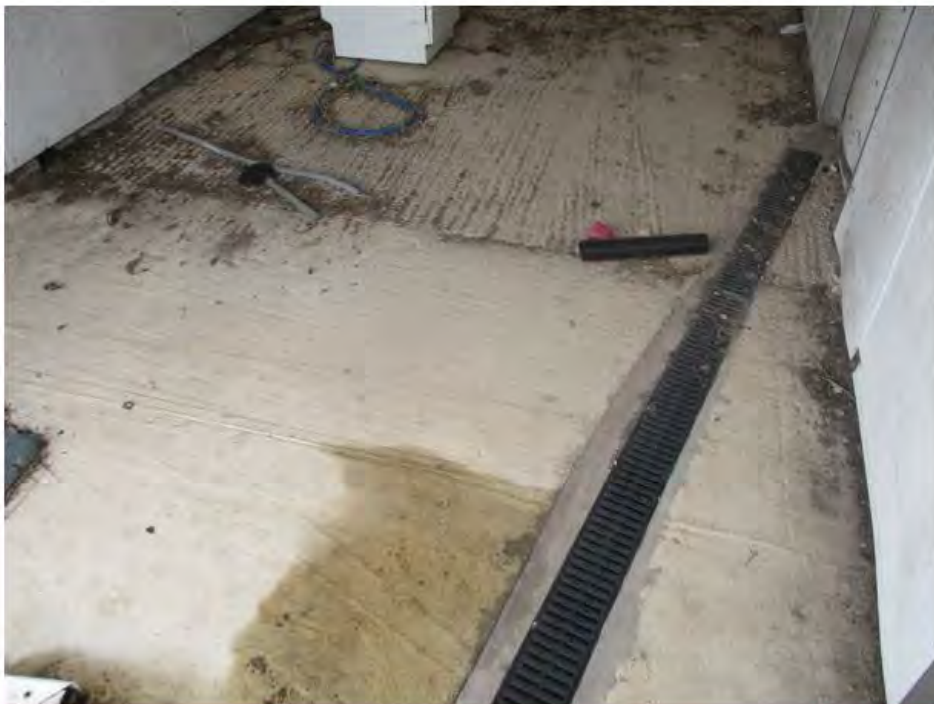
**Photo No.7: Example shot of concrete flooring in central, formerly refrigerated unit of the stables**

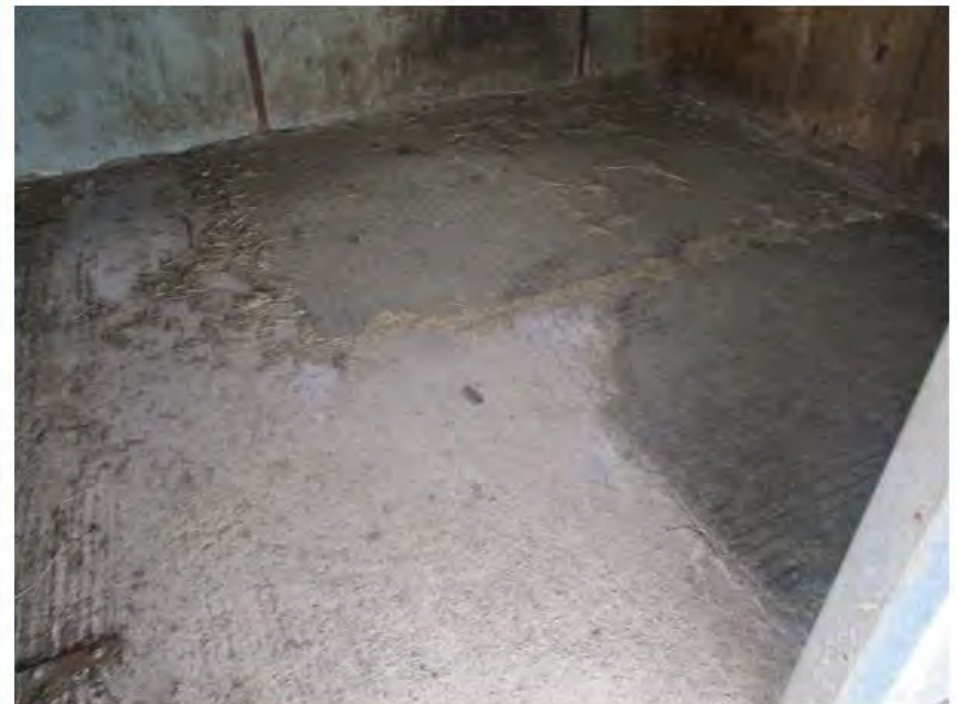
**Photo No.8: Example shot of the concrete flooring in the stables to either side of the central refrigerated unit**

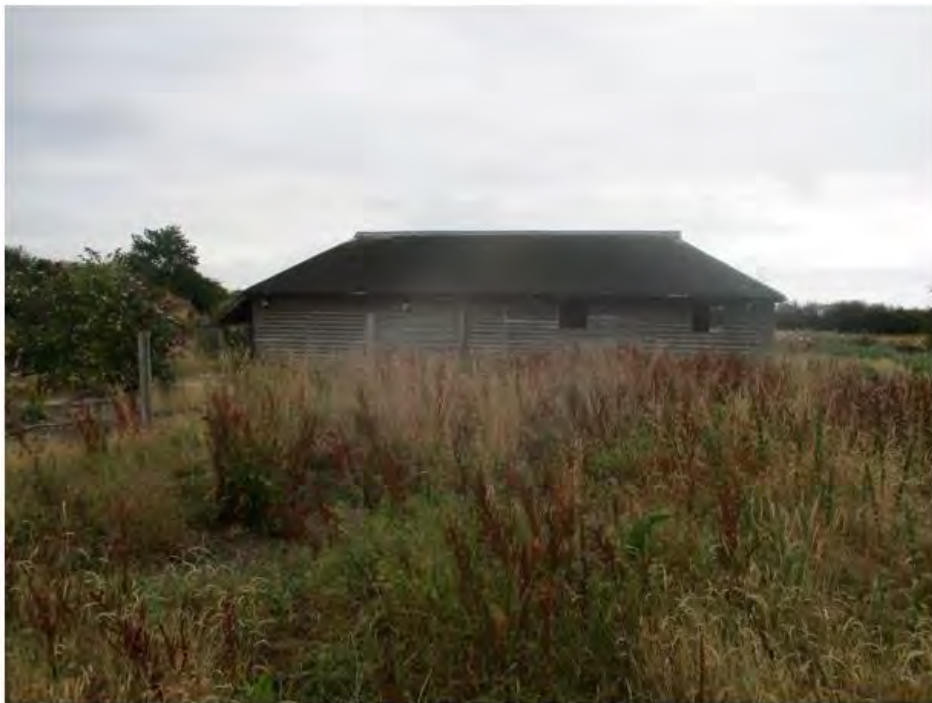
**Photo No.11: Facing south showing the northern face of the stables from the northern boundary of site**

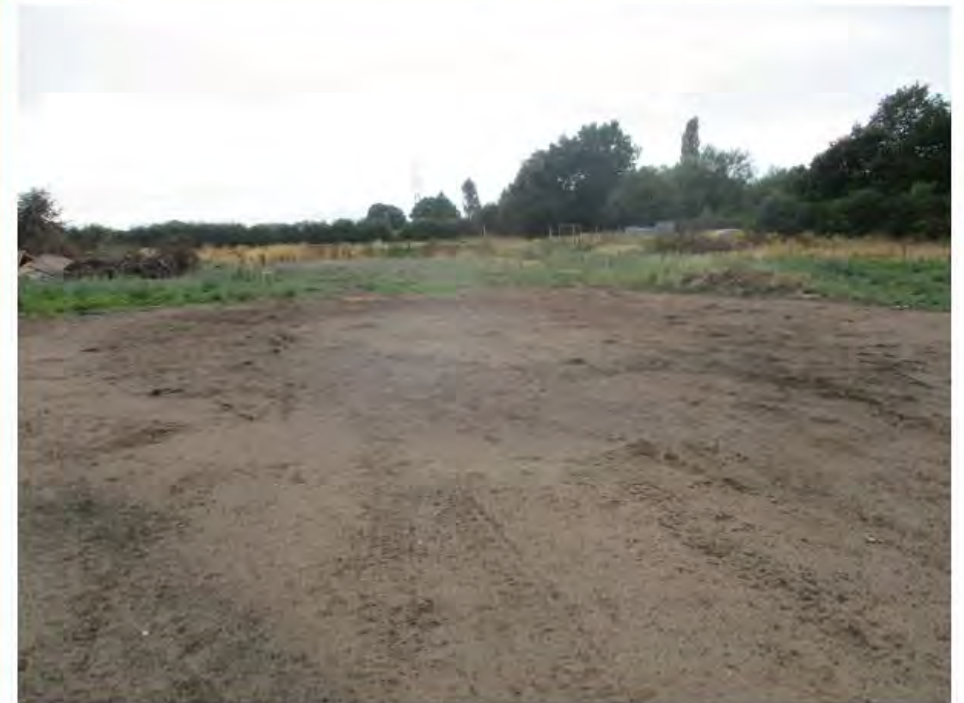
**Photo No.12: Facing slightly SW from the NW extent of site back towards the site access showing proposed dwelling area**
