# Site Investigation Report

158684.1.USI

Auger were commissioned by Crawford & Co to undertake a site investigation and CCTV inspection of the underground drainage within the area of concern (AOC) at the property.

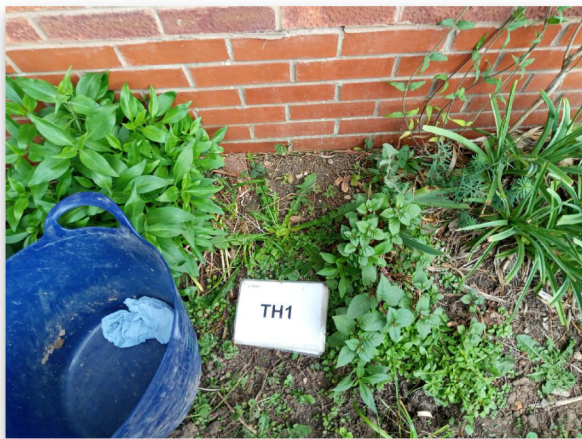
Fig 1.1: Trial Hole 1 Location

Trial hole 1 was moved to the **left hand side soil bed to avoid going through the raised patio.** The trial hole reached the depth requested and the footing was discovered. A root sample was taken at 1.0m and soil samples were taken at 1.0m, 1.5m, 2m and 2.5m.

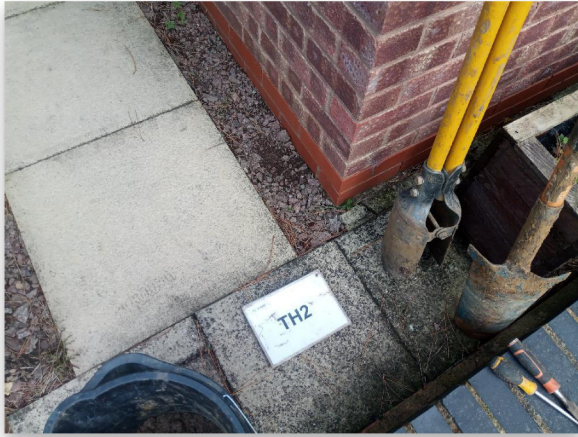
Fig 2.1: Trial Hole 2 Location

Trial hole 2 was moved to the **right hand side of the conservatory to avoid going through the raised patio.** The trial hole reached the requested depth and the footing was discovered. A root sample was taken at 1.0m and soil samples were taken at 1.0m, 1.5m, 2.0m and 2.5m.

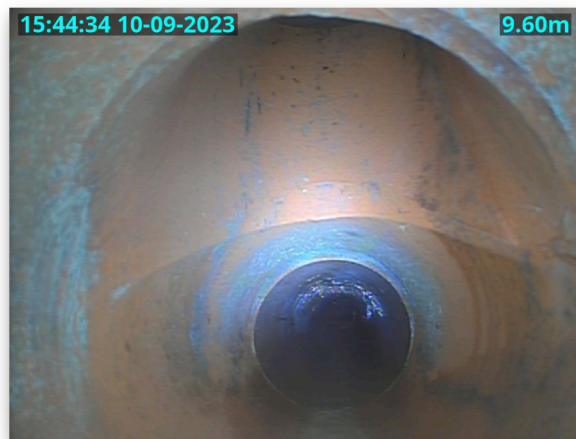
Fig 3.1: Line 2 meets line from WG2

Our survey of line 2 revealed no significant defects to the pipework on this line which could be allowing an escape of water.

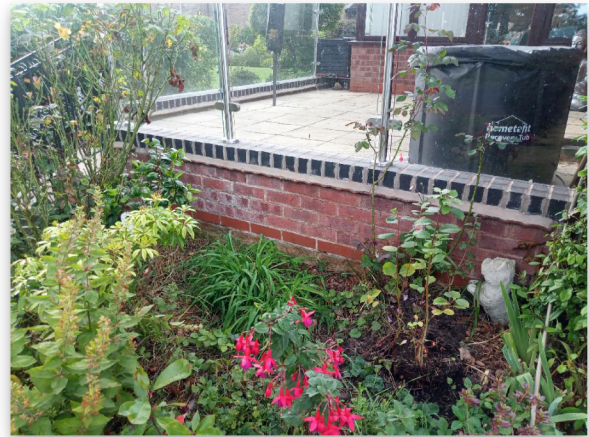
Fig 4.2: Raised and concreted patio

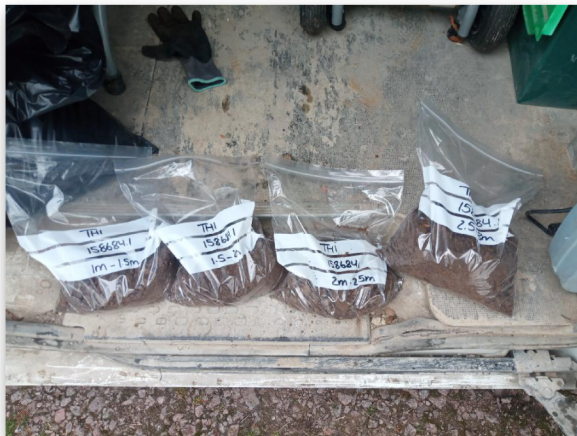
Fig 4.3: Trial hole 1 soil samples

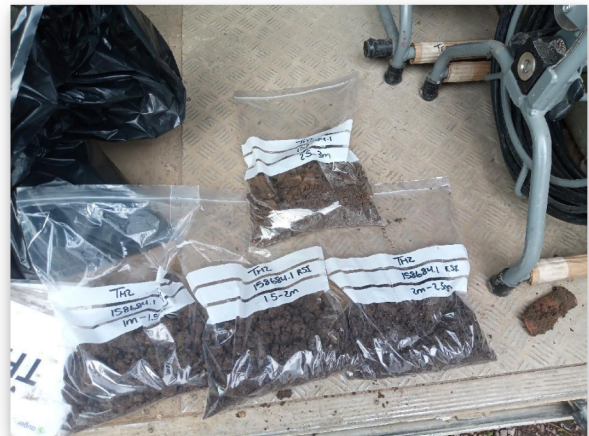
Fig 4.4: Trial hole 2 soil samples
