BS5837:2012 Tree Survey  
Land at Kirkby Moats Industrial Estate  
Newbold Road  
Kirkby Mallory  
Leicestershire  
NGR SK45547 01853

| <p>smas<br/>worksafe<br/>consultant<br/>www.smasltd.com<br/>as recognised by<br/>SSIP SAFETY<br/>SCHEMES IN<br/>PROCUREMENT</p> | Report prepared by:<br>C Barker | Date Issued: 15 March 2023 |

# **BS5837 Tree Survey, Land at Kirkby Moats Industrial Estate**

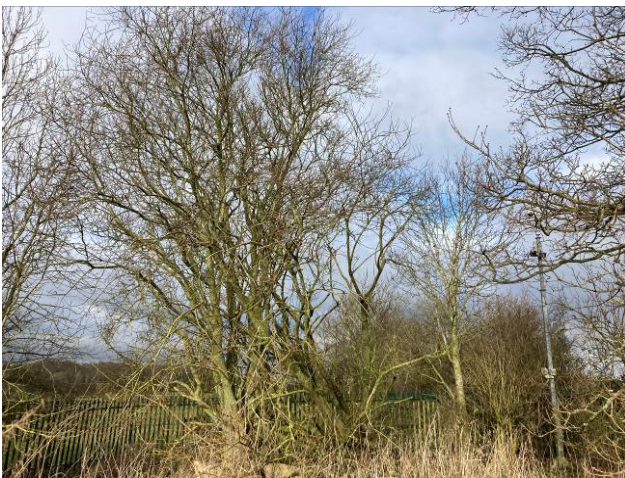
T1 and T2

**Trees T1 – T3 and Group G4** comprise Ash and Goat Willow situated on or close to the northern boundary of the survey area. None of these are large veteran trees but the Goat Willow are mature specimens with one having fallen over. Only Ash T1 is of sufficient quality and longevity to be placed into Category B2.

| Ref | Tree | Category | Potential Impact of development |
|---|---|---|---|
| T1 | Ash | B2 | No impact from development and no works required to the tree canopy. |
| T2 | Goat Willow | U | The calculated RPA extends into the edge of the area identified for the construction of the soakaway. Minor loss of RPA will not impact the quality of longevity of this poor-quality tree. |

| Tree No | Species | Ht (m) | Stem Diam mm@ 1.5m | Canopy Spread (m) | Height of Crown Clearance | Age Class | Est yrs | Overall Condition | Structural condition | Recommendations | BS 5837 Category | RPA Radius (m) |
|---|---|---|---|---|---|---|---|---|---|---|---|---|
| T1 | Ash<br><i>Fraxinus excelsior</i> | 7 | 240 | N-4<br>S-1<br>E-3<br>W-3 | 3 | Y | 20 | F | Leans north. Crown irregular extending north across fence. No structural faults visible from ground level but lean needs monitoring. | | B2 | 2.8 |
| T2 | Goat Willow<br><i>Salix caprea</i> | 5 | 465 | N-1<br>S-7<br>E-1<br>W-3 | 0 | OM | <10 | P | Fallen and lying on the ground with root bole exposed. I | Remove if a constraint. | U | 5.5 |

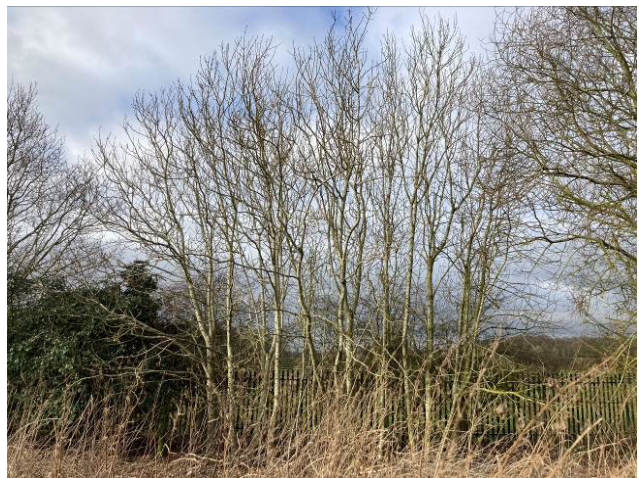
Group G4

| Ref | Tree | Category | Potential Impact of development |
|---|---|---|---|
| G4 | Ash | C2 | The calculated RPA extends into the edge of the area identified for the construction of the soakaway. Minor loss of RPA will not impact the quality of longevity of this tree group. |

| Tree No | Species | Ht (m) | Stem Diam mm@ 1.5m | Canopy Spread (m) | Height of Crown Clearance | Age Class | Est yrs | Overall Condition | Structural condition | Recommendations | BS 5837 Category | RPA Radius (m) |
|---|---|---|---|---|---|---|---|---|---|---|---|---|
| G4 | Ash<br><i>Fraxinus excelsior</i> | 6-7 | <200 | N-3<br>S-3<br>E-3<br>W-3 | 1 | Y | 10 | F | Line of crowded young self-seeded / coppice regeneration. No structural faults visible from ground level | | C2 | 2.4 |

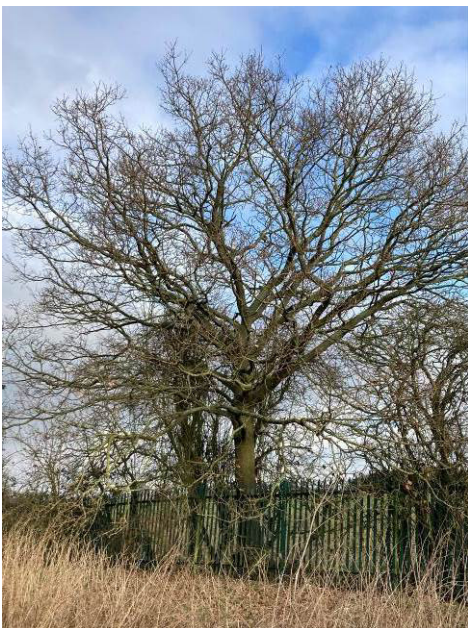
Oak T5

**Oak T5 and Hedgerow H6** are situated outside of the site separated from this by an existing palisade fence. Oak T6 is a tree of good shape and quality with 40 years of useful life expectancy in this location and has been placed into Category A2. The hedgerow comprises untrimmed Hawthorn with some Elder and is placed into Category C2.

| Ref | Tree | Category | Potential Impact of development |
|---|---|---|---|
| T5 | Oak | A2 | The calculated RPA extends into the edge of the area identified for the construction of the soakaway. It is recommended that the shaping of the soakaway should be amended to run along the outside edge of the RPA of this tree rather than disturb ground within this area. The RPA will need to be protected by fencing as the soakaway is constructed. |

| Tree No | Species | Ht (m) | Stem Diam mm@ 1.5m | Canopy Spread (m) | Height of Crown Clearance | Age Class | Est yrs | Overall Condition | Structural condition | Recommendations | BS 5837 Category | RPA Radius (m) |
|---|---|---|---|---|---|---|---|---|---|---|---|---|
| T5 | Oak<br><i>Quercus petraea</i> | 12 | 455 | N-7<br>S-6<br>E-6<br>W-6 | 4 | SM | 4- | G | Broad balanced crown with under canopy Hawthorn and Elder. No structural faults visible from ground level | | A2 | 5.4 |

Both T5 and T7 are located sufficiently close to the area where the soakaway is to be excavated that protection fencing will be required to ensure there is no trafficking by excavators or other vehicles within the calculated RPAs.

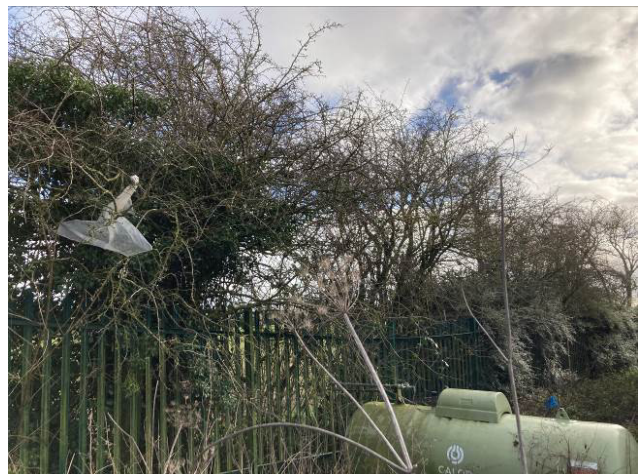
Hedgerow H6

| Ref | Tree | Category | Potential Impact of development |
|---|---|---|---|
| H6 | Hawthorn \ Elder | C2 | No impact from development and no works required to the tree canopy. |

| Tree No | Species | Ht (m) | Stem Diam mm@ 1.5m | Canopy Spread (m) | Height of Crown Clearance | Age Class | Est yrs | Overall Condition | Structural condition | Recommendations | BS 5837 Category | RPA Radius (m) |
|---|---|---|---|---|---|---|---|---|---|---|---|---|
| H6 | Hawthorn<br><i>Crataegus monogyna</i><br>Elder<br><i>Sambucus nigra</i> | 3-5 | <250 | N-3<br>S-3<br>E-3<br>W-3 | 0 | SM | 10 | F | Untrimmed hedgerows dominated by Hawthorn behind the boundary palisade fencing. No structural faults visible from ground level | | C2 | 3.0 |

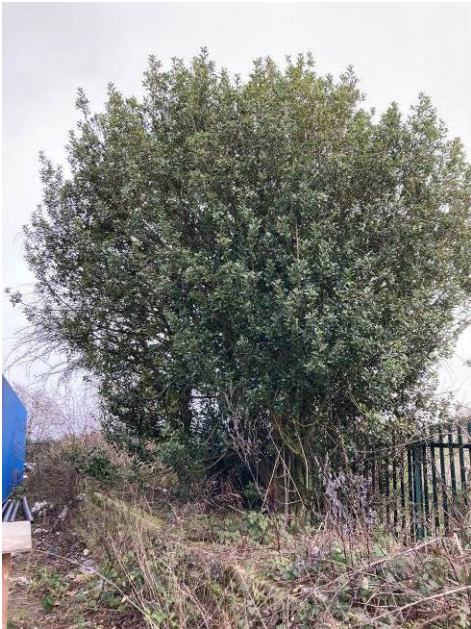
Holly T9

**Holly T9 and Hawthorn T10** are two individual trees on the southern boundary of the site located just outside of the boundary palisade fence. Neither tree is of great stature and both are placed within Category C2.

| Ref | Tree | Category | Potential Impact of development |
|---|---|---|---|
| T9 | Holly | C2 | No impact from development and no works required to the tree canopy. |

| Tree No | Species | Ht (m) | Stem Diam mm@ 1.5m | Canopy Spread (m) | Height of Crown Clearance | Age Class | Est yrs | Overall Condition | Structural condition | Recommendations | BS 5837 Category | RPA Radius (m) |
|---|---|---|---|---|---|---|---|---|---|---|---|---|
| T9 | Holly<br><i>Ilex aquifolium</i> | 5 | 305 | N-3<br>S-2<br>E-3<br>W-3 | 0 | M | 10 | F | Dense and bushy crown with internal regeneration throughout.<br>No structural faults visible from ground level | | C2 | 3.6 |

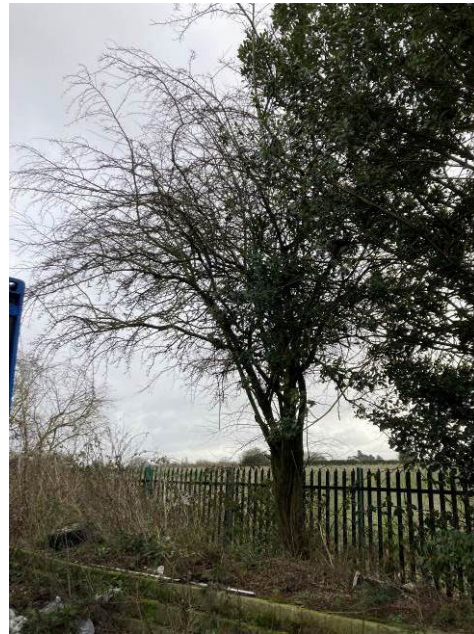
Hawthorn T10

| Ref | Tree | Category | Potential Impact of development |
|---|---|---|---|
| T10 | Hawthorn | C2 | No impact from development and no works required to the tree canopy. |

| Tree No | Species | Ht (m) | Stem Diam mm@ 1.5m | Canopy Spread (m) | Height of Crown Clearance | Age Class | Est yrs | Overall Condition | Structural condition | Recommendations | BS 5837 Category | RPA Radius (m) |
|---|---|---|---|---|---|---|---|---|---|---|---|---|
| T10 | Hawthorn<br><i>Crataegus monogyna</i> | 5 | 185 | N-3<br>S-2<br>E-3<br>W-2 | 2 | SM | 10 | F | Irregular crown extending to the east. Crowded by Holly T9.<br>No structural faults visible from ground level | | C2 | 2.2 |

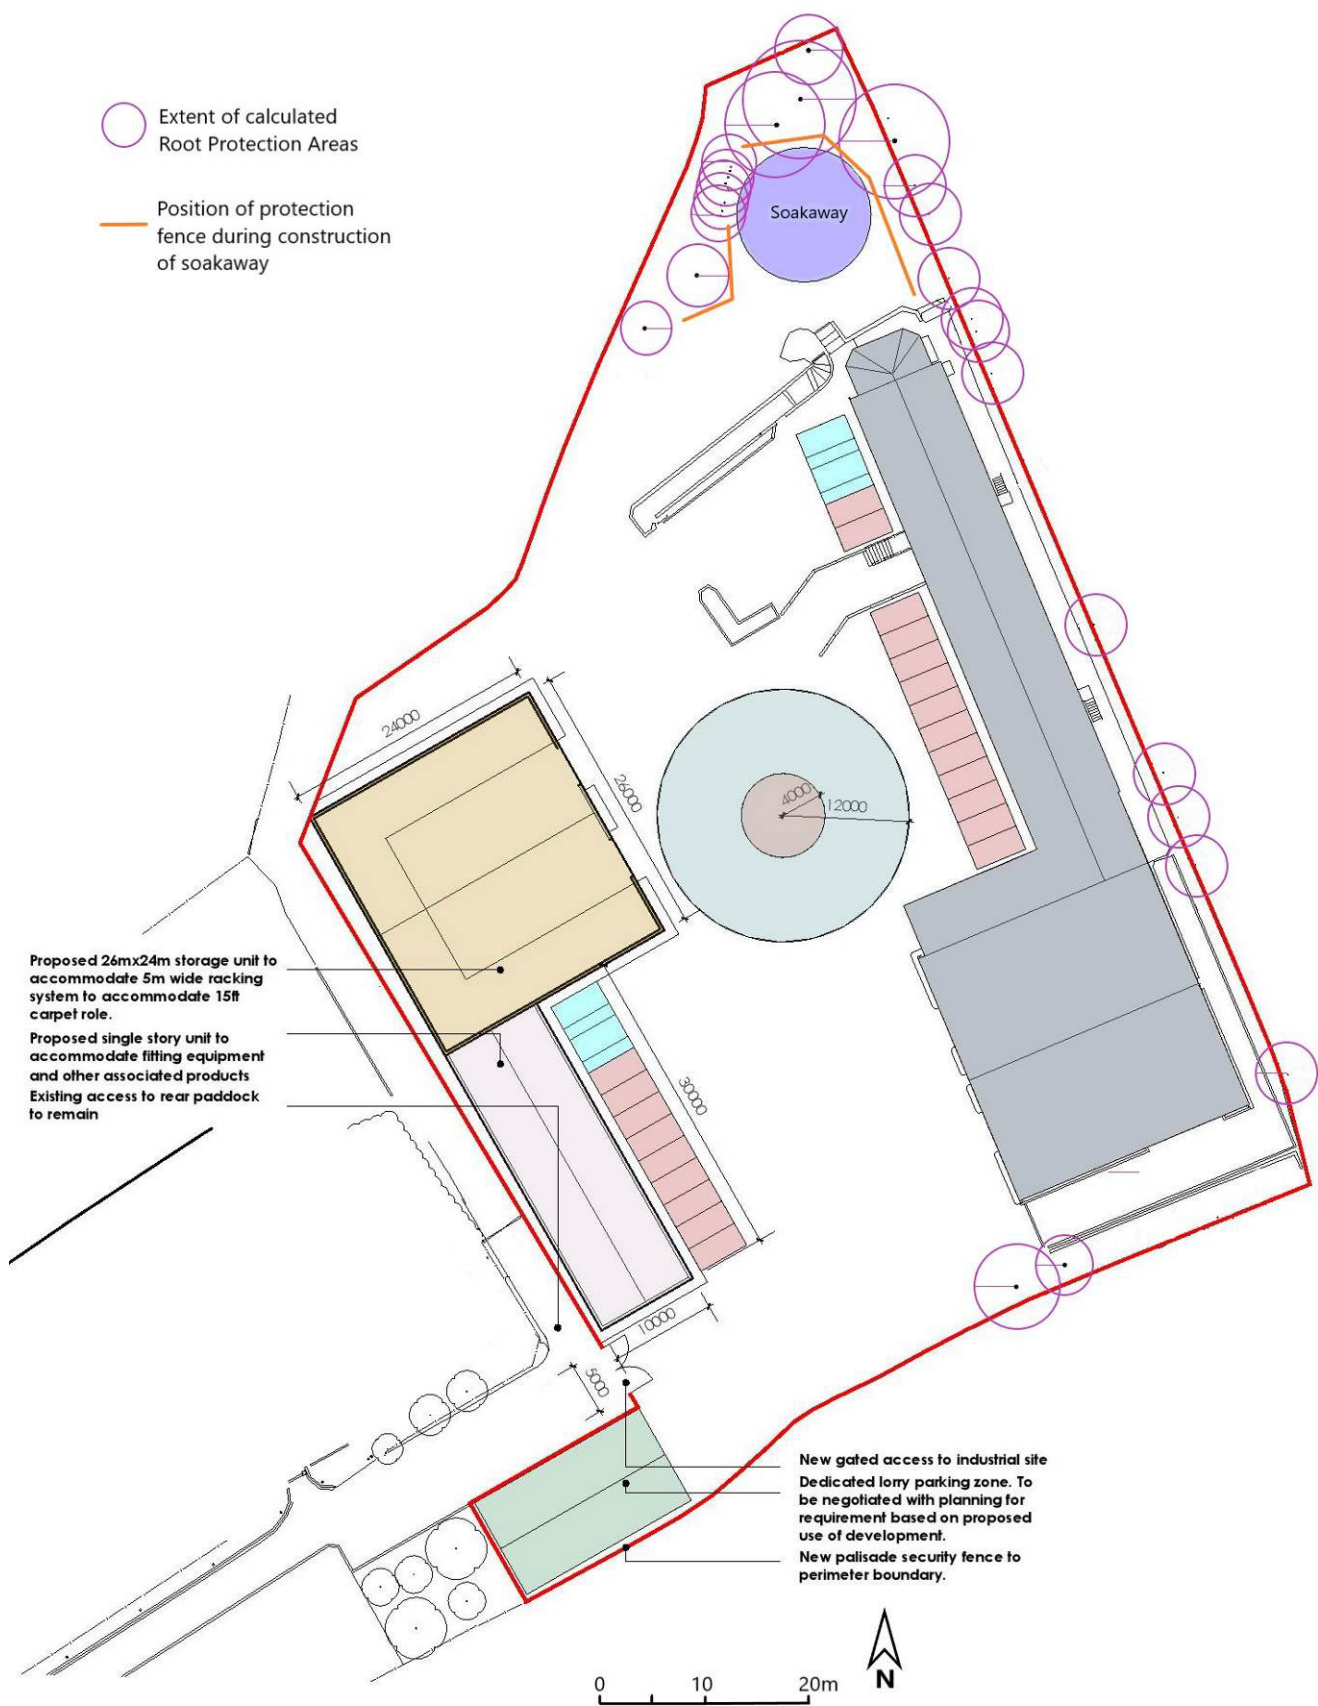
**Figure 4 – Constraints Plan**

At the time this survey was completed no development plan were provided. The calculated RPAs are shown within **Figure 4** to provide guidance for the development layout.
