# **Structural Inspection Report for the Existing Barn at Pretty Oak Farm, Upton Lane, Stoke Golding Nuneaton, Warwickshire CV13 6EV**

Reference: 82875-01

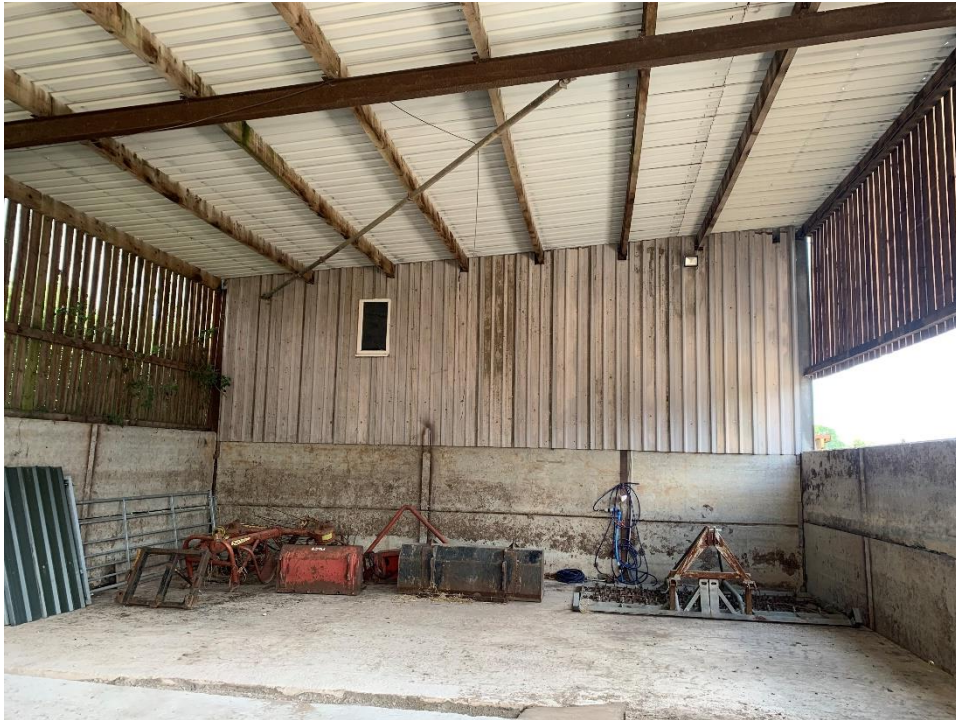
- 2.2 The barn was a single storey steel framed building which was clad using a combination of vertical timber joists, pre-cast concrete panels and profiled steel sheeting. The roof was covered with a single layer of profiled steel sheeting and supported by timber purlins spanning between steel rafters. The intermittent timber joist cladding at high level was supported by horizontal timber rails spanning between the steel stanchions. The pre-cast concrete panels at lower level spanned horizontally between steel stanchions and were supported by the inner and outer flanges of the stanchion (photograph 1).

Photograph 1 – Internal view of left hand side of barn

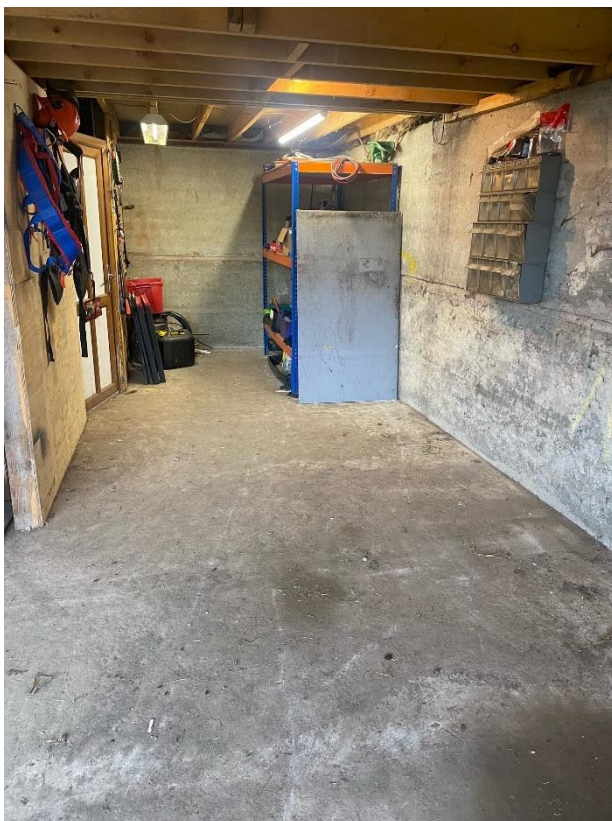
- 2.3 There was a mezzanine floor to the right hand end of the building formed in timber and supported by timber partitions, which in turn were built from the concrete ground bearing slab (photograph 2).

Photograph 2 – Mezzanine floor to right hand end of barn

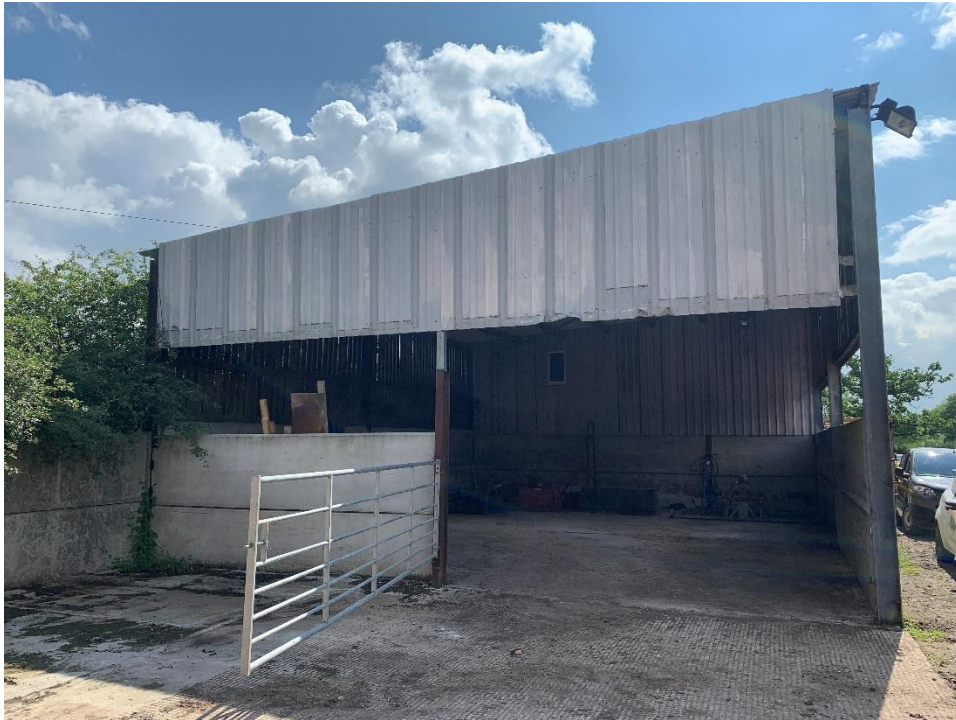
- 2.4 A full height division wall separated the barn into two distinct areas.
- 2.5 The left hand gable end of the building was partially clad at high level using profiled steel sheeting and open at the lower level (photograph 3).

Photograph 3 – left hand gable end wall

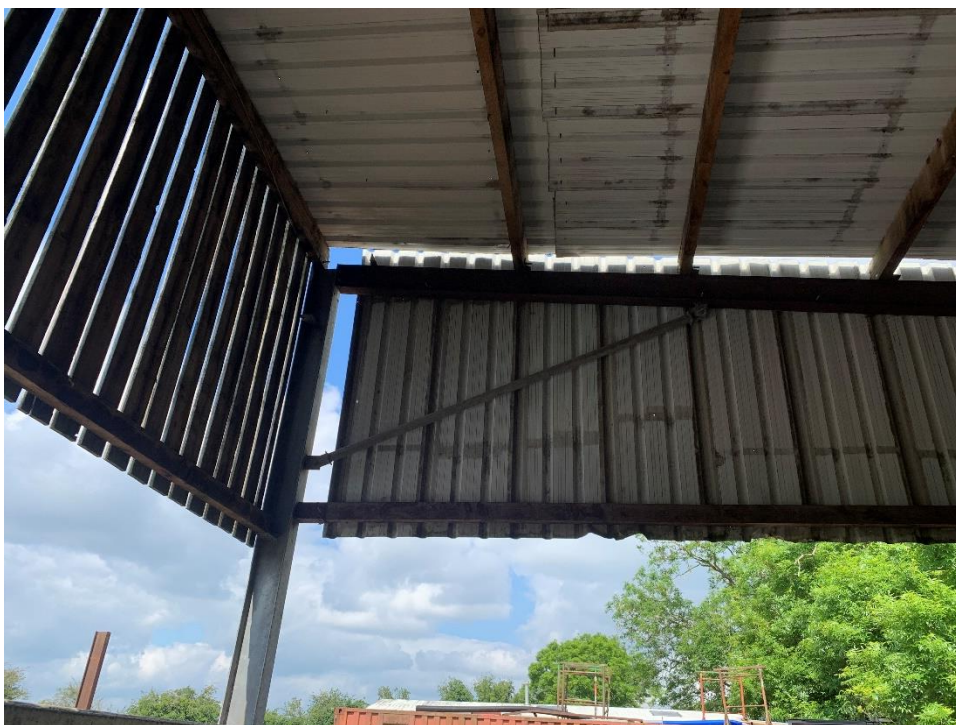
- 3.1 The building appeared to be in a good overall general condition with no obvious indications of structural distress.
- 3.2 The walls were perforated and following development will most likely attract additional wind loading to the steel frame. The frame will need to be assessed by a suitably qualified engineer to ensure the frame has the capacity to sustain the additional loading without undue distortion (photograph 4).

Photograph 4 – Perforated timber and steel profiled sheet cladding

- 4.1 The building was in a good overall structural condition and suitable for conversion to residential use.
- 4.2 The frame should be assessed by a suitably qualified engineer to ensure that any additional loads placed upon it, as a result of a conversion to a residential property, can be safely sustained without undue distortion.
- 4.3 The roof, walls and ground bearing concrete floor slab will need to be thermally upgraded.
- 4.4 The rafter to stanchion connections at eaves level will require enhancement, by the provision of a steel haunch, to secure the connection and provide additional stiffness to the frame.
- 4.5 Foul and surface water drainage systems will need to be provided either by the connection into existing mains drainage systems or the provision of a septic tank and sustainable surface water drainage.

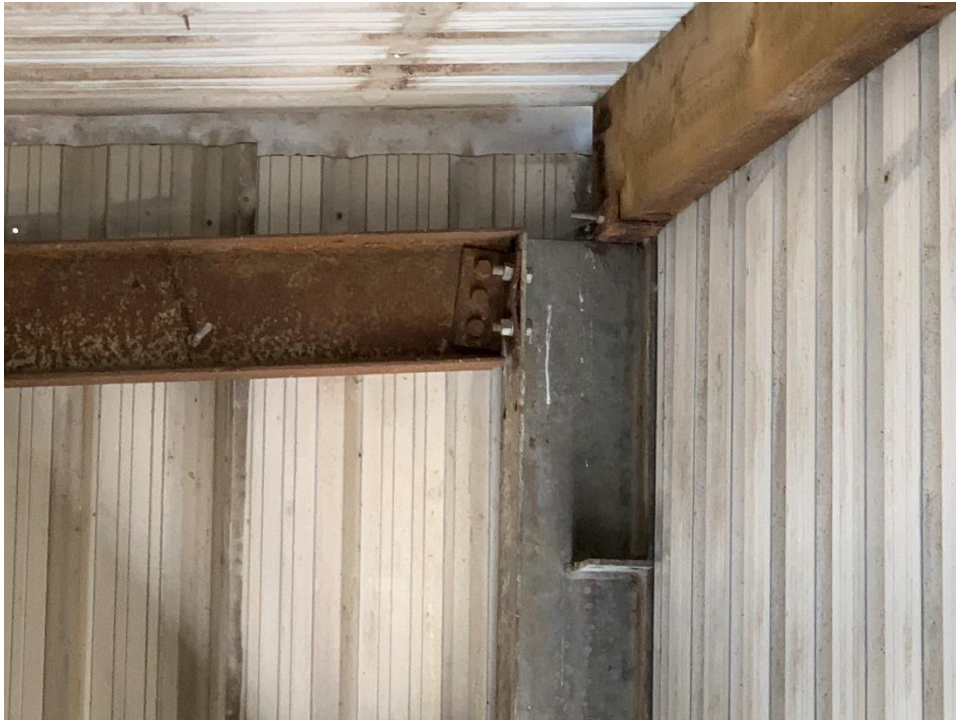
- 3.4 There was some distortion in some of the steel to steel connections at eaves level. It is anticipated that the connections will need to be enhanced by the provision of a steel haunch to stiffen the frame (photograph 5).

Photograph 5 – Distortion of the rafter/stanchion connection at eaves level
