ARBORICULTURAL REPORT

to BS 5837:2012 at:

Phase 2:
***Stanton under Bardon,
Markfield,
LE67 9TQ***

Reference: AWA6724

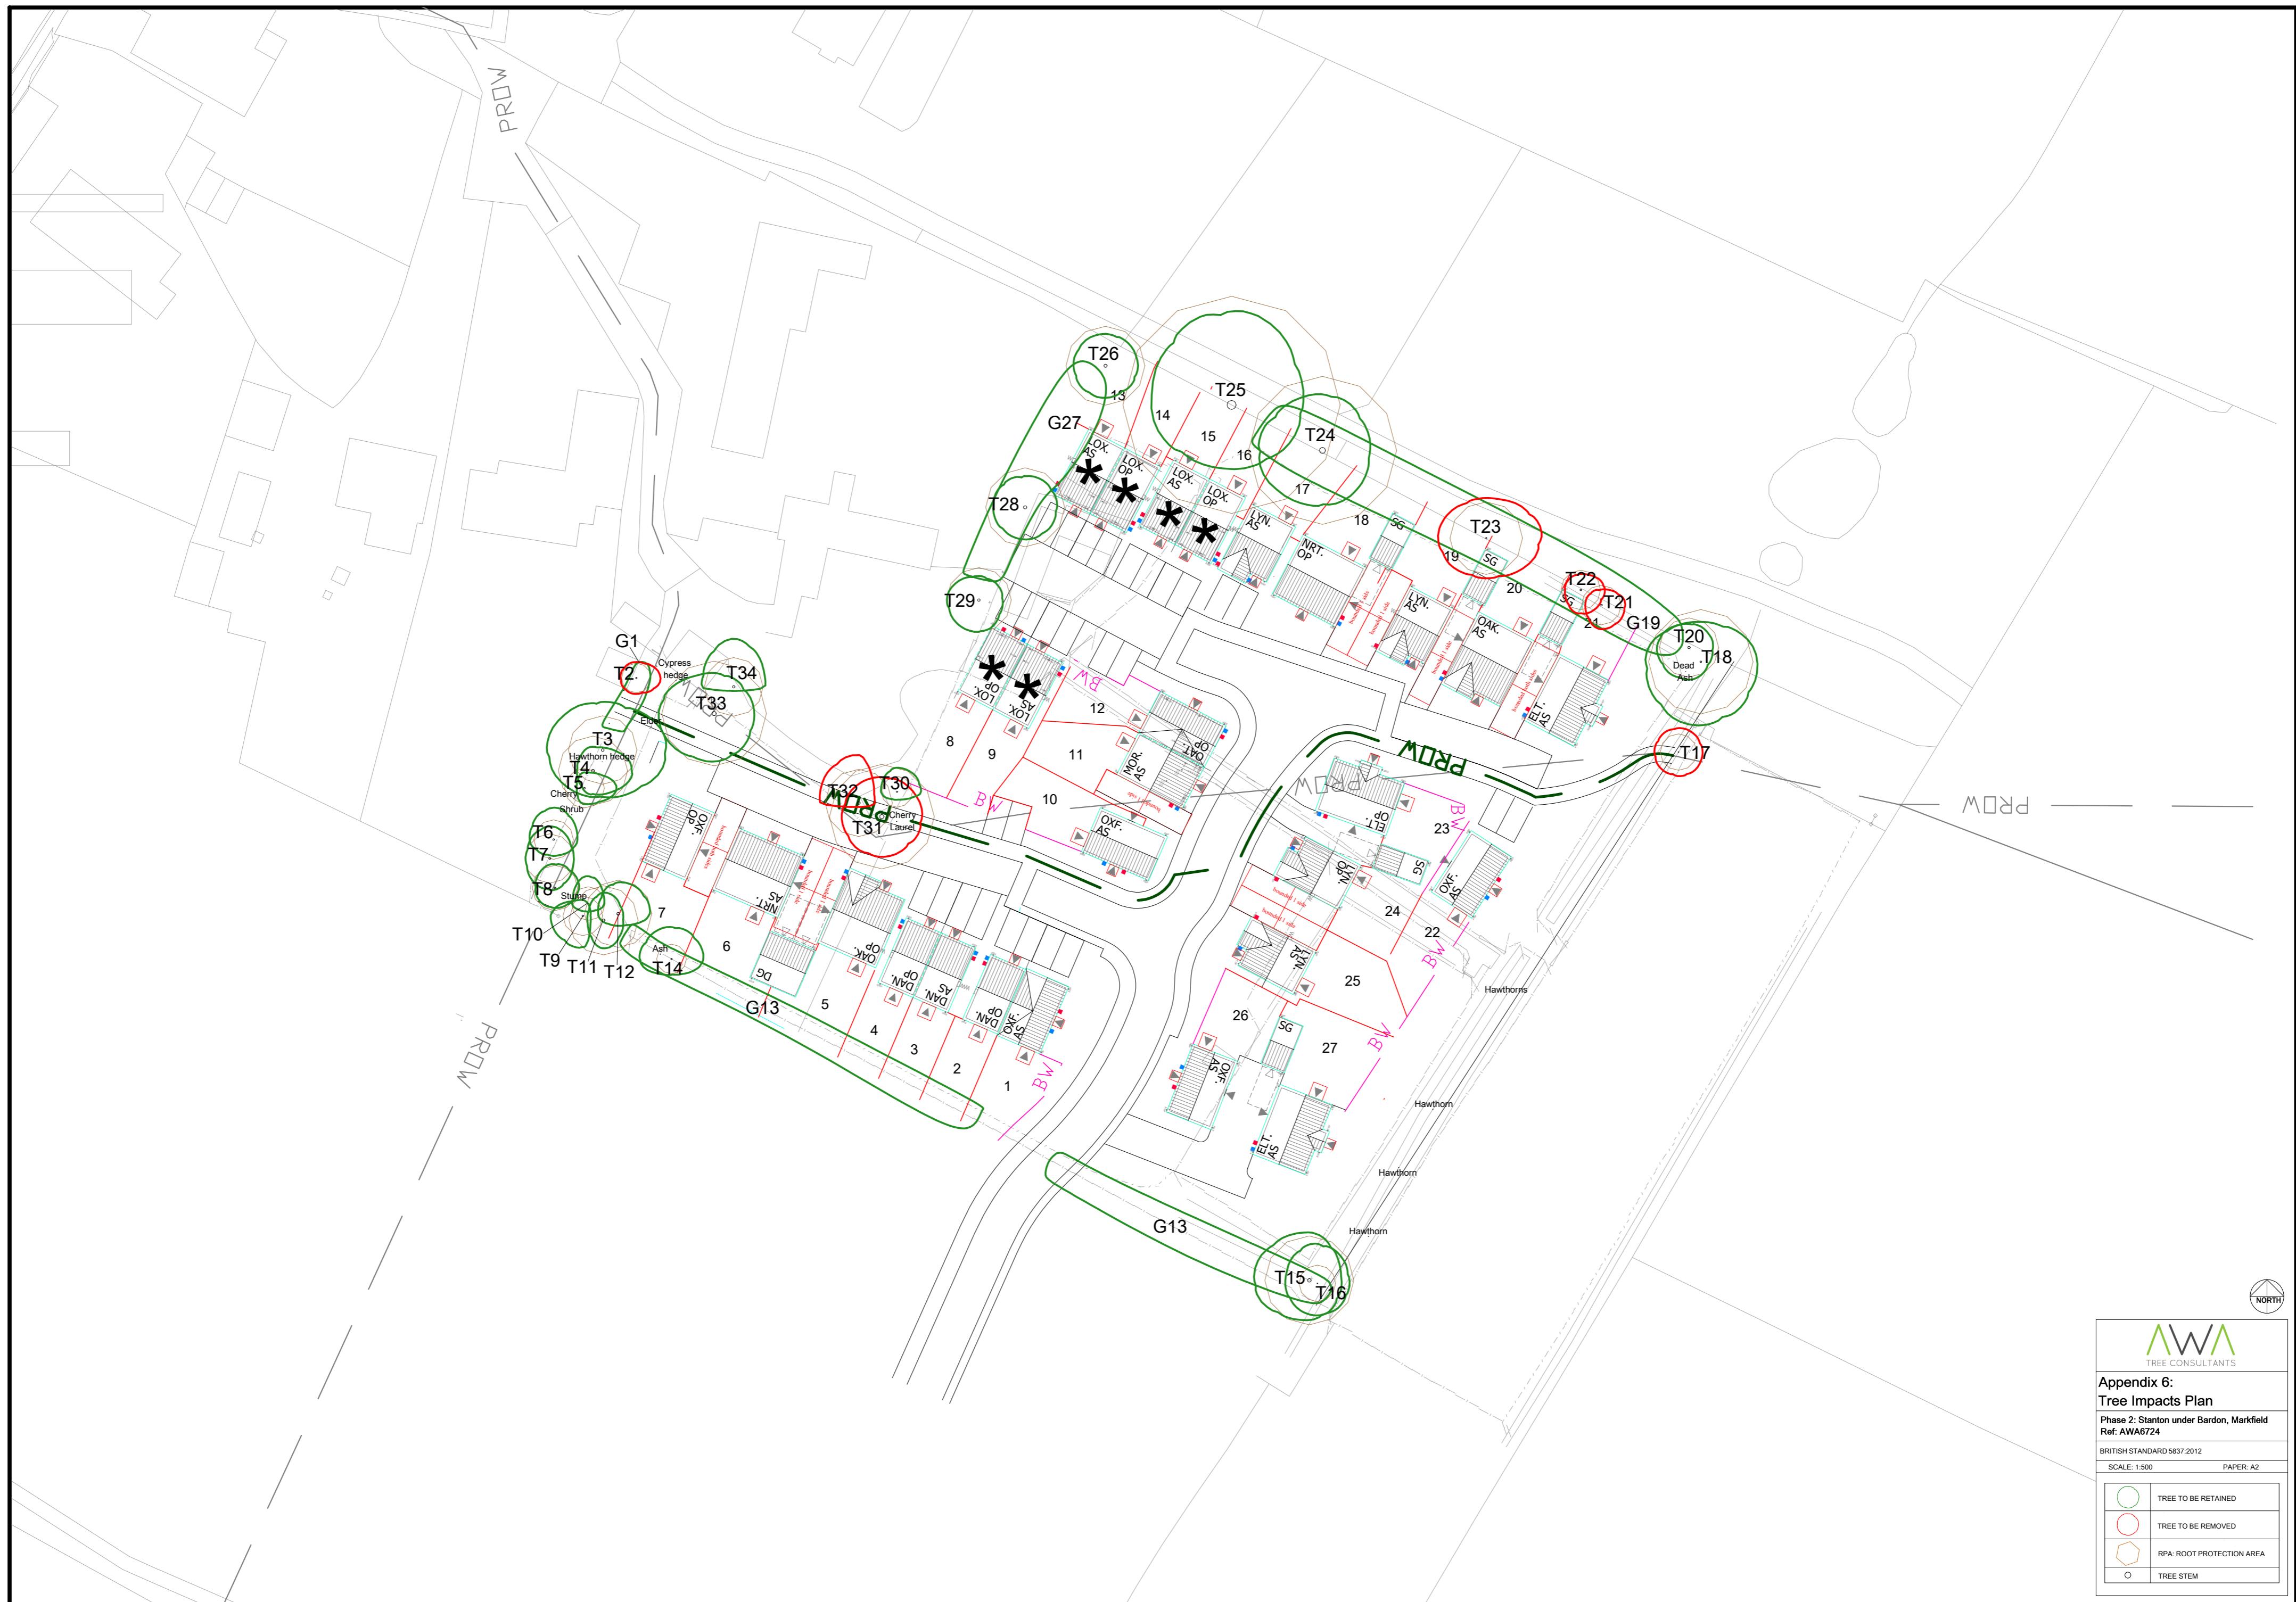
Appendix 6: Tree Impacts Plan

4.2.2 The trees that require removal to facilitate the development are T17, T21, T22, T23, T31, and T32.

4.3.2 Potentially damaging activities are proposed in the vicinity of retained trees. The new development encroaches into the RPAs of T24, T25, T28 and T29. The construction within the RPA may have negative impacts on tree roots. For T24, T28 and T29 the encroachment is very minor. However, within the RPA of T25, it should be possible to employ special foundation design such as mini/micro pile and suspended beam or a cantilevered foundation, in order to overcome or minimise any negative impact on the tree roots.

4.3.4 Potentially damaging activities are proposed in the vicinity of retained trees. New boundary fencing is proposed within the RPAs of T11, T12, G13, T14, G19, T24, T25, G27, and T30. The encroachment into the trees' RPAs should not significantly adversely impact on the health or future condition of the trees, provided the fence is adjusted to accommodate the stem of

4.2.7 Cherry T11, Birch T12 and Apple T14 require minor pruning works to facilitate the proposed new fencing. Crown lift these trees to 3m to provide adequate clearance for the proposed fencing.

4.2.8 Ash T28 and Norway Maple T29 require minor pruning works to facilitate the proposed new parking bays. Crown lift these trees to 3m to provide adequate clearance for the proposed new parking.

4.2.9 Oak T24 and Ash T25 require pruning works to require crown lifting to facilitate the new development. Crown lift both trees to 3.5m from ground level to provide the required clearance for the proposed gardens.

development. Crown reduce their southern crowns by 2m to provide adequate clearance for the proposed development. Whilst the crown reductions will provide clearance for the proposed development, the crowns will still significantly overhang into the proposed garden areas.
