## TREE INVENTORY REPORT

### RATBY LIBRARY

13<sup>th</sup> April 2023

Ratby Library  
No.62 Main Street  
Ratby  
Leicester  
LE6 0LL

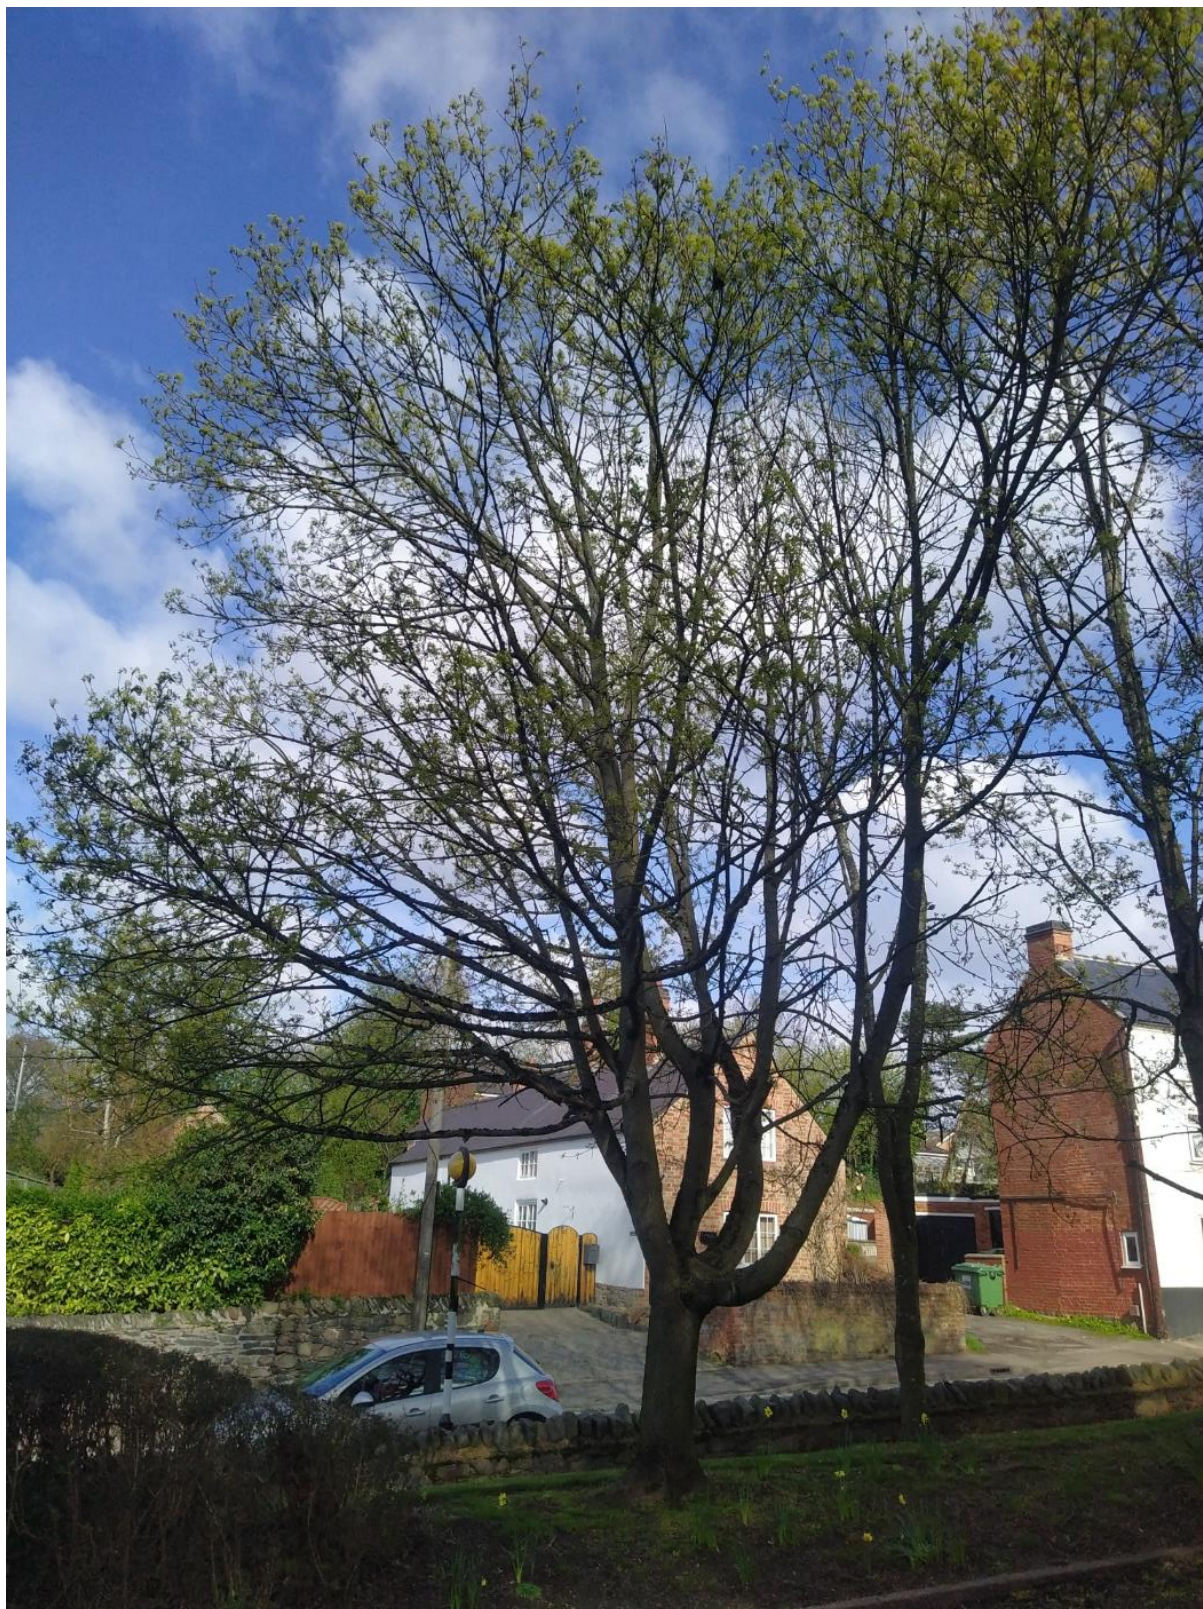
**T001: Norway Maple (*Acer platnoides*)**

| Location: | Ratby Library, No.62, Main Street, Ratby, Leicester, LE6 0LL | Client: | Debbie Huxtable | | Date: | 13 <sup>th</sup> April 2023 | Reference: | SEV230403 | |
|---|---|---|---|---|---|---|---|---|---|
| 0001 | Norway Maple ( <i>Acer platanoides</i> ) | SM | 320 | 11 | 8 , 10 | <b>Physiologically:</b> Good<br><b>Structurally:</b> Fair<br>This tree's multi-stemmed framework is borne from the bifurcation at 1.5m on the main stem. The North side of the crown contains moderate deadwood. Branches on the western side of the crown are encroaching on the highway. | Shorten branch tips on the Western side of the crown to provide 5.2m clearance above the highway<br><br>Remove deadwood over 50mm diameter. | 3 | 24 |
| 0002 | Common Ash ( <i>Fraxinus excelsior</i> ) | EM | 220 | 11 | 5 , 6 | <b>Physiologically:</b> Fair<br><b>Structurally:</b> Fair<br>This tree is sparse in healthy bud development, only those branches within the lower crown appear to be healthy. Branches on the western side of the crown are encroaching on the highway. Branches in the north side of the crown are also touching the adjacent phone cable. | Re-inspect in late spring/summer to assess the tree's vitality.<br><br>Shorten branch tips on the Western side of the crown to provide 5.2m clearance above the highway<br><br>Provide 1m clearance to the adjacent phone line | 1<br><br>3 | 3 |

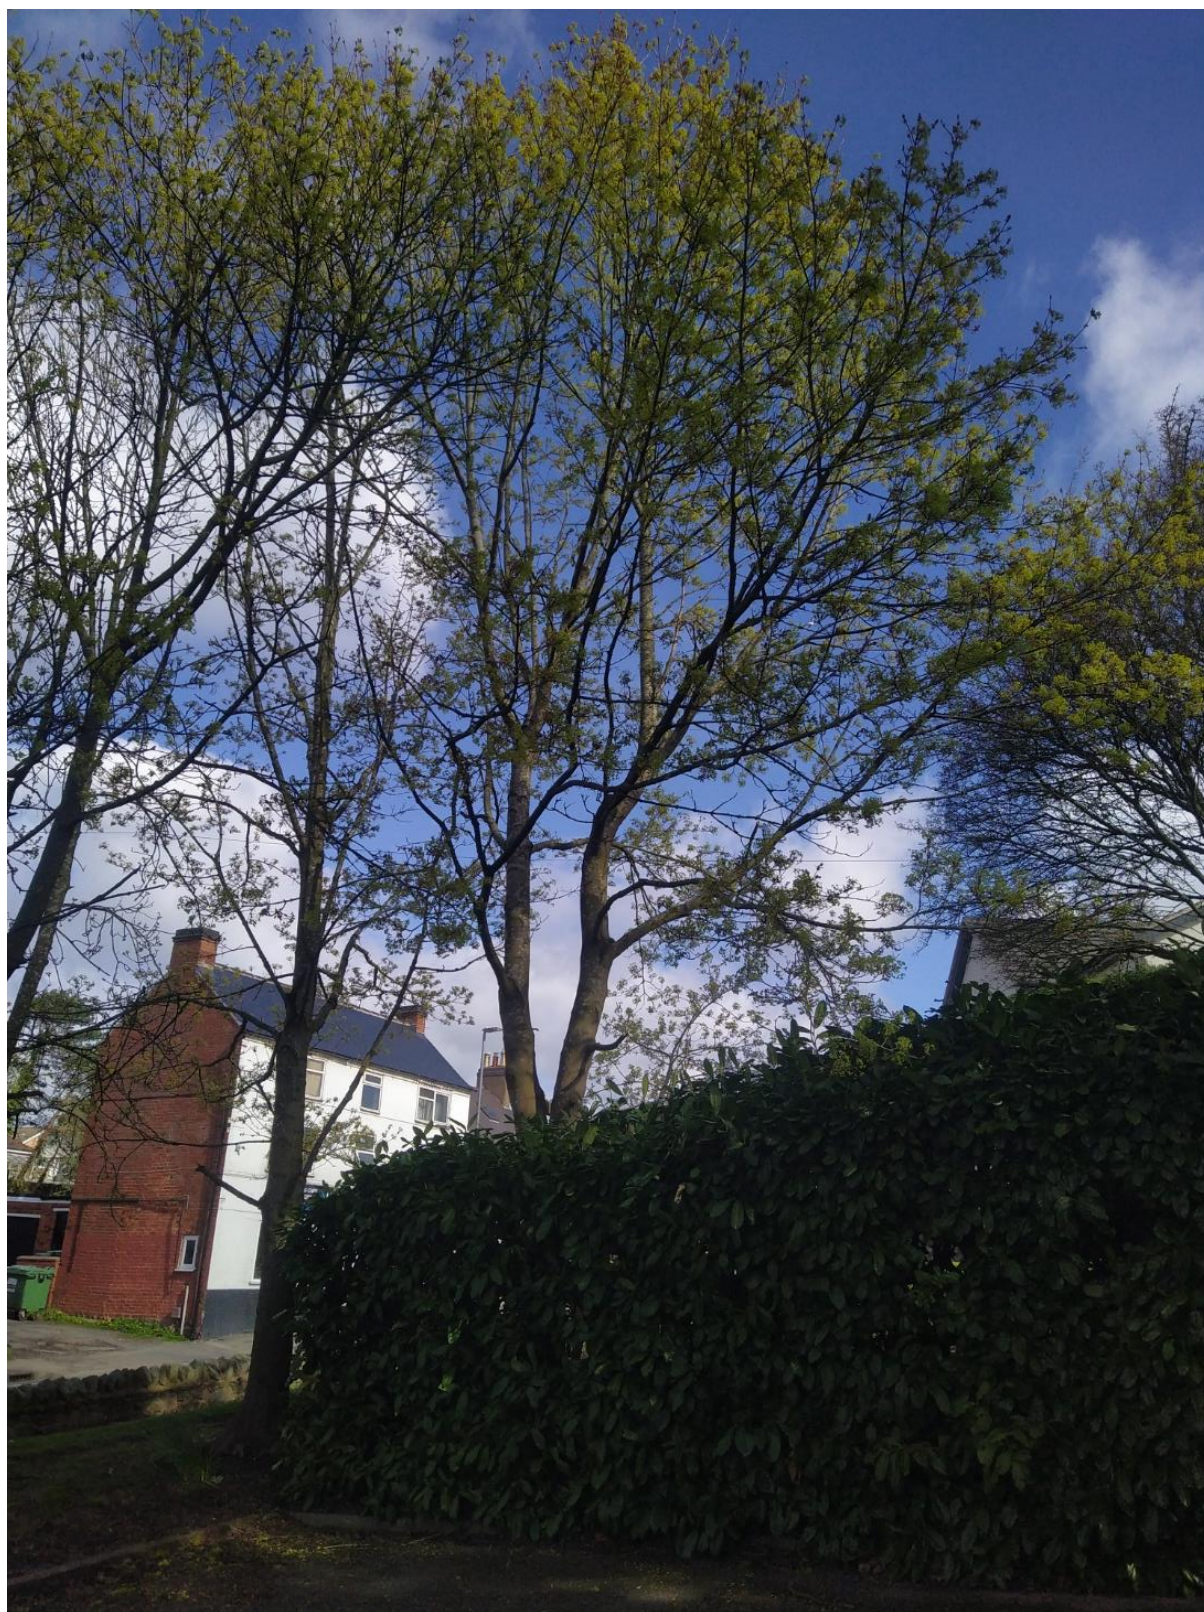
**T003: Norway Maple (*Acer platnoides*)**

| Location: | Ratby Library, No.62, Main Street, Ratby, Leicester, LE6 0LL | Client: | Debbie Huxtable | | Date: | 13 <sup>th</sup> April 2023 | Reference: | SEV230403 | |
|---|---|---|---|---|---|---|---|---|---|
| 0003 | Norway Maple ( <i>Acer platanoides</i> ) | SM | 300 | 14 | 7 , 6 | <b>Physiologically:</b> Good<br><b>Structurally:</b> Good<br>A well-formed single stemmed specimen. A number of small diameter branches are encroaching on the adjacent phone line. Minor deadwood can be seen throughout the crown. | Provide 1m clearance to the adjacent phone line<br><br>Remove deadwood over 50mm diameter | 3 | 24 |

| Tree Number | Species | Age Class | Diameter (mm) | Est Height (m) | Crown Spread: N-S , E-W (m) | Condition | Recommendations | Priority | Inspection Frequency |
|---|---|---|---|---|---|---|---|---|---|
| 0004 | Norway Maple<br>( <i>Acer platanoides</i> ) | SM | 380 | 14 | 9 , 10 | <b>Physiologically:</b> Good<br><b>Structurally:</b> Good<br>The main stem of this tree bifurcates at 2m to produce a co-dominant framework. Minor deadwood is present throughout the crown. Low branches are overhanging the car parking bays. Branches in the north side of the crown are encroaching on the adjacent phone line. | Provide 1m clearance to the adjacent phone line<br><br>Remove deadwood over 50mm diameter<br><br>Crown lift to 3.5m over the car park | 3 | 36 |

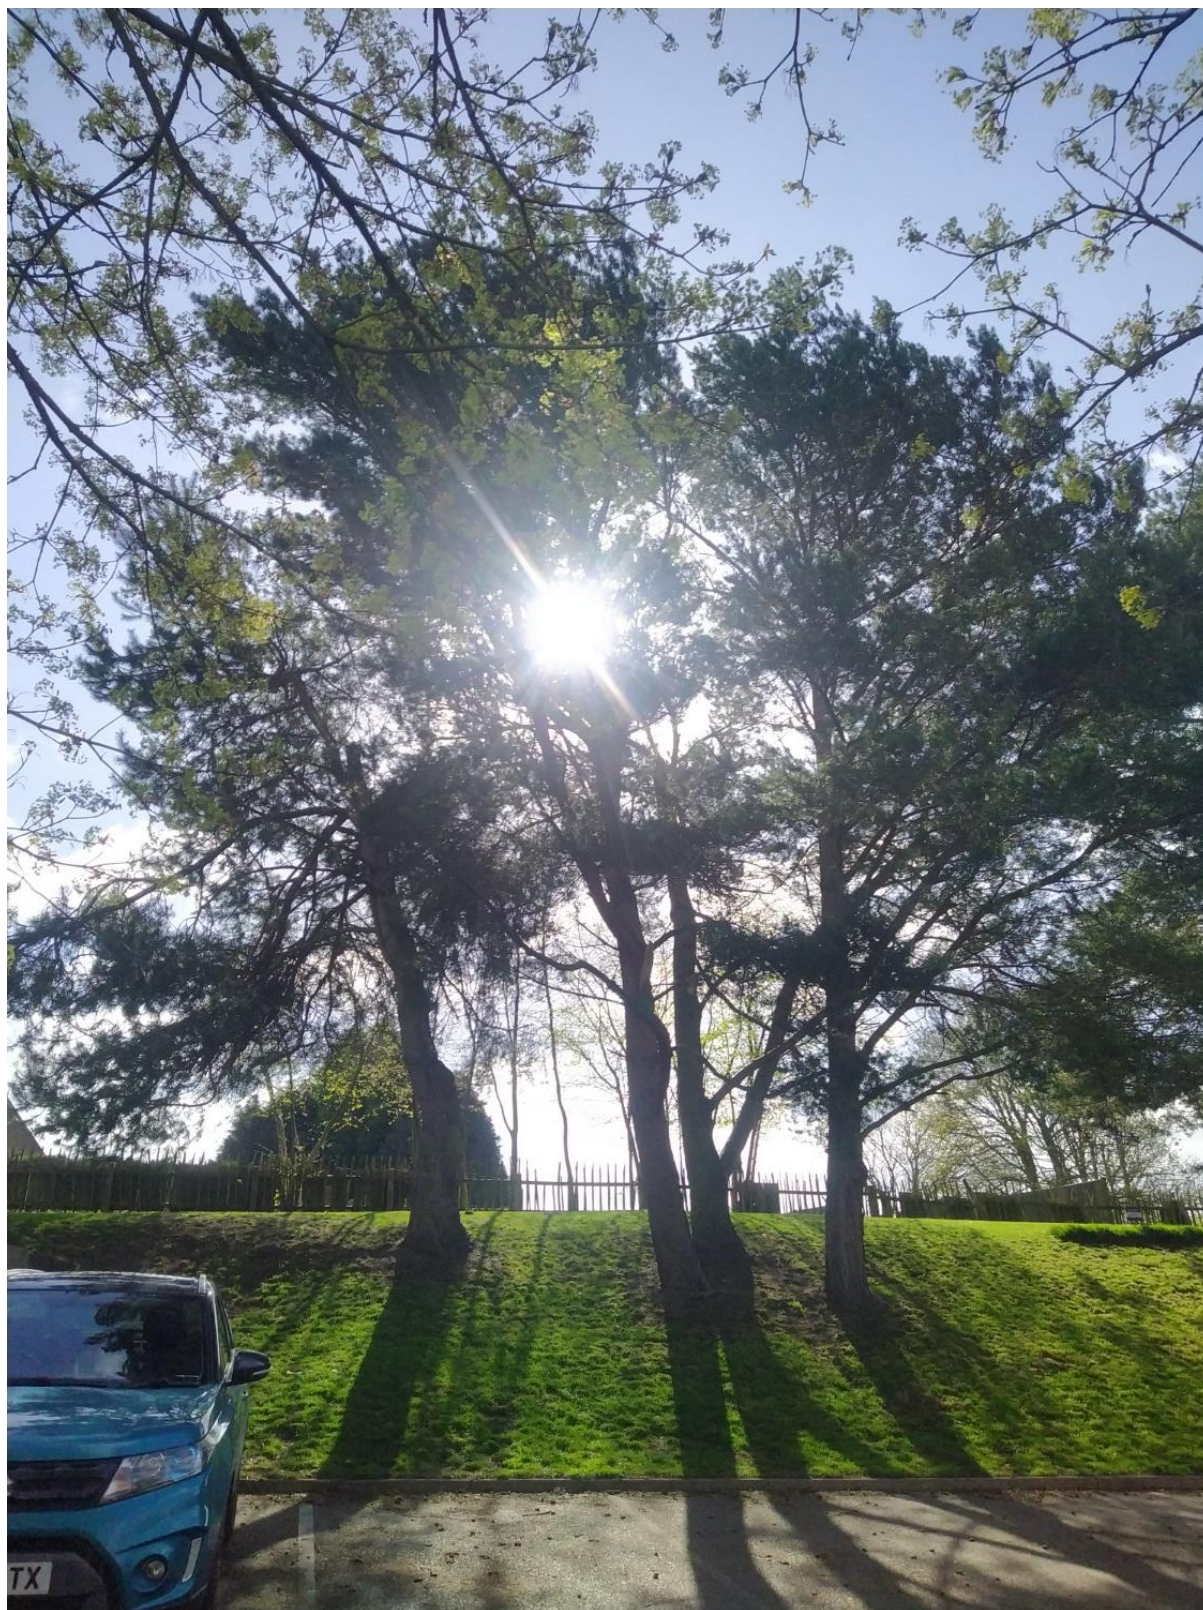
**T005: Corsican Pine (*Pinus nigra*)**  
**T006, T007, T008: Scots Pine (*Pinus sylvestris*)**

| Tree Number | Species | Age Class | Diameter (mm) | Est Height (m) | Crown Spread: N-S , E-W (m) | Condition | Recommendations | Priority | Inspection Frequency |
|---|---|---|---|---|---|---|---|---|---|
| 0005 | Corsican Pine<br>( <i>Pinus nigra</i> ) | M | 520 | 12 | 9 , 10 | <b>Physiologically:</b> Good<br><b>Structurally:</b> Fair<br>This tree has a northward lean. The top of the crown has seen historic storm damage with an old failure wound at approximately 8m. The crown's main branch structure is also significantly weighted on the North side. A limb originating on the North-East side at 6.4m is being braced by branches within the lower crown and is at risk of failure. Another branch originating on the North side at 5.4m is at risk of failure due to its slender form and exposure to weather stresses. | Reduce branch originating at 6.4m back by approximately 4m to a suitable growth point.<br><br>Reduce branch originating at 5.4m back by approximately 3m to a suitable growth point. | 1 | 24 |
| 0006 | Scots Pine<br>( <i>Pinus sylvestris</i> ) | SM | 430 | 14 | 8 , 10 | <b>Physiologically:</b> Good<br><b>Structurally:</b> Fair<br>A narrowly formed tree due to its proximity to adjacent trees. The stems that make up the upper crown are slender and now exposed due to the failures within the crowns of adjacent trees. An old branch stub from a previous failure is present at 3m on the West side | Reduce crown's height by up to 3m to minimise the risk of wind snap in the upper crown<br><br>Reduce lateral branches on the west side by up to 1.5m | 1 | 36 |

| Tree Number | Species | Age Class | Diameter (mm) | Est Height (m) | Crown Spread: N-S, E-W (m) | Condition | Recommendations | Priority | Inspection Frequency |
|---|---|---|---|---|---|---|---|---|---|
| 0007 | Scots Pine (Pinus sylvestris) | M | 530 | 12 | 10 , 8 | <b>Physiologically:</b> Good<br><b>Structurally:</b> Fair<br>The main stem bifurcates at 1.1m. The Northern stem has previously had its top fail. The Southern stem is intact but is now becoming weighted and exposed. | Reduce Southern stem by approximately 3m | 2 | 36 |
| 0008 | Scots Pine (Pinus sylvestris) | M | 440 | 14 | 9 , 9 | <b>Physiologically:</b> Good<br><b>Structurally:</b> Good<br>A well-formed single stemmed tree. Works to the adjacent trees will increase exposure to weather stresses to the upper crown. | Reduce the height of the tree by up to 2m ideally at the same time as the works to T005, T006, and T007 | 2 | 36 |

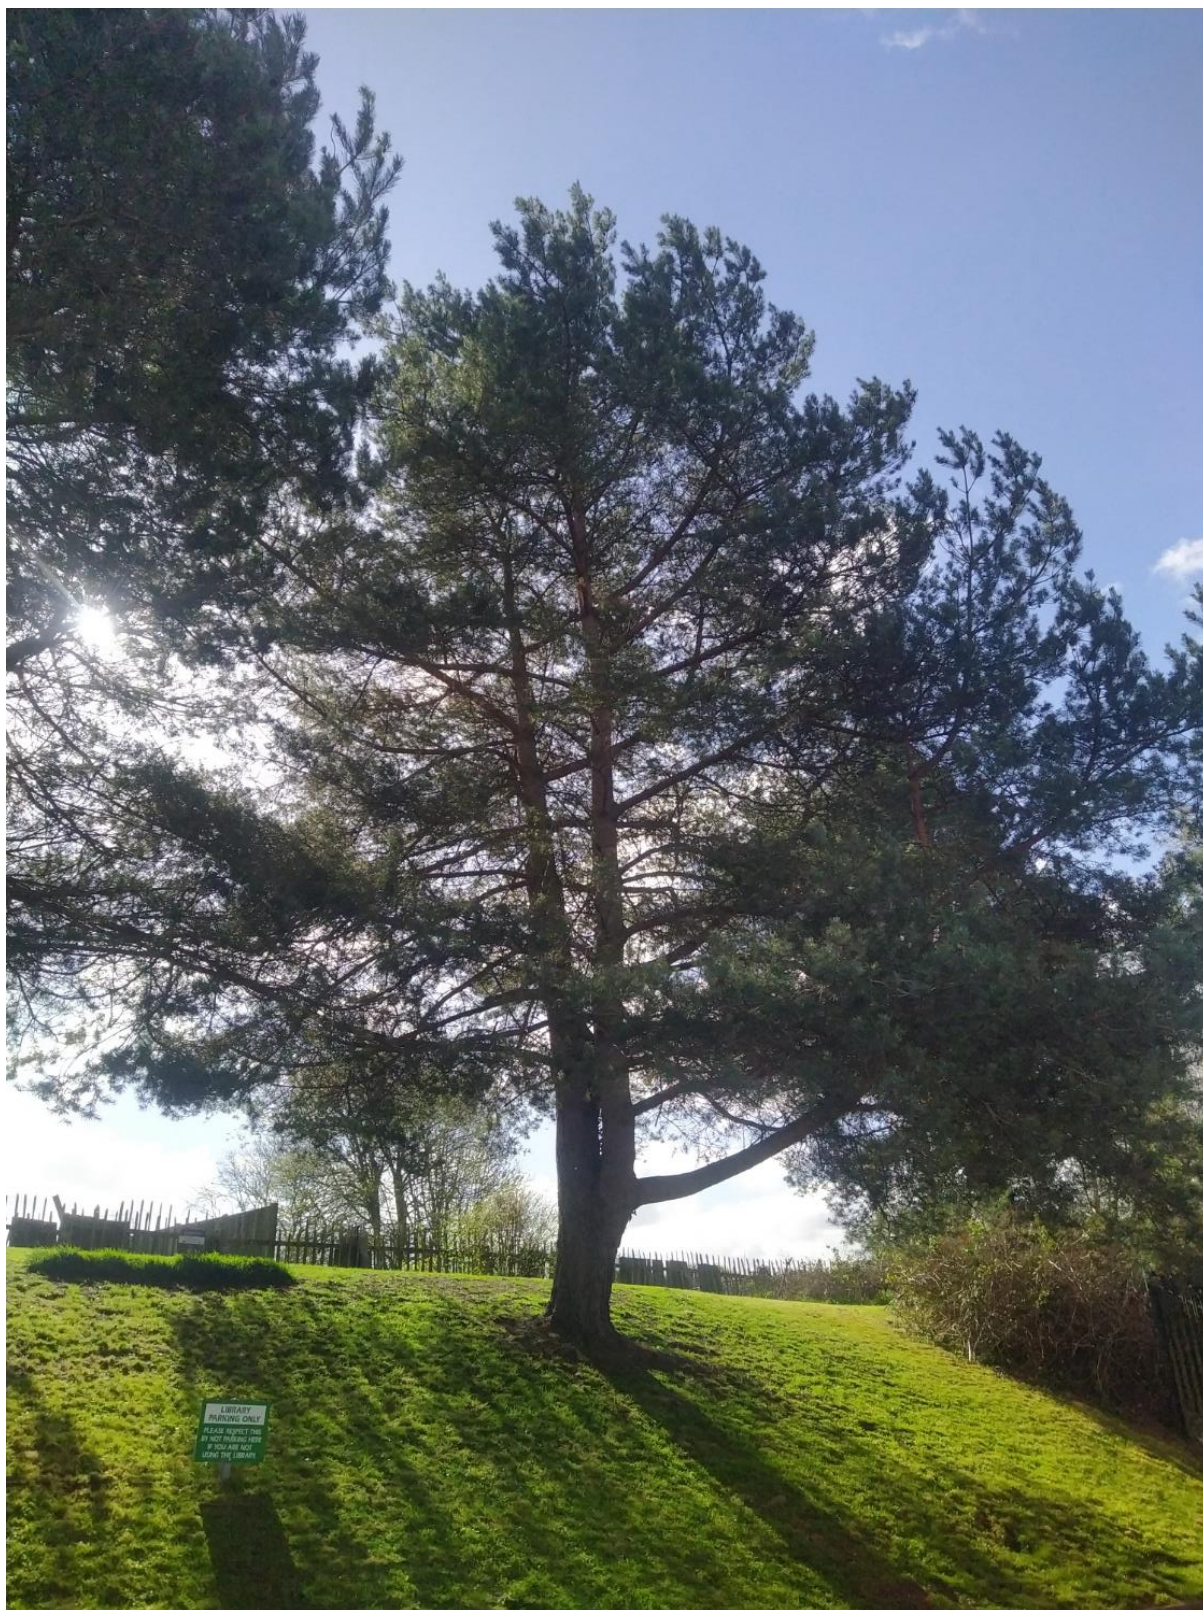
### T009: Scotts Pine (*Pinus sylvestris*)

| Tree Number | Species | Age Class | Diameter (mm) | Est Height (m) | Crown Spread: N-S, E-W (m) | Condition | Recommendations | Priority | Inspection Frequency |
|---|---|---|---|---|---|---|---|---|---|
| 0009 | Scots Pine (Pinus sylvestris) | M | 670 | 14 | 12 , 12 | <b>Physiologically:</b> Good<br><b>Structurally:</b> Good<br>A single standing tree which is twin stemmed from 1.6m. The west side of the crown has 3 branches overhanging the car park at 3m, 6.4m and 7.3m. | Reduce the 3 branches overhanging the car park by 2m | 3 | 36 |

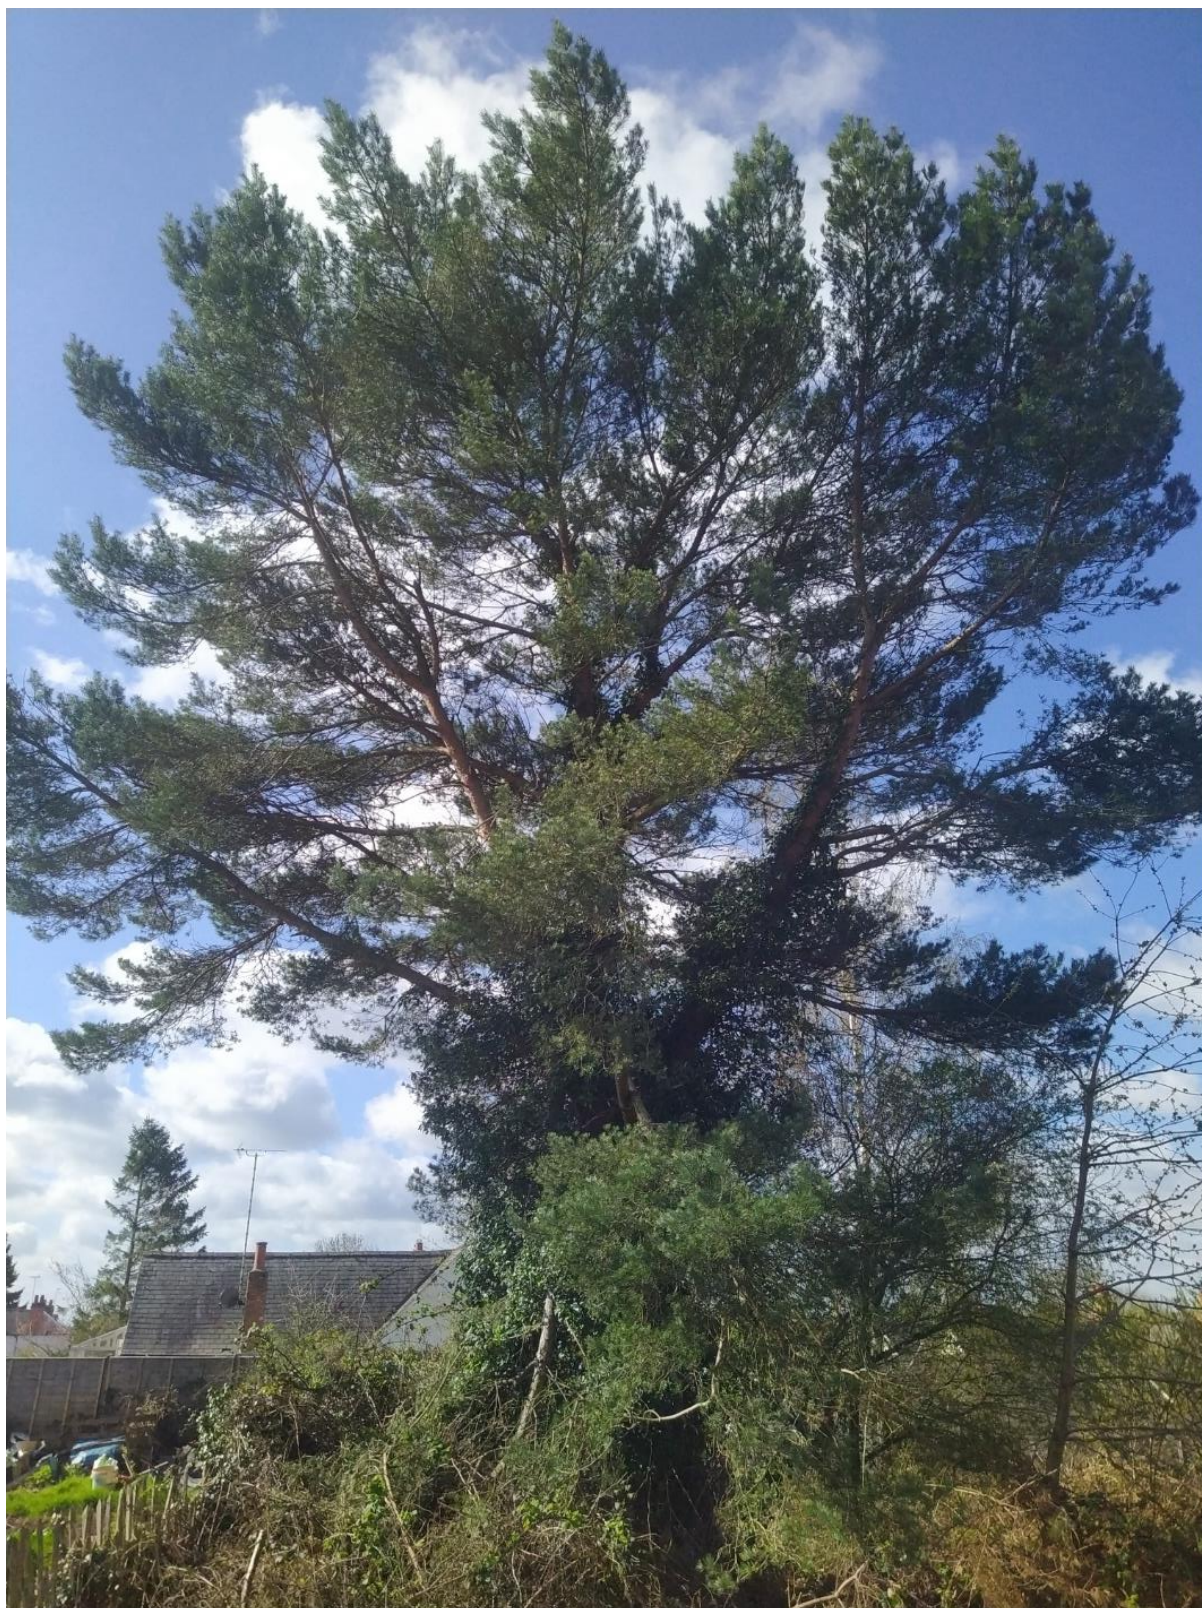
**T010: Scotts Pine (*Pinus sylvestris*)**

| Tree Number | Species | Age Class | Diameter (mm) | Est Height (m) | Crown Spread: N-S, E-W (m) | Condition | Recommendations | Priority | Inspection Frequency |
|---|---|---|---|---|---|---|---|---|---|
| 0010 | Scots Pine (Pinus sylvestris) | M | 550 | 15 | 12 , 12 | <b>Physiologically:</b> Good<br><b>Structurally:</b> Good<br>An Ivy clad tree located behind the library in an area of scrubland. Ivy extends up to 10m and is preventing inspection of the tree's main branch unions. There is evidence of multiple historic branch failures throughout the crown. | Sever Ivy<br>Reduce crown by 2.5m to provide a better framework and reduce the risk of further branch failures | 2 | 36 |

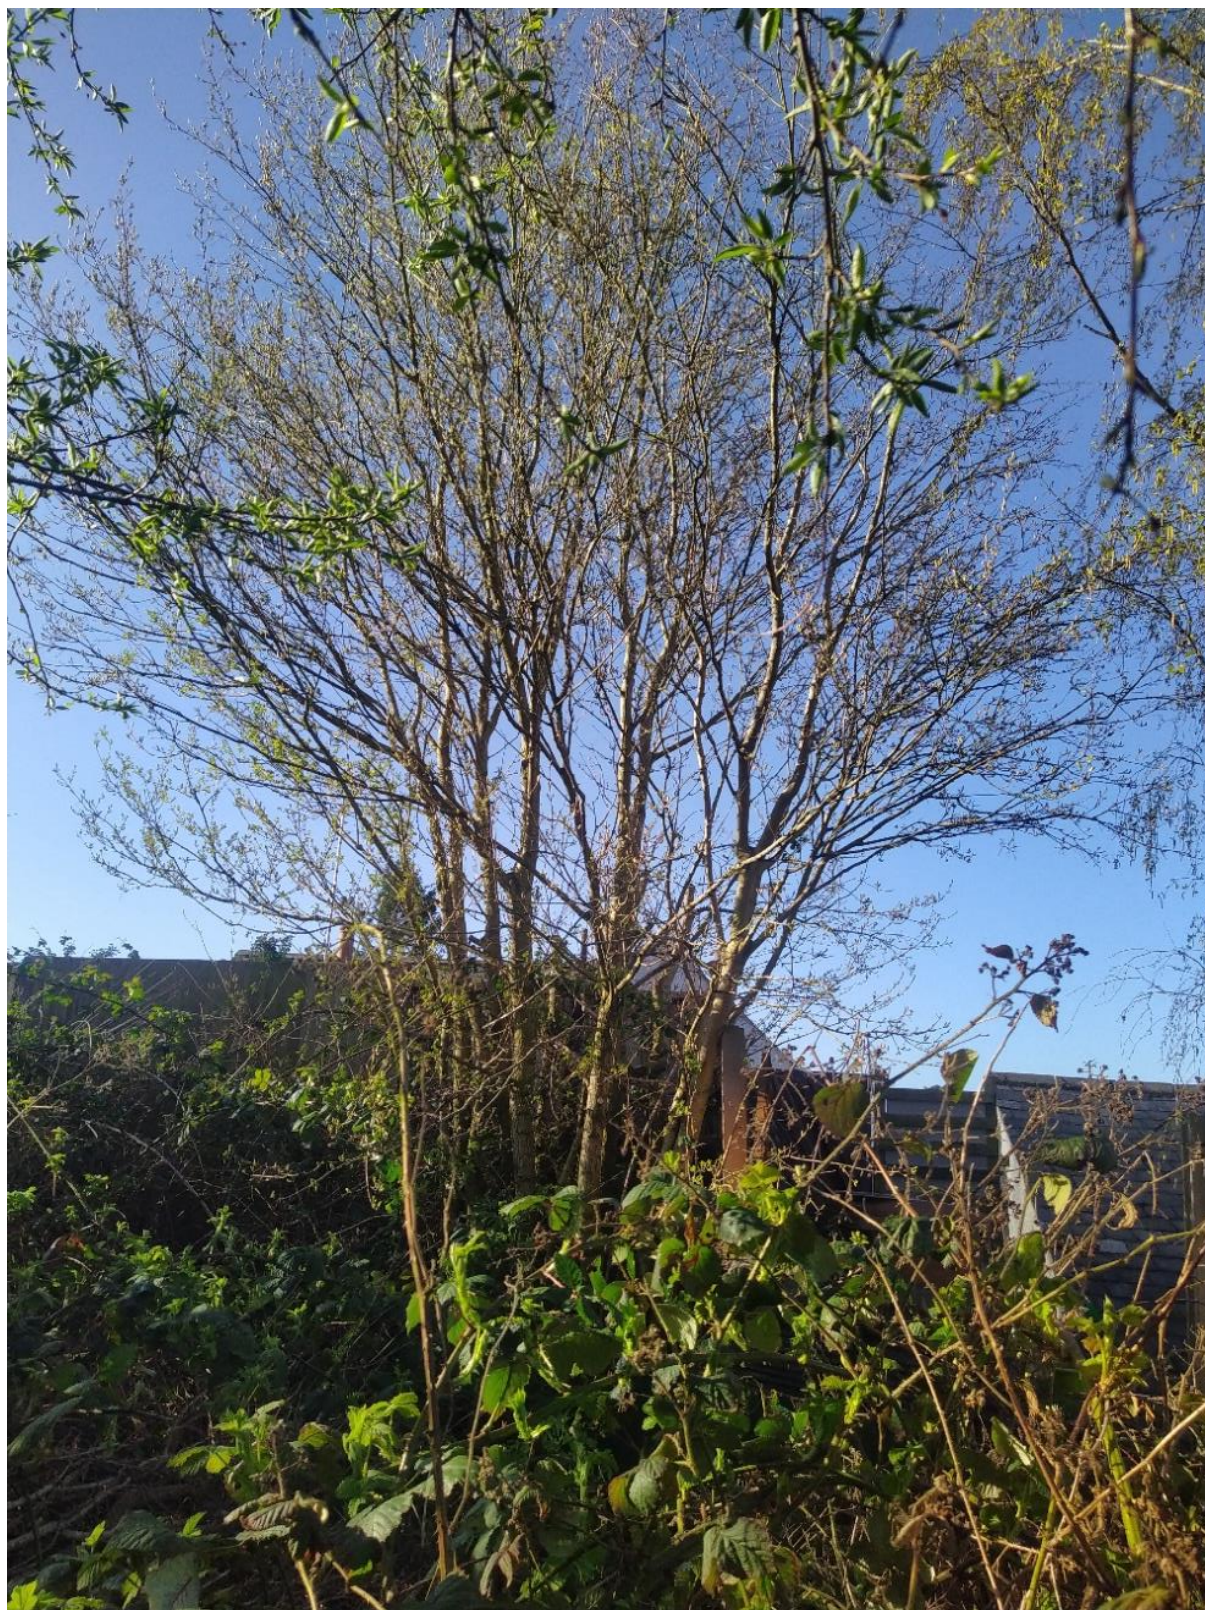
**T012: Field Maple (*Acer campestre*)**

| Tree Number | Species | Age Class | Diameter (mm) | Est Height (m) | Crown Spread: N-S, E-W (m) | Condition | Recommendations | Priority | Inspection Frequency |
|---|---|---|---|---|---|---|---|---|---|
| 0012 | Field Maple<br>( <i>Acer campestre</i> ) | EM | Multi-stemmed<br>100 – 190 | 6 | 5, 5 | <b>Physiologically:</b> Good<br><b>Structurally:</b> Good<br>Located in the southwest corner of the library's grounds and situated next to the boundary fence. Multiple branches have been truncated as a result of poorly executed pruning works. This tree will ultimately cause damage to the boundary fence line. | Consider this tree's removal within 4 years. | O | 36 |

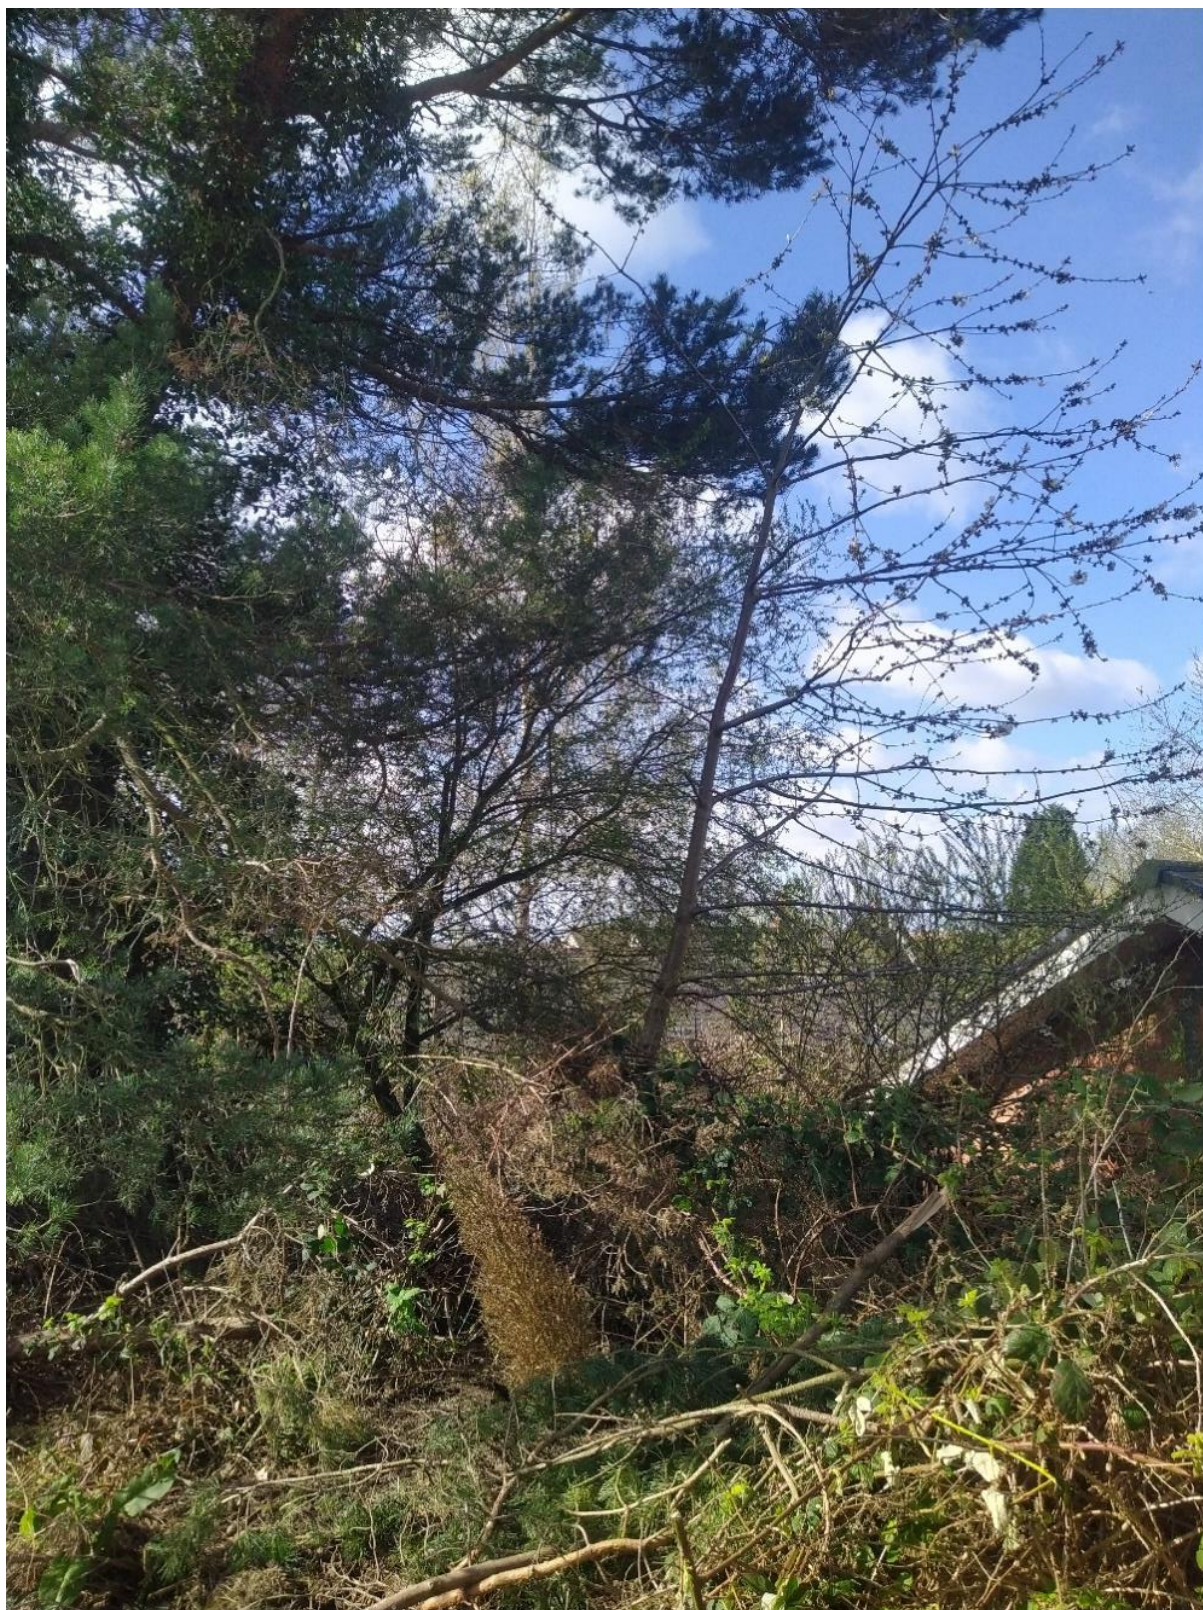
**T013: Plum (*Prunus domestica*)**  
**T014: Wild Cherry (*Prunus avium*)**

| Tree Number | Species | Age Class | Diameter (mm) | Est Height (m) | Crown Spread: N-S, E-W (m) | Condition | Recommendations | Priority | Inspection Frequency |
|---|---|---|---|---|---|---|---|---|---|
| 0013 | Plum<br>( <i>Prunus domestica</i> ) | EM | 120 | 5 | 4, 4 | <b>Physiologically:</b> Good<br><b>Structurally:</b> Good<br>A self-set tree that has been suppressed by the adjacent Pine (T0010) | No action | | 36 |
| 0014 | Wild Cherry<br>( <i>Prunus avium</i> ) | EM | 110 | 5 | 4, 4 | <b>Physiologically:</b> Good<br><b>Structurally:</b> Good<br>A self-set single stemmed tree. The stem has developed a westward lean due to being suppressed by T0010 | Take down to ground level | 3 | - |

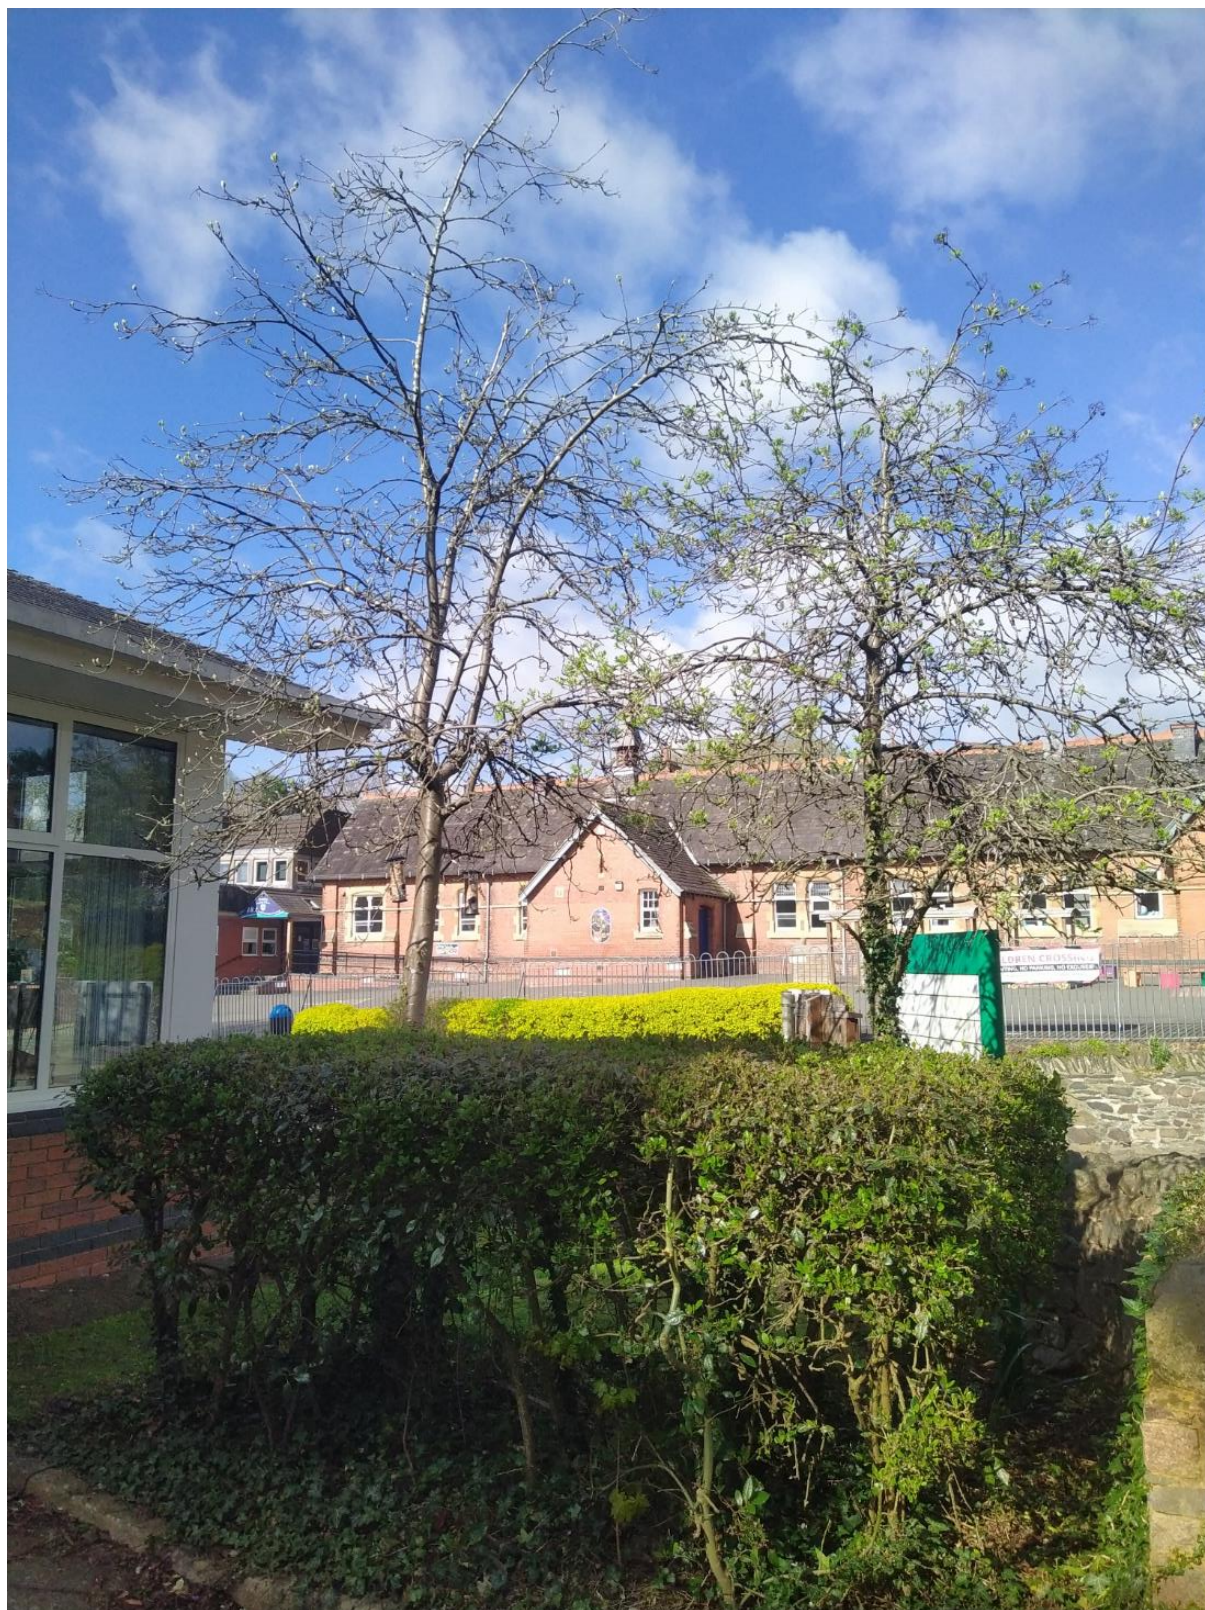
| Tree Number | Species | Age Class | Diameter (mm) | Est Height (m) | Crown Spread: N-S, E-W (m) | Condition | Recommendations | Priority | Inspection Frequency |
|---|---|---|---|---|---|---|---|---|---|
| 0015 | Rowan<br>( <i>Sorbus aucuparia</i> ) | EM | 130 | 4 | 2, 2 | <b>Physiologically:</b> Good<br><b>Structurally:</b> Good<br>A small tree of which the main stem bifurcates at 1.9m. | No action | - | 36 |
| 0016 | Rowan<br>( <i>Sorbus aucuparia</i> ) | EM | 110 | 3 | 2, 2 | <b>Physiologically:</b> Good<br><b>Structurally:</b> Good<br>A small well-formed tree. Ivy is beginning to clad the main stem. | Sever Ivy | 3 | 36 |

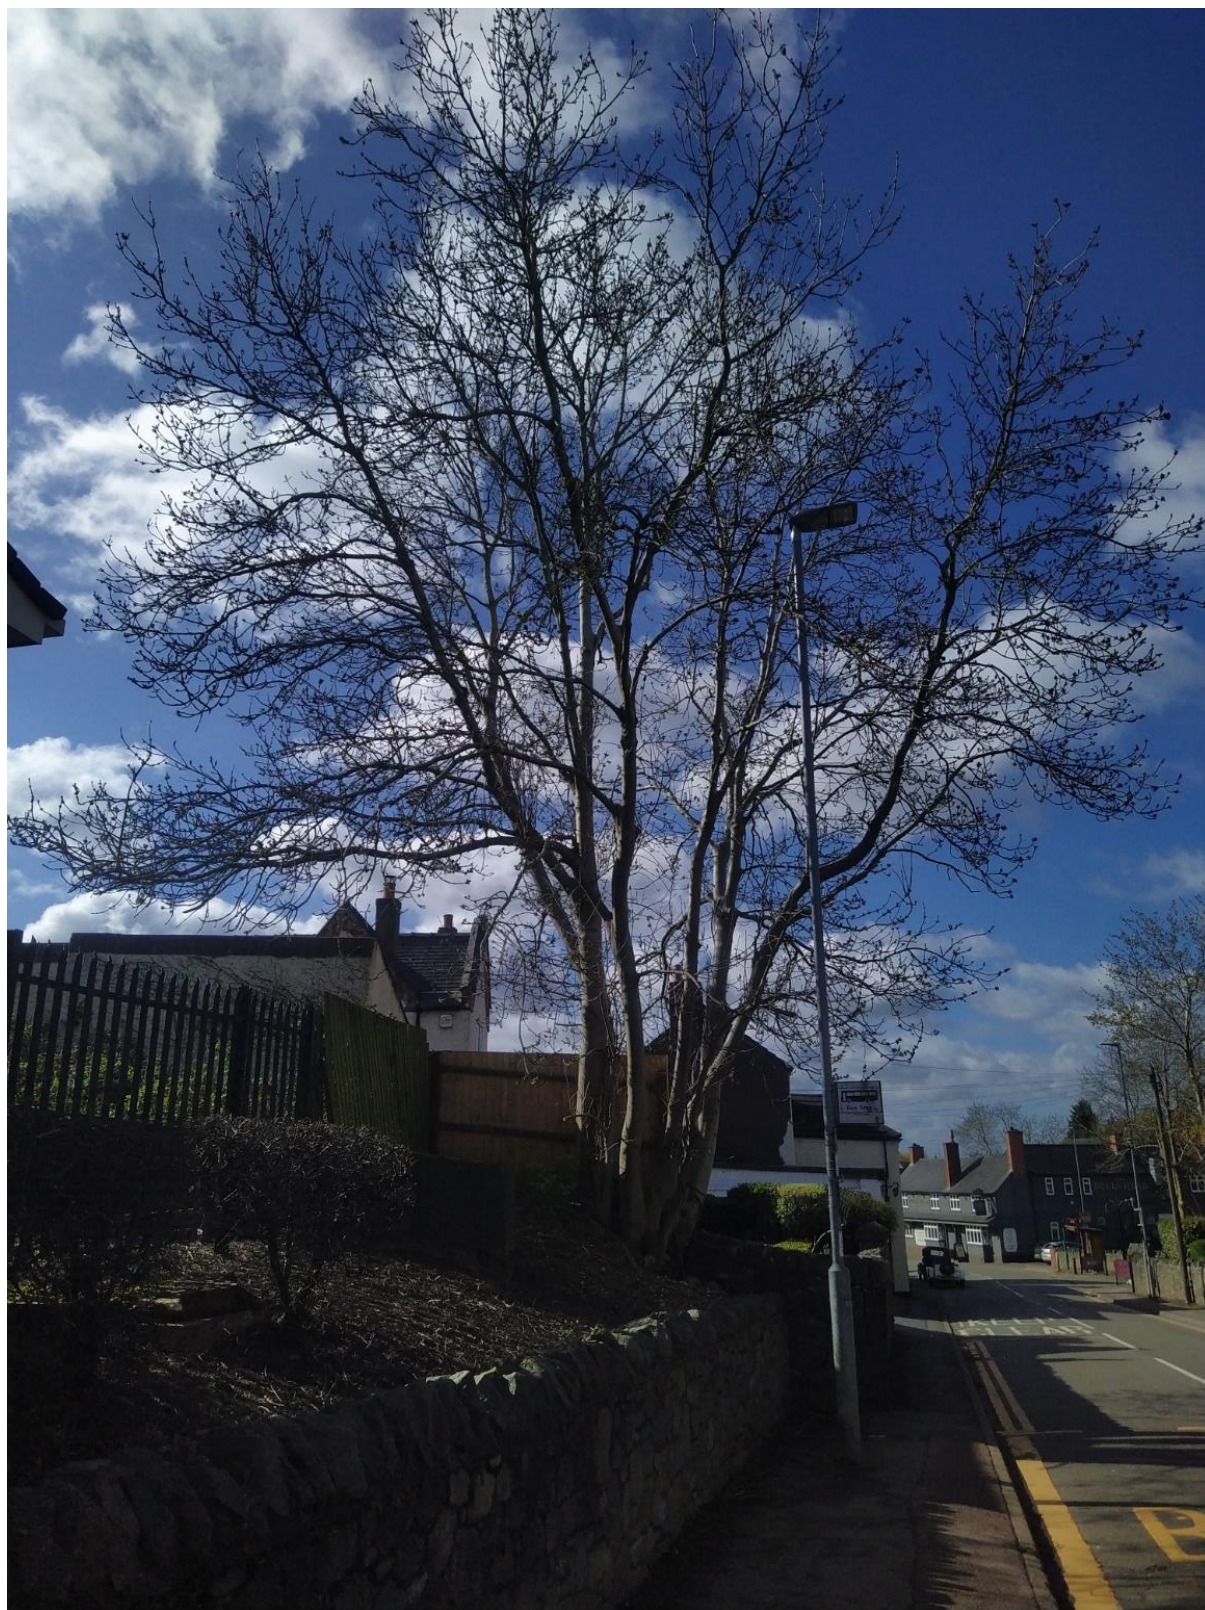
**T017: Common Ash (*Fraxinus excelsior*)**

| Tree Number | Species | Age Class | Diameter (mm) | Est Height (m) | Crown Spread: N-S, E-W (m) | Condition | Recommendations | Priority | Inspection Frequency |
|---|---|---|---|---|---|---|---|---|---|
| 0017 | Common Ash<br>( <i>Fraxinus excelsior</i> ) | M | Multi-stemmed<br>180 - 360 | 13 | 12 , 12 | <b>Physiologically:</b> Fair<br><b>Structurally:</b> Fair<br>A mature tree located in the South-West corner of the Library's grounds. The tree is multi-stemmed from ground level with epicormic present around the main unions. The West side of the stem base shows signs of Ash Canker ( <i>Pseudomonas syringae ssp.</i> ). The south side of the stem base from ground level to 1.2m is in contact with and has damaged the adjacent stone wall. The East side of the stem base has a tight basal union between the two largest stems of the tree, of which the southernmost stem is extending towards the neighbouring property. The north-west side of the crown is impeding the light splay from the adjacent lamp column. | <b>OPTION</b> | 0 | 36 |

| Tree Number | Species | Age Class | Diameter (mm) | Est Height (m) | Crown Spread: N-S, E-W (m) | Condition | Recommendations | Priority | Inspection Frequency |
|---|---|---|---|---|---|---|---|---|---|
| | | | | | | | <b>EITHER</b><br><b>Retain The Tree</b><br>Reduce by 3m in height and 2.5m in lateral spread, as Priority 2<br><br>However ultimately the tree will require removing should the damage to the adjacent wall worsen | 2 | |
| | | | | | | | <b>OR</b><br><b>Remove The Tree</b><br>Take down to ground level and treat stump to prevent regrowth, as priority 2 | 2 | |

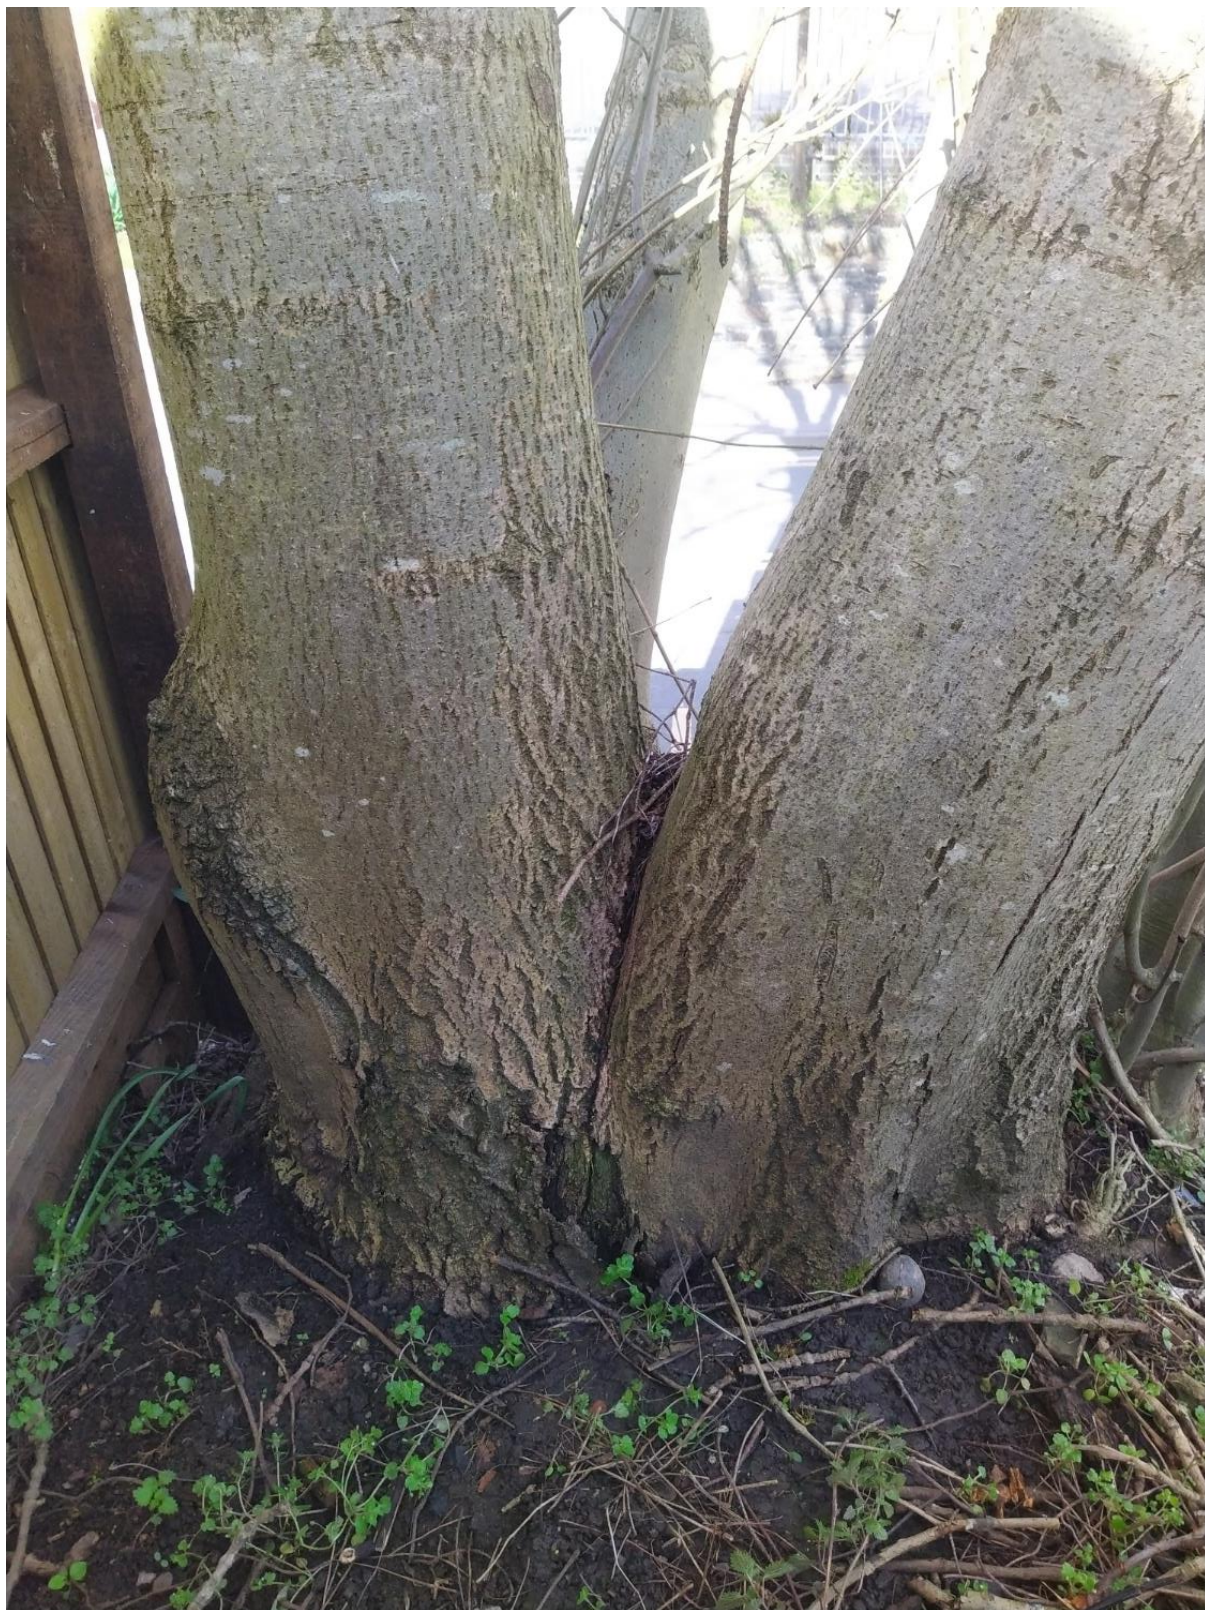
**T017: Common Ash (*Fraxinus excelsior*)**  
**Tight basal union on the East side**
