## TREE INVENTORY REPORT

### RATBY LIBRARY

13<sup>th</sup> April 2023

Ratby Library  
No.62 Main Street  
Ratby  
Leicester  
LE6 0LL

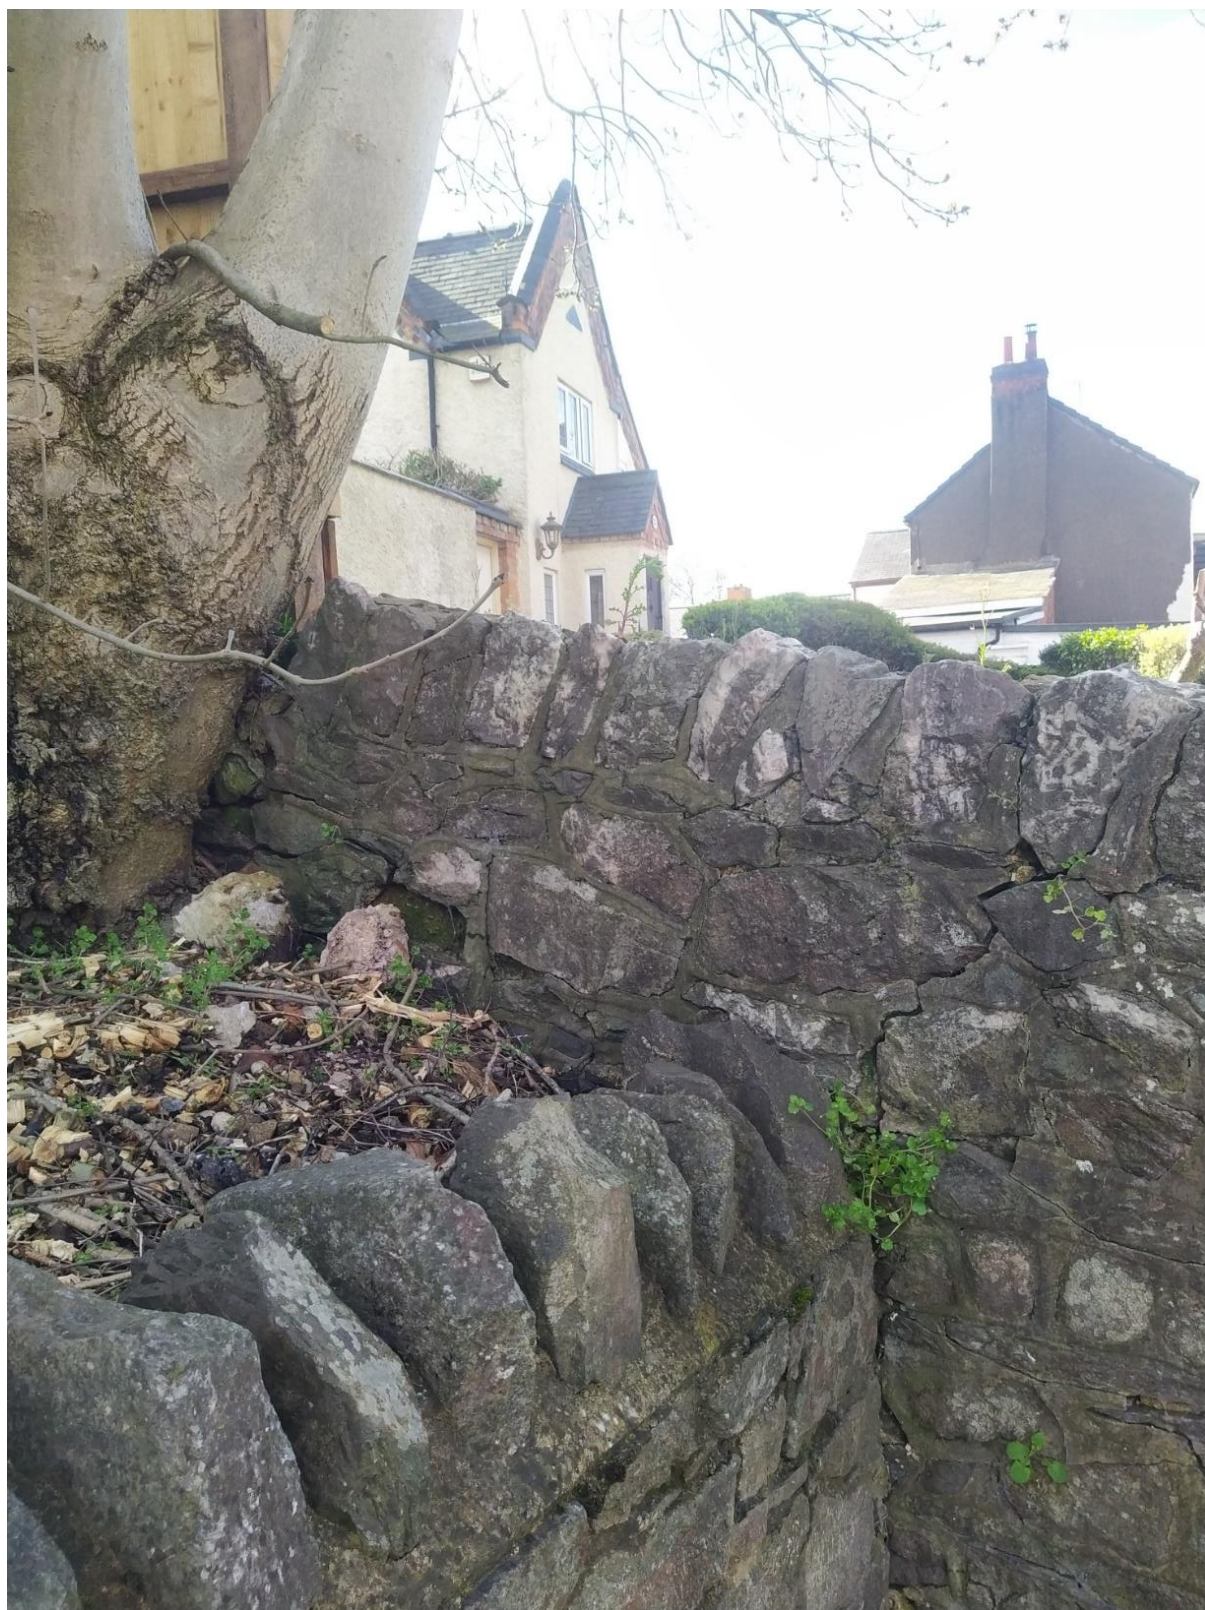
**T017: Common Ash (*Fraxinus excelsior*)**  
**Wall Damage**

| Tree Number | Species | Age Class | Diameter (mm) | Est Height (m) | Crown Spread: N-S, E-W (m) | Condition | Recommendations | Priority | Inspection Frequency |
|---|---|---|---|---|---|---|---|---|---|
| | | | | | | | <b>EITHER</b><br><b>Retain The Tree</b><br>Reduce by 3m in height and 2.5m in lateral spread, as Priority 2<br><br>However ultimately the tree will require removing should the damage to the adjacent wall worsen | 2 | |
| | | | | | | | <b>OR</b><br><b>Remove The Tree</b><br>Take down to ground level and treat stump to prevent regrowth, as priority 2 | 2 | |
