# Asbestos Survey

**Client Name:** Mr James Godwin  
**Address:** 8 Wood Lane  
Norton-Juxta  
Atherstone  
CV9 3QB  
**Purpose of Report:** ASBESTOS MANAGEMENT SURVEY  
**Report Reference:** AMS|MJC|2025  
**Inspection Date:** 16 Apr 2025  
**Surveyor Name:** C McLean BSc Hons, MCIOB, CSRT, CSSW, DipDEA, UKAS-P402/P405  
**Building Surveyor Engineer Name:** Greg Owen BSc (Hons) C Build E, MCABE

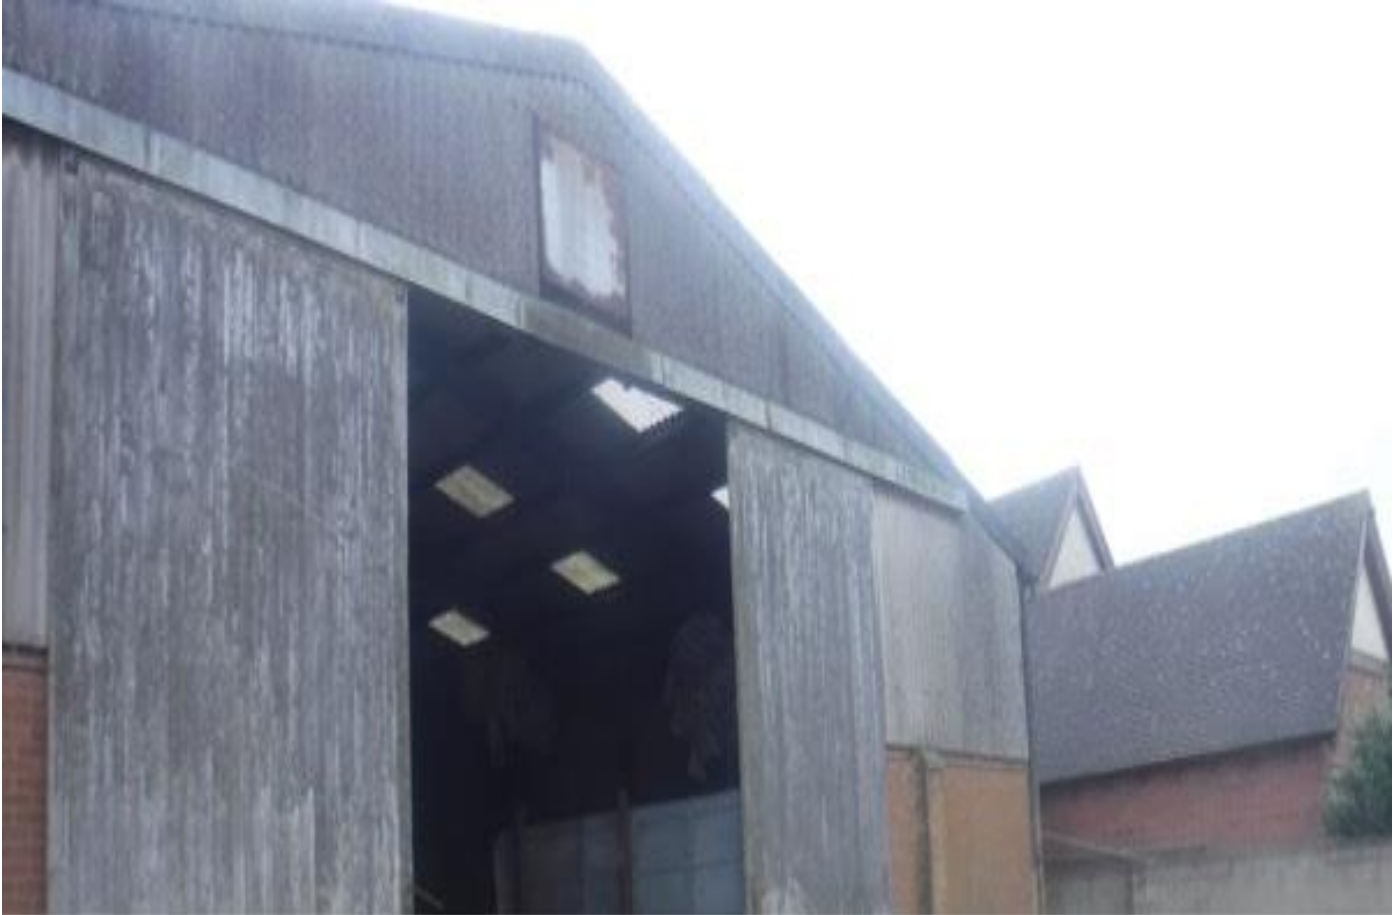
### Barn 1

| <ul style="list-style-type: none"> <li>The larger attached agricultural buildings had profiled fibre cement roof coverings which were <u>compromised and generally in a poor condition, the majority of walls had a similar fibre cement sheet covering to the upper elevations, water was discharged into a mixture of fibre cement and PVCu gutters and down pipes.</u></li> </ul> |
| <ul style="list-style-type: none"> <li>The fibre cement sheet roof coverings and wall linings are presumed to be an (Asbestos Containing Material), as per CAR2012 regulations.</li> <li><b>Following sample &amp; testing of the potential Asbestos containing material Chrysotile (white asbestos) was detected at the time of inspection in the material tested in this area, (bulk fibre analysis report attached)</b></li> </ul> |

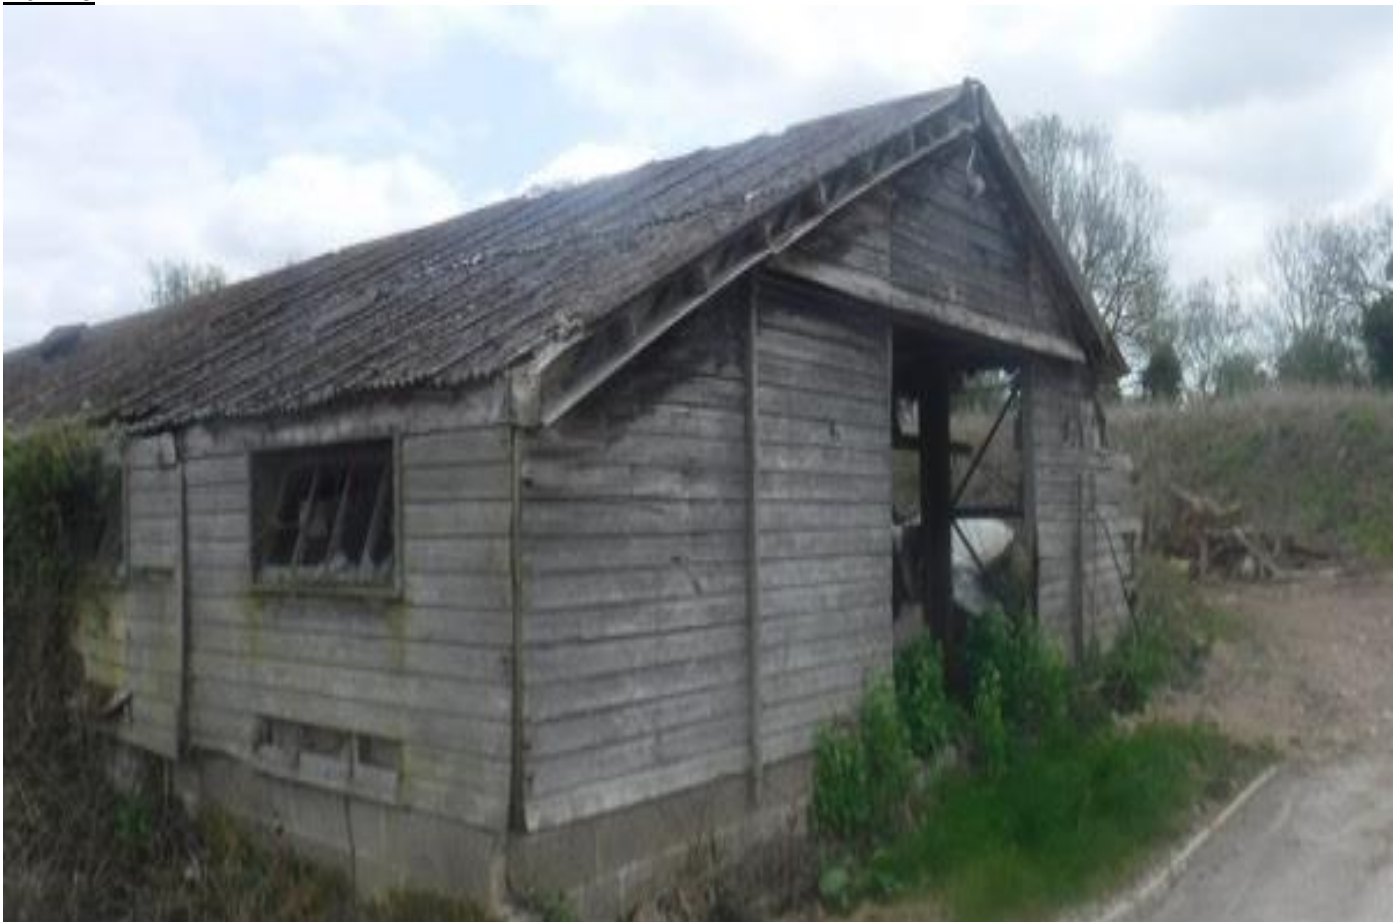
### Barn 3

- The timber framed agricultural building was partially collapsed and in a poor condition. The internal walls and vaulted ceiling had a flat board fibre cement lining, the roof had a profiled roof sheet covering, there were no gutters to the building.

- The fibre cement sheet roof coverings, wall and ceiling linings are presumed to be an (Asbestos Containing Material), as per CAR2012 regulations.
- **Following sample & testing of the potential Asbestos containing material Chrysotile (white asbestos) was detected at the time of inspection in the material tested in this area, (bulk fibre analysis report attached)**
