STRUCTURAL ENGINEER'S REPORT

Site Address: Rowden House Farm, Higham On The Hill, CV13 6BP

Project No: 251025

Date of Inspection: 4th November 2025

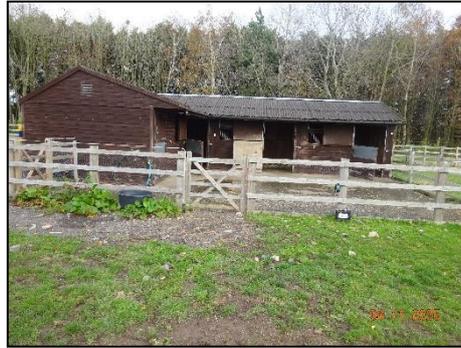
23. Fig 1 is a general view of the front of the building.
24. The building is a timber stable; the stable is enclosed on all sides.
25. **CONSTRUCTION OF BUILDING**
(All dimensions and sizes quoted are approximate)

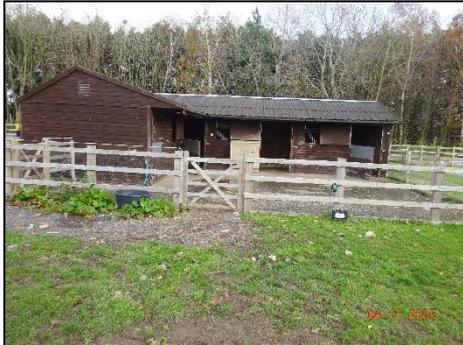
39. Fig FE1 is a general view of the front elevation.
40. Fig FE2 shows the sag in the bituminous roof sheets.
41. Fig FE3 is a view of the valley gutter.

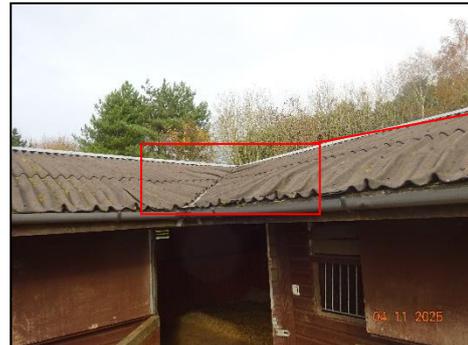
Fig FE2

61. The roof is constructed from a corrugated bituminous material. The roof panels have distorted and sagged; this has been caused by the long term weathering; alternate heating and cooling of the roof panels.

66. The existing corrugated bituminous sheets are to be replaced with a lightweight steel roof sheet.

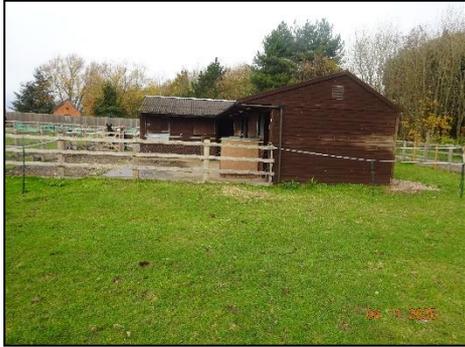
- 43. Fig SE1.1 is a general view of the side elevation (SE1).
- 44. Fig SE1.2 shows the sag in the bituminous roof sheets.
- 45. Fig SE1.3 shows the gutter downpipe on the side elevation.

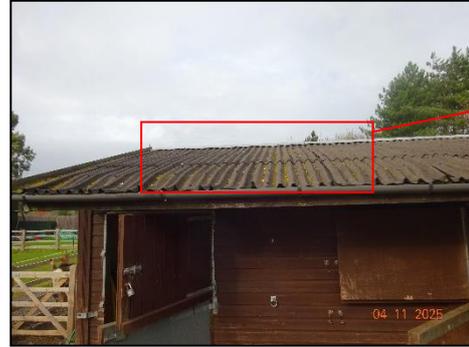
Fig SE1.2

Sag in
Roof

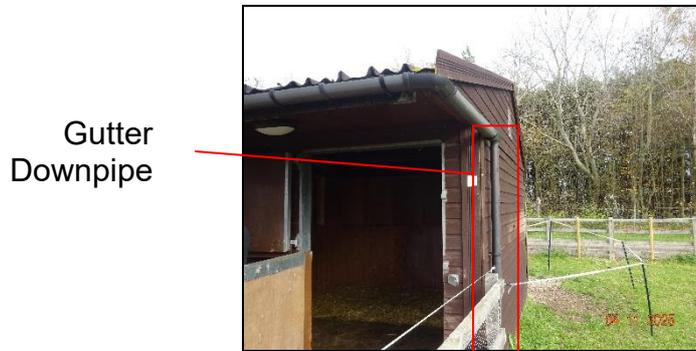
Fig SE1.3

Gutter
Downpipe

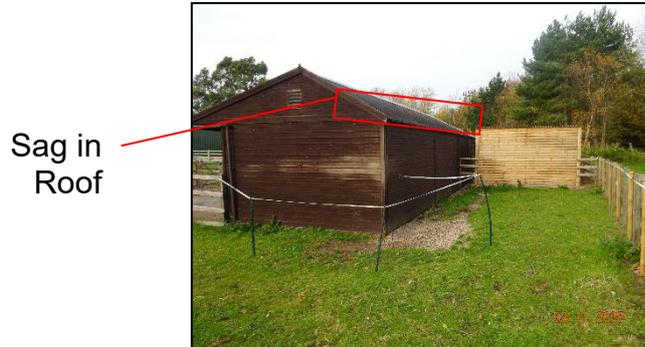
47. Fig RE1 shows the sag in the bituminous roof sheets.

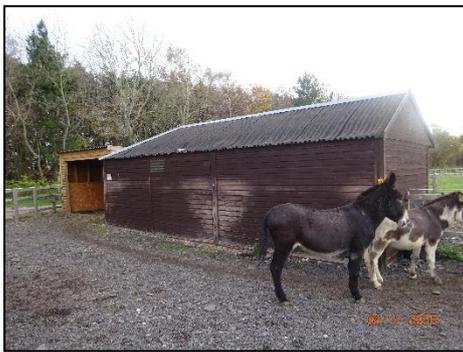
49. Fig SE2.1 is a general view of the side elevation (SE2).

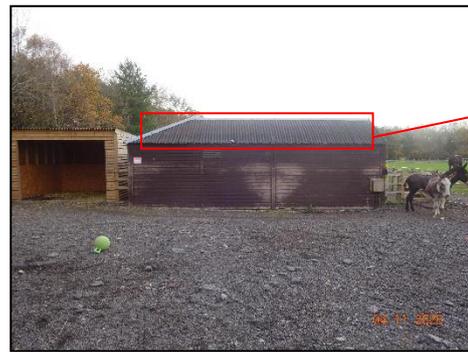
50. Fig SE2.2 shows the sag in the bituminous roof sheets.

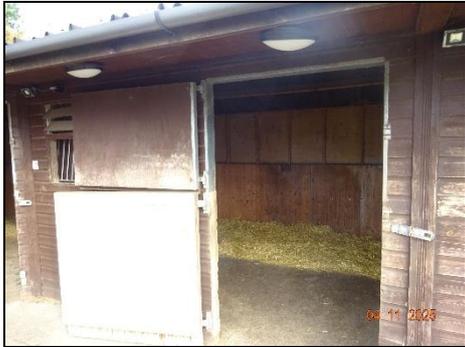
52. Fig GF1 shows the rear wall of the stable.
53. Fig GF2 and Fig GF3 show a typical internal timber structural partition, these are at 3.50m centres and they support the roof. The external timber stud walls are tied into the internal stud partitions.

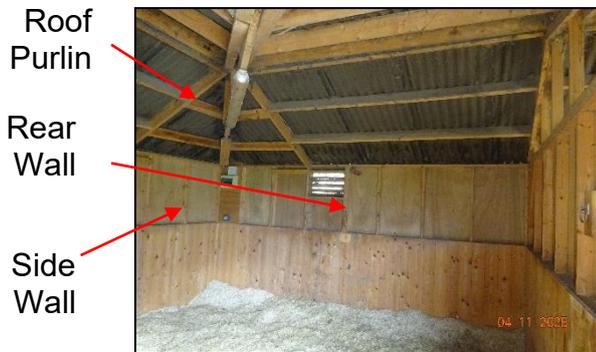
54. Fig GF4 shows the side (SE2) and rear walls.
55. Fig GF5 and Fig GF6 show the A Symmetrical timber 'A' frame roof truss.
56. Fig GF7 and Fig GF8 show the typical partition wall support for the roof purlins.
57. Fig GF9 shows the brickwork support to the timber walls. The external walls of the timber structure bear onto the brickwork plinth.
