# PRELIMINARY ARBORICULTURAL REPORT

2 Main Street, Ratby, Leicester LE6 0JG

PRI Ref: 328995

Survey Date: 16-06-2025

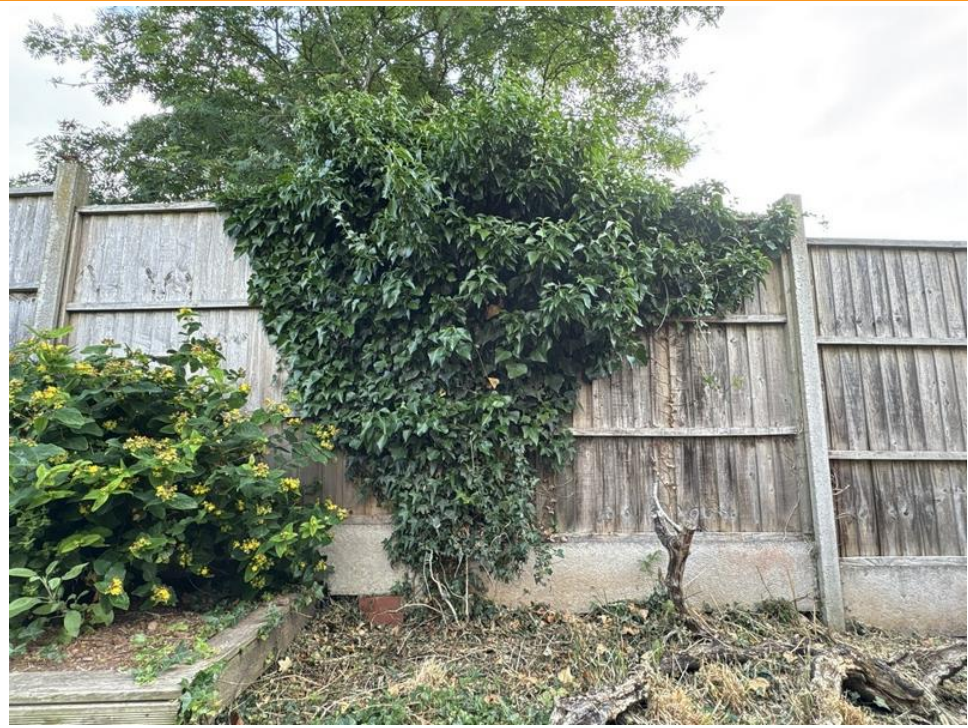
C1 Ivy

| Tree No: | Common Name | Age Class | Condition | Height (m) | Crown Spread (m) | Stem diam. (mm) | No. of Stems | Dist to bldg. (m) | Roots Implicated | Pruning History | Recommendation | Tree Work Constraints | Notes | Owner address | Owner |
|---|---|---|---|---|---|---|---|---|---|---|---|---|---|---|---|
| C1 | Ivy | Semi-Mature | Fair | 2.00 | 2.00 | 25 | 5 | 2.50 | Yes | No significant past works. | Sever climber stems and treat stump. | There are no restrictions to the site or to the tree - scheduled rates may apply. | Climbing on fence. Stem count and diameters estimated. | 2 Main Street<br>Ratby<br>Leicester<br>LE6 0JG | PH |

| Tree No: | Species | Works Required | CA | TPO | Ownership |
|---|---|---|---|---|---|
| C1 | Ivy | Sever climber stems and treat stump. | No | No | PH |

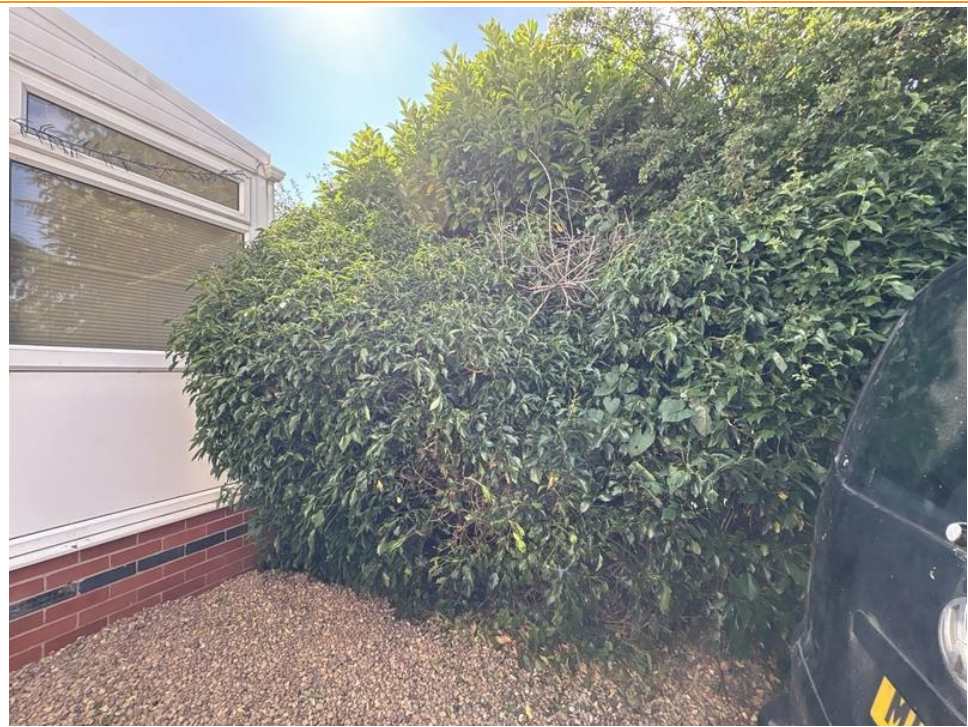
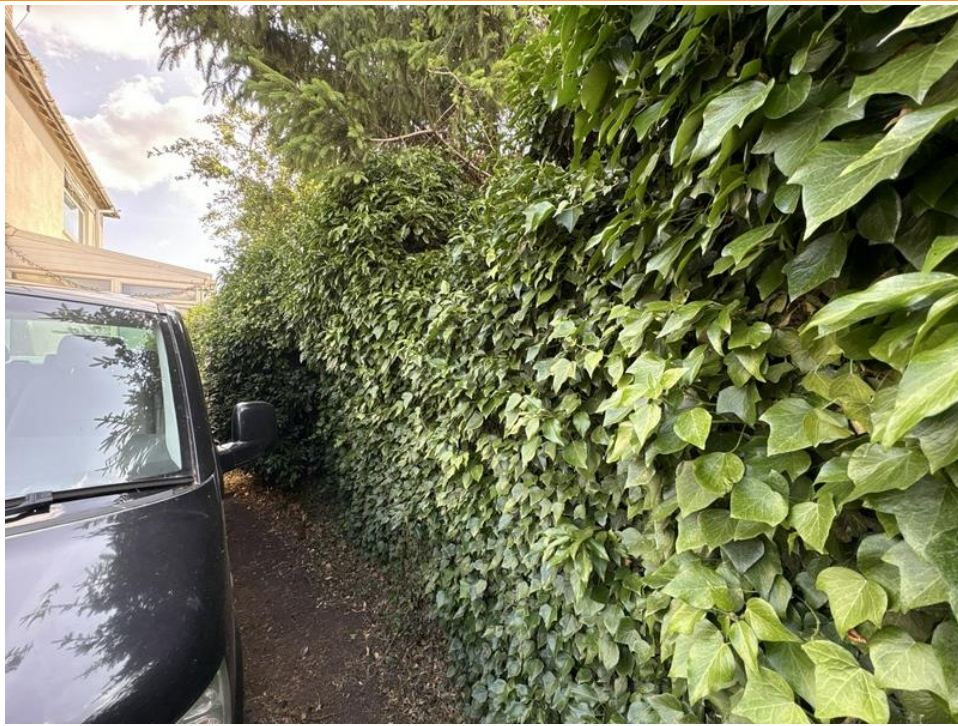
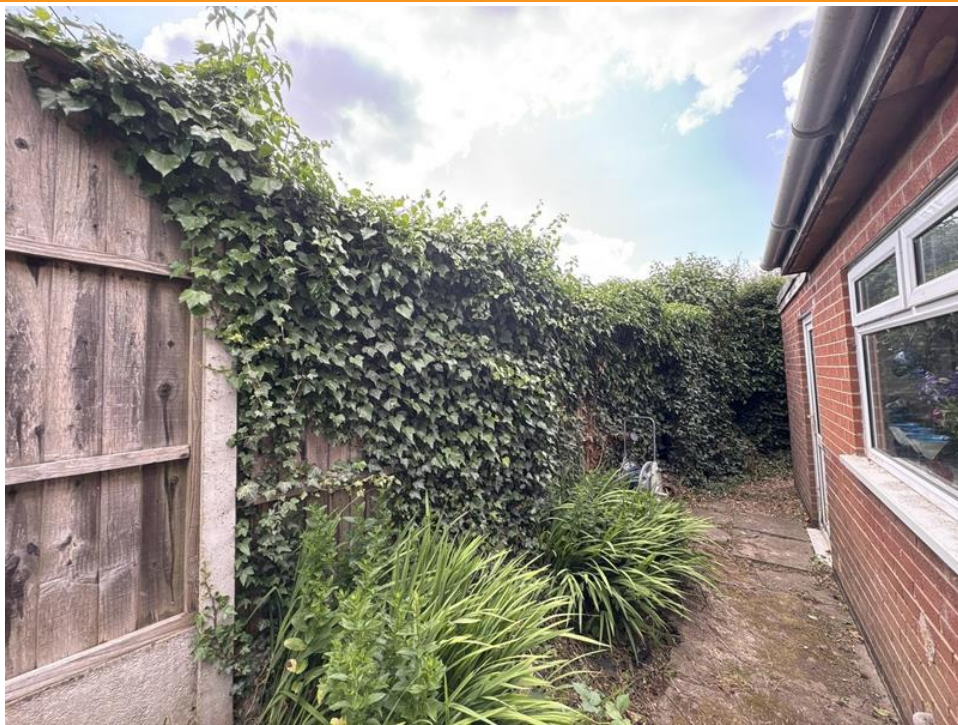
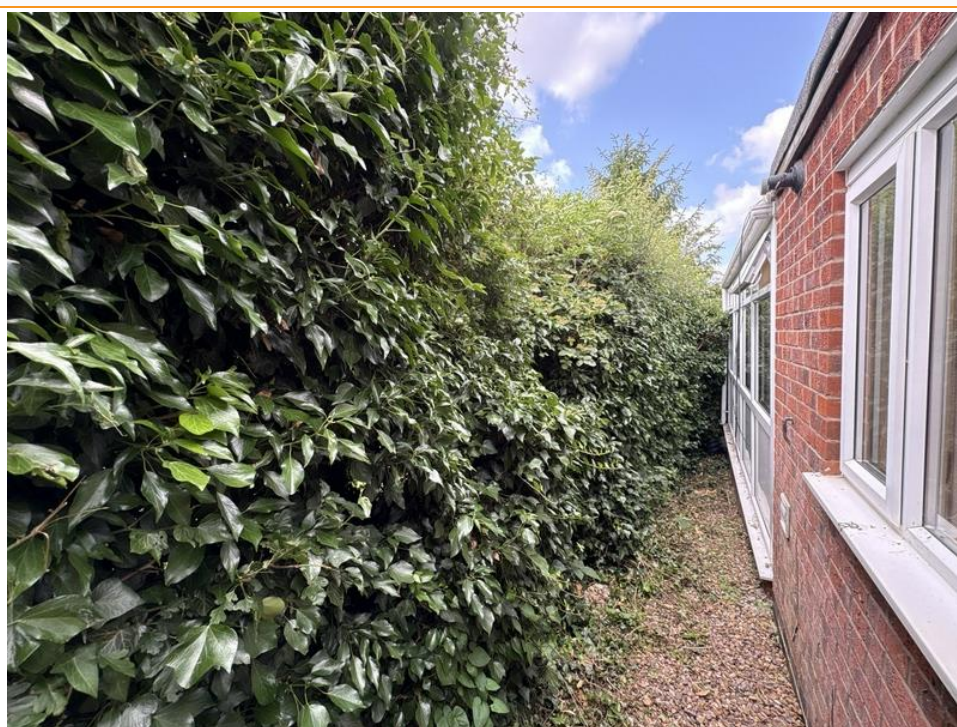
CG1 Ivy

| Tree No: | Common Name | Age Class | Condition | Height (m) | Crown Spread (m) | Stem diam. (mm) | No. of Stems | Dist to bldg. (m) | Roots Implicated | Pruning History | Recommendation | Tree Work Constraints | Notes | Owner address | Owner |
|---|---|---|---|---|---|---|---|---|---|---|---|---|---|---|---|
| CG1 | Ivy | Mature | Fair | 2.00 | 1.00 | 25 | 20 | 0.50 | Yes | No significant past works. | Sever climber stems and treat stump. | There are no restrictions to the site or to the tree - scheduled rates may apply. | Stem count and diameters estimated. | 2 Main Street<br>Ratby<br>Leicester<br>LE6 0JG | PH |

| Tree No: | Species | Works Required | CA | TPO | Ownership |
|---|---|---|---|---|---|
| CG1 | Ivy | Sever climber stems and treat stump. | No | No | PH |

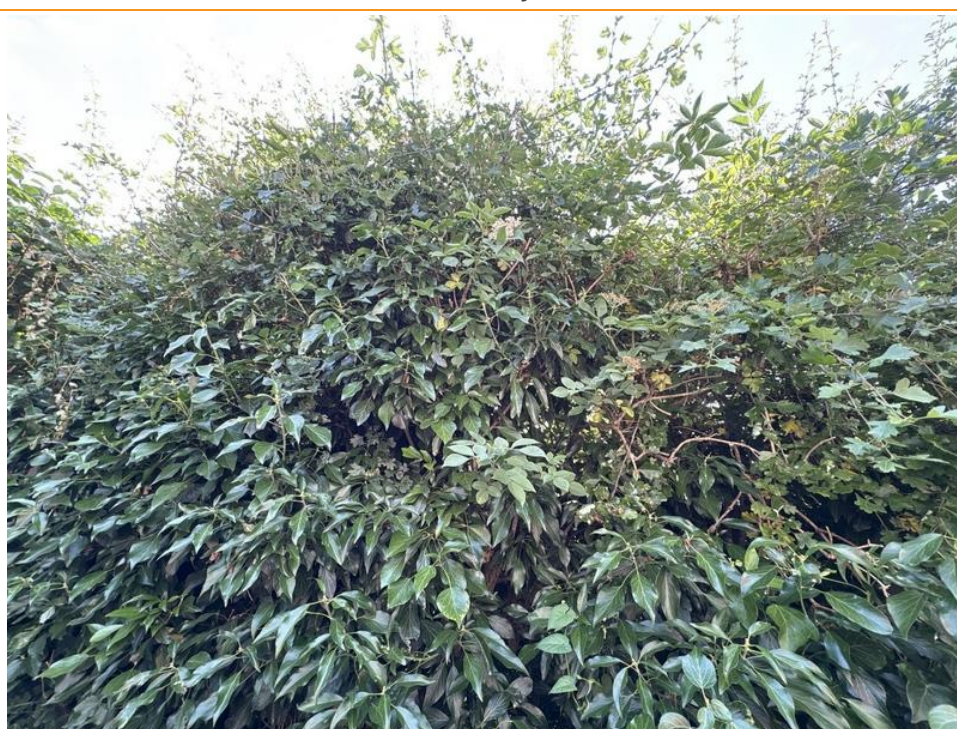
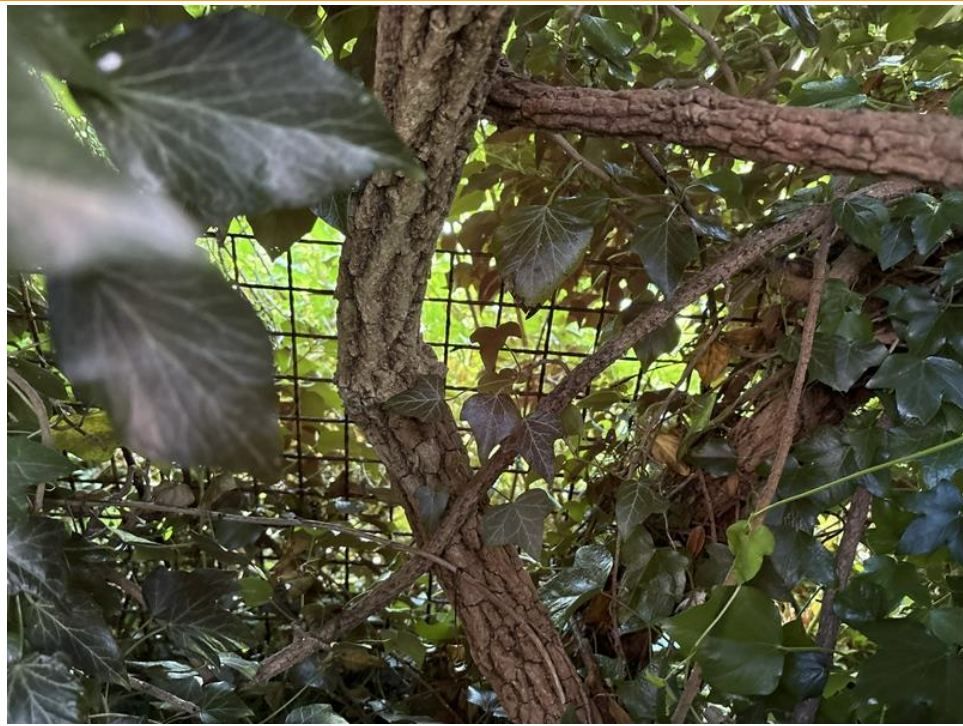
S2 Elder

| Tree No: | Common Name | Age Class | Condition | Height (m) | Crown Spread (m) | Stem diam. (mm) | No. of Stems | Dist to bldg. (m) | Roots Implicated | Pruning History | Recommendation | Tree Work Constraints | Notes | Owner address | Owner |
|---|---|---|---|---|---|---|---|---|---|---|---|---|---|---|---|
| S2 | Elder | Semi-Mature | Fair | 2.50 | 1.00 | 25 | 1 | 1.50 | No | No significant past works. | Fell and treat stump with eco plugs (broadleaved). | There are restrictions to the site or to the tree - contractor should quote. Access through side gate. | None to add | 2 Main Street<br>Ratby<br>Leicester<br>LE6 0JG | PH |

| Tree No: | Species | Works Required | CA | TPO | Ownership |
|---|---|---|---|---|---|
| S2 | Elder | Fell and treat stump with eco plugs (broadleaved). | No | No | PH |

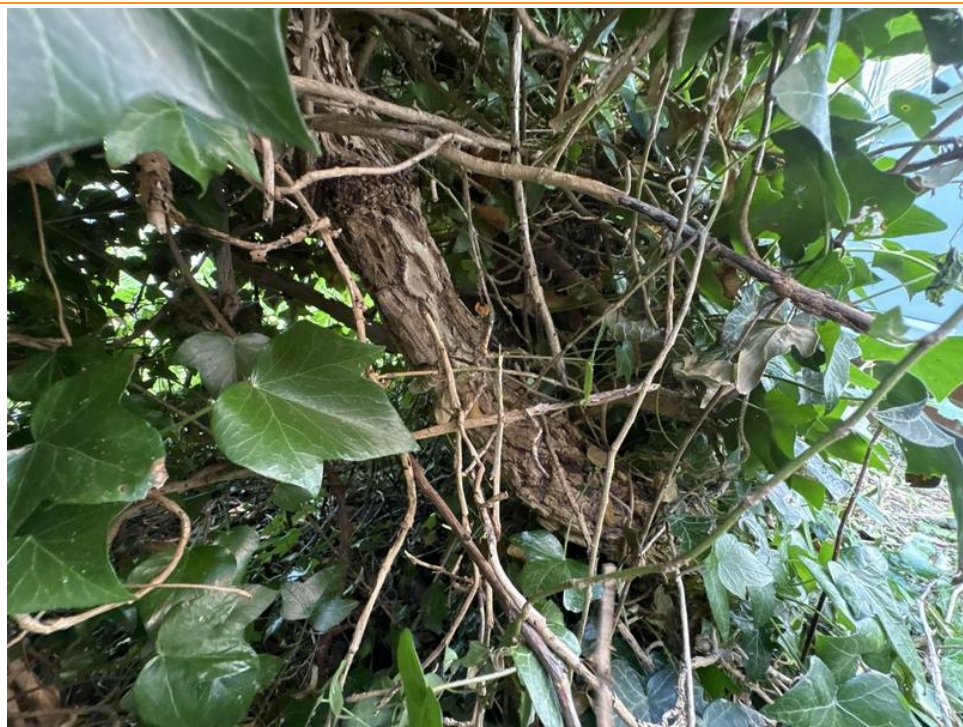
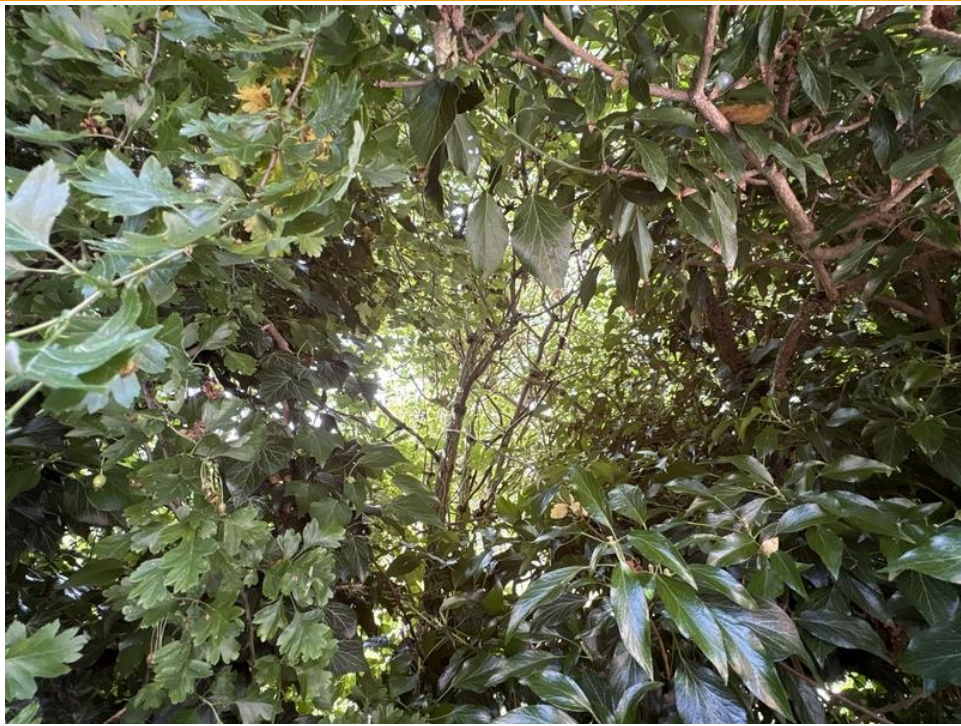
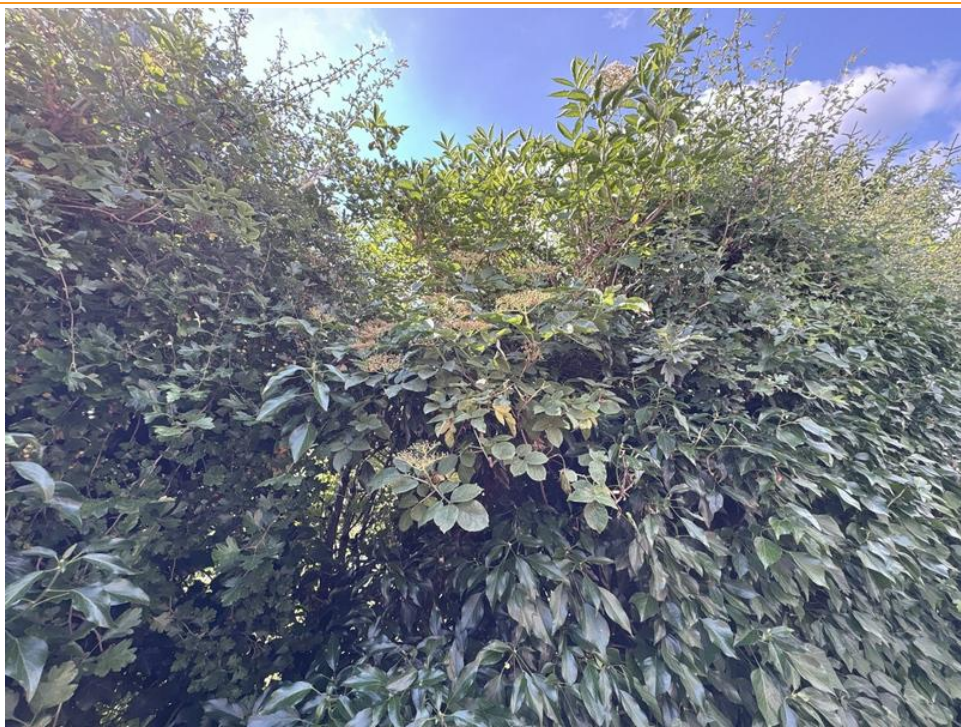
S3 Elder

| Tree No: | Common Name | Age Class | Condition | Height (m) | Crown Spread (m) | Stem diam. (mm) | No. of Stems | Dist to bldg. (m) | Roots Implicated | Pruning History | Recommendation | Tree Work Constraints | Notes | Owner address | Owner |
|---|---|---|---|---|---|---|---|---|---|---|---|---|---|---|---|
| S3 | Elder | Semi-Mature | Fair | 2.50 | 1.00 | 25 | 2 | 1.50 | No | No significant past works. | Fell and treat stump with eco plugs (broadleaved). | There are restrictions to the site or to the tree - contractor should quote. Access through side gate. | None to add | 2 Main Street<br>Ratby<br>Leicester<br>LE6 0JG | PH |

| Tree No: | Species | Works Required | CA | TPO | Ownership |
|---|---|---|---|---|---|
| S3 | Elder | Fell and treat stump with eco plugs (broadleaved). | No | No | PH |

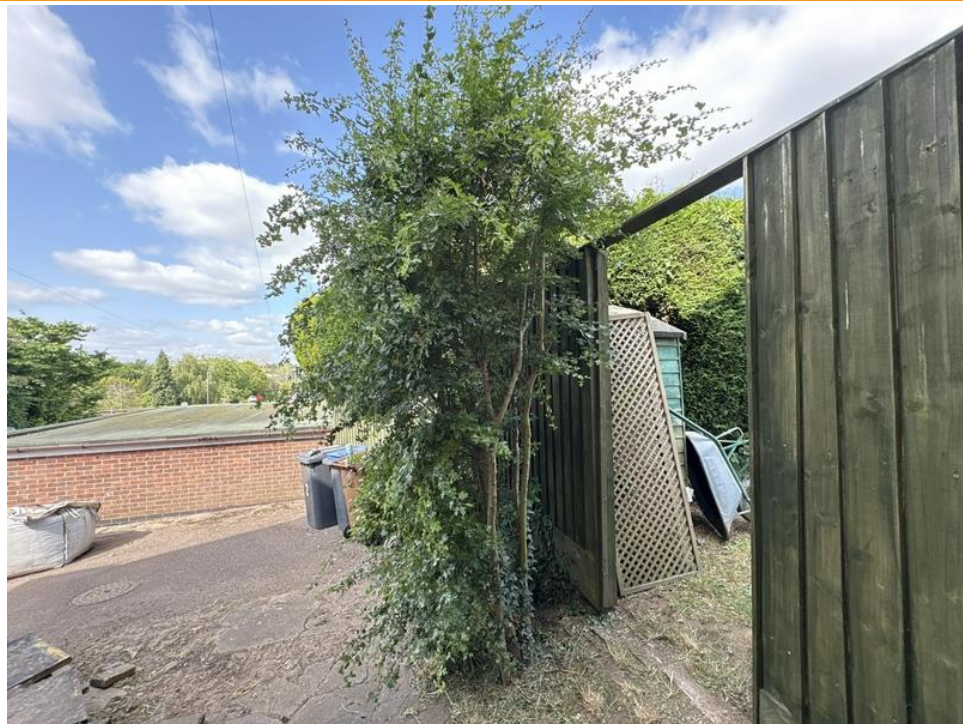
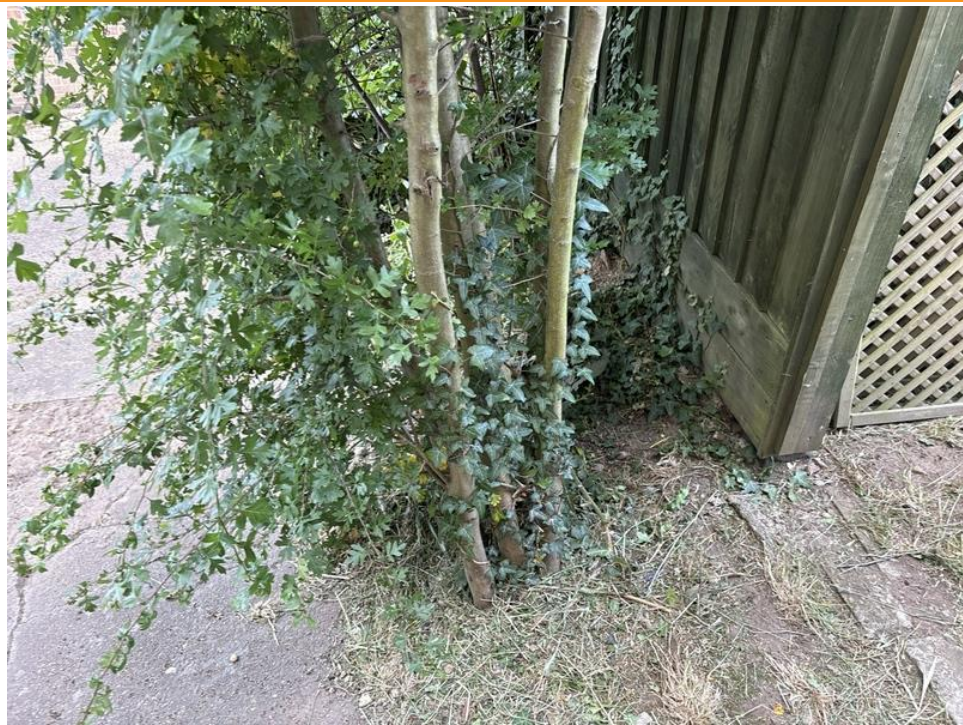
T2 Hawthorn

| Tree No: | Common Name | Age Class | Condition | Height (m) | Crown Spread (m) | Stem diam. (mm) | No. of Stems | Dist to bldg. (m) | Roots Implicated | Pruning History | Recommendation | Tree Work Constraints | Notes | Owner address | Owner |
|---|---|---|---|---|---|---|---|---|---|---|---|---|---|---|---|
| T2 | Hawthorn | Semi-Mature | Fair | 3.50 | 2.00 | 25 | 6 | 1.70 | Yes | Subject to historic crown reduction management. | Fell and treat stump with eco plugs (broadleaved). | There are no restrictions to the site or to the tree - scheduled rates may apply. | Stem diameter range from 15mm-30mm. | 2 Main Street<br>Ratby<br>Leicester<br>LE6 0JG | PH |

| Tree No: | Species | Works Required | CA | TPO | Ownership |
|---|---|---|---|---|---|
| T2 | Hawthorn | Fell and treat stump with eco plugs (broadleaved). | No | No | PH |

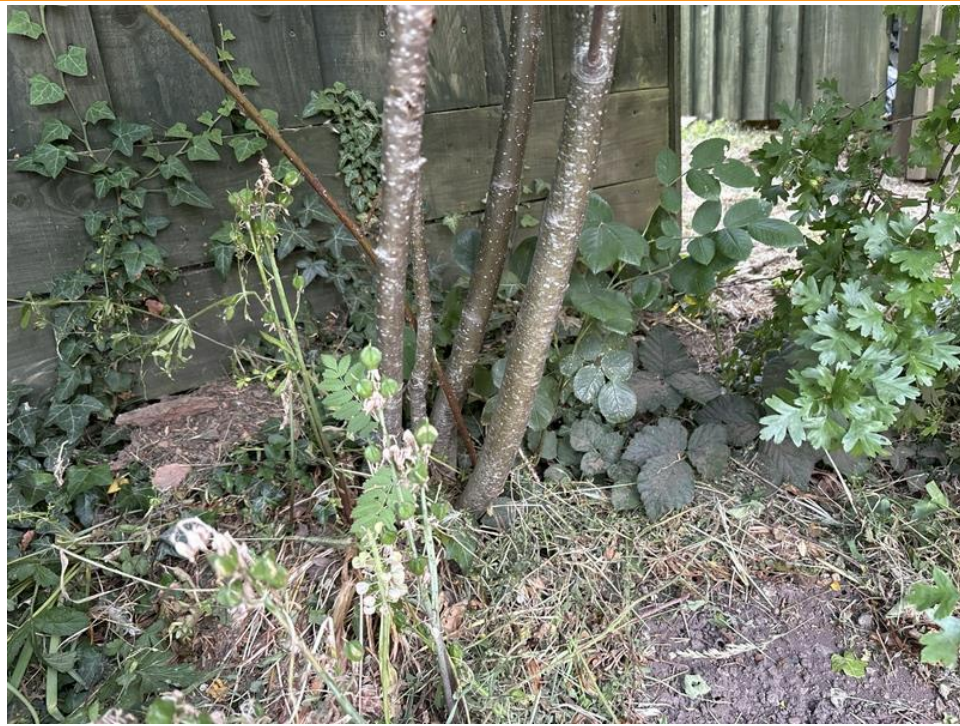
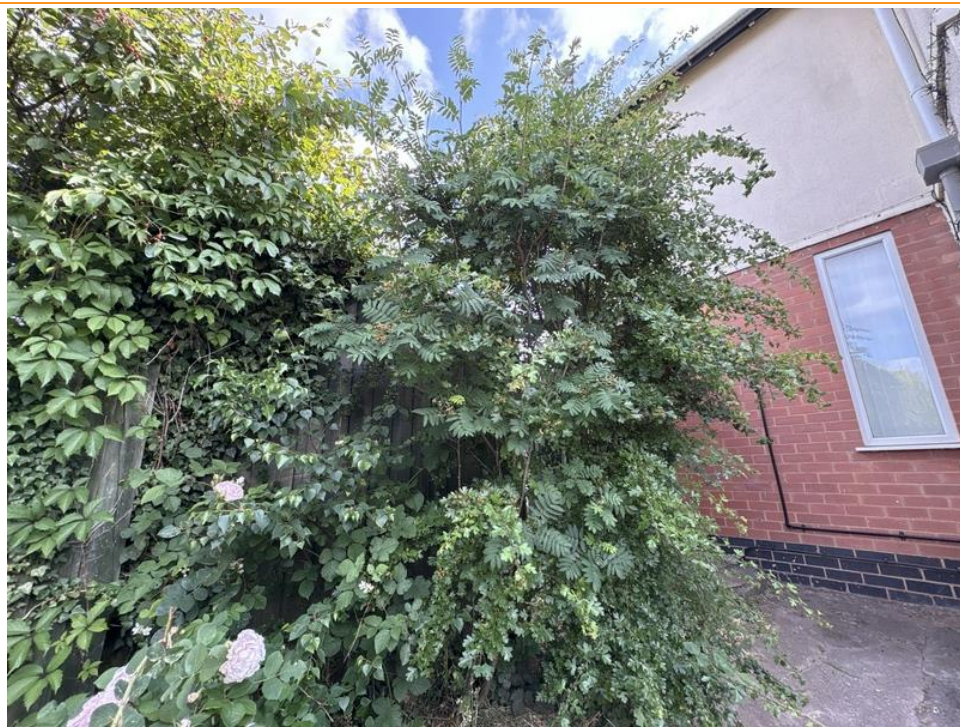
T3 Rowan

| Tree No: | Common Name | Age Class | Condition | Height (m) | Crown Spread (m) | Stem diam. (mm) | No. of Stems | Dist to bldg. (m) | Roots Implicated | Pruning History | Recommendation | Tree Work Constraints | Notes | Owner address | Owner |
|---|---|---|---|---|---|---|---|---|---|---|---|---|---|---|---|
| T3 | Rowan | Young | Fair | 3.00 | 1.50 | 25 | 4 | 2.20 | Yes | No significant past works. | Fell and treat stump with eco plugs (broadleaved). | There are no restrictions to the site or to the tree - scheduled rates may apply. | Stem diameter range from 5mm-20mm. | 2 Main Street<br>Ratby<br>Leicester<br>LE6 0JG | PH |

| Tree No: | Species | Works Required | CA | TPO | Ownership |
|---|---|---|---|---|---|
| T3 | Rowan | Fell and treat stump with eco plugs (broadleaved). | No | No | PH |

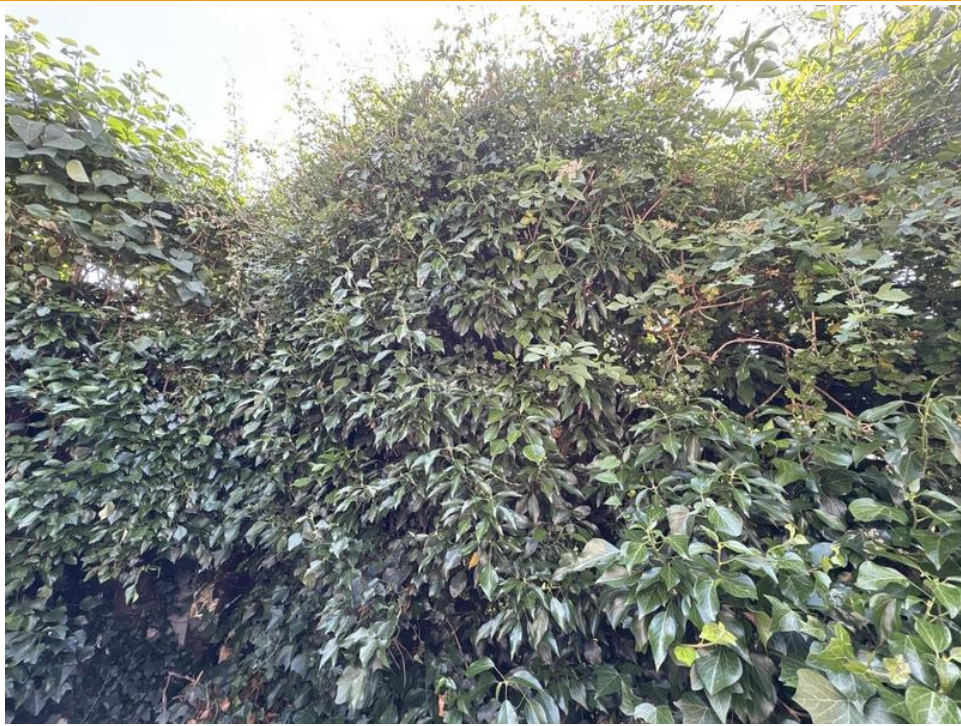
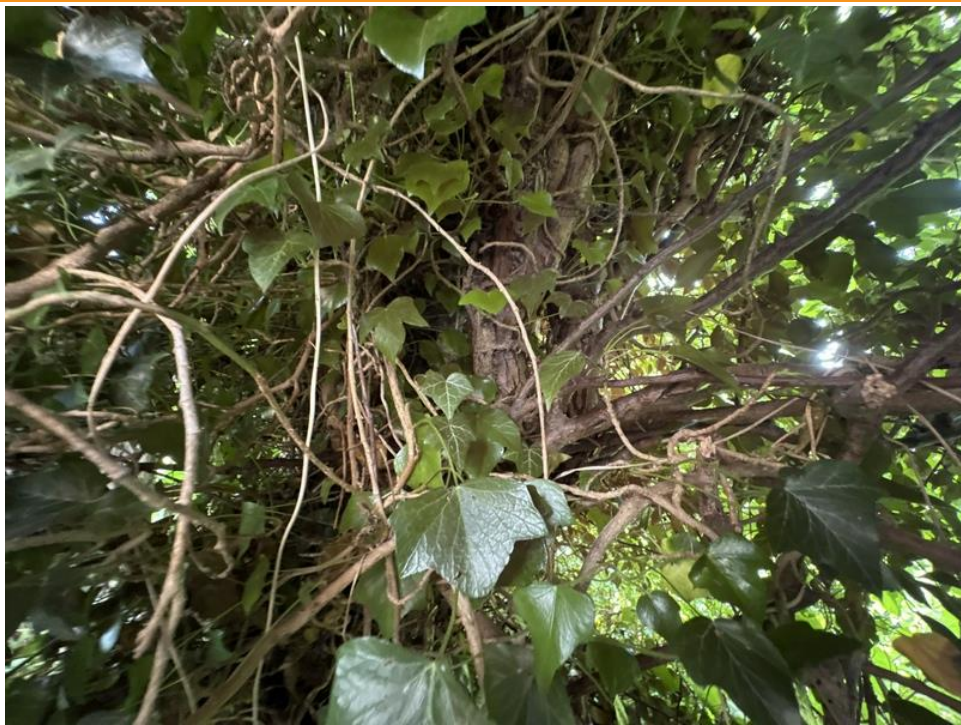
T6 Hawthorn

| Tree No: | Common Name | Age Class | Condition | Height (m) | Crown Spread (m) | Stem diam. (mm) | No. of Stems | Dist to bldg. (m) | Roots Implicated | Pruning History | Recommendation | Tree Work Constraints | Notes | Owner address | Owner |
|---|---|---|---|---|---|---|---|---|---|---|---|---|---|---|---|
| T6 | Hawthorn | Semi-Mature | Fair | 3.00 | 1.50 | 50 | 5 | 1.50 | Yes | Subject to historic crown reduction management. | Fell and treat stump with eco plugs (broadleaved). | There are restrictions to the site or to the tree - contractor should quote. Access through side gate. | Estimated stem diameter range from 25mm-75mm. | 2 Main Street<br>Ratby<br>Leicester<br>LE6 0JG | PH |

| Tree No: | Species | Works Required | CA | TPO | Ownership |
|---|---|---|---|---|---|
| T6 | Hawthorn | Fell and treat stump with eco plugs (broadleaved). | Yes | No | PH |

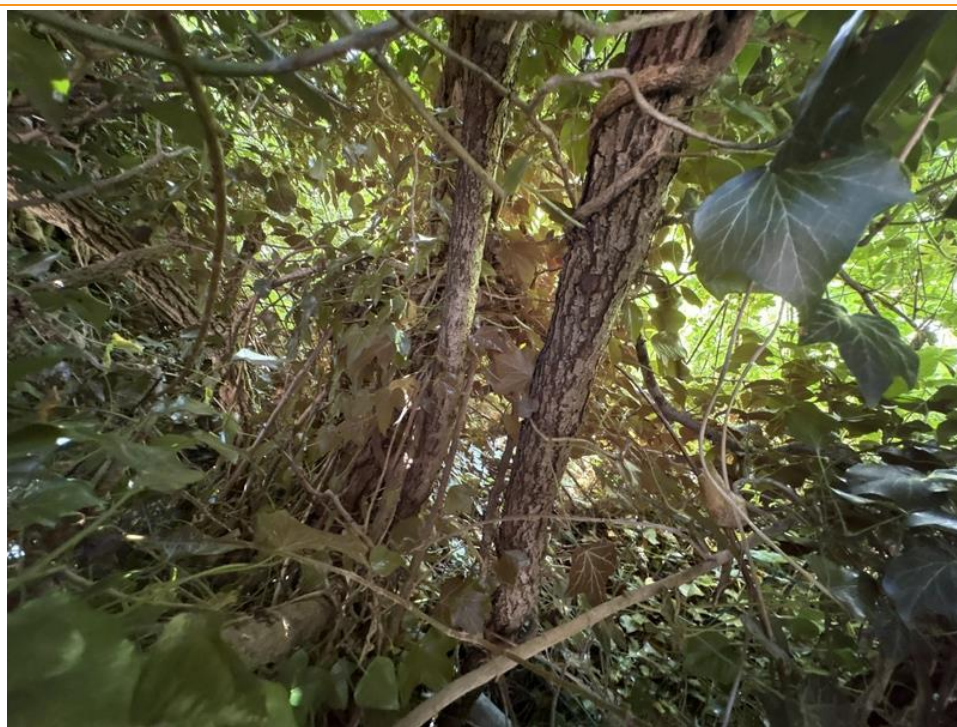
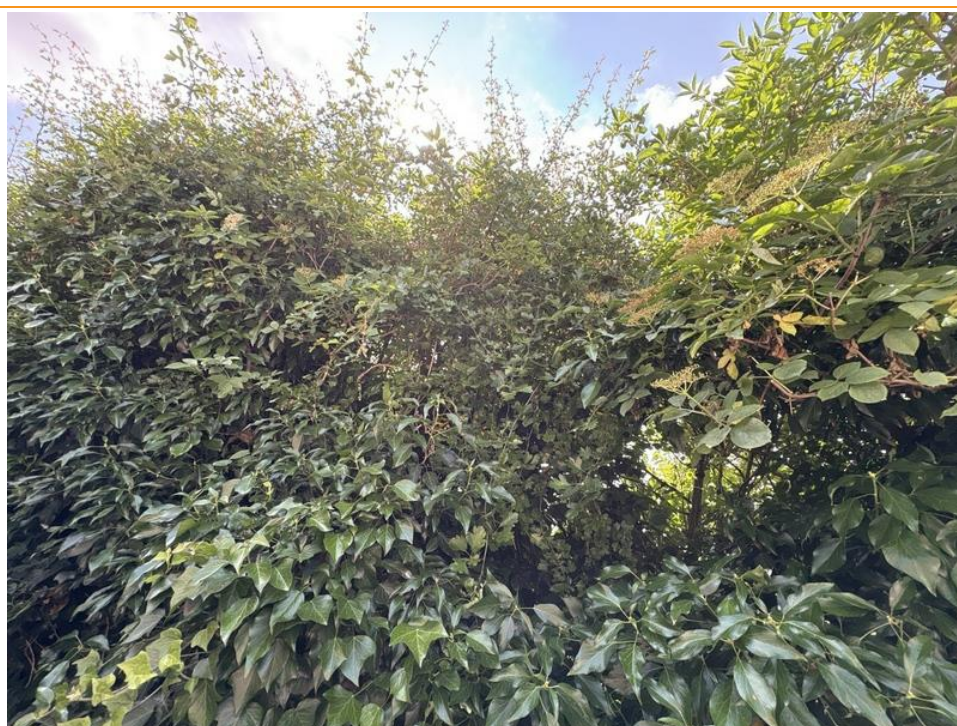
T7 Hawthorn

| Tree No: | Common Name | Age Class | Condition | Height (m) | Crown Spread (m) | Stem diam. (mm) | No. of Stems | Dist to bldg. (m) | Roots Implicated | Pruning History | Recommendation | Tree Work Constraints | Notes | Owner address | Owner |
|---|---|---|---|---|---|---|---|---|---|---|---|---|---|---|---|
| T7 | Hawthorn | Semi-Mature | Fair | 3.00 | 1.50 | 25 | 2 | 1.50 | Yes | Subject to historic crown reduction management. | Fell and treat stump with eco plugs (broadleaved). | There are restrictions to the site or to the tree - contractor should quote. Access through side gate. | Estimated stem diameter range from 25mm-75mm. | 2 Main Street<br>Ratby<br>Leicester<br>LE6 0JG | PH |

| Tree No: | Species | Works Required | CA | TPO | Ownership |
|---|---|---|---|---|---|
| T7 | Hawthorn | Fell and treat stump with eco plugs (broadleaved). | Yes | No | PH |

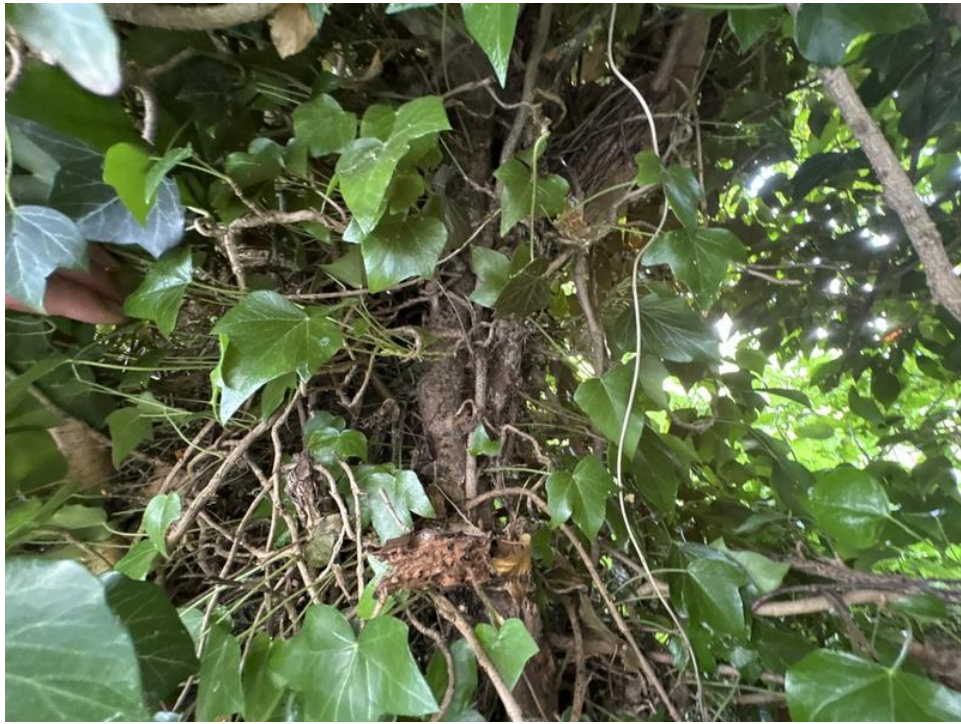
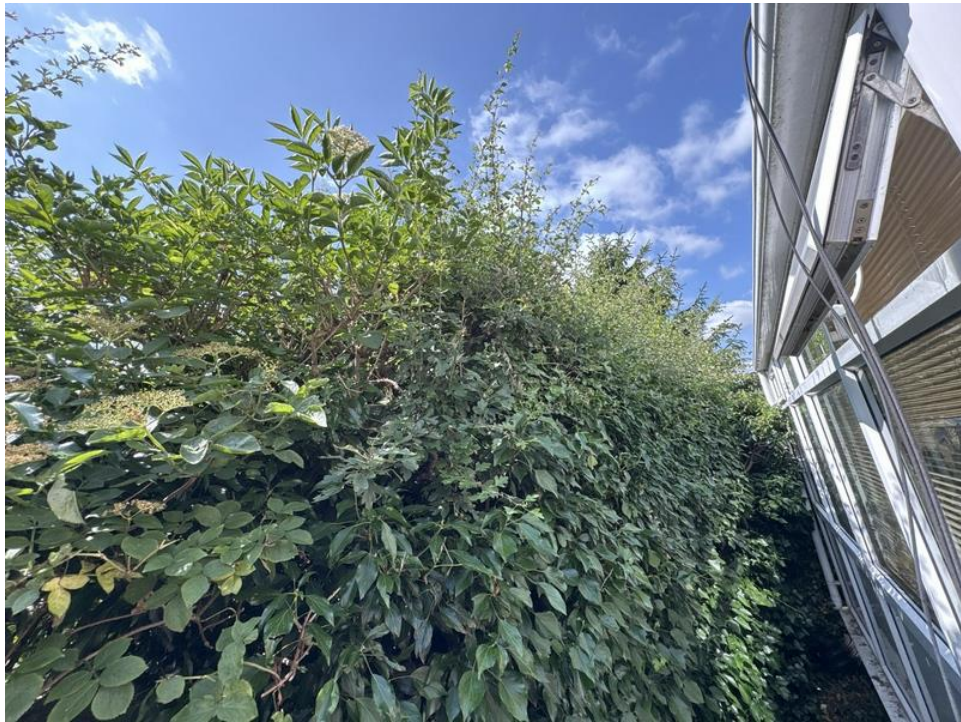
T8 Hawthorn

| Tree No: | Common Name | Age Class | Condition | Height (m) | Crown Spread (m) | Stem diam. (mm) | No. of Stems | Dist to bldg. (m) | Roots Implicated | Pruning History | Recommendation | Tree Work Constraints | Notes | Owner address | Owner |
|---|---|---|---|---|---|---|---|---|---|---|---|---|---|---|---|
| T8 | Hawthorn | Semi-Mature | Fair | 3.00 | 1.50 | 50 | 2 | 1.50 | Yes | Subject to historic crown reduction management. | Fell and treat stump with eco plugs (broadleaved). | There are restrictions to the site or to the tree - contractor should quote. Access through side gate. | Estimated stem diameter range from 25mm-75mm. | 2 Main Street<br>Ratby<br>Leicester<br>LE6 0JG | PH |

| Tree No: | Species | Works Required | CA | TPO | Ownership |
|---|---|---|---|---|---|
| T8 | Hawthorn | Fell and treat stump with eco plugs (broadleaved). | Yes | No | PH |

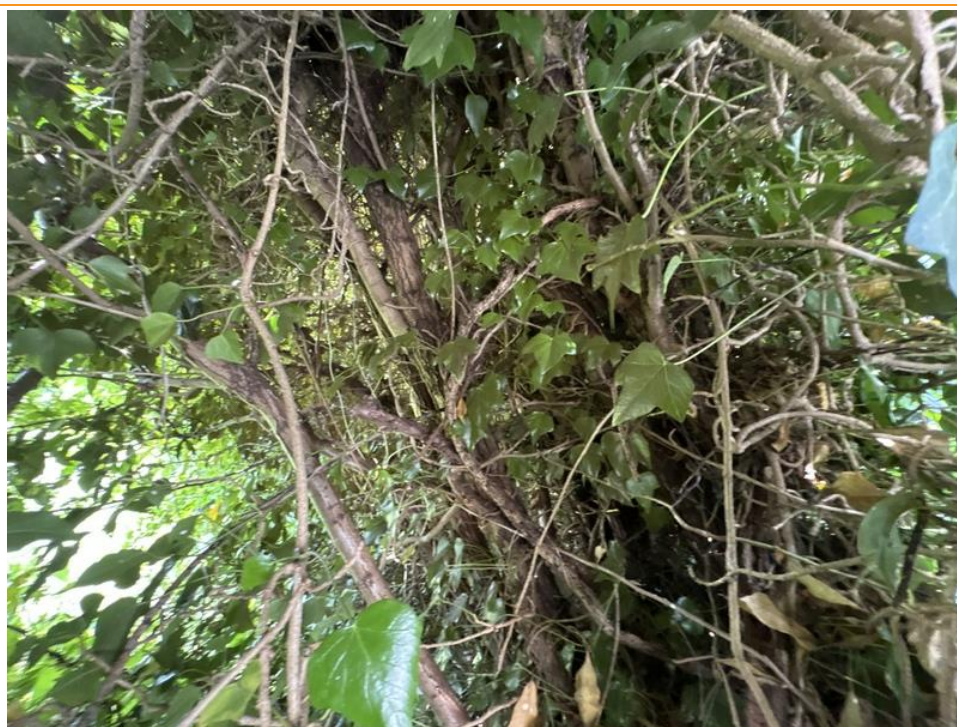
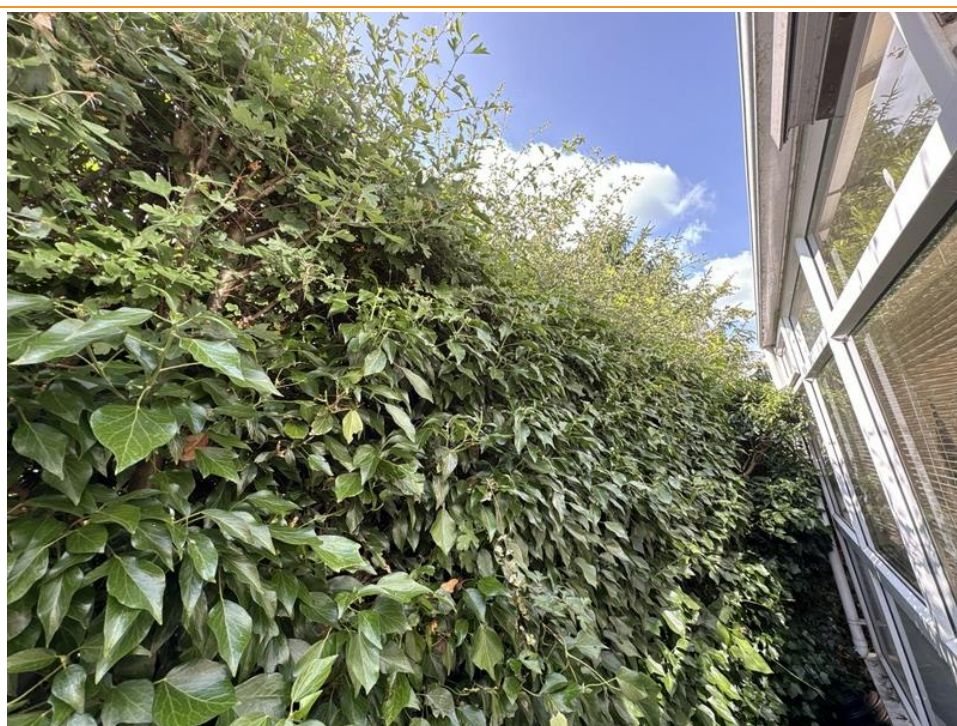
T9 Hawthorn

| Tree No: | Common Name | Age Class | Condition | Height (m) | Crown Spread (m) | Stem diam. (mm) | No. of Stems | Dist to bldg. (m) | Roots Implicated | Pruning History | Recommendation | Tree Work Constraints | Notes | Owner address | Owner |
|---|---|---|---|---|---|---|---|---|---|---|---|---|---|---|---|
| T9 | Hawthorn | Semi-Mature | Fair | 3.00 | 1.50 | 50 | 2 | 1.40 | Yes | Subject to historic crown reduction management. | Fell and treat stump with eco plugs (broadleaved). | There are restrictions to the site or to the tree - contractor should quote. Access through side gate. | Estimated stem diameter range from 25mm-75mm. | 2 Main Street<br>Ratby<br>Leicester<br>LE6 0JG | PH |

| Tree No: | Species | Works Required | CA | TPO | Ownership |
|---|---|---|---|---|---|
| T9 | Hawthorn | Fell and treat stump with eco plugs (broadleaved). | Yes | No | PH |

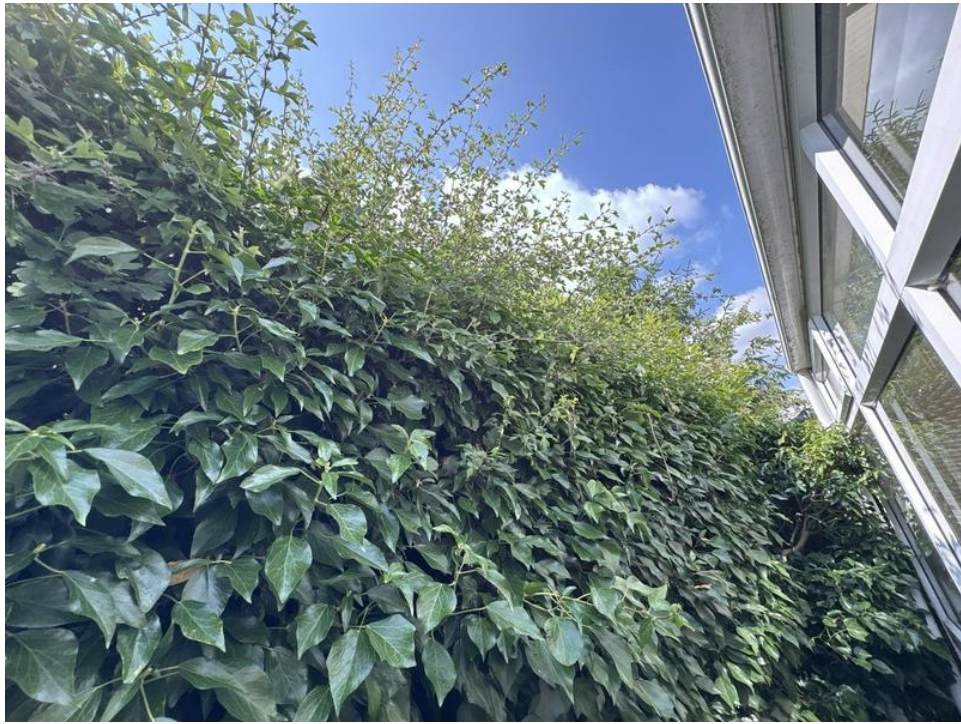
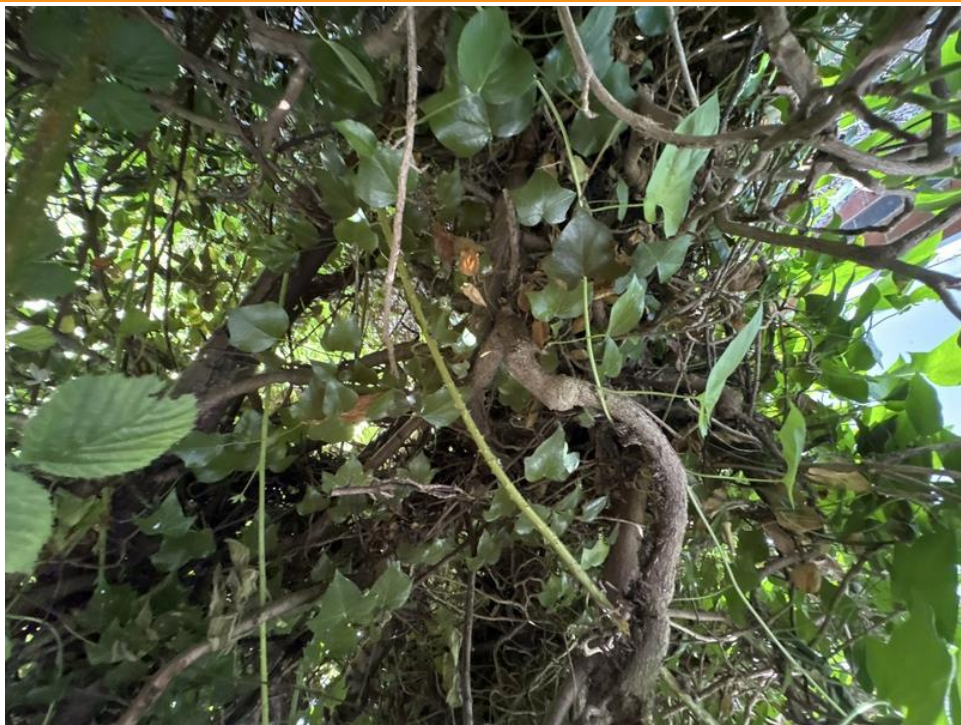
T10 Hawthorn

| Tree No: | Common Name | Age Class | Condition | Height (m) | Crown Spread (m) | Stem diam. (mm) | No. of Stems | Dist to bldg. (m) | Roots Implicated | Pruning History | Recommendation | Tree Work Constraints | Notes | Owner address | Owner |
|---|---|---|---|---|---|---|---|---|---|---|---|---|---|---|---|
| T10 | Hawthorn | Semi-Mature | Fair | 3.00 | 2.00 | 50 | 4 | 1.40 | Yes | Subject to historic crown reduction management. | Fell and treat stump with eco plugs (broadleaved). | There are restrictions to the site or to the tree - contractor should quote. Access through side gate. | Estimated stem diameter range from 25mm-75mm. | 2 Main Street<br>Ratby<br>Leicester<br>LE6 0JG | PH |

| Tree No: | Species | Works Required | CA | TPO | Ownership |
|---|---|---|---|---|---|
| T10 | Hawthorn | Fell and treat stump with eco plugs (broadleaved). | Yes | No | PH |

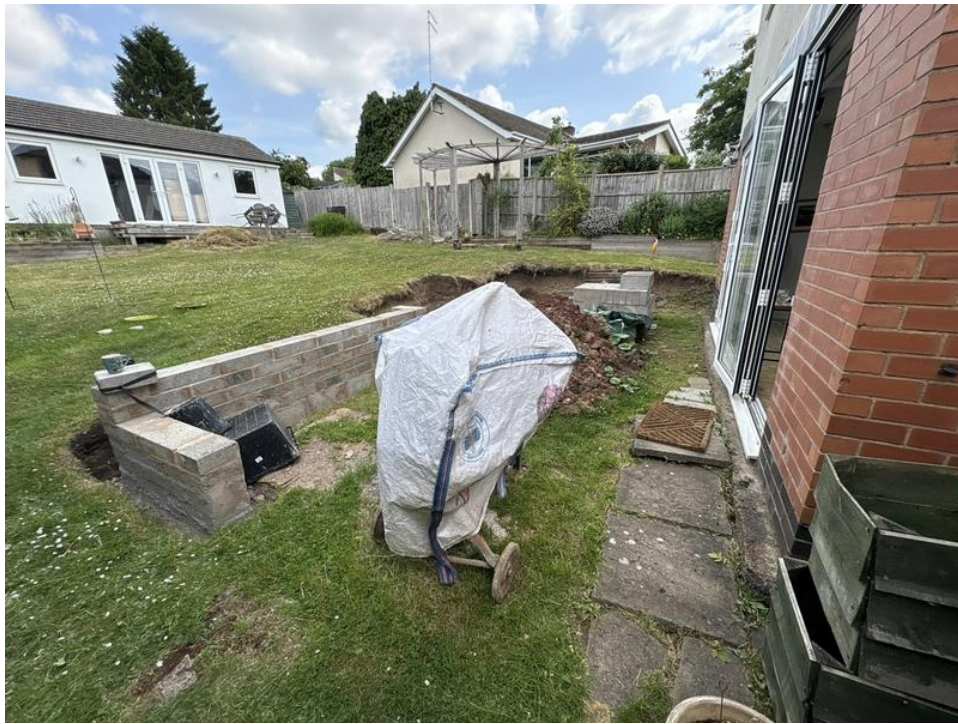
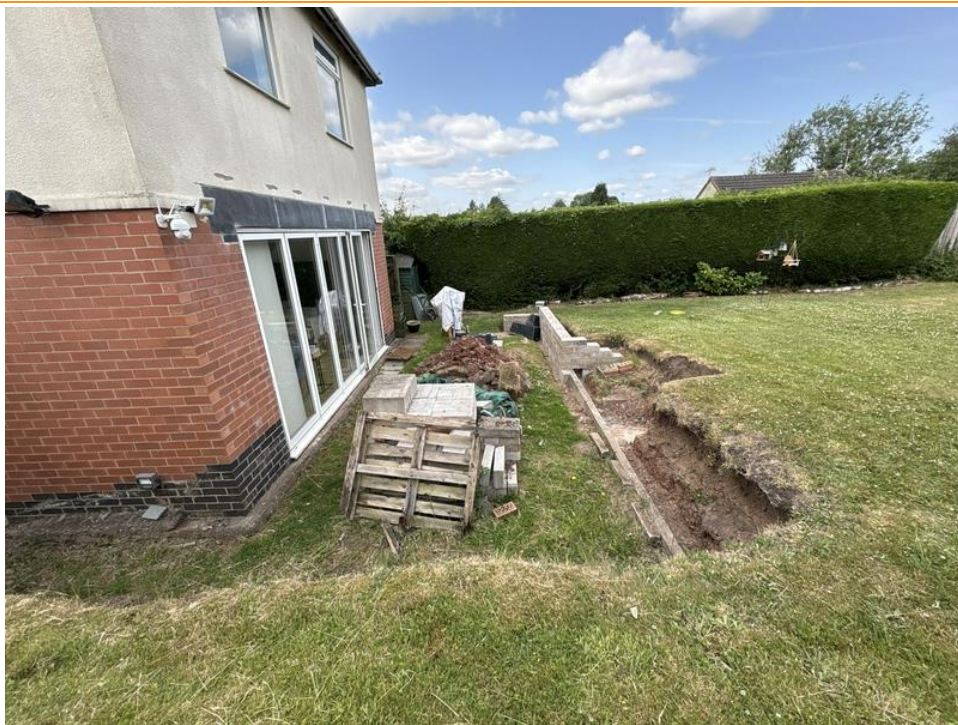
Construction of a patio to left hand side

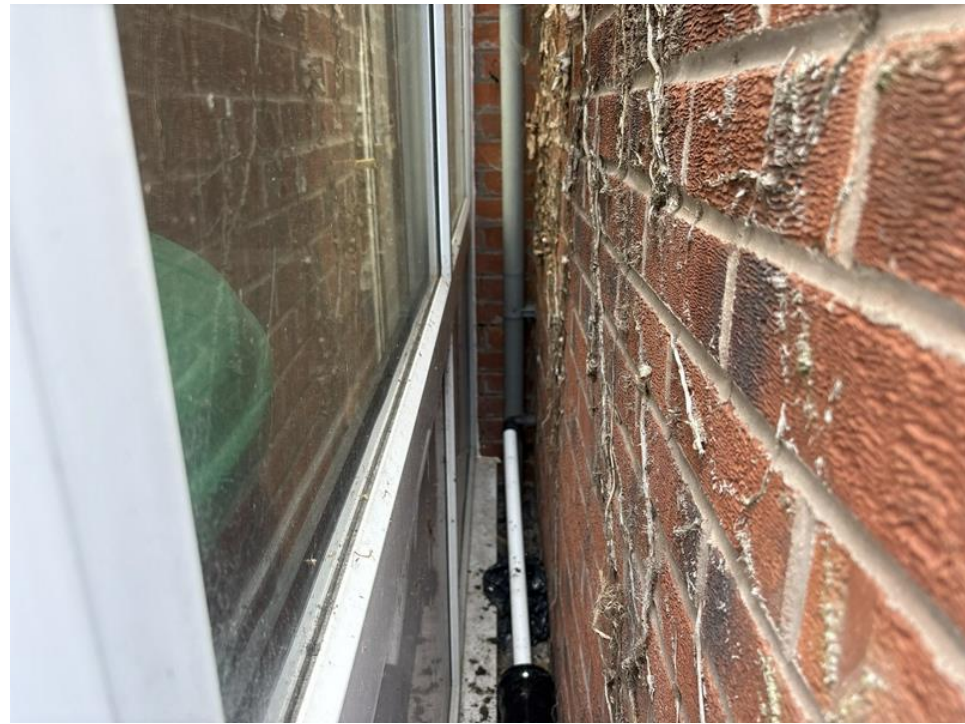
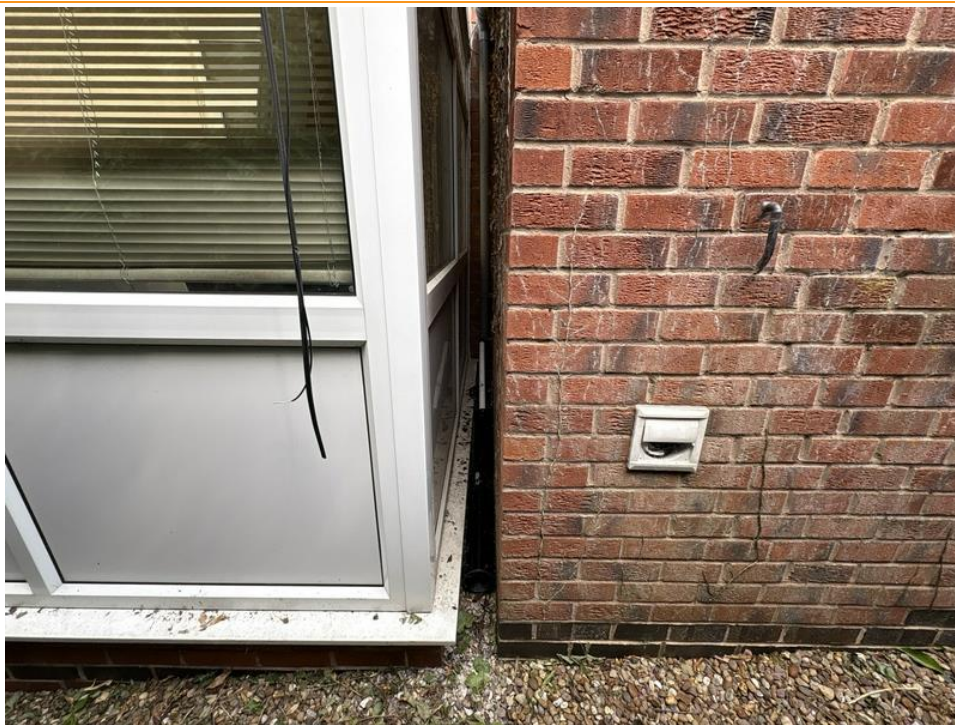
Extension drainage

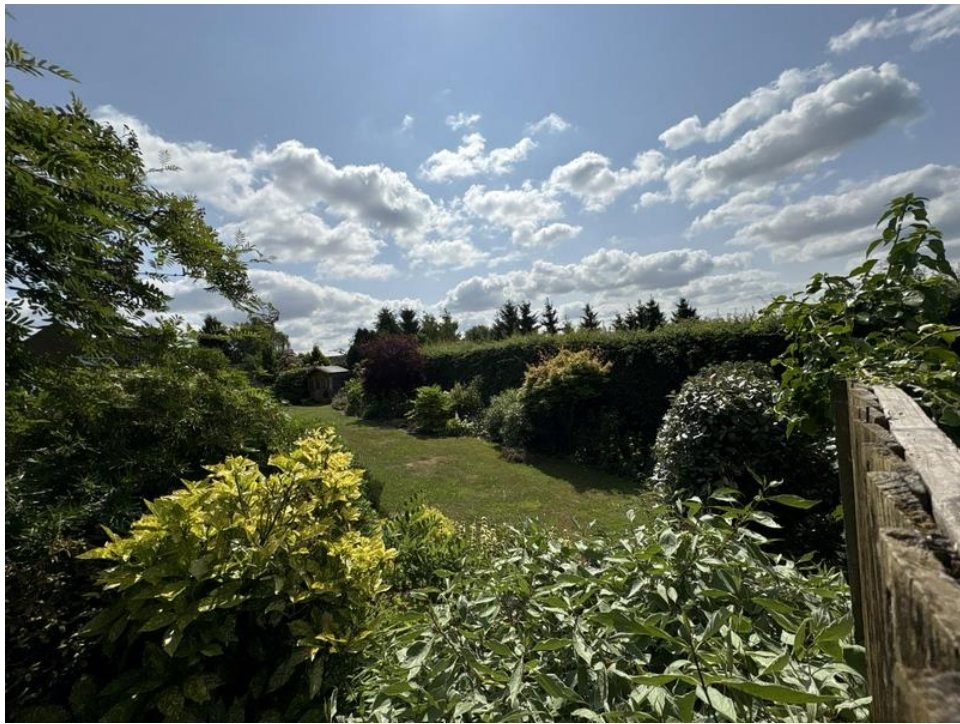
Vegetation to rear outside of an expected influencing range
