## SITE INVESTIGATION FACTUAL REPORT

Report No: SI-930113  
Client: Sedgwick International UK - Maidstone  
Site: 2 Main Street, Ratby  
Leicestershire  
Client Ref: 10420891  
Date of Visit: 4/12/2024

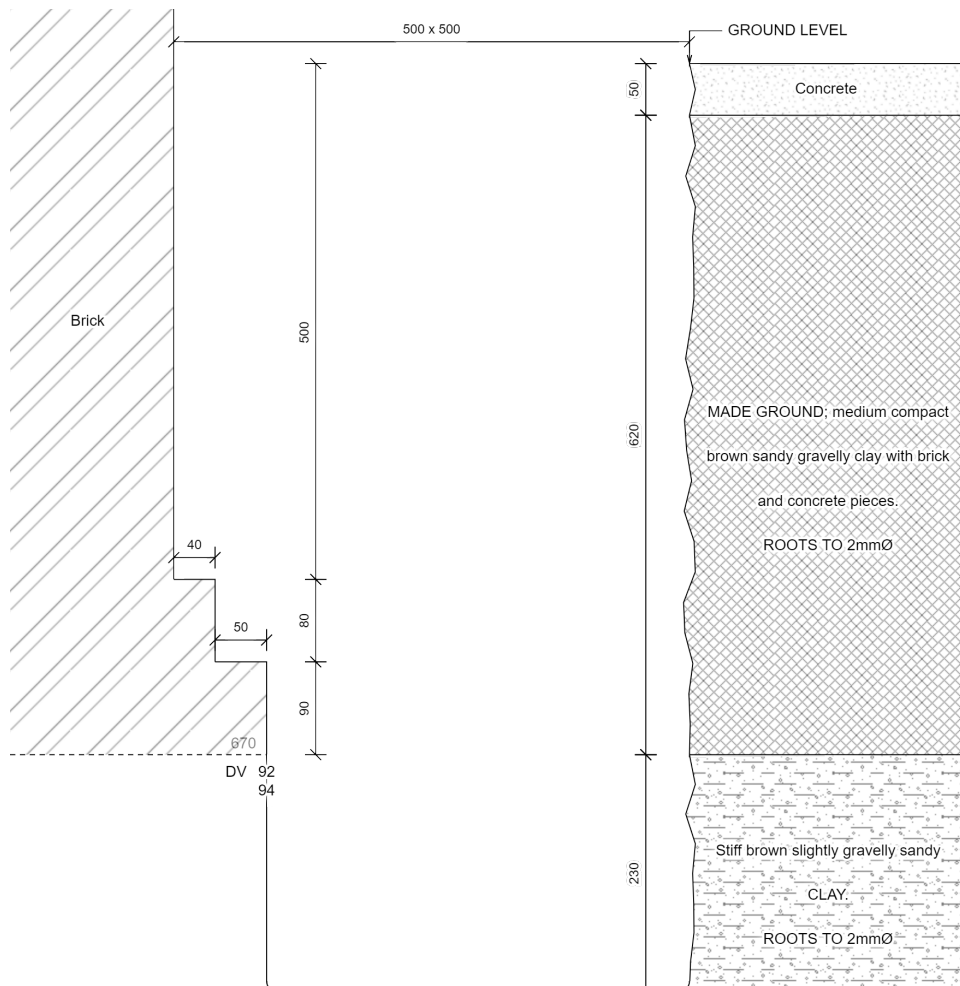
REPORT NUMBER: C5005560 / 325027.1.1.1  
TRIAL PIT REF: TP1  
CLIENT: Sedgwick International UK  
JOB NO: 930113  
EXCAVATION METHOD: Hand tools

curved steel pin driven 200mm under foundation at 670mm below ground level.

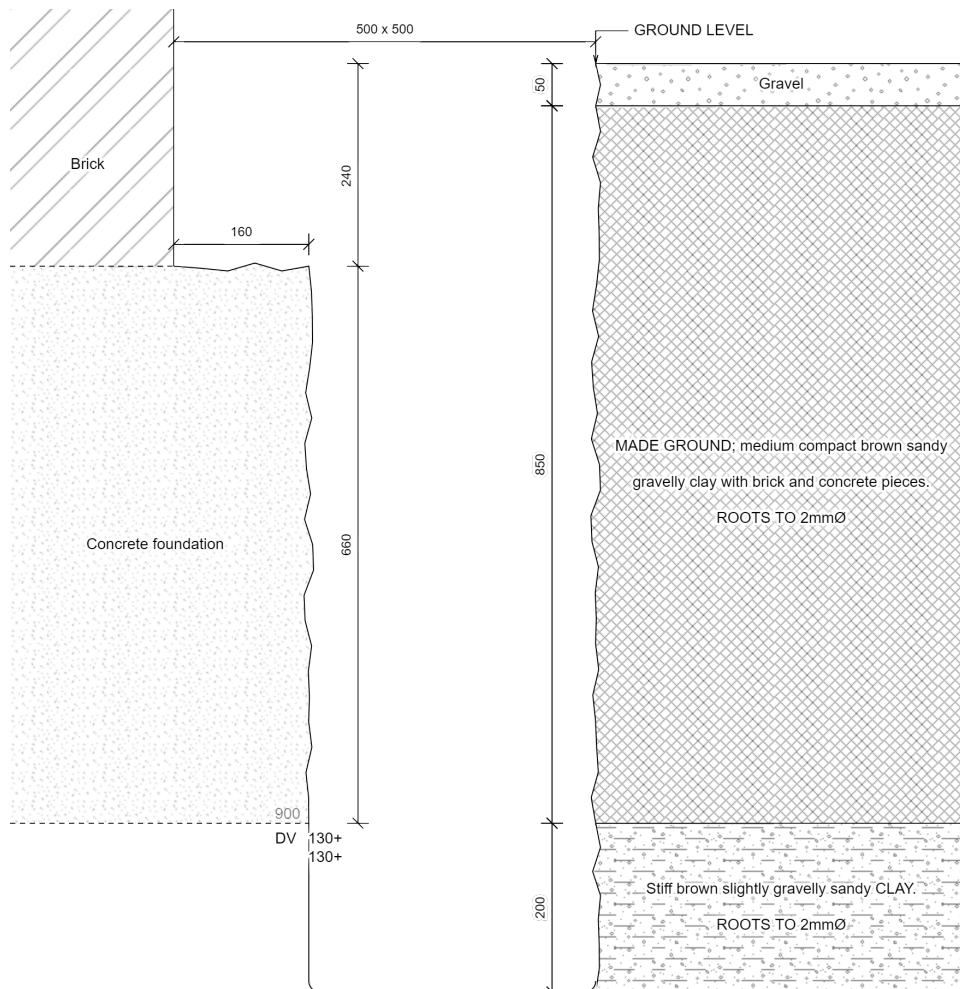
REPORT NUMBER: C5005560 / 325027.1.1.2  
TRIAL PIT REF: TP2  
CLIENT: Sedgwick International UK  
JOB NO: 930113  
EXCAVATION METHOD: Hand tools

Curved steel pin driven 200mm under foundation at 900mm below ground level.
