Structural report:

Suitability of barns for conversion to dwellings

Frog Hall Farm, Sheepy Magna

Job No. 21116-A

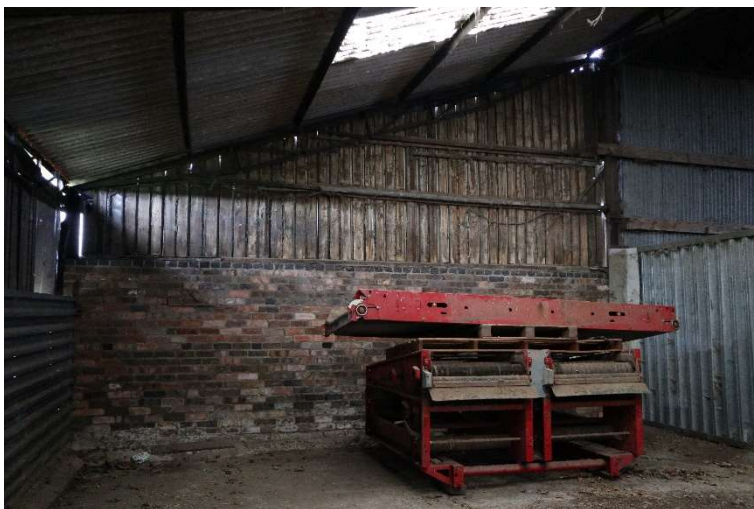
2.4 The roof consists of corrugated cement sheeting and walls consist of a combination of steel corrugated sheeting and blockwork. The rear wall is partially of brickwork construction with timber cladding over.

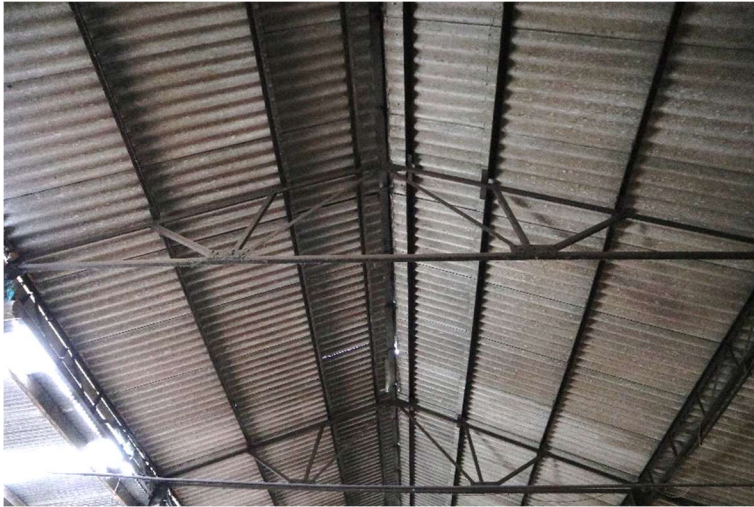
2.5 The main structure consists of steel columns and steel trusses, with steel purlins. There is no vertical bracing or roof bracing.

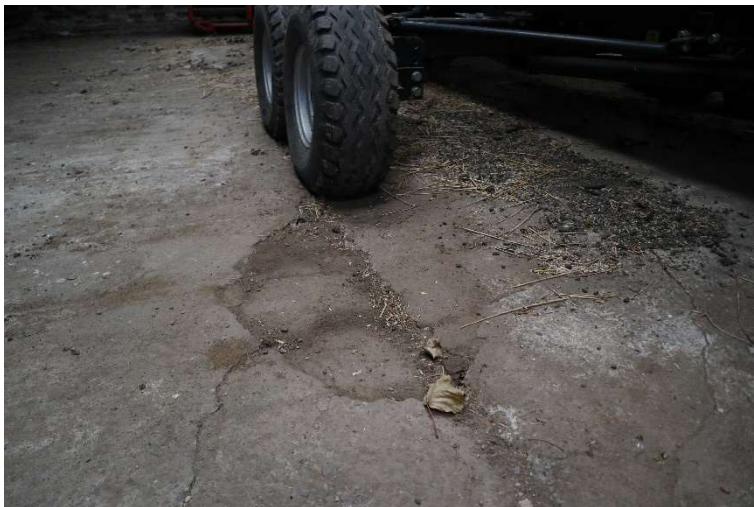
2.6 The floor is covered with concrete slabs which has settled or been damaged in places, presumably due to heavy wheel loads.

3.5 The concrete slabs in places showed signs of some settlement due to heavy traffic. These should be possible to be repaired to form the basis for ground floor slabs for the much smaller domestic loading requirements.

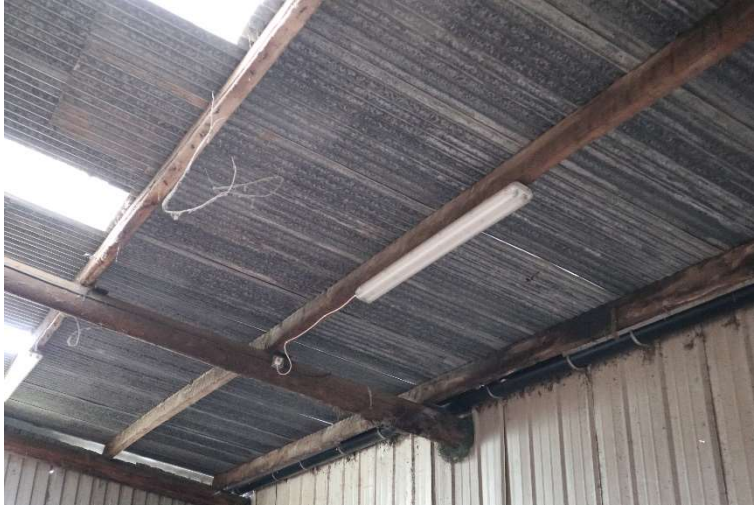
Barn 01 infill section

2.7 There is an infill building between barns 01 and 02 which has been created by using timber poles to form rafters between the two other barns. The rafters have slender timber purlins, with galvanised steel sheeting over.

3.7 The infill roof with the timber rafters is in our view inadequate and should be replaced with steel rafters and steel "Z" purlins. The columns and foundations for adjacent barns should be checked for this load.

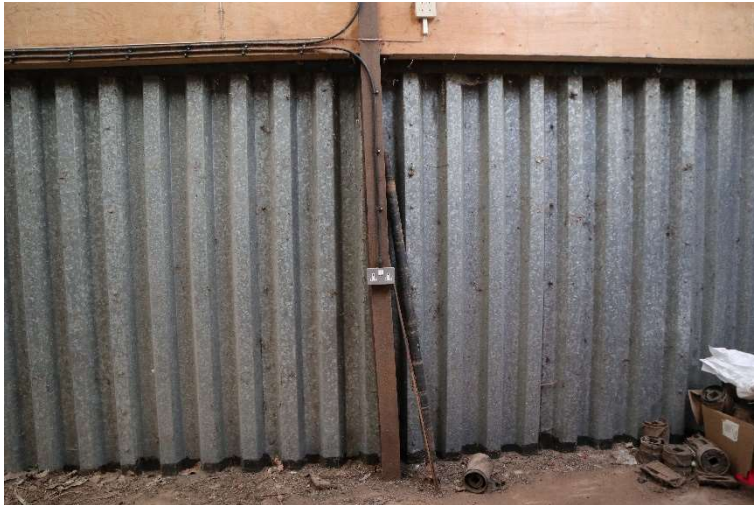
2.8 Some of the steel columns are damaged and will need remedial strengthening.

3.2 There were a small number of steel columns which were showing signs of advanced corrosion at the base. These columns should be replaced or repaired.

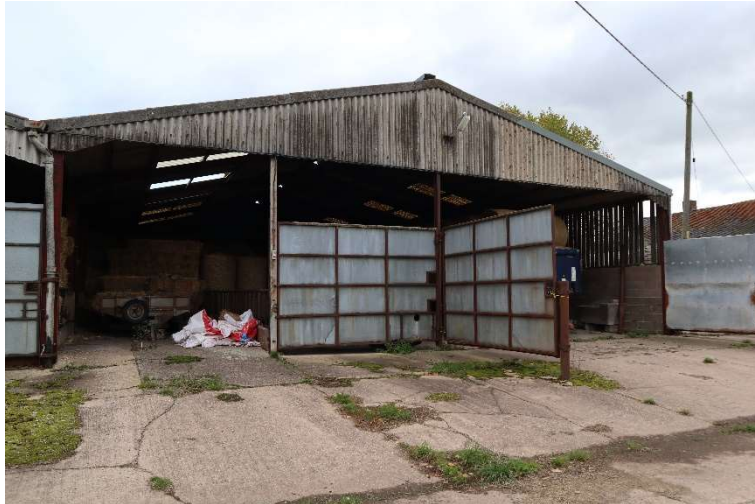
2.9 Barn 02 is a steel portal frame building consisting of two barns joined at the location of the middle columns. The left hand barn is approximately 12m span between columns, and the right hand barn is approximately 14.7m span between columns. The Ridge is around six metres, and the eaves are approximately 4.4 metres above ground level. There are steel purlins and corrugated fibre cement sheeting to the roof.

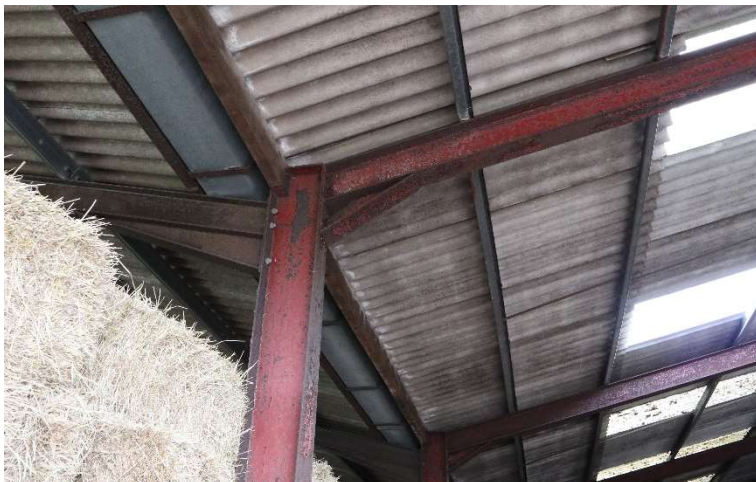
2.10 The left hand frame has some roof bracing and vertical bracing. There is no roof bracing or vertical bracing to the right hand frame. There are no rafter stays or torsional restraint to columns. There is an eaves haunch and apex haunch visible on the left hand frame, as is common to most portal frame buildings.

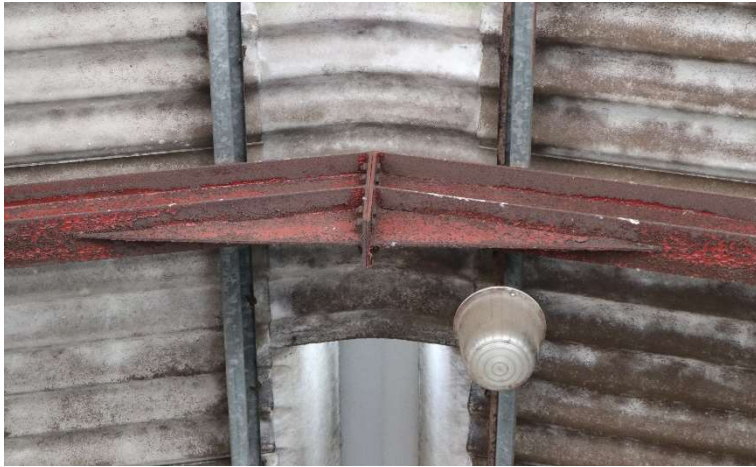
2.11 To the right hand frame, the eaves haunch is shorter than usual, and the apex haunch is missing and consists only of a web of thin steel (see next photo). This is likely to be inadequate and will need some additional plate welding in place.

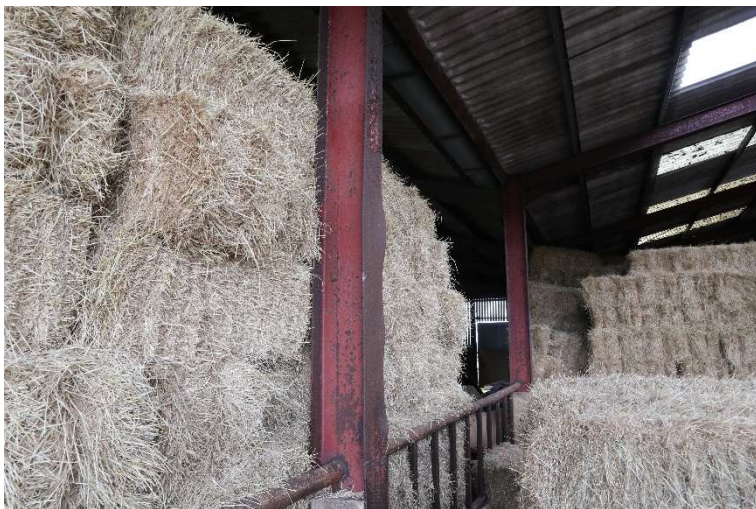
2.12 Some columns are damaged by vehicle impact, and will need to be repaired.

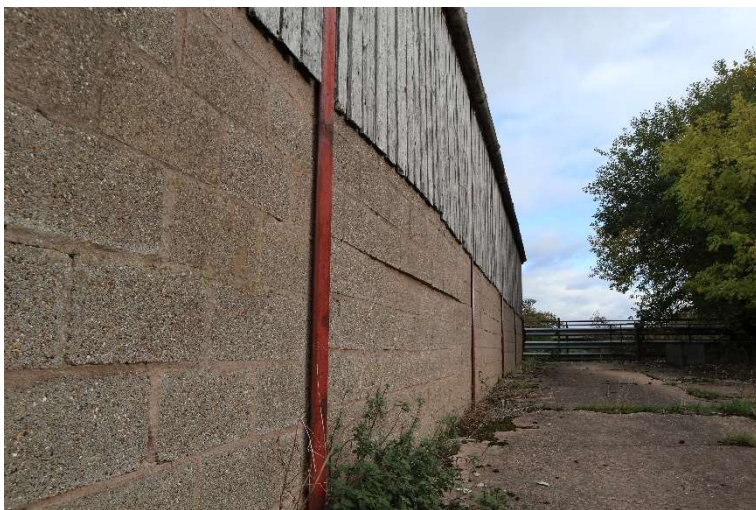
2.13 The sides of the barn consist of blockwork and timber cladding.

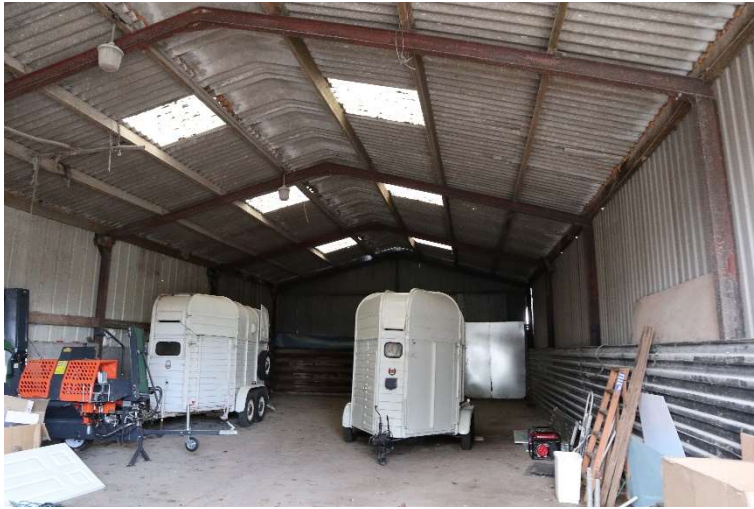
2.20 Barn 3 is a steel portal frame structure of 9m span with 4.5m column spacing, 4m eaves height and 5.1m apex height. The roof consists of timber purlins and corrugated fibre cement sheeting. The sides consist of steel sheeting on timber sheeting rails.

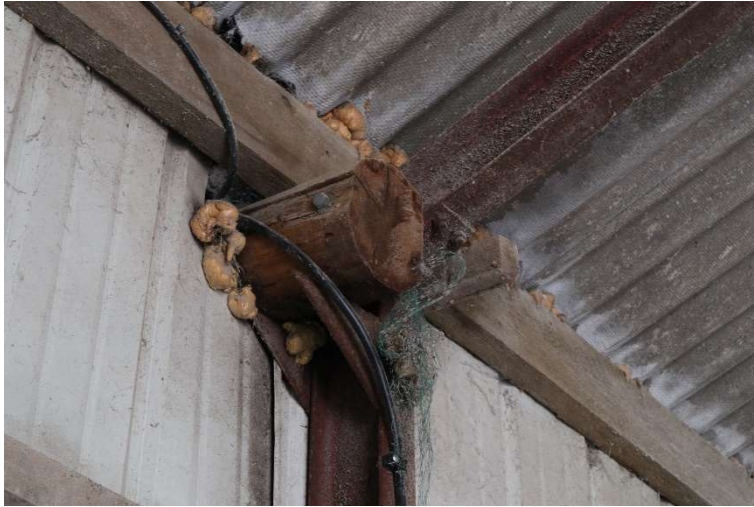
2.23 The timber rafters of barn 01 are seen to be supported on the left hand columns of this barn.
