## **ASBESTOS SURVEY REPORT**

**SURVEY TYPE : Demolition Survey**

**ADDRESS : 68 Wood Street  
Earl Shilton  
Leicestershire  
LE9 7ND**

**SURVEY REPORT NO. : SNM/DS/TR/01848**

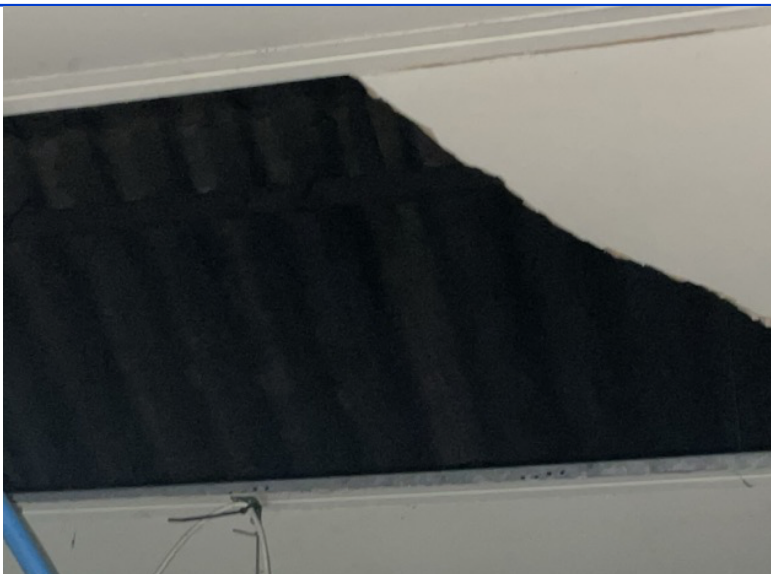
| <b>Area References</b> | 0001/10 | | |

| <b>Material</b> | Cement | | |

| <b>Asbestos Type</b> | Chrysotile | |
| <b>Quantity</b> | 170 m2 | |

A sample was collected and the material listed above was found to contain Chrysotile.

The material was found to be in a relatively good condition, however, some minor damage was identified.

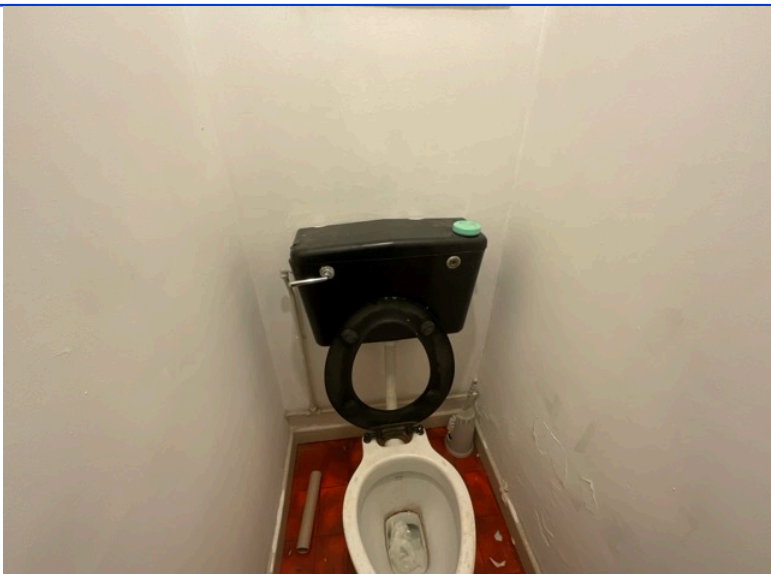
| <b>Area References</b> | 0002/04 | | |

| <b>Material</b> | Resin | | |

| <b>Asbestos Type</b> | Amosite | |

A sample was collected and the material listed above was found to contain Amosite.

The material is in a good condition and no damage was identified.

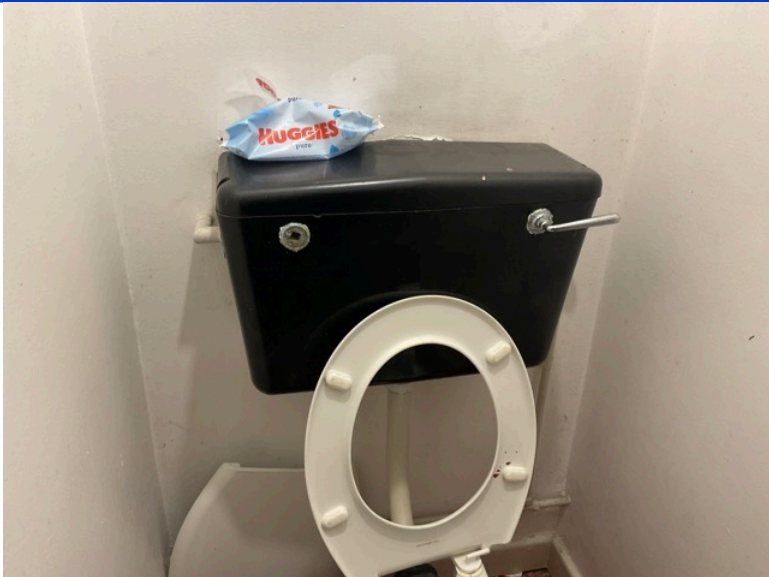
| <b>Area References</b> | 0003/04 | | |

| <b>Material</b> | Resin | | |

| <b>Asbestos Type</b> | Amosite | |

A sample was collected and the material listed above was found to contain Amosite.

The material is in a good condition and no damage was identified.

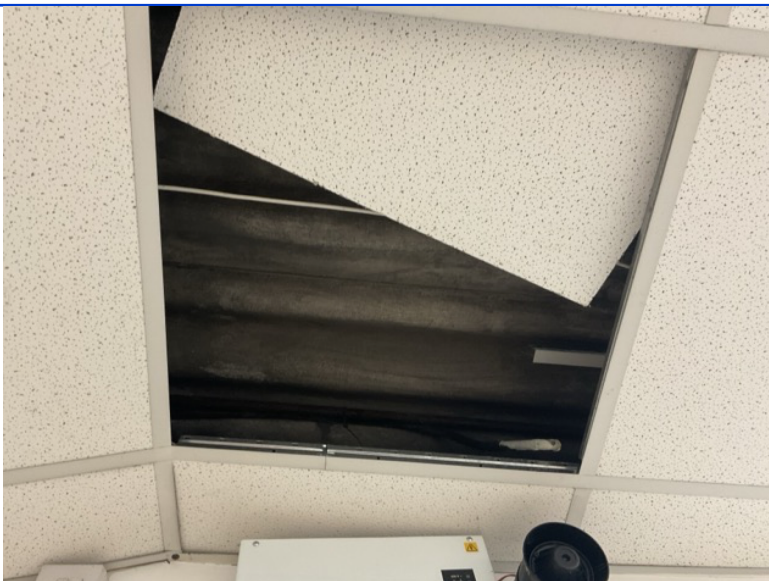
| <b>Area References</b> | 0004/06 | | |

| <b>Material</b> | Cement | | |

| <b>Asbestos Type</b> | Chrysotile | |

A sample was collected and the material listed above was found to contain Chrysotile.

The material was found to be in a relatively good condition, however, some minor damage was identified.

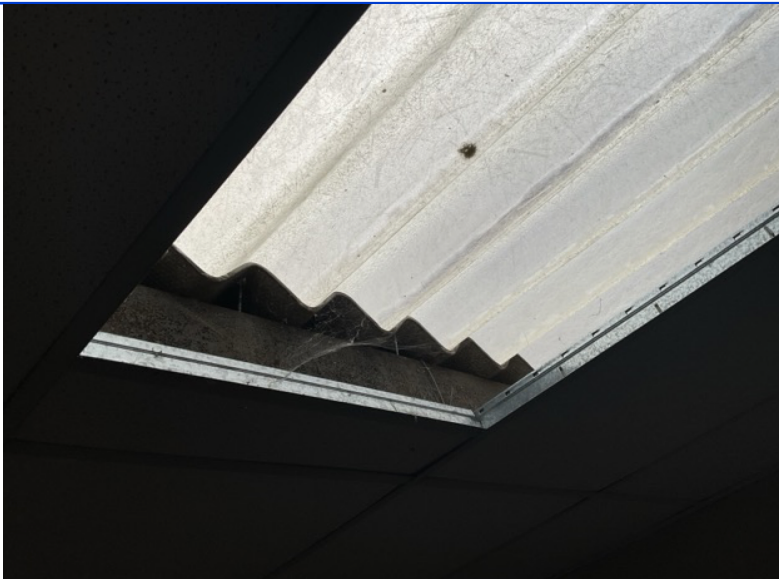
| <b>Area References</b> | 0005/05 | | |

| <b>Material</b> | Cement | | |

| <b>Asbestos Type</b> | Chrysotile | |

A sample was collected and the material listed above was found to contain Chrysotile.

The material was found to be in a relatively good condition, however, some minor damage was identified.

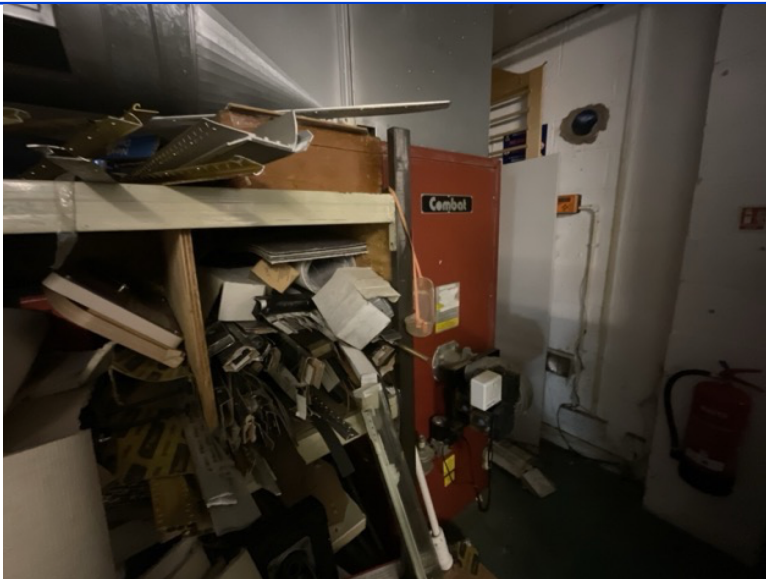
| <b>Area References</b> | 0006/05 | | |

| <b>Material</b> | May Contain Concealed Asbestos | | |

| <b>Asbestos Type</b> | Presumed Crocidolite | |

The material is in a good condition and no damage was identified.

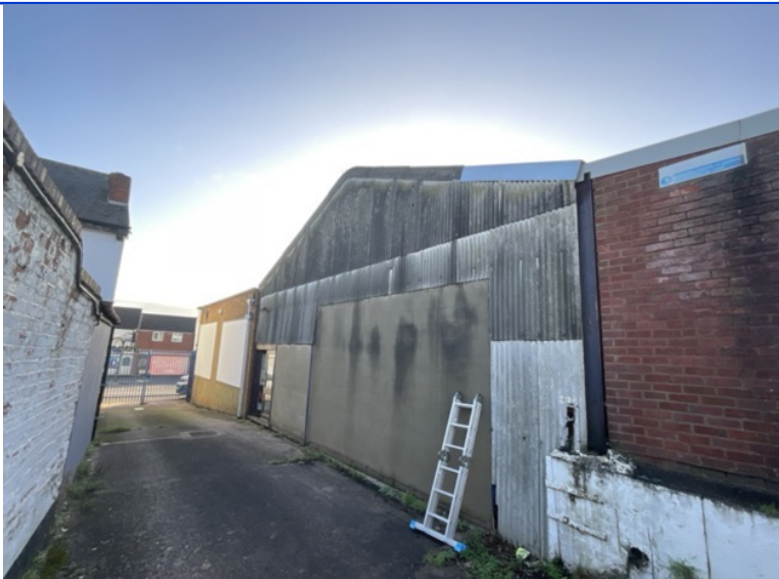
| <b>Area References</b> | 0009/05 | | |

| <b>Material</b> | Cement | | |

| <b>Asbestos Type</b> | Chrysotile | |

A sample was collected and the material listed above was found to contain Chrysotile.

The material was found to be in a relatively good condition, however, some minor damage was identified.

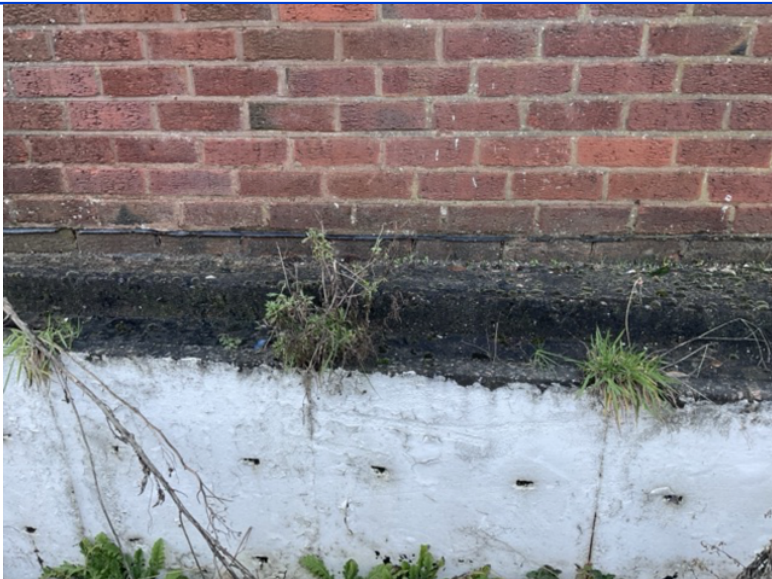
| <b>Area References</b> | 0009/06 | | |

| <b>Material</b> | Bitumen | | |

| <b>Asbestos Type</b> | Chrysotile | |

A sample was collected and the material listed above was found to contain Chrysotile.

The material is in a good condition and no damage was identified.

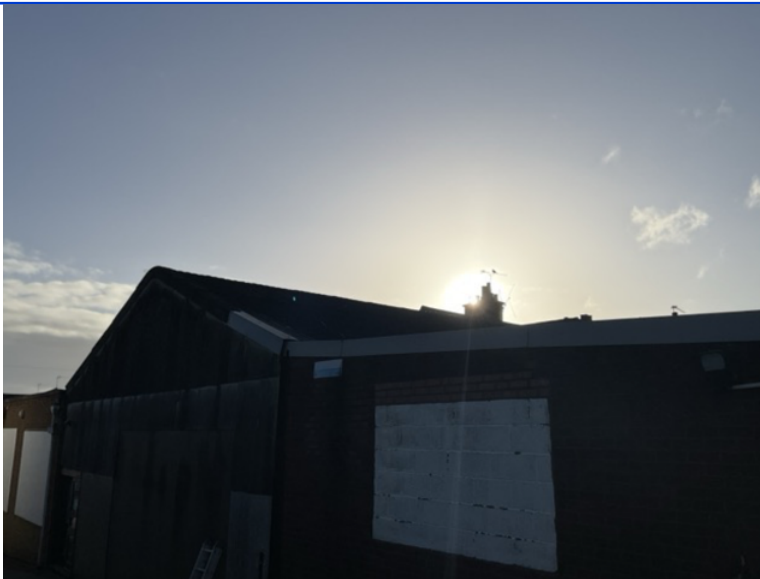
| <b>Area References</b> | 0009/07 | | |

| <b>Material</b> | Cement | | |

| <b>Asbestos Type</b> | Chrysotile | |

A sample was collected and the material listed above was found to contain Chrysotile.

The material was found to be in a relatively good condition, however, some minor damage was identified.

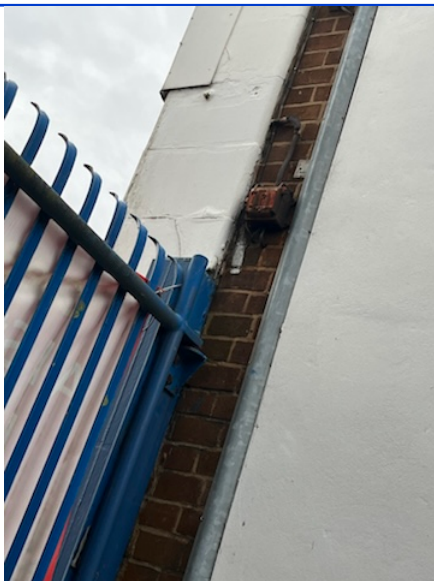
| <b>Area References</b> | 0009/14 | | |

| <b>Material</b> | May Contain Concealed Asbestos | | |

| <b>Asbestos Type</b> | Presumed Crocidolite | |

The material is in a good condition and no damage was identified.

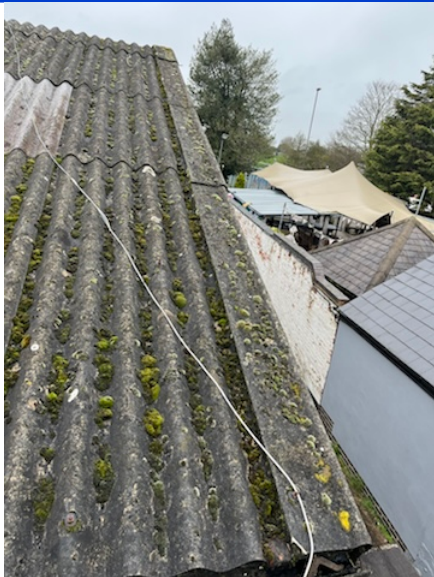
| <b>Area References</b> | 0009/18 | | |

| <b>Material</b> | Cement | | |

| <b>Asbestos Type</b> | Chrysotile | | |

A sample was collected and the material listed above was found to contain Chrysotile.

The material was found to be in a relatively good condition, however, some minor damage was identified.

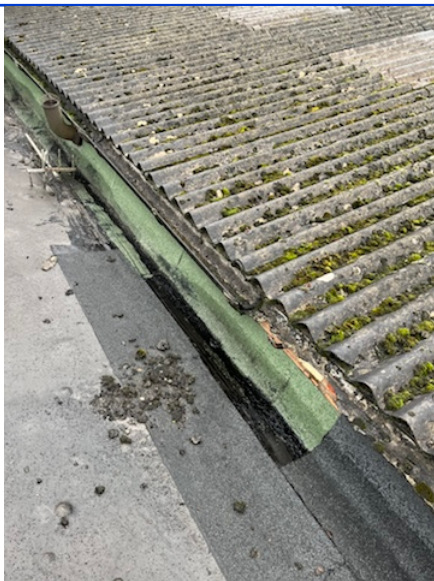
| <b>Area References</b> | 0009/20 | | |

| <b>Material</b> | Cement | | |

| <b>Asbestos Type</b> | Chrysotile | |

A sample was collected and the material listed above was found to contain Chrysotile.

The material is in poor condition and it is not sealed or painted.

Materials of this type are not likely to give rise to significant fibre release and may therefore be left in situ. The material should however be monitored periodically to assess its condition.

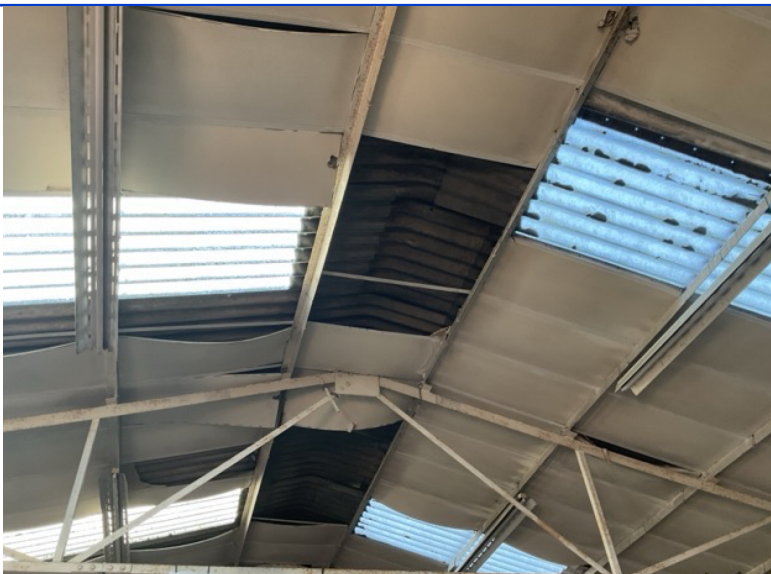
| <b>Area References</b> | 0010/05 | | |

| <b>Material</b> | Cement | | |

| <b>Asbestos Type</b> | Chrysotile | |

A sample was collected and the material listed above was found to contain Chrysotile.

The material was found to be in a relatively good condition, however, some minor damage was identified.

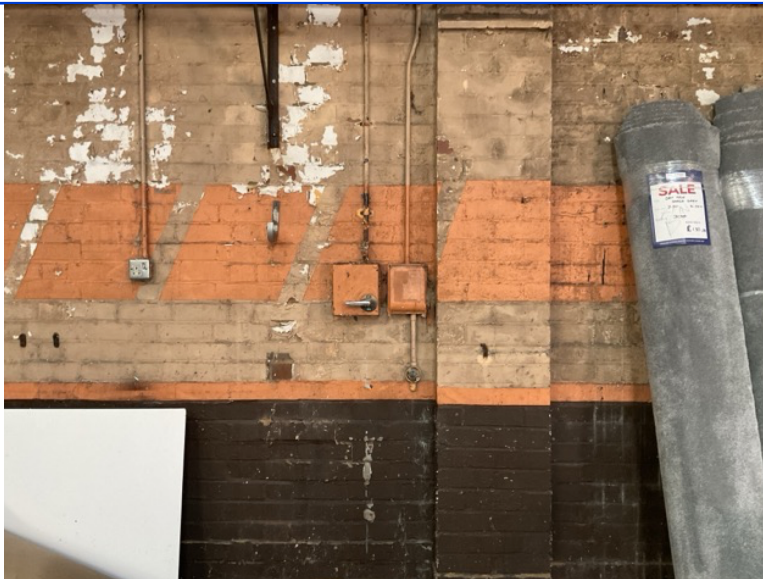
| <b>Area References</b> | 0010/06 | | |

| <b>Material</b> | May Contain Concealed Asbestos | | |

| <b>Asbestos Type</b> | Presumed Crocidolite | |

The material is in a good condition and no damage was identified.

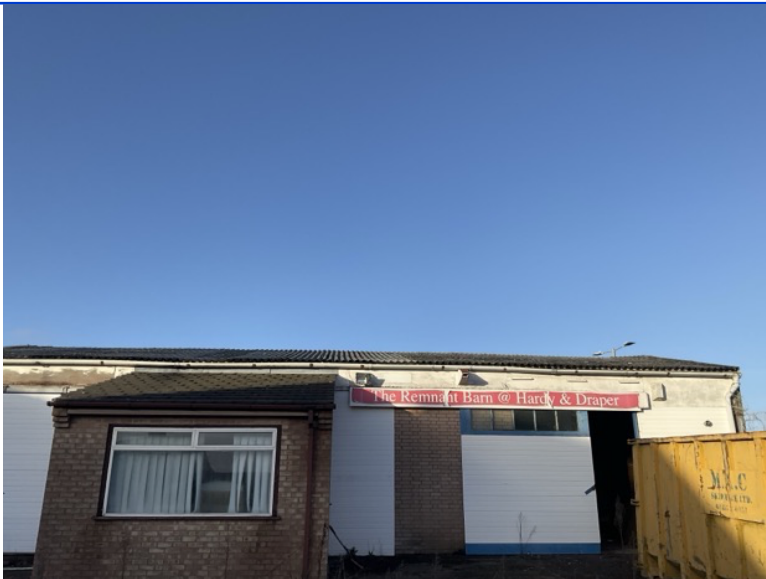
| <b>Area References</b> | 0013/01 | | |

| <b>Material</b> | Cement | | |

| <b>Asbestos Type</b> | Chrysotile | |

A sample was collected and the material listed above was found to contain Chrysotile.

The material was found to be in a relatively good condition, however, some minor damage was identified.
