## **ASBESTOS SURVEY REPORT**

**SURVEY TYPE : Management Survey**

**ADDRESS : 68 Wood Street  
Earl Shilton  
Leicestershire  
LE9 7ND**

**SURVEY REPORT NO. : SNM/MA/CN/01725**

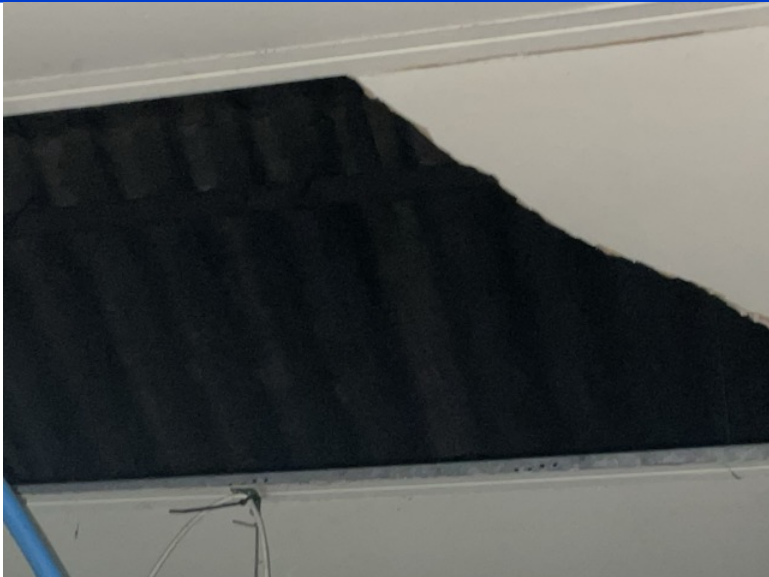
| <b>Area References</b> | 0001/10 | | |

| <b>Material</b> | Cement | | |

| <b>Asbestos Type</b> | Chrysotile | |

A sample was collected and the material listed above was found to contain Chrysotile.

The material is in a good condition and no damage was identified.

Materials of this type are not likely to give rise to significant fibre release and may therefore be left in situ. The material should however be monitored periodically to assess its condition.

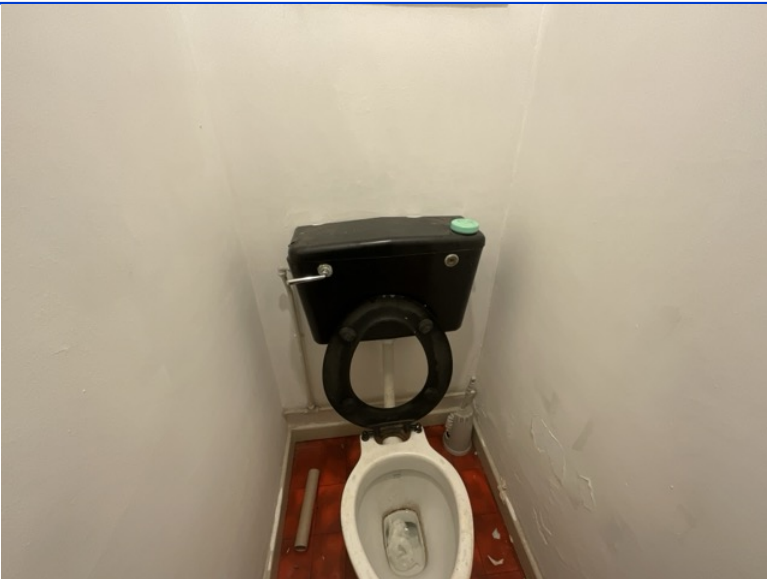
| <b>Area References</b> | 0002/04 | | |

| <b>Material</b> | Resin | | |

| <b>Asbestos Type</b> | Amosite | |

A sample was collected and the material listed above was found to contain Amosite.

The material is in a good condition and no damage was identified.

Materials of this type are not likely to give rise to significant fibre release and may therefore be left in situ. The material should however be monitored periodically to assess its condition.

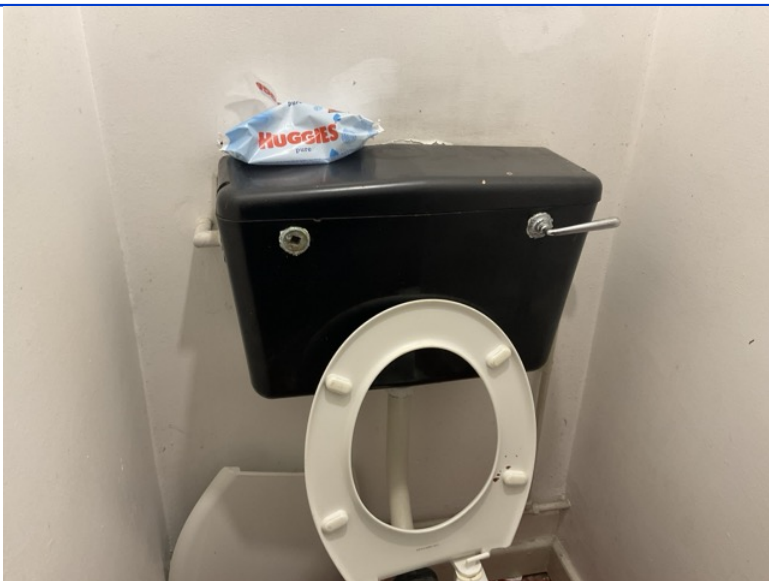
| <b>Area References</b> | 0003/04 | | |

| <b>Material</b> | Resin | | |

| <b>Asbestos Type</b> | Amosite | |

A sample was collected and the material listed above was found to contain Amosite.

The material is in a good condition and no damage was identified.

Materials of this type are not likely to give rise to significant fibre release and may therefore be left in situ. The material should however be monitored periodically to assess its condition.

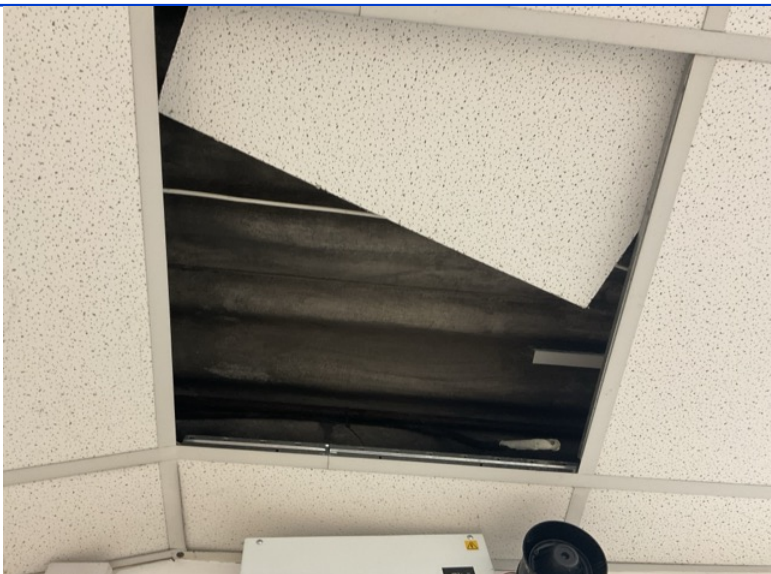
| <b>Area References</b> | 0004/06 | | |

| <b>Material</b> | Cement | | |

| <b>Asbestos Type</b> | Chrysotile | |

A sample was collected and the material listed above was found to contain Chrysotile.

The material is in a good condition and no damage was identified.

Materials of this type are not likely to give rise to significant fibre release and may therefore be left in situ. The material should however be monitored periodically to assess its condition.

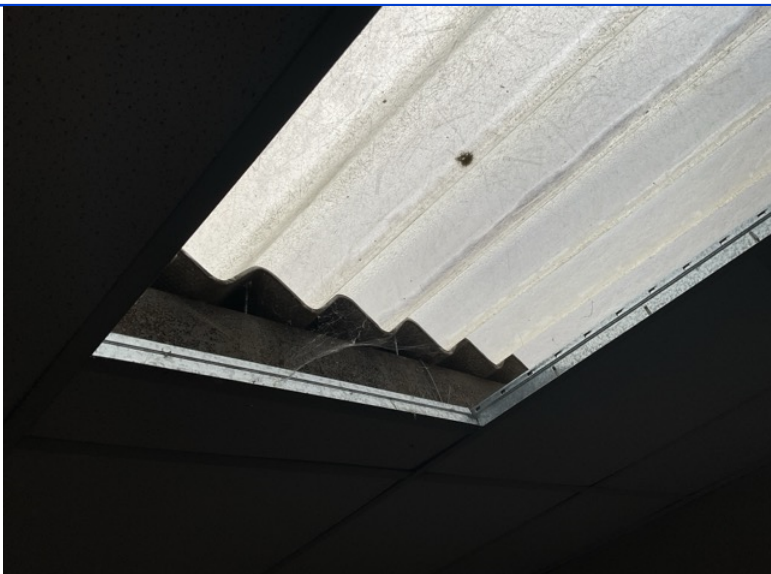
| <b>Area References</b> | 0005/05 | | |

| <b>Material</b> | Cement | | |

| <b>Asbestos Type</b> | Chrysotile | |

A sample was collected and the material listed above was found to contain Chrysotile.

The material is in a good condition and no damage was identified.

Materials of this type are not likely to give rise to significant fibre release and may therefore be left in situ. The material should however be monitored periodically to assess its condition.

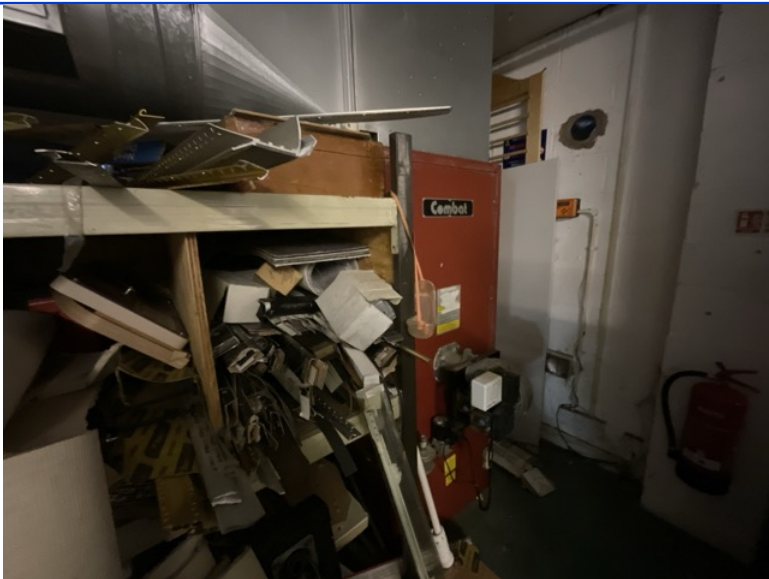
| <b>Area References</b> | 0006/05 | | |

| <b>Material</b> | May Contain Concealed Asbestos | | |

| <b>Asbestos Type</b> | Presumed Crocidolite | |

The material is in a good condition and no damage was identified.

Materials of this type are not likely to give rise to significant fibre release and may therefore be left in situ. The material should however be monitored periodically to assess its condition.

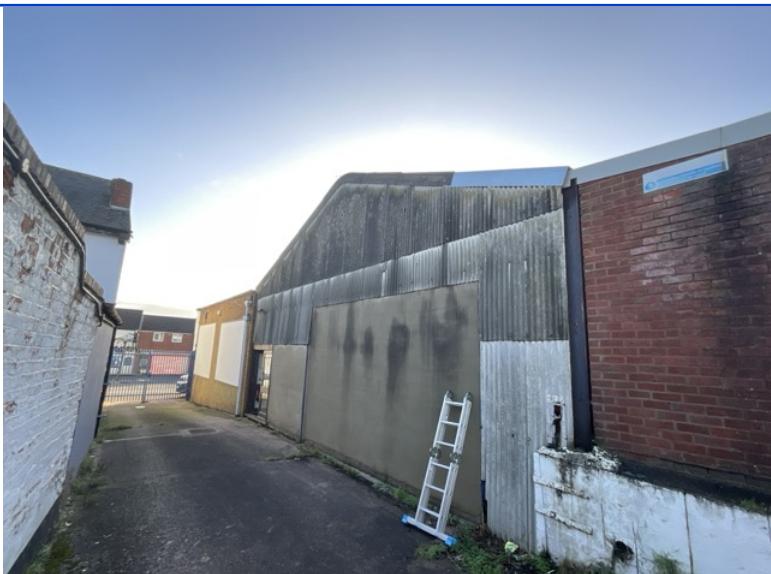
| <b>Area References</b> | 0009/05 | | |

| <b>Material</b> | Cement | | |

| <b>Asbestos Type</b> | Chrysotile | |

A sample was collected and the material listed above was found to contain Chrysotile.

The material was found to be in a relatively good condition, however, some minor damage was identified.

Materials of this type are not likely to give rise to significant fibre release and may therefore be left in situ. The material should however be monitored periodically to assess its condition.

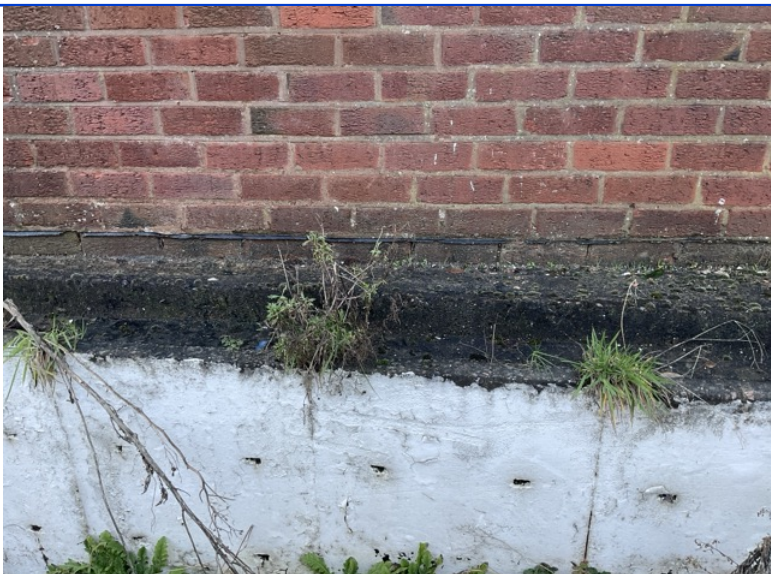
| <b>Area References</b> | 0009/06 | | |

| <b>Material</b> | Bitumen | | |

| <b>Asbestos Type</b> | Chrysotile | |

A sample was collected and the material listed above was found to contain Chrysotile.

The material is in a good condition and no damage was identified.

Materials of this type are not likely to give rise to significant fibre release and may therefore be left in situ. The material should however be monitored periodically to assess its condition.

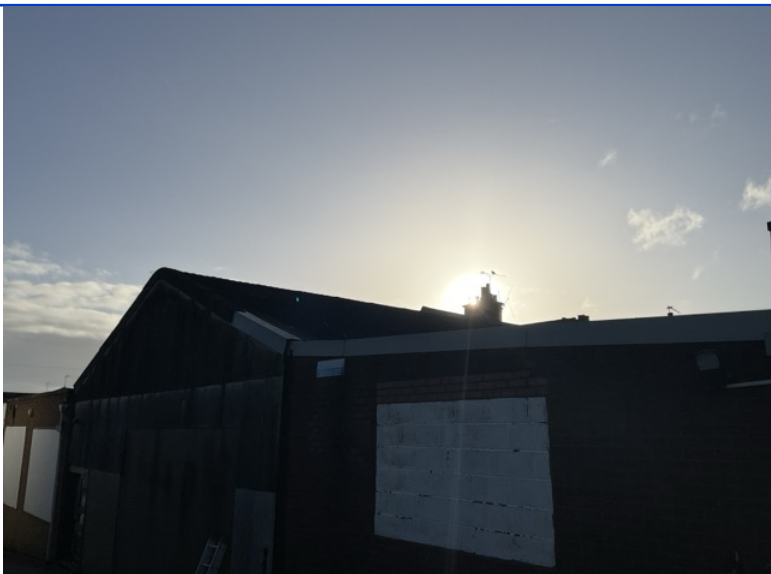
| <b>Area References</b> | 0009/07 | | |

| <b>Material</b> | Cement | | |

| <b>Asbestos Type</b> | Chrysotile | |

A sample was collected and the material listed above was found to contain Chrysotile.

The material is in a good condition and no damage was identified.

Materials of this type are not likely to give rise to significant fibre release and may therefore be left in situ. The material should however be monitored periodically to assess its condition.

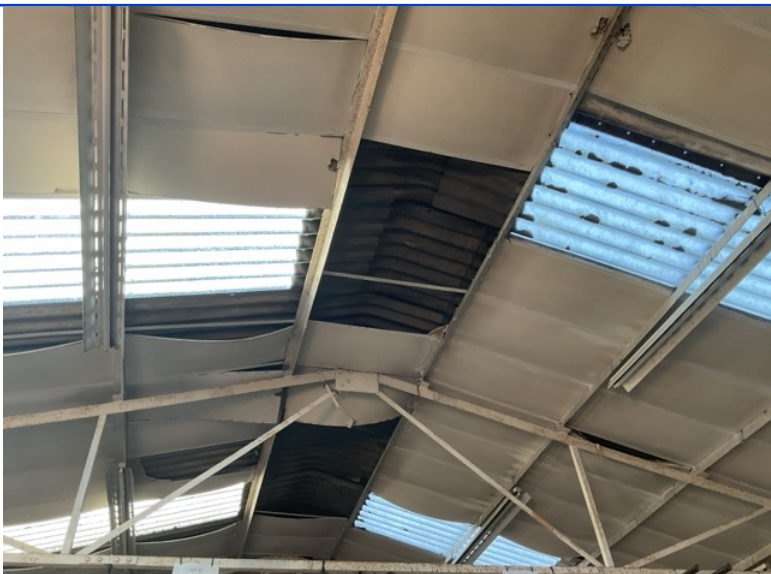
| <b>Area References</b> | 0010/05 | | |

| <b>Material</b> | Cement | | |

| <b>Asbestos Type</b> | Chrysotile | |

A sample was collected and the material listed above was found to contain Chrysotile.

The material was found to be in a relatively good condition, however, some minor damage was identified.

Materials of this type are not likely to give rise to significant fibre release and may therefore be left in situ. The material should however be monitored periodically to assess its condition.

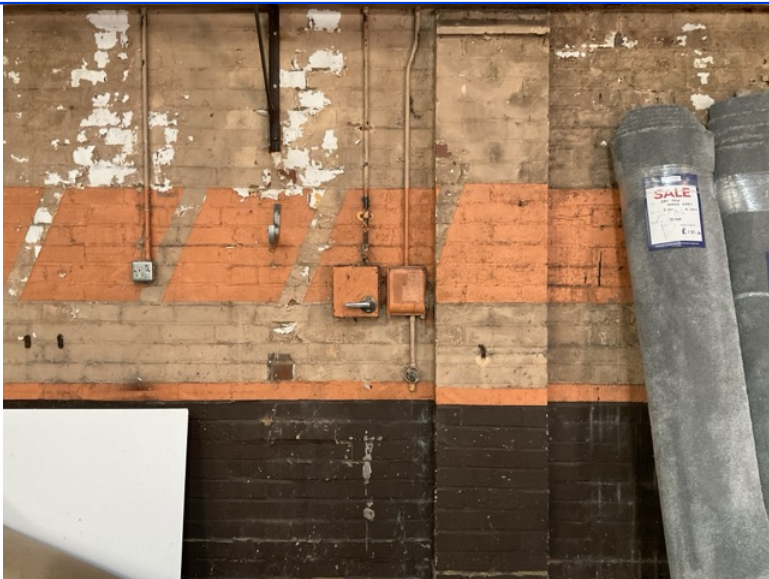
| <b>Area References</b> | 0010/06 | | |

| <b>Material</b> | May Contain Concealed Asbestos | | |

| <b>Asbestos Type</b> | Presumed Crocidolite | |

The material is in a good condition and no damage was identified.

Materials of this type are not likely to give rise to significant fibre release and may therefore be left in situ. The material should however be monitored periodically to assess its condition.

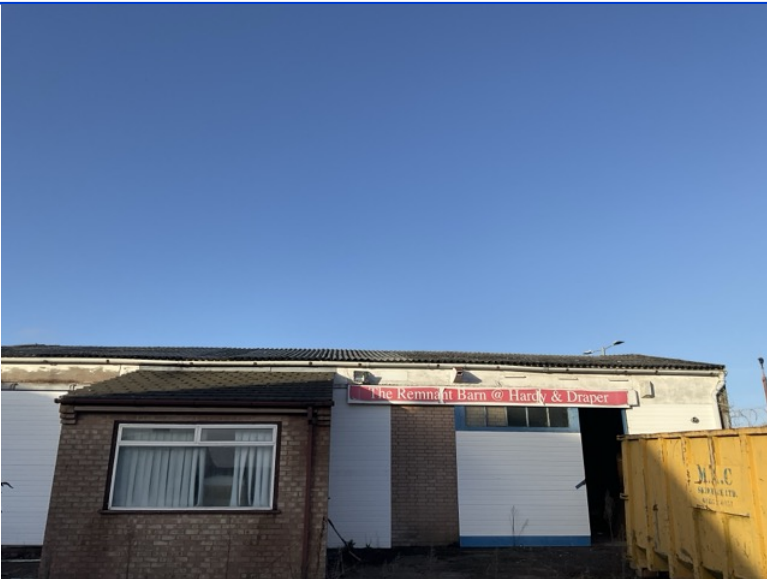
| <b>Area References</b> | 0013/01 | | |

| <b>Material</b> | Cement | | |

| <b>Asbestos Type</b> | Chrysotile | |

A sample was collected and the material listed above was found to contain Chrysotile.

The material is in a good condition and no damage was identified.

Materials of this type are not likely to give rise to significant fibre release and may therefore be left in situ. The material should however be monitored periodically to assess its condition.

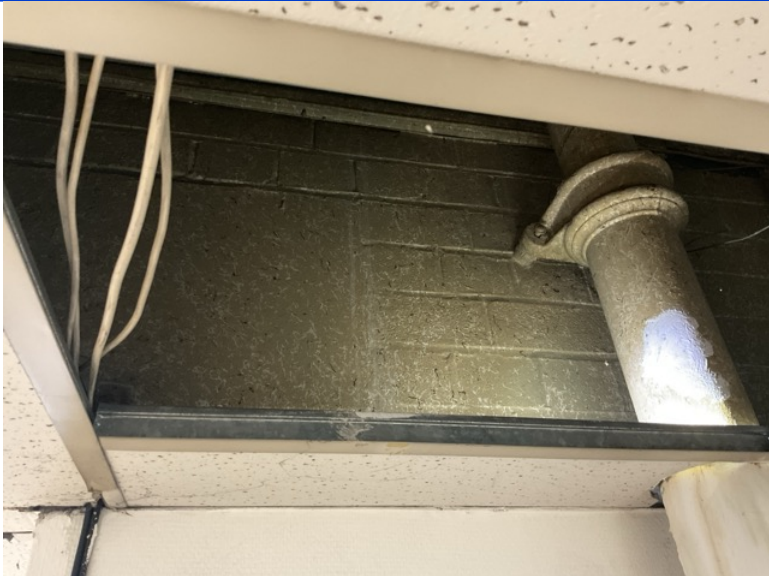
| <b>Area References</b> | 0001/06 |

| <b>Material</b> | Textured Paint |

| <b>Asbestos Type</b> | None Detected | |

A sample of the material identified above was collected and analysed, the result of which was found to be 'Non Detected'.

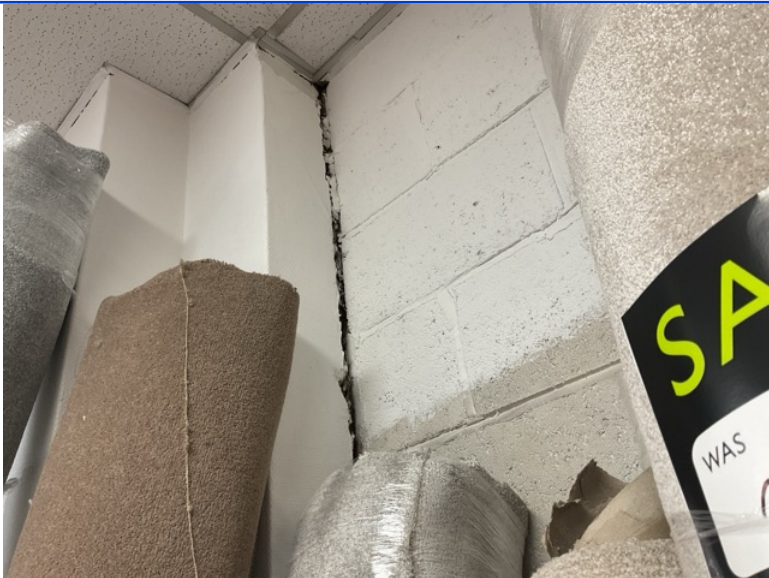
| <b>Area References</b> | 0001/07 |

| <b>Material</b> | Bitumen |

| <b>Asbestos Type</b> | None Detected | |

A sample of the material identified above was collected and analysed, the result of which was found to be 'Non Detected'.

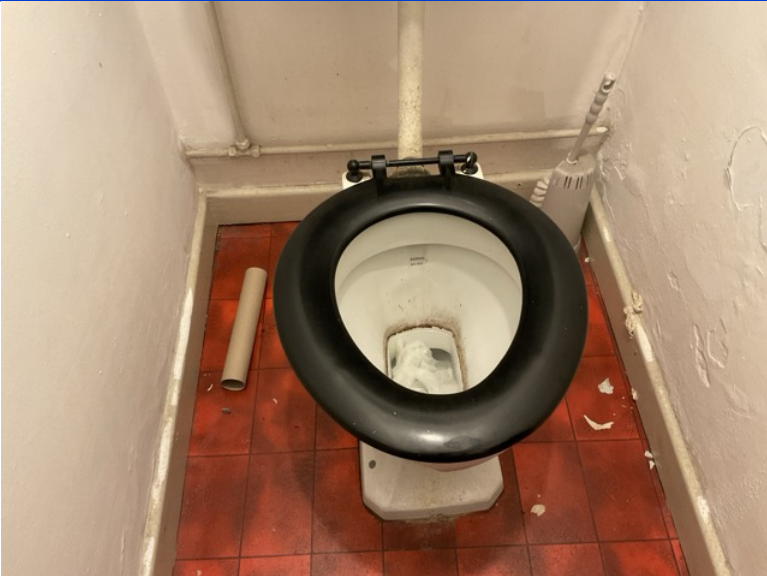
| <b>Area References</b> | 0002/05 |

| <b>Material</b> | Resin |

| <b>Asbestos Type</b> | None Detected | |

A sample of the material identified above was collected and analysed, the result of which was found to be 'Non Detected'.

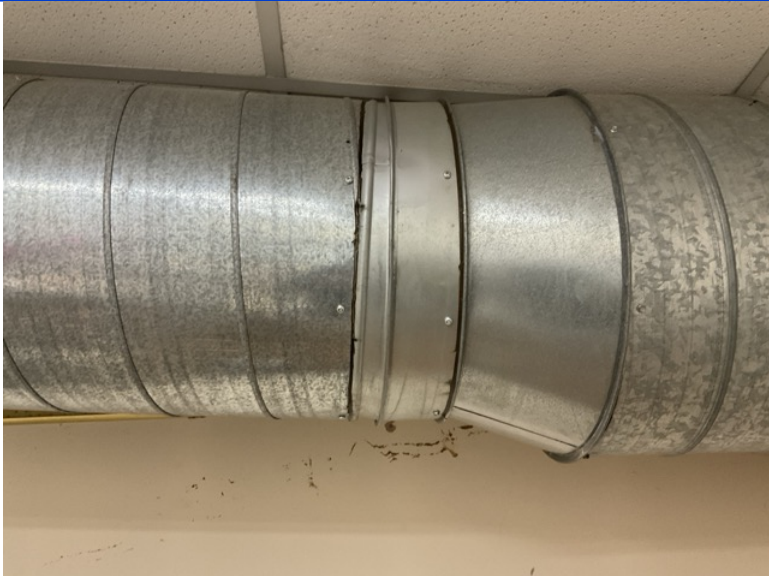
| <b>Area References</b> | 0004/07 |

| <b>Material</b> | Mastic |

| <b>Asbestos Type</b> | None Detected | |

A sample of the material identified above was collected and analysed, the result of which was found to be 'Non Detected'.

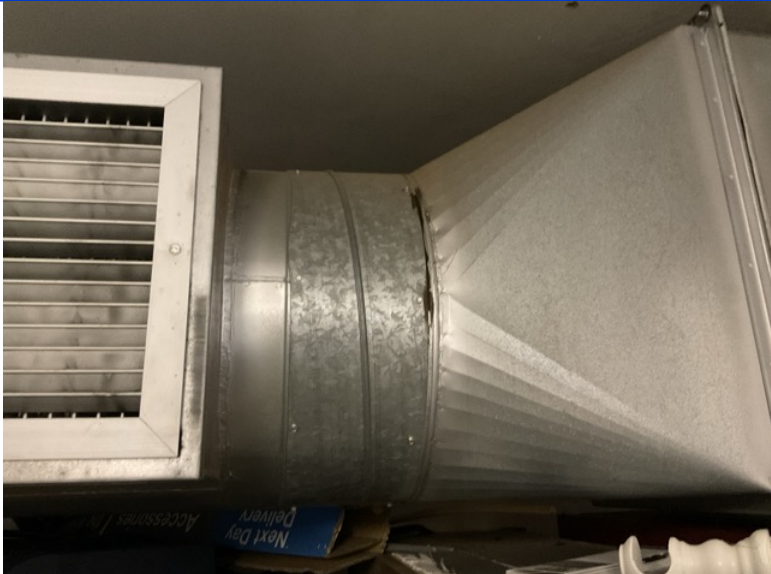
| <b>Area References</b> | 0006/06 |

| <b>Material</b> | Mastic |

| <b>Asbestos Type</b> | None Detected | |

A sample of the material identified above was collected and analysed, the result of which was found to be 'Non Detected'.

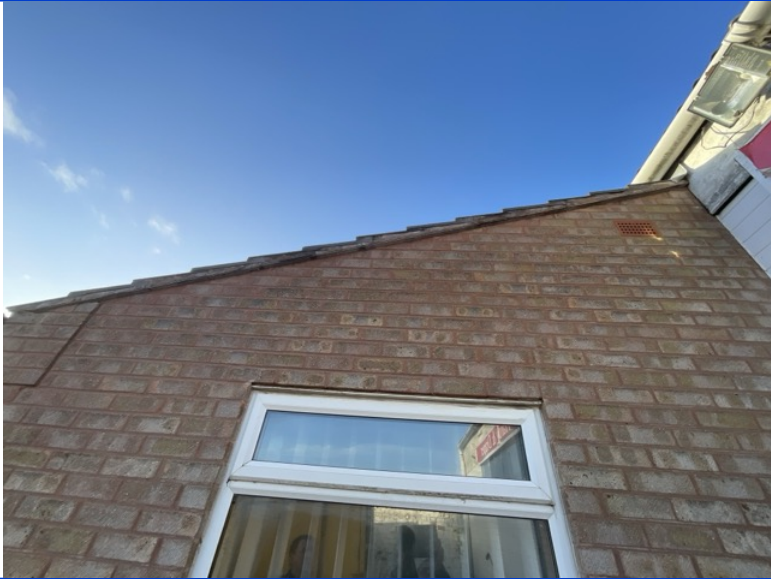
| <b>Area References</b> | 0013/05 |

| <b>Material</b> | Cement |

| <b>Asbestos Type</b> | None Detected | |

A sample of the material identified above was collected and analysed, the result of which was found to be 'Non Detected'.
