**Phase 1 Land Contamination  
Risk Assessment**

**Change of Use of Agricultural  
Buildings to Dwellings (C3) with  
Associated Site Works**

**Hill Farm, Markfield Lane,  
Botches ton LE9 9FH**

**Date: December 2020**

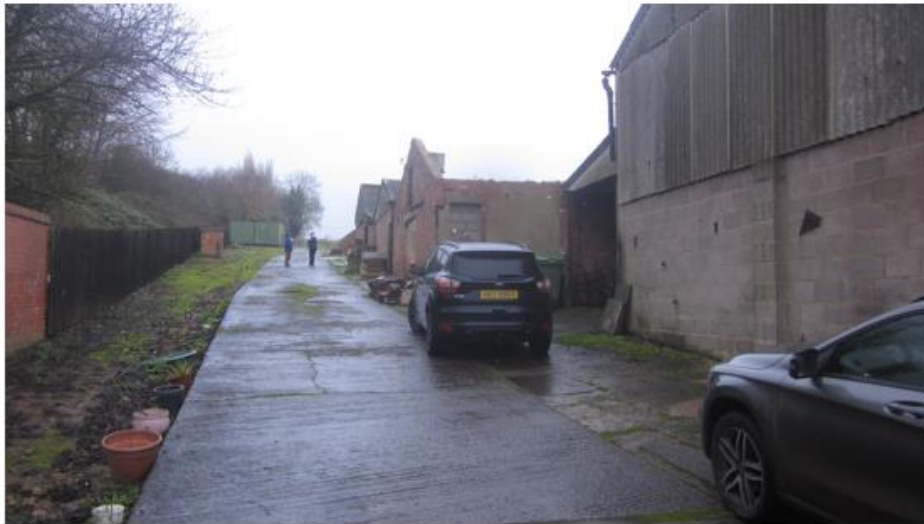
**Photo No.1: Facing NE from western corner of site showing access track with barns to right**

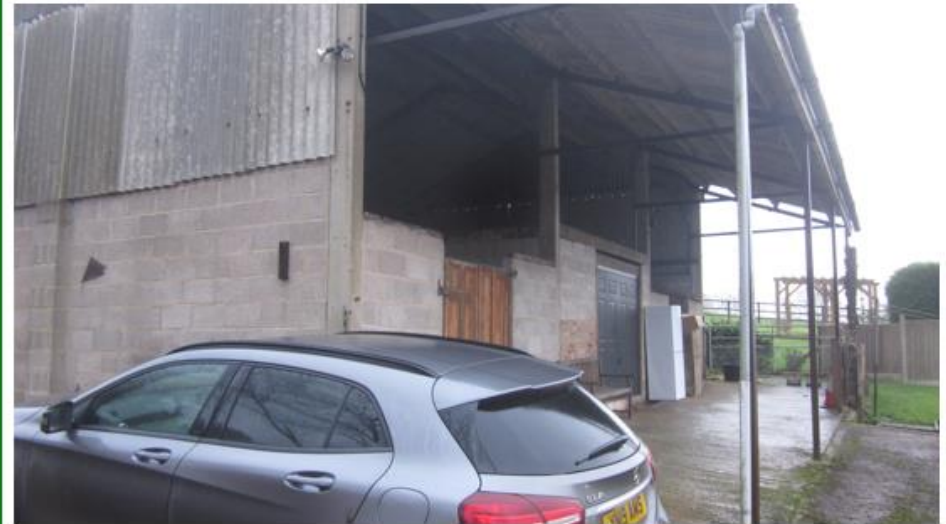
The south westernmost barn (Barn No.1) was seen to be in use for the storage of household amenities and miscellaneous furniture. This barn was

**Photo No.2: South westernmost barn on site (Barn No.1), in use for storage of misc. furniture etc and concrete based**

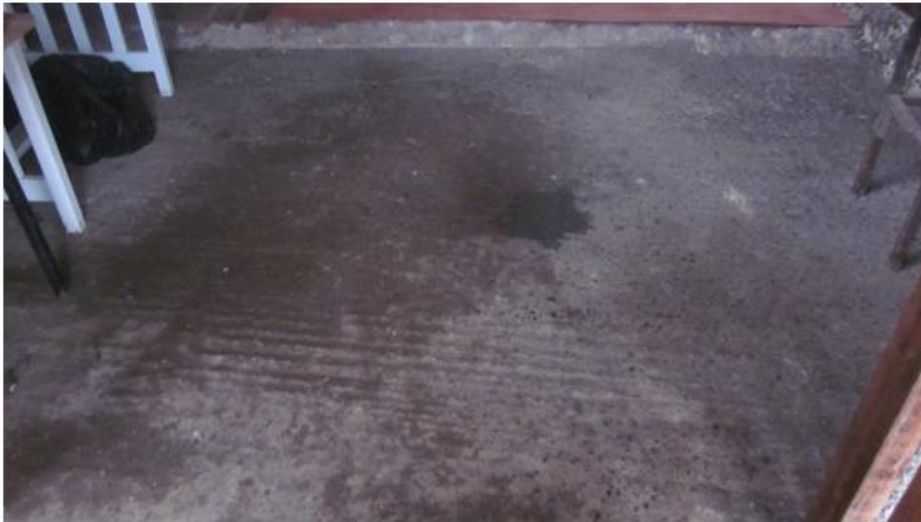
**Photo No.3: Example of concrete base in south westernmost barn on site**

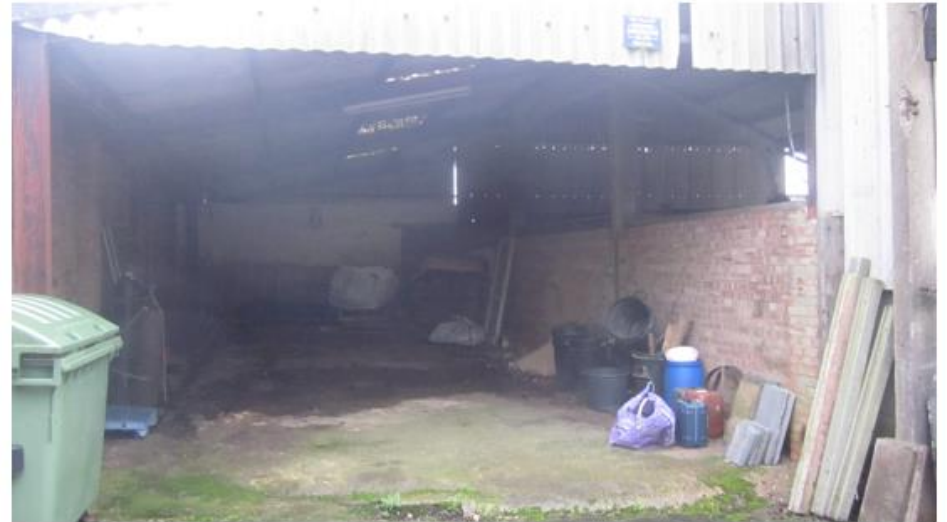
**Photo No.4: Facing SE showing concrete base and storage in the rear of Barn No.1**

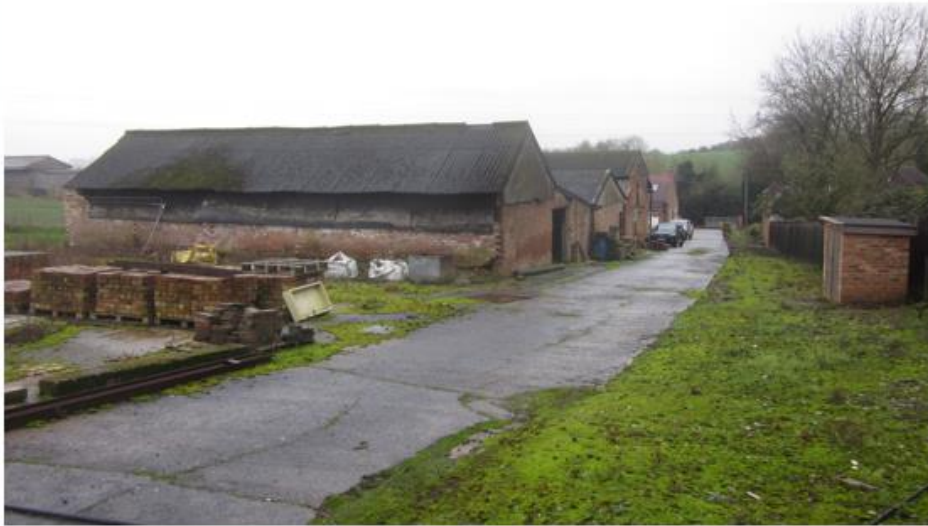
**Photo No.5: Facing SW from northern corner of site**

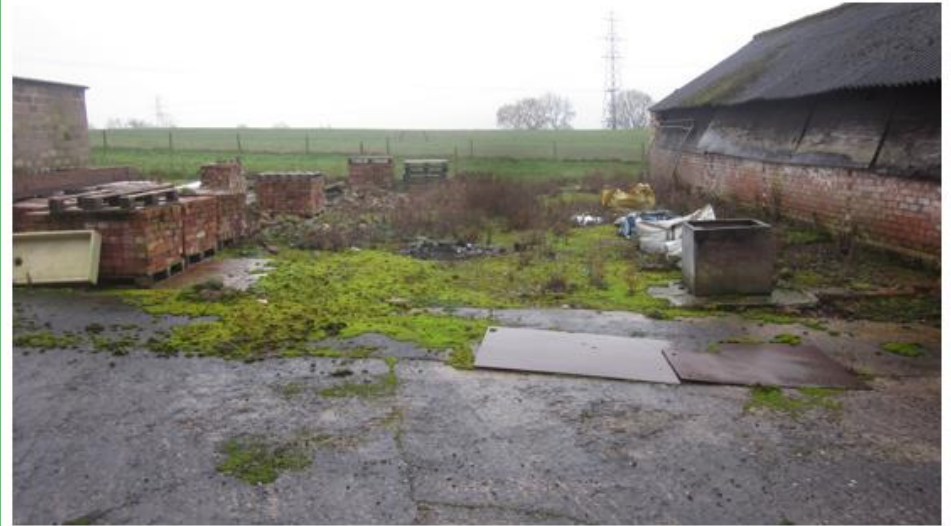
Moving north east again from these barns lies an open area, presumably a former barn which has been demolished. The storage of miscellaneous construction materials such as brick pallets, timber, sacking and herras fencing was noted here. Additionally, an area of burning was noted with the remains noted to comprise household refuse including plastics and foodstuffs.

**Photo No.6: Facing SE showing open area and construction storage, located between barns No.2 and No.3**

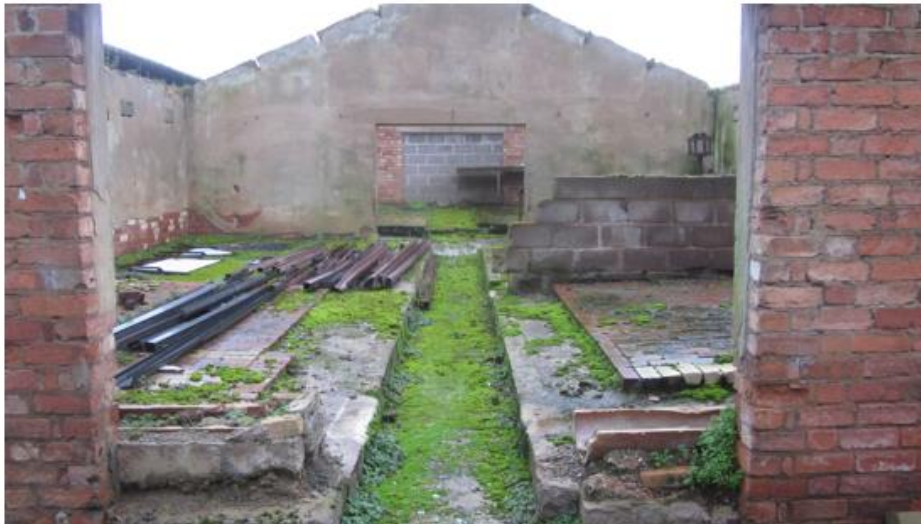
The next series of barns, named and numbered “Adjoined Barns No.2” (see site walkover plan), comprise a series of at least 4 No. red bricked barns extending from Barn No.1 north west to an open area. These barns were seen to be in a poor state of repair and comprised former piggeries, with soil, concrete and brick-based flooring and potentially asbestos containing corrugated roofing materials. Some broken corrugated material was noted within the barns. The south westernmost barn in this series is roofless.

**Photo No.7: Interior of Adjoined Barns No.2, facing south east**

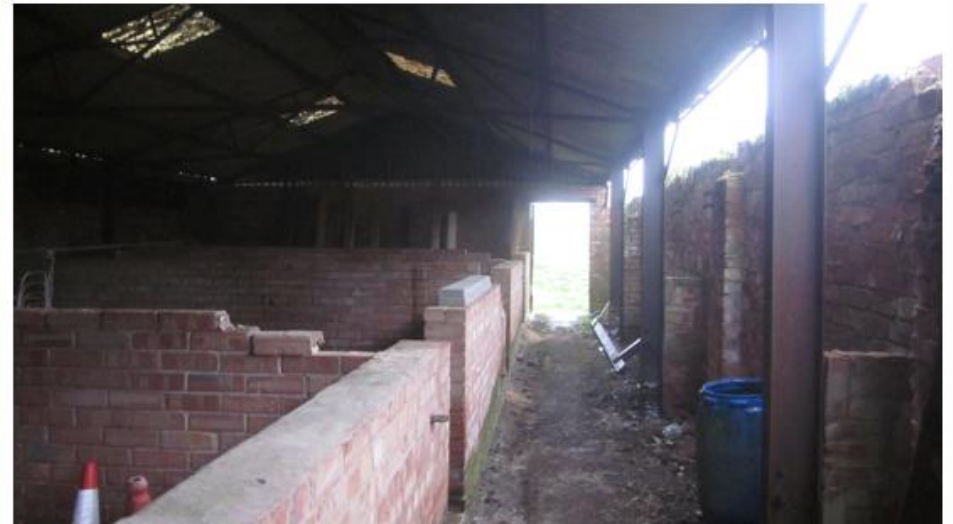
**Photo No.8: Interior of Adjoined Barns No.2, facing south east**

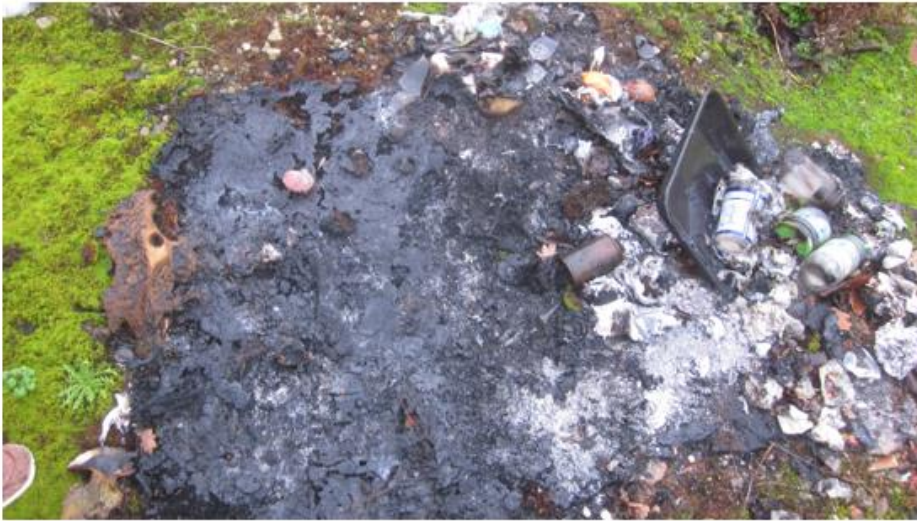
A number of potentially contaminative sources have been identified on-site. These include: the general historical agricultural usage of the site over time; the potentially asbestos containing roofing and cladding materials noted on the buildings; broken roofing and cladding materials noted on historical satellite imagery (residual asbestos fibres); broken asbestos sheeting noted within some of the barns; made ground deposits noted in the north eastern extent of site and along and within the north western boundary of site (glass, tarmac, demolition rubble etc); historical skips, refuse heaps and miscellaneous storage noted along and within this boundary; demolition rubble and a potential former fuel tank plinth noted at the location of Barn No.3; and the area of former burning with evidence of melted plastics, household refuse and foodstuffs noted.

**Photo No.9: Evidence of burning noted in open area with foodstuffs, household waste, and plastics noted within**

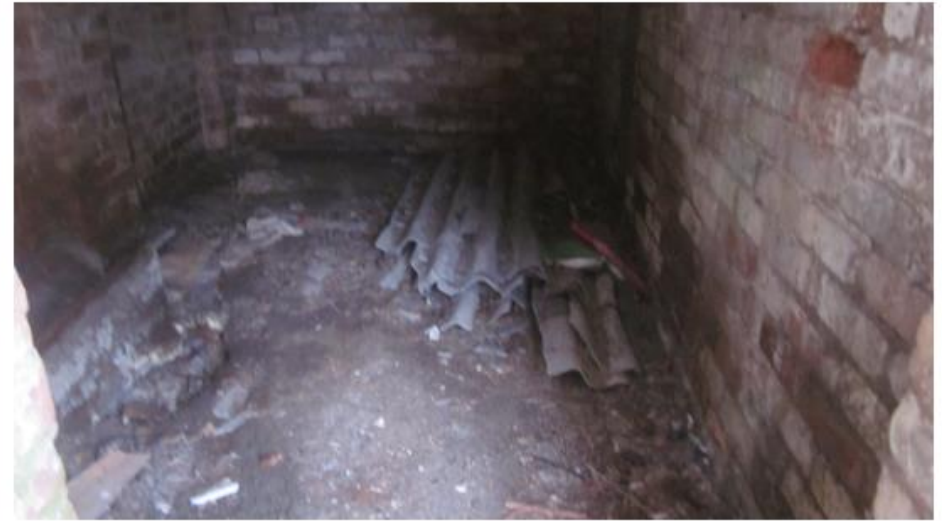
**Photo No.10: Potentially asbestos sheeting noted stored and broken in barn No.4**

**It is recommended that the Buildings on site should be subject to an asbestos survey and removal by appropriately qualified personal prior to any demolition or redevelopment occurring in order to ensure site works do not cause future contamination of the site.**

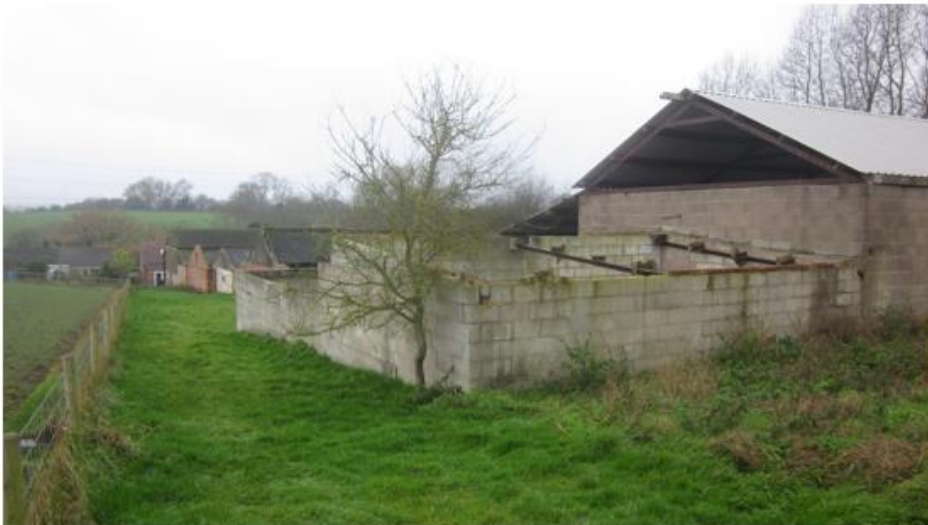
**Photo No.11: Facing SW from easternmost corner showing grassed SE boundary and disused cinderblock barn**

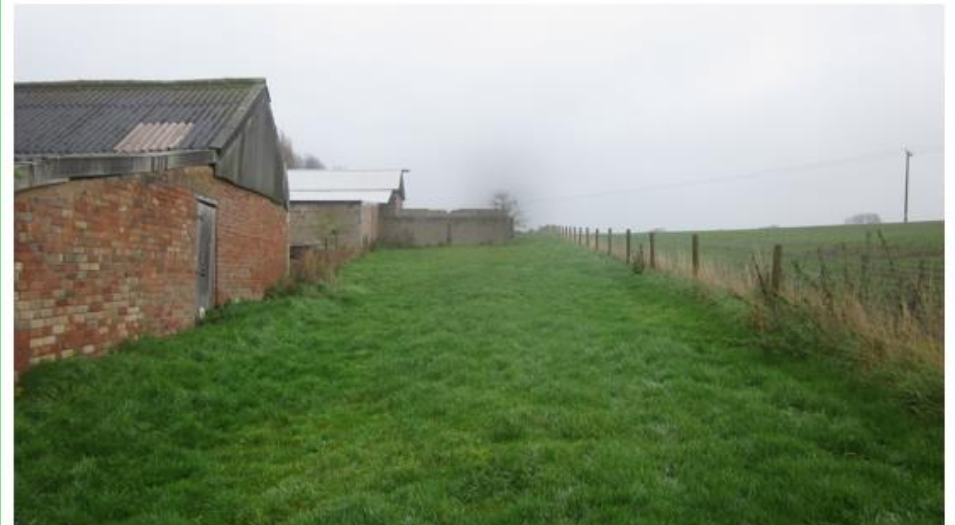
**Photo No.12: Facing north east showing grassed area adjacent to the south eastern boundary (right)**

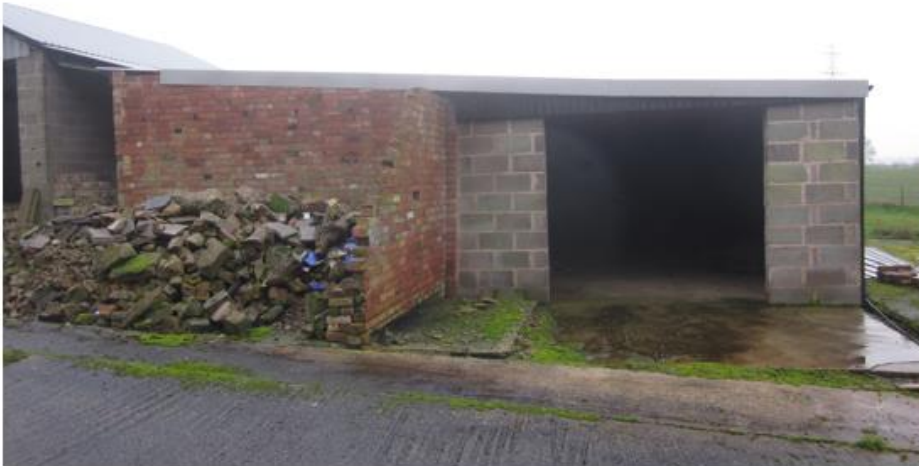
Barn No.3 is located to the north east of the open area and comprises a cinderblock garage type structure adjoined to a red bricked stable-like structure, both of which contained concrete flooring. Both of these structures are roofed with corrugated metal which appears to be relatively new in comparison the other barns and roofing materials. A rubble spoil pile was noted in this area along with a potential former fuel plinth.

**Photo No.13: Facing SE showing Barn No.3 (red brick and cinderblock barns – adjoined) and demolition rubble pile**

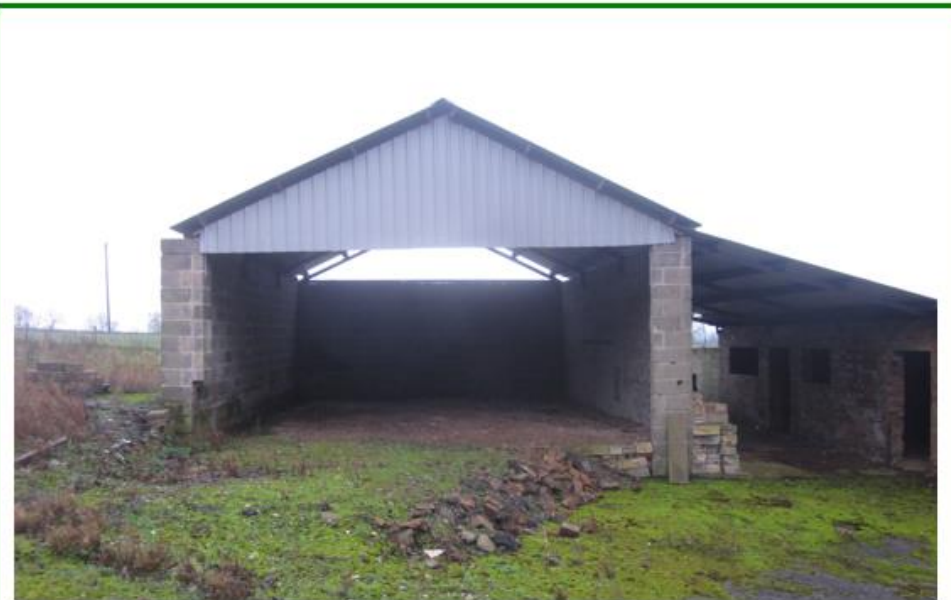
The final and north easternmost barn on site also appears to be relatively new in comparison with the other barns and was seen to be constructed of cinderblock with corrugated metal roofing. The flooring appeared to have been infilled with a clayey, stony medium with areas of made ground including rubble, glass and possible ash and tarmac chippings noted at the entrance to the barn.

**Photo No.14: Facing SE showing Barn No.4, the north eastern most barn on site and infilled with made ground base**

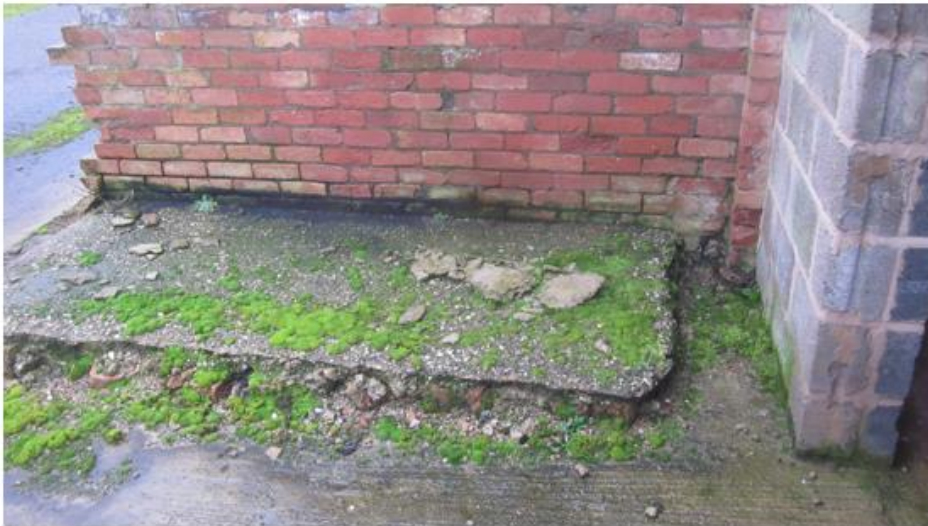
No significant sources of potential ground gas generation have been identified. A potential former fuel tank plinth noted in the north eastern extent of site at Barn No.3 may have the potential to be producing localised hazardous ground vapours and as such, this area should be investigated.

| Contaminant | Pathway | Receptor | Probability of Pollutant Linkage | Consequence | Risk | Possible Mitigation |
|---|---|---|---|---|---|---|
| Volatile and Semi-volatile Organic Compounds | Vertical and lateral migration | End Users & Building Envelope | Li | Md | M | A potential former fuel tank plinth has been identified. Should spillages or leakages have occurred, there may be a potential for hazardous vapour generation. This should be investigated. |

**Photo No.15: Potential former plinth for unknown contents tank noted at Barn No.3**

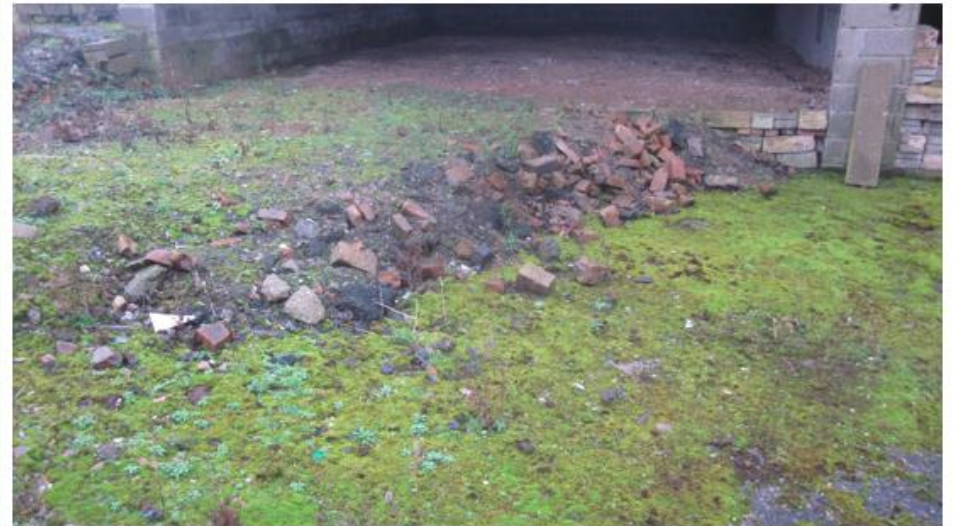
**Photo No.16: Made ground deposits noted outside of Barn No.4 and within the barn itself**

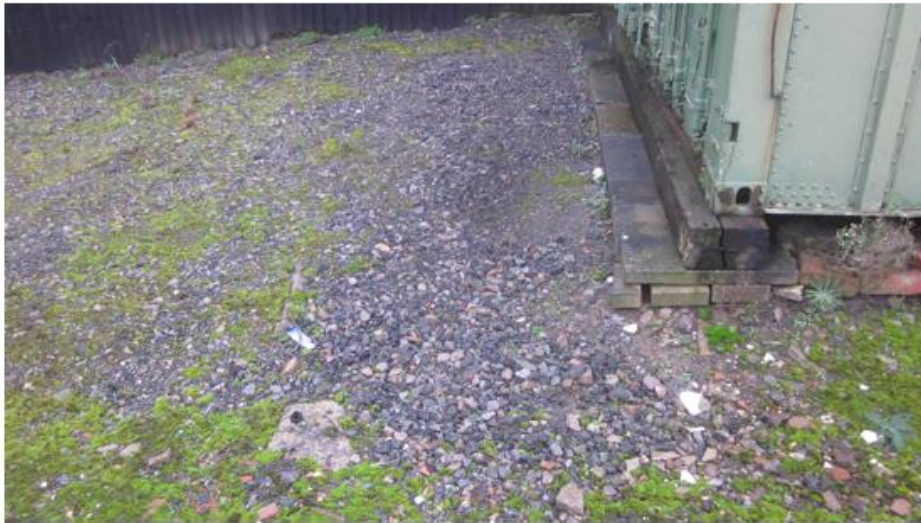
**Photo No.17: Made ground noted around shipping containers noted in the far northern corner of site, facing NW**

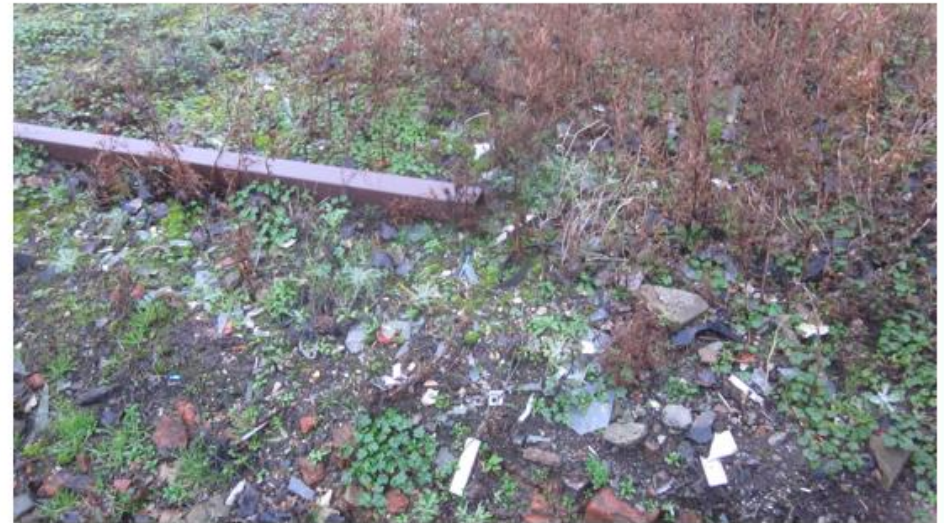
**Photo No.18: Facing SW showing example of made ground noted running the length of the north western boundary**

It is recommended that a Phase 2 Intrusive Ground Investigation be planned and undertaken. This should generally characterise the site, however, specific attention should be paid to areas of proposed soft-landscaping. These areas should be tested for a standard suite of contaminants, including the north eastern area of site and the strips of land located along the south eastern and north western boundaries of site.
