# **Phase 2 Land Contamination Risk Assessment**

**Change of Use of Agricultural  
Buildings to Dwellings (C3) with  
Associated Site Works**

**Hill Farm, Markfield Lane,  
Botcheston LE9 9FH**

**Date: March 2021**

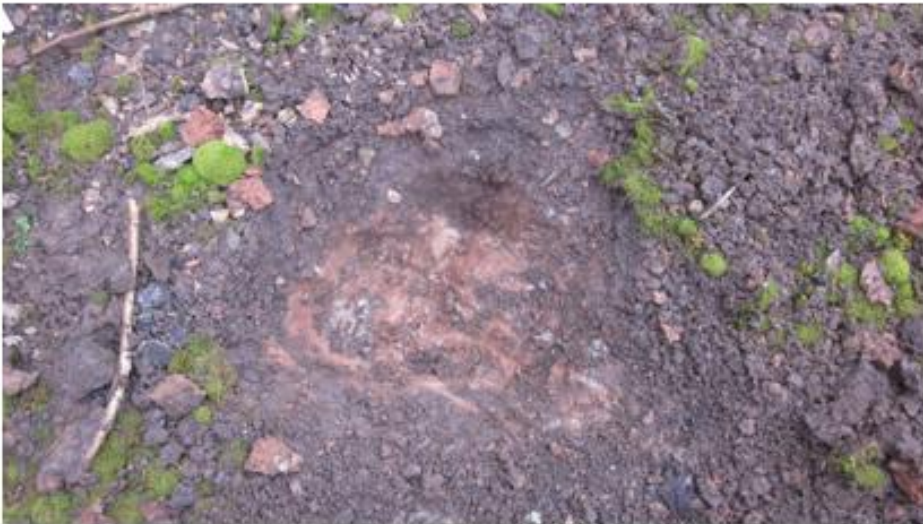
**Photo No.1: TP01 located in the western extent of site adjacent to the north western boundary**

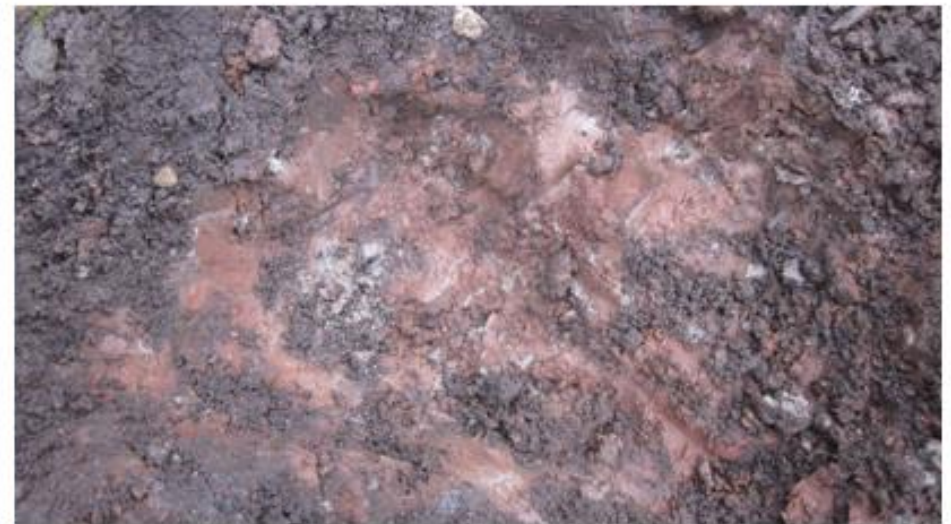
**Photo No.2: TP01 hand excavated due to known and unknown buried services in the area, showing made ground spoil**

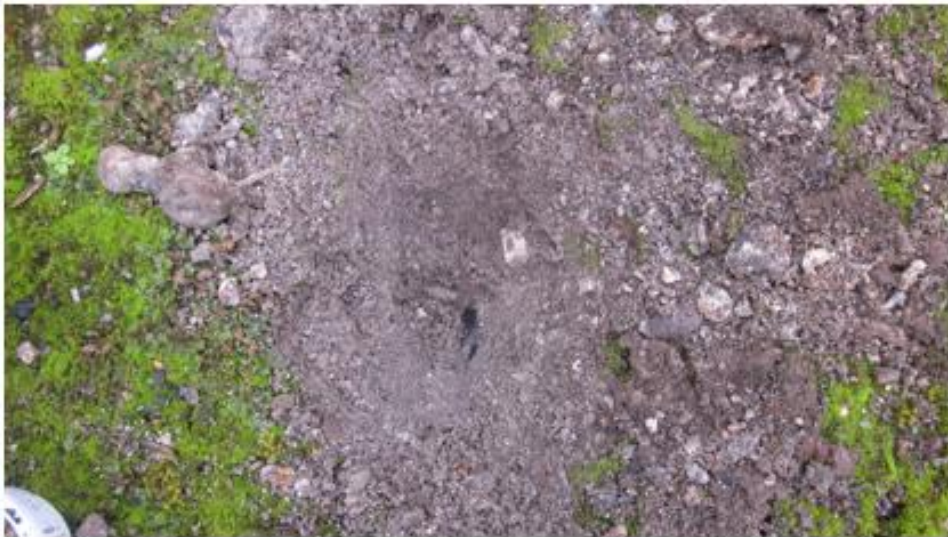
**Photo No.3: TP02 located adjacent to the central area of the north western boundary**

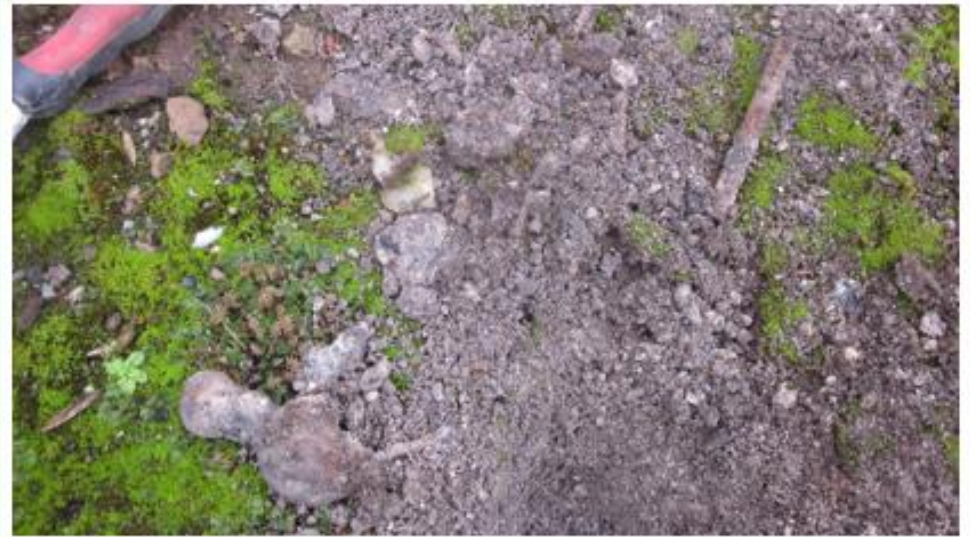
**Photo No.4: TP02 hand excavated due to known and unknown buried services in the area, showing made ground spoil**

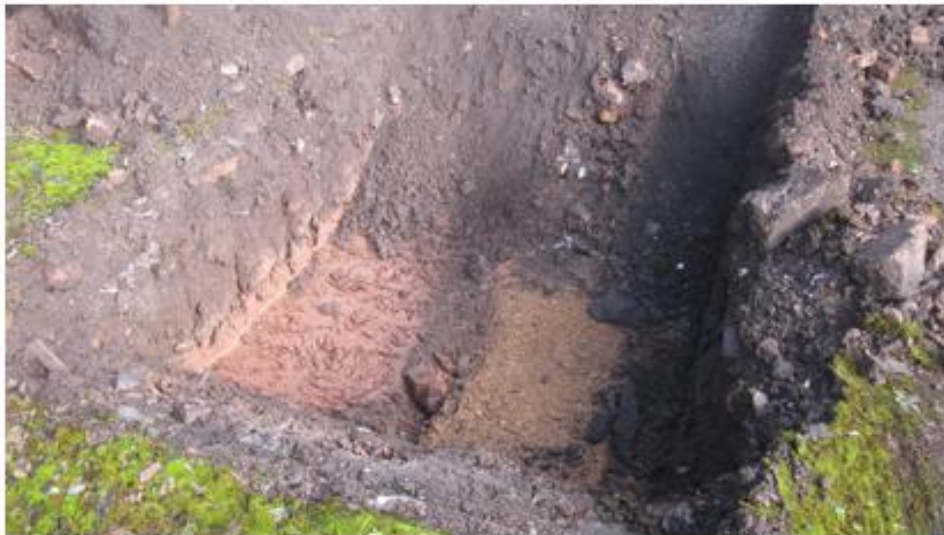
**Photo No.5: TP03 located in the northern extent of site showing clay pit bottom (left) and service run gravel (right)**

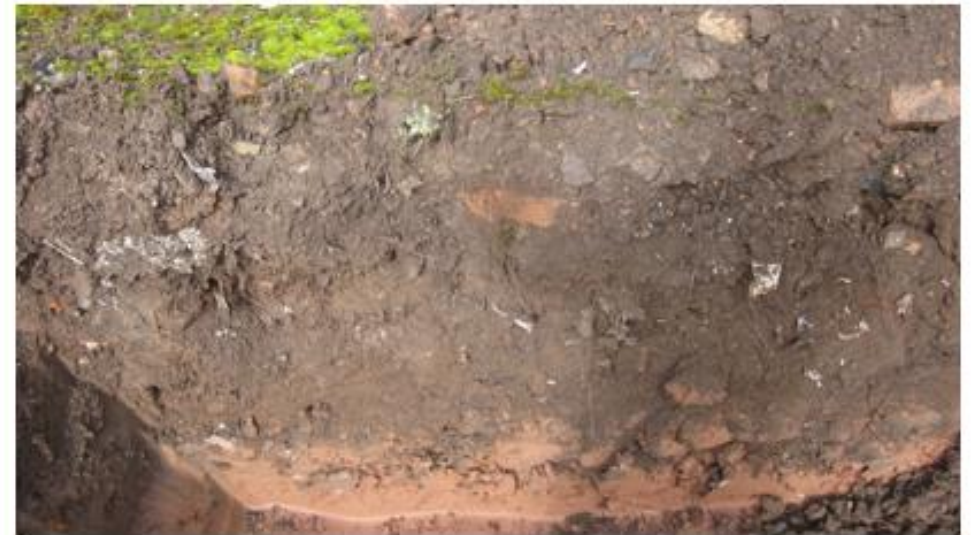
**Photo No.6: TP03 pit side showing 0.70m of made ground**

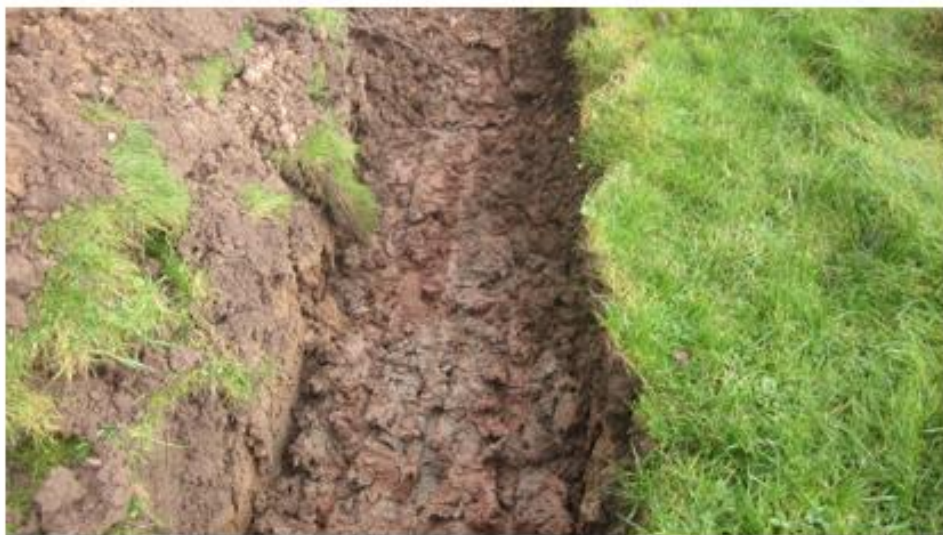
**Photo No.7: TP04 located in the far north eastern corner of site, to east of northern structures on site**

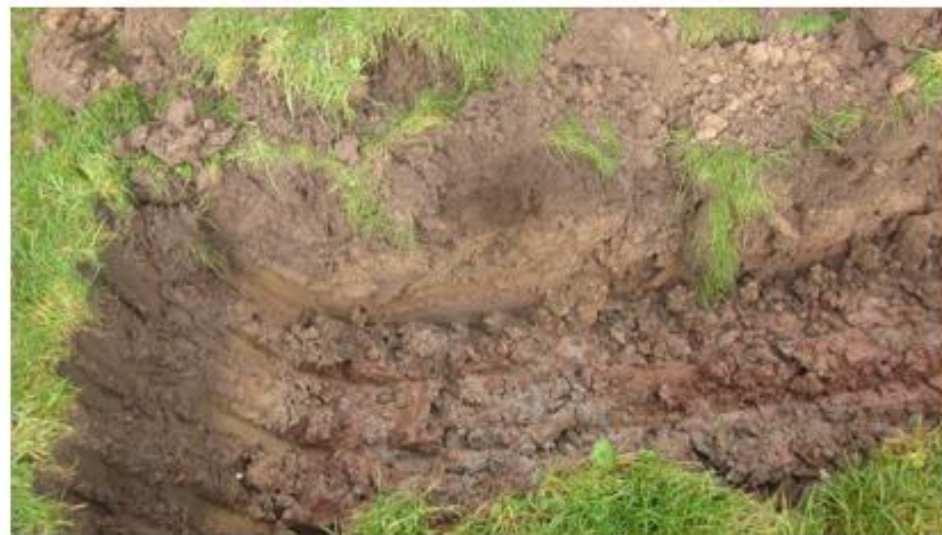
**Photo No.8: TP04 showing topsoil atop natural clays**

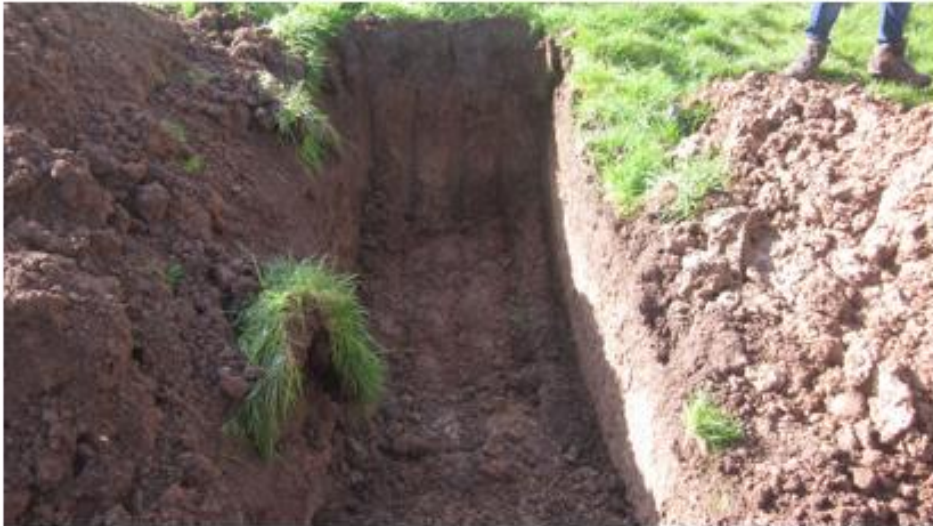
**Photo No.9: TP05 located adjacent to central area of the south eastern boundary of site in proposed garden area**

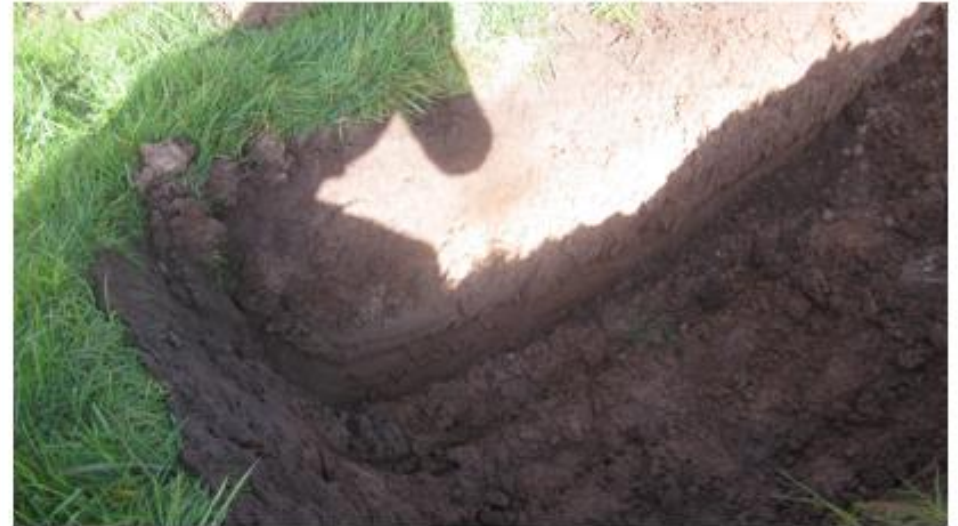
**Photo No.10: TP05 pit side showing topsoil atop natural clays**

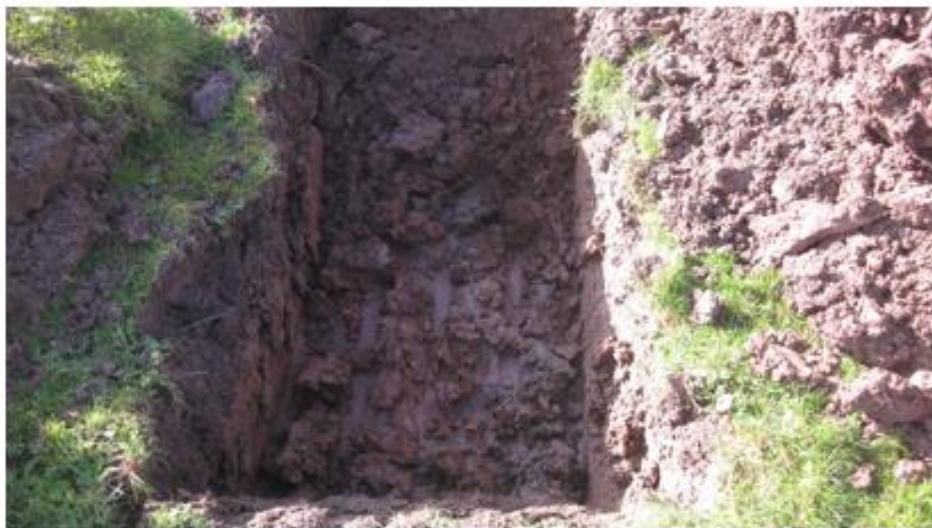
**Photo No.11: TP06 located in the south western extent of the proposed garden areas (see Trial Pit Plan)**

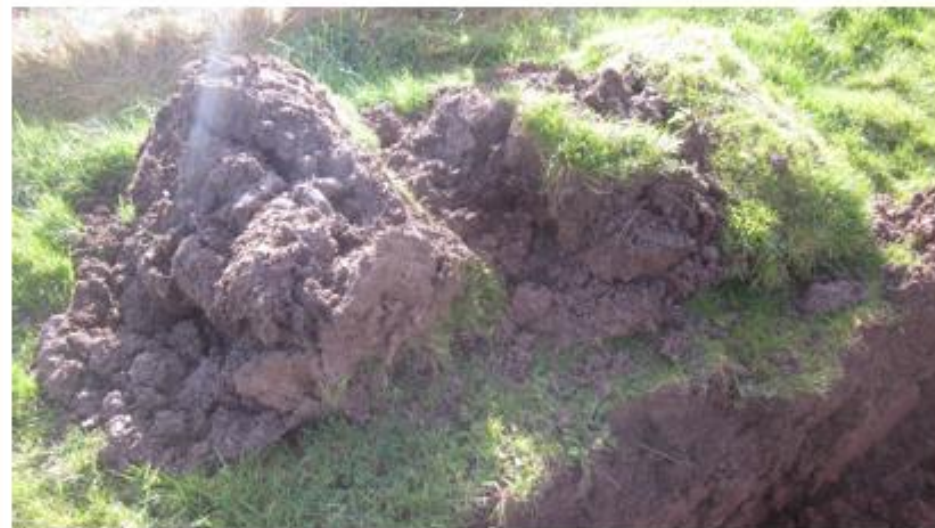
**Photo No.12: TP06 spoil showing topsoil and clays**
