## Asbestos Risk Assessment

Hilltop Farm, Earl Shilton

Proposed Residential Development

Document Title: Asbestos Risk Assessment  
Document No.: STX7263-R01-Rev\_A  
Date: September 2025  
Prepared For: Snowdon Homes Ltd

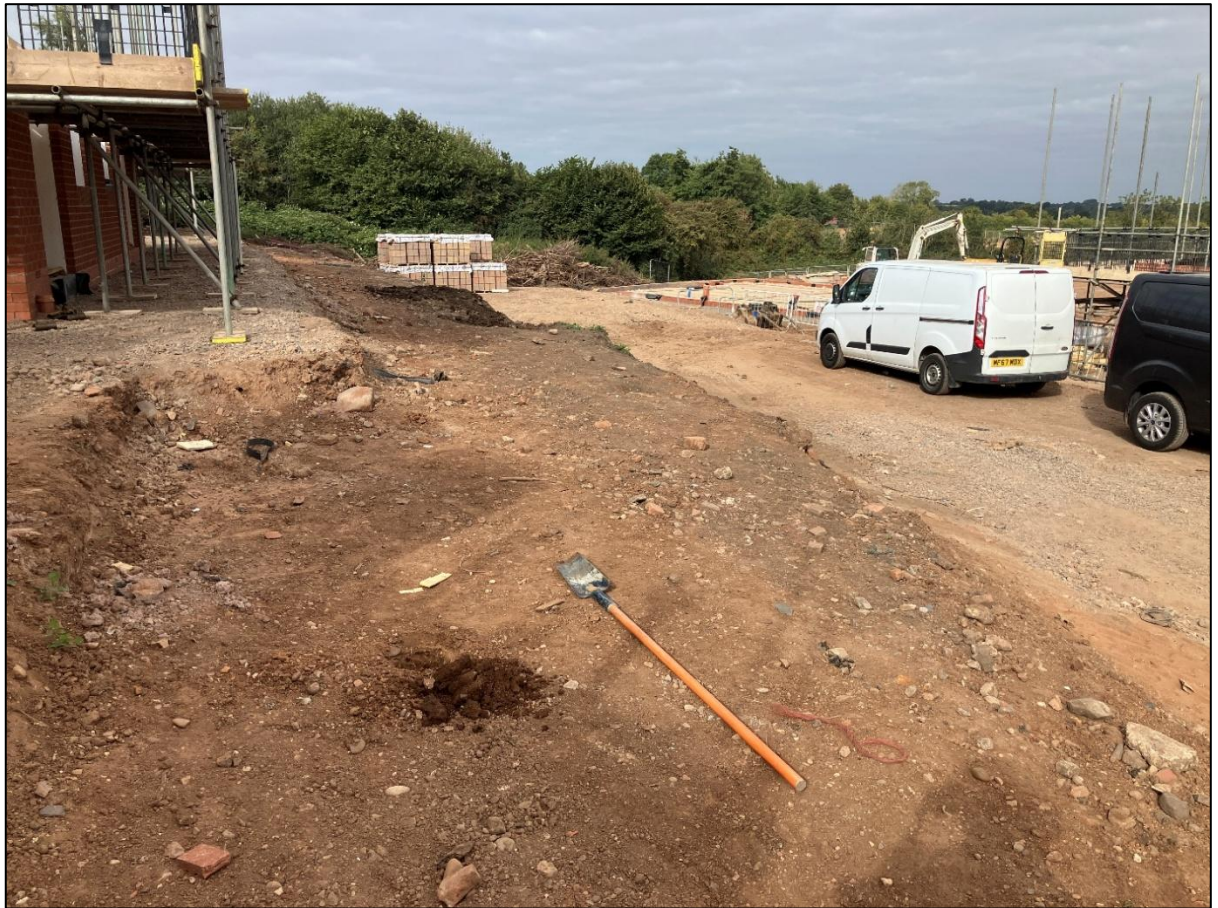
Figure 3-B: Soil within the vicinity of SL01

- 3.3.1 The soils encountered within the footprints of the former buildings were generally described as reddish/grey brown gravelly clay/sand with gravel comprising demolition material such as brick, concrete, ceramic and glass. Full descriptions and photos of soils are included within the site diary in Appendix C. Selected photos are included below.
- 3.3.2 Suspected asbestos containing materials (ACMs) were not encountered within any of the 10 hand pits undertaken. Very infrequent suspected asbestos surface debris was identified across the site. Subsequently, 5 pieces of suspected ACMs were sampled as a precaution and submitted for testing. One was confirmed as chrysotile cement (SL11) shown below. The other four were confirmed not to be ACM.

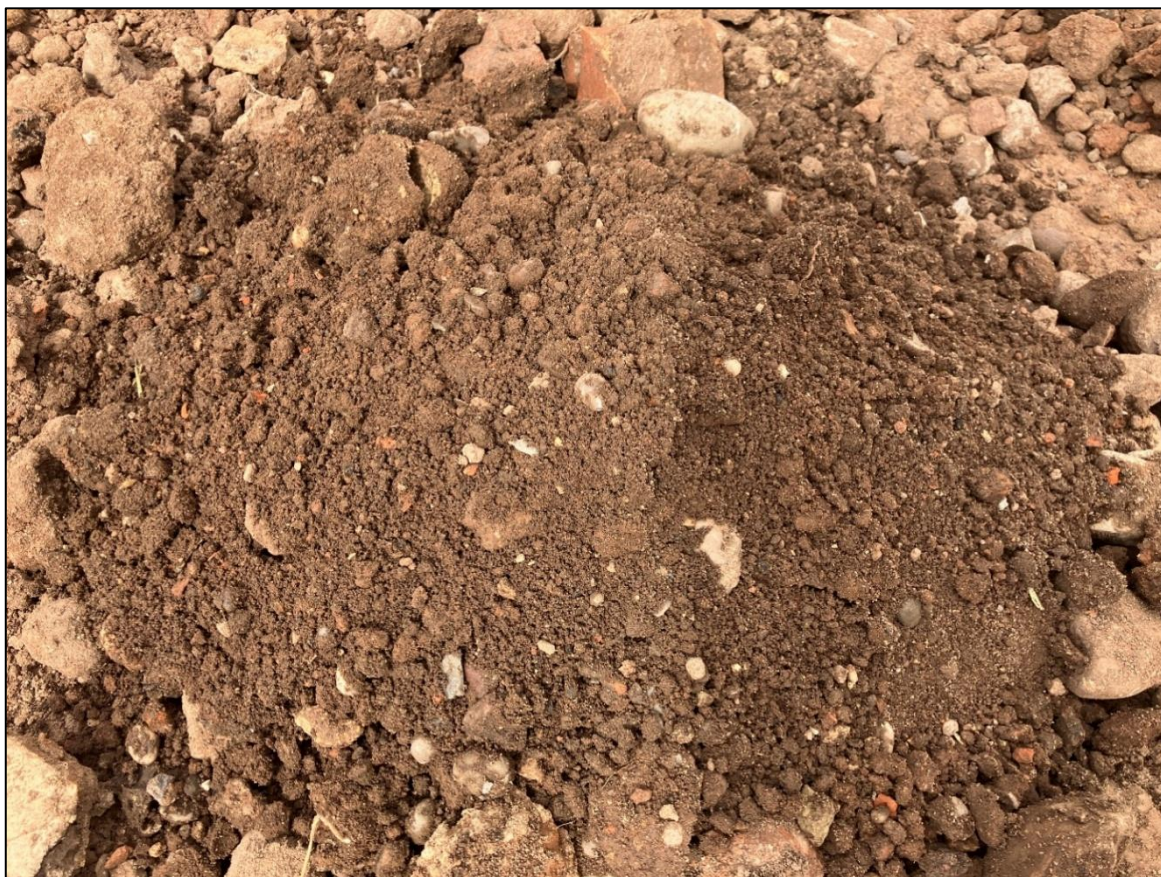
Figure 3-D: Soils sampled at SL06

| Material Sampled | No. samples | Sample refs | Laboratory testing outcome |
|---|---|---|---|
| Soils within hand pits | 16 | SL01-SL10 | 1 of 16 samples (SL06) indicating trace levels of chrysotile cement |

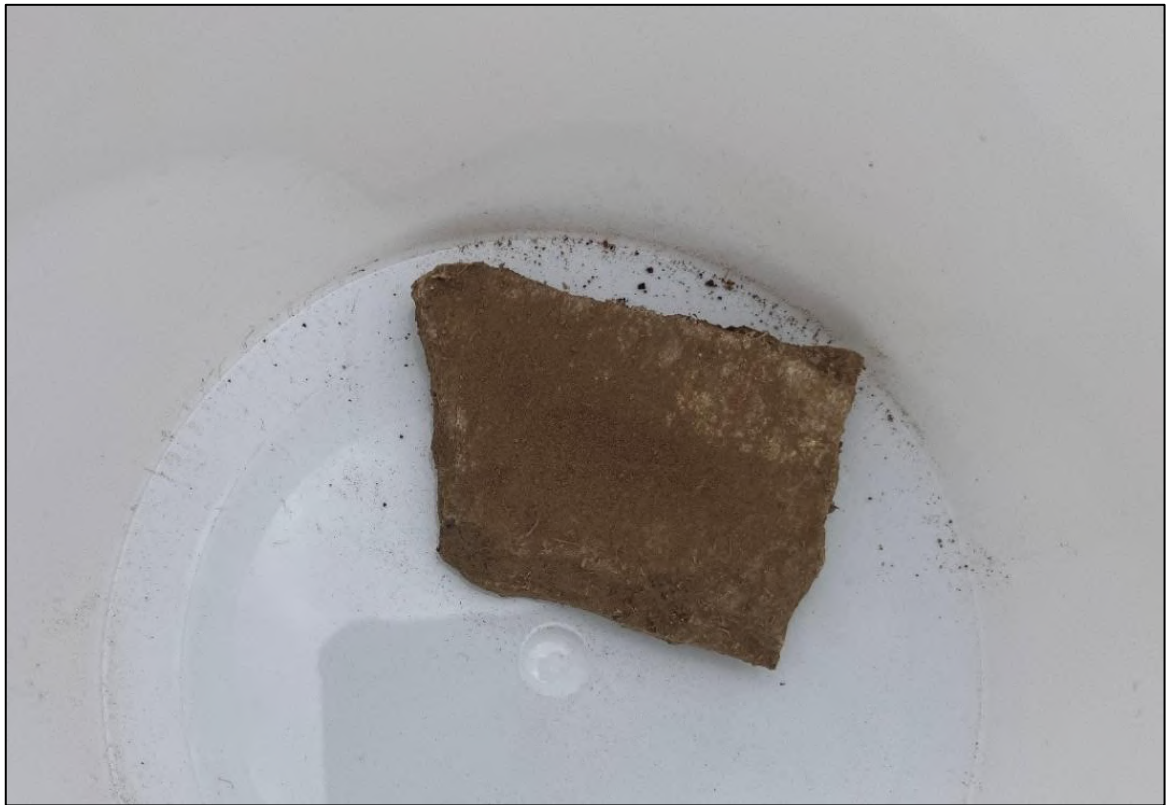
*Figure 3-E: Confirmed chrysotile cement in SL11*

| Material Sampled | No. samples | Sample refs | Laboratory testing outcome |
|---|---|---|---|
| Suspected ACMs on surface | 5 | SL11-SL15 | 1 of 5 samples (SL11) confirmed as ACM in the form of chrysotile cement |

- 6.1.2 This Asbestos Risk Assessment report has shown that the material within the footprint of the demolished buildings can be used safely within the scheme, providing it is placed at shallow depth beneath soft landscaping or hardstanding cover.

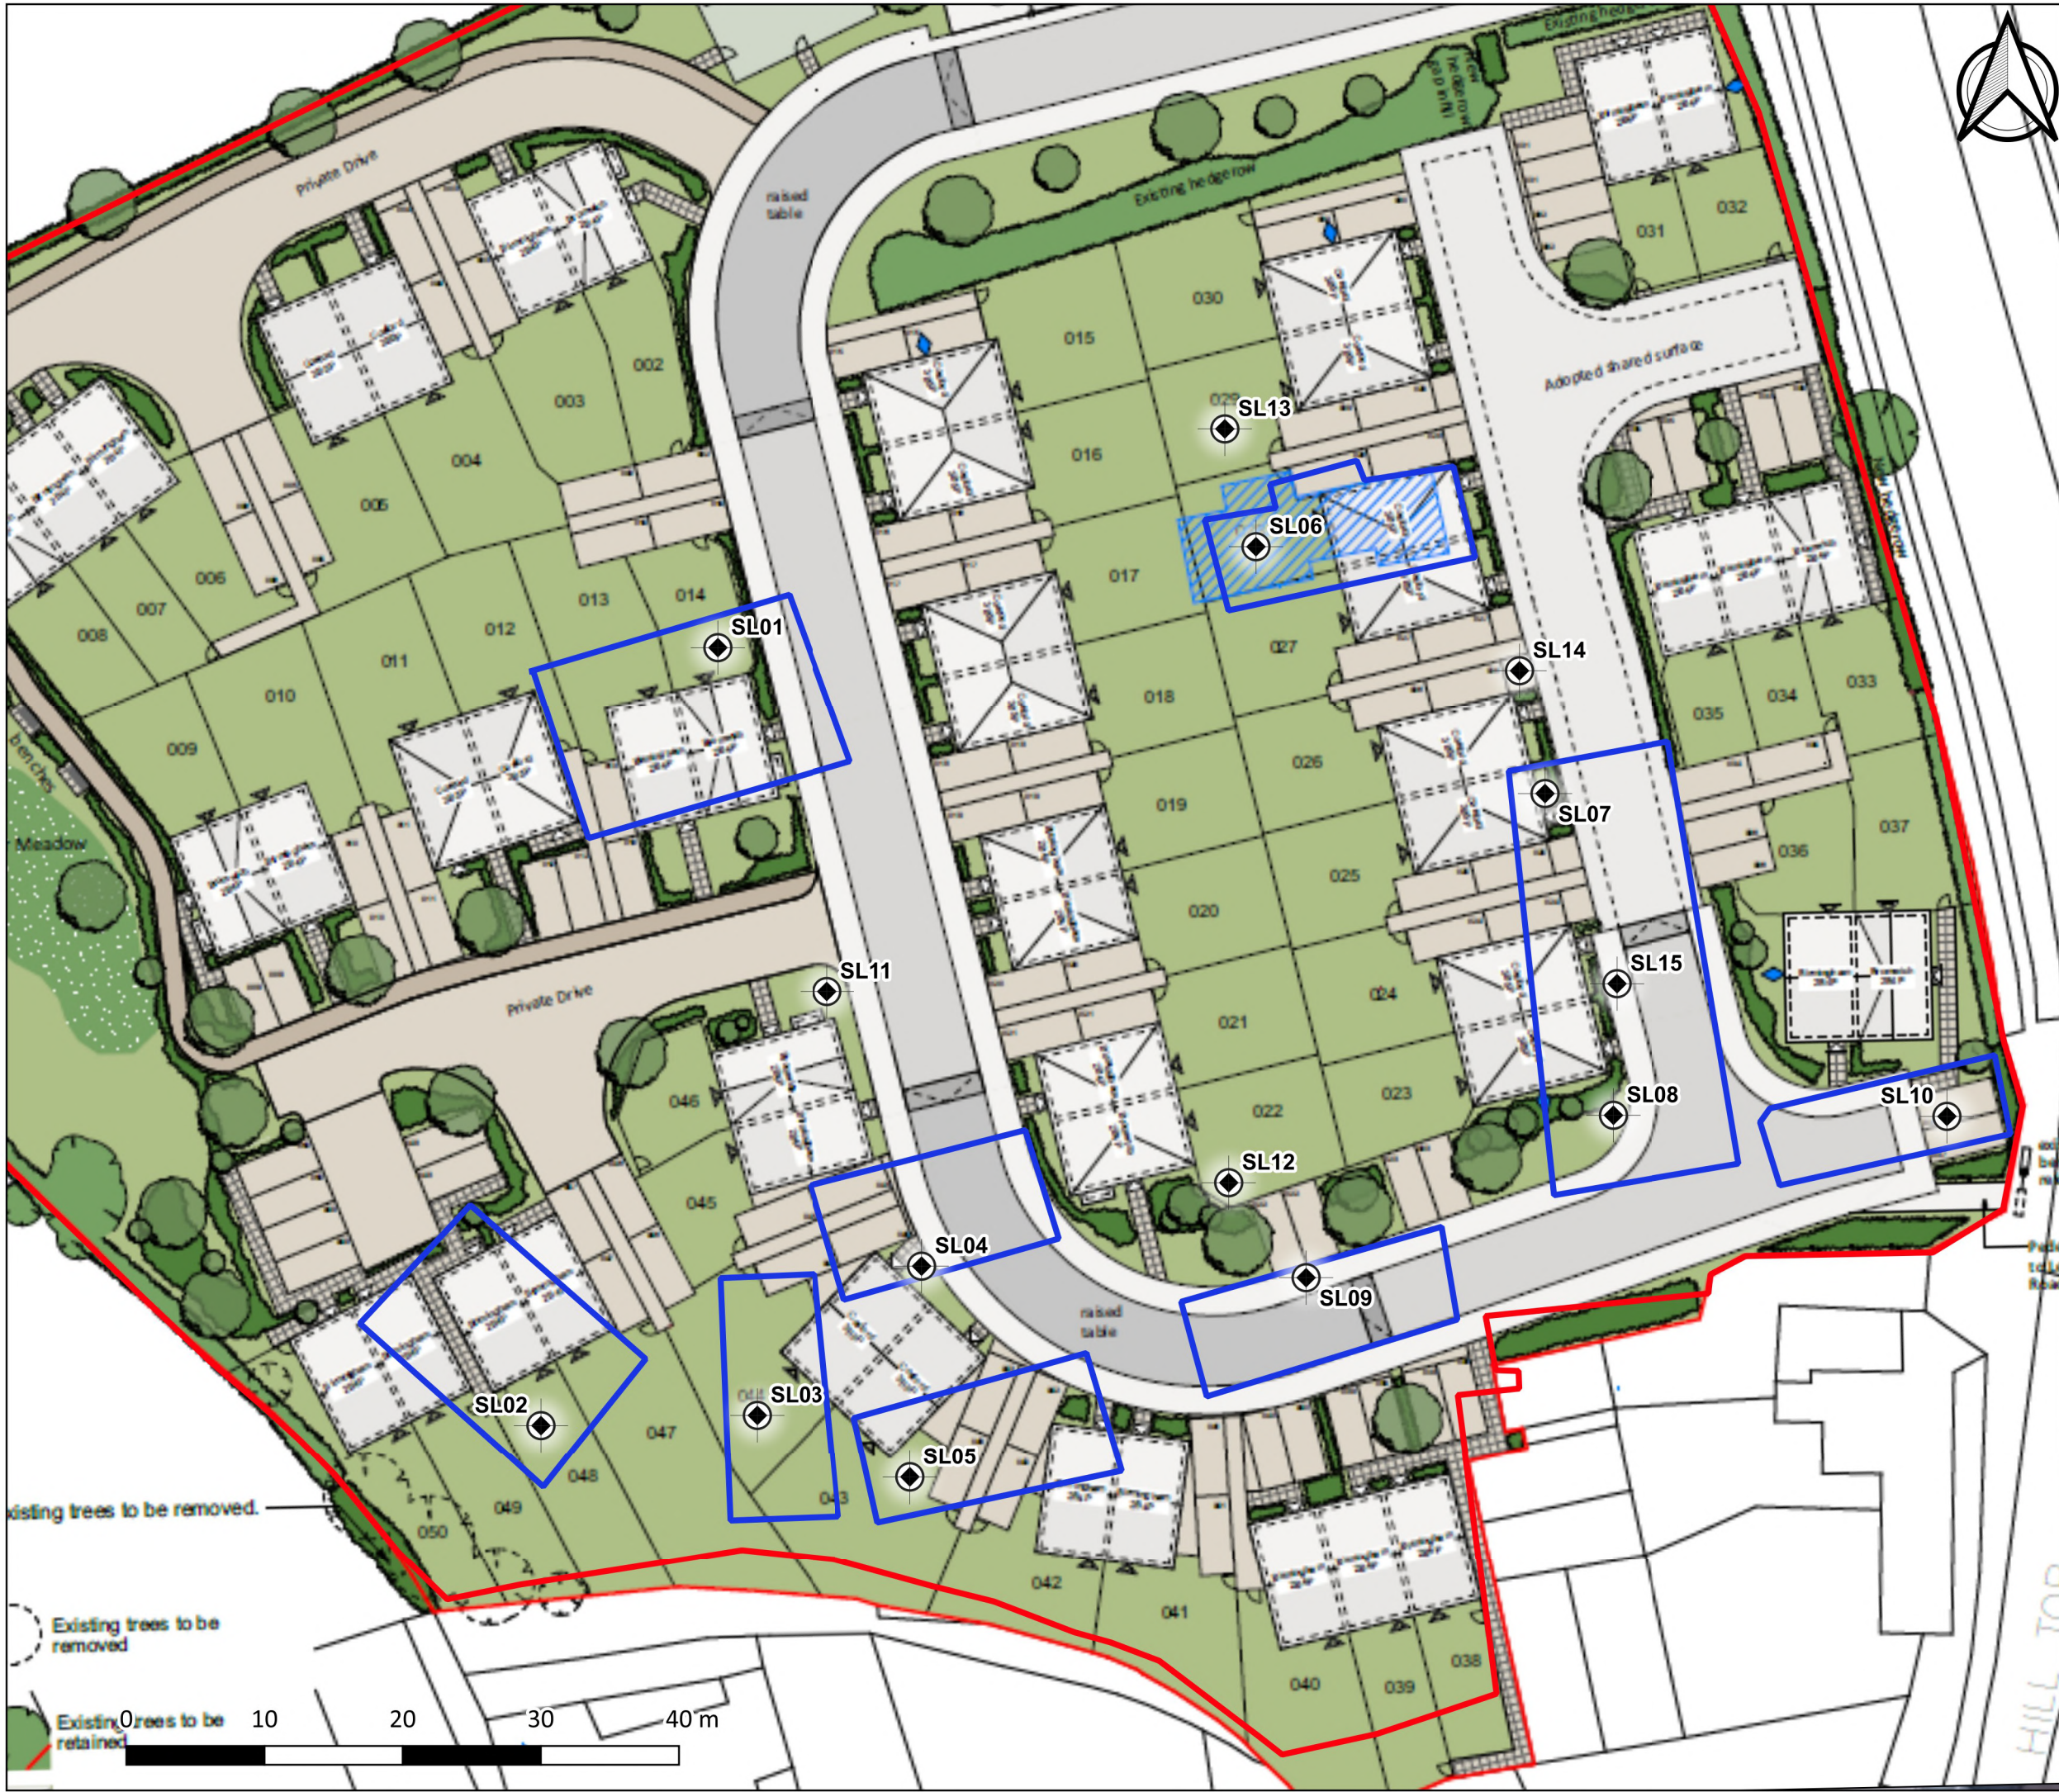
Sampling Location Plan

- Exploratory Holes
- Sampling Location
- Footprint of former buildings

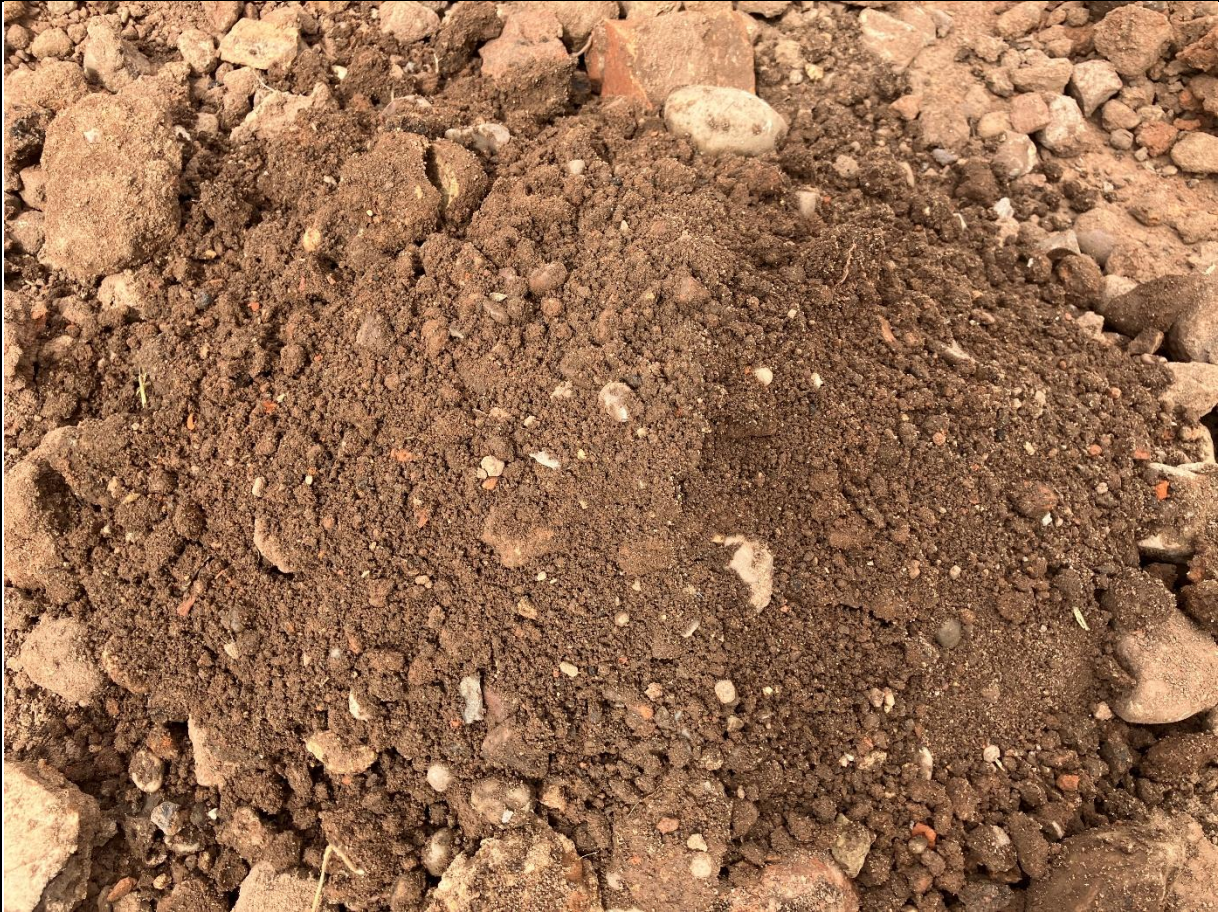
SL06 – soils

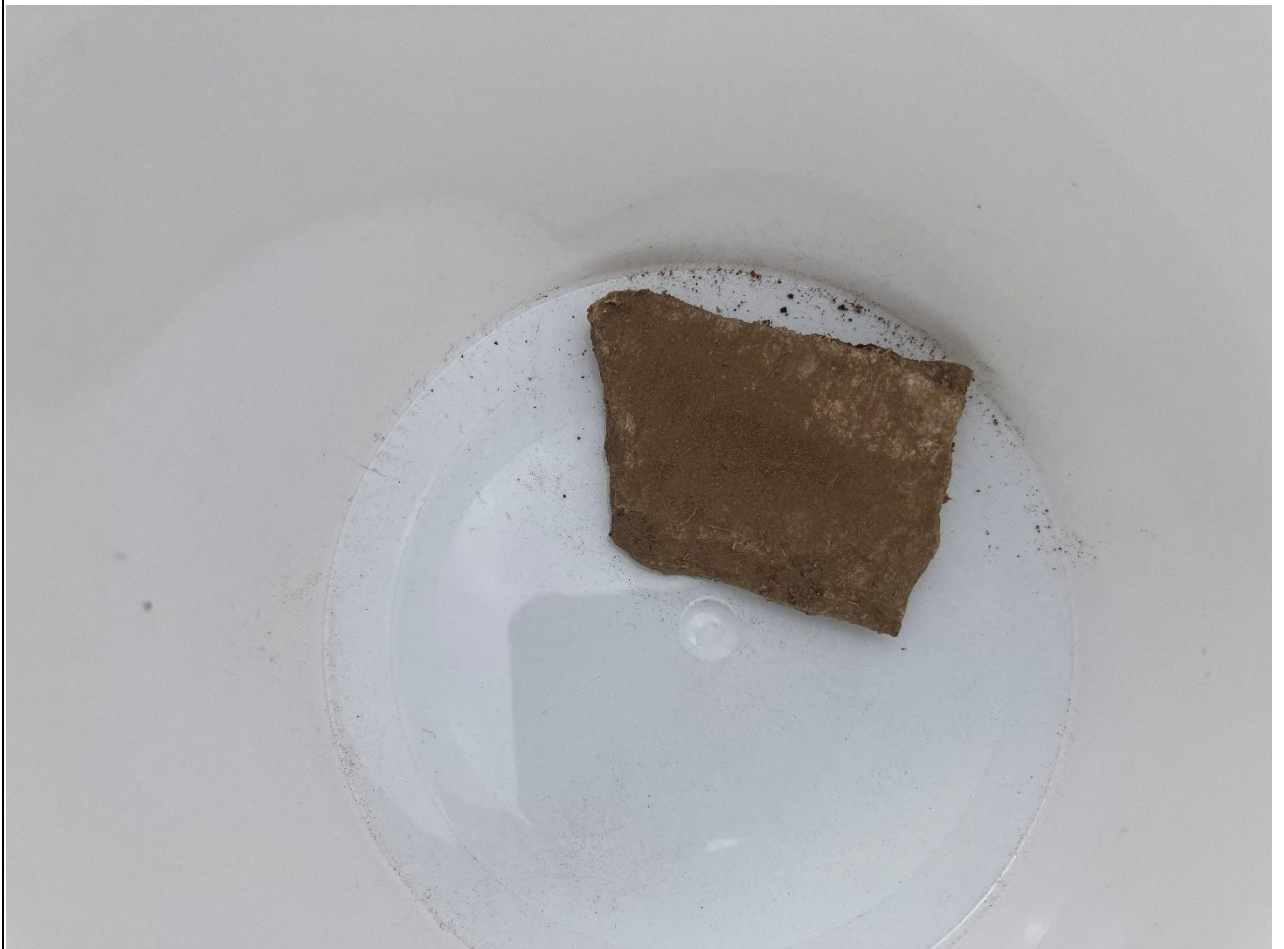
SL11 – Confirmed chrysotile cement
