PHASE 1 SITE INVESTIGATION

2-4 Queens Road, Hinckley

All Cars Repaired Ltd

November 2025

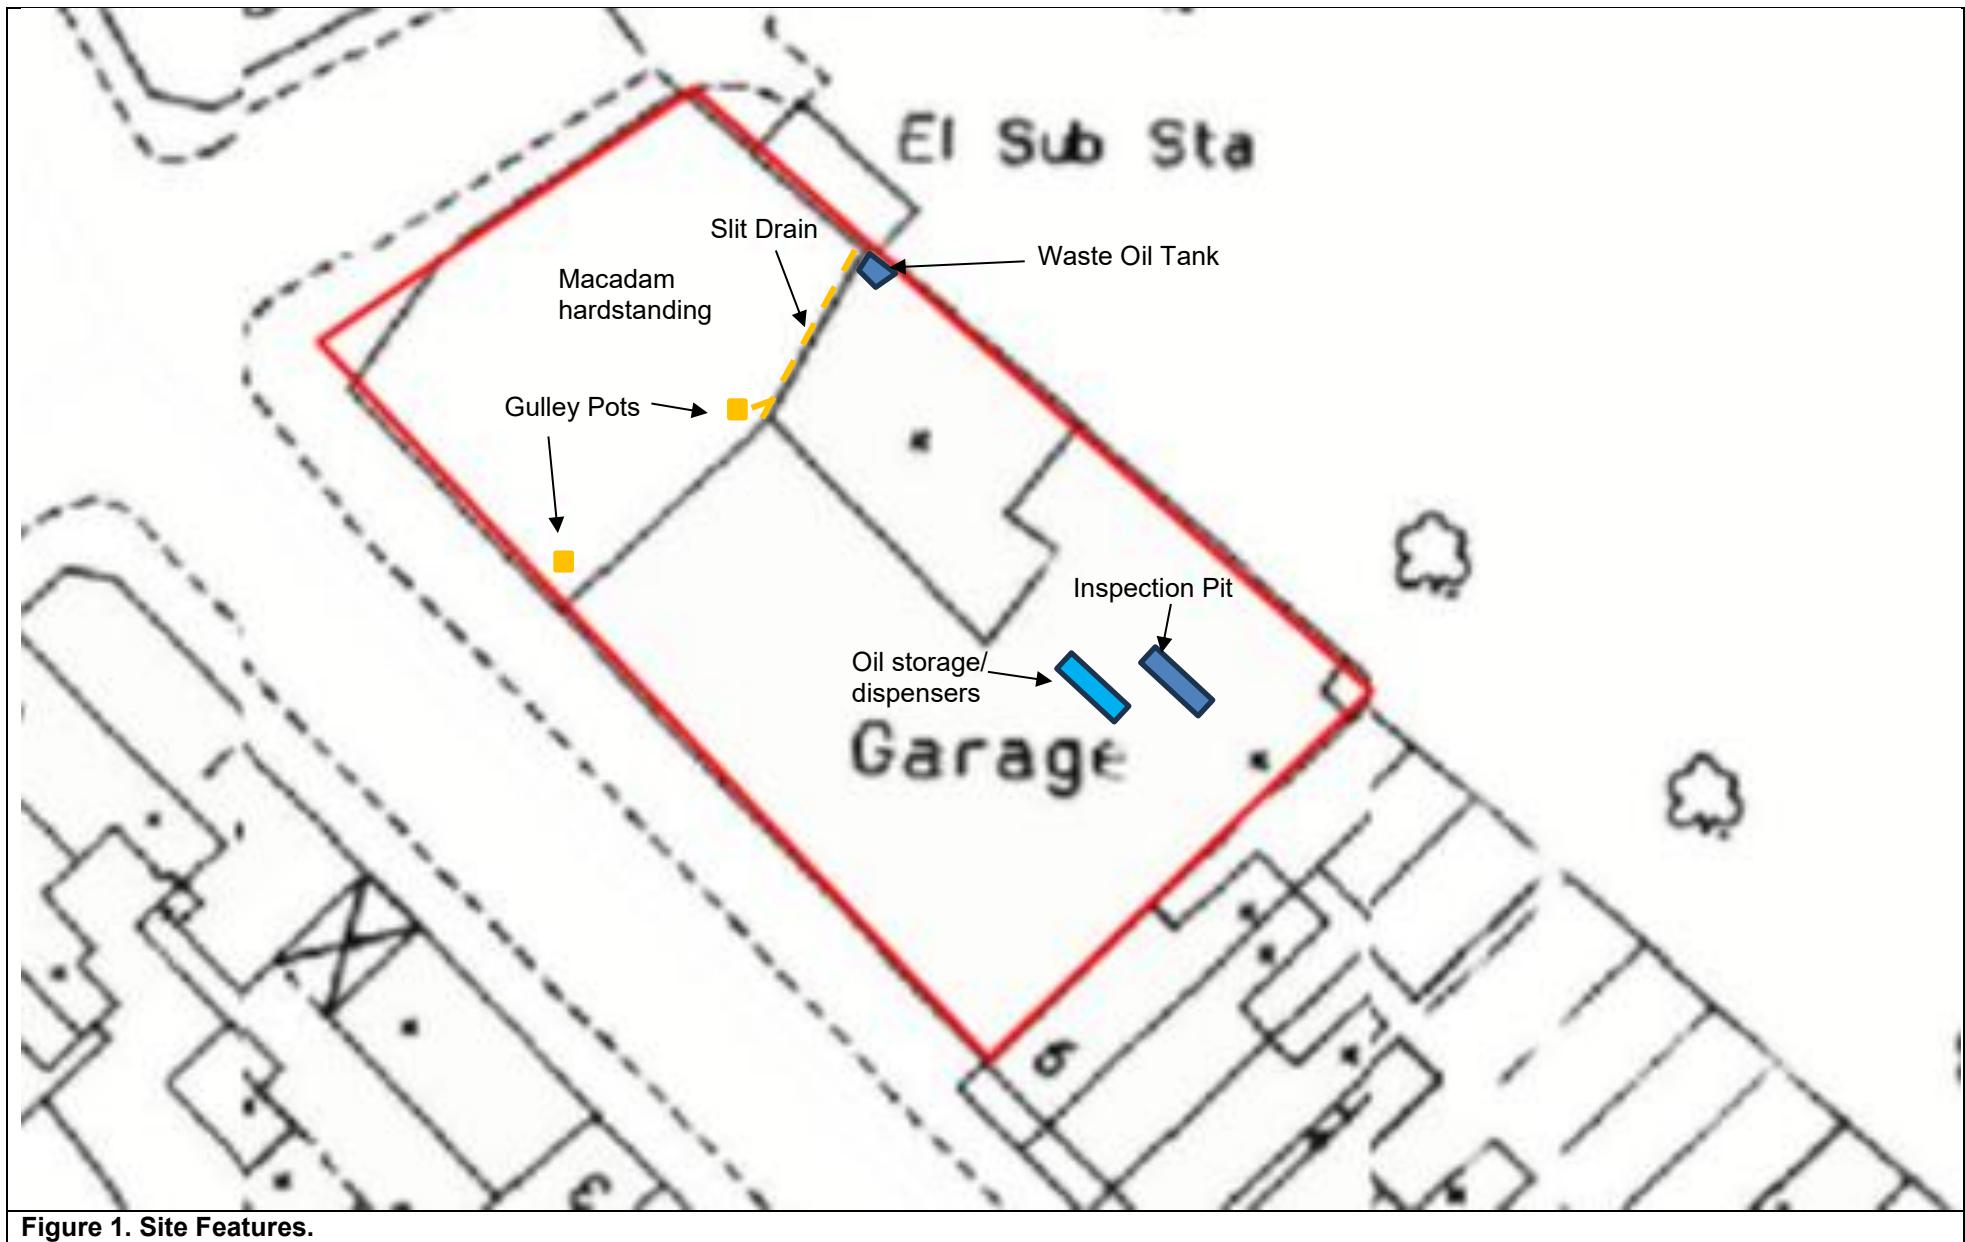
Figure 1. Site Features.

A site walkover was carried out on 24th October 2025. Site features are shown in figure 1. The site was in use a vehicle servicing garage at the time of visit and comprised a single storey building with an external area of hardstanding occupying the north of the site. The external hardstanding comprised macadam which was in reasonable condition with some breakage evident and was observed to slope to the south consistent with the adjacent road. Internally, a concrete floor was present throughout which was observed to be in good condition. A single inspection pit was observed to be present. This was wood covered and vehicles were parked over it so access was not possible. However, a discussion with the site owner confirmed that this feature was concrete lined.

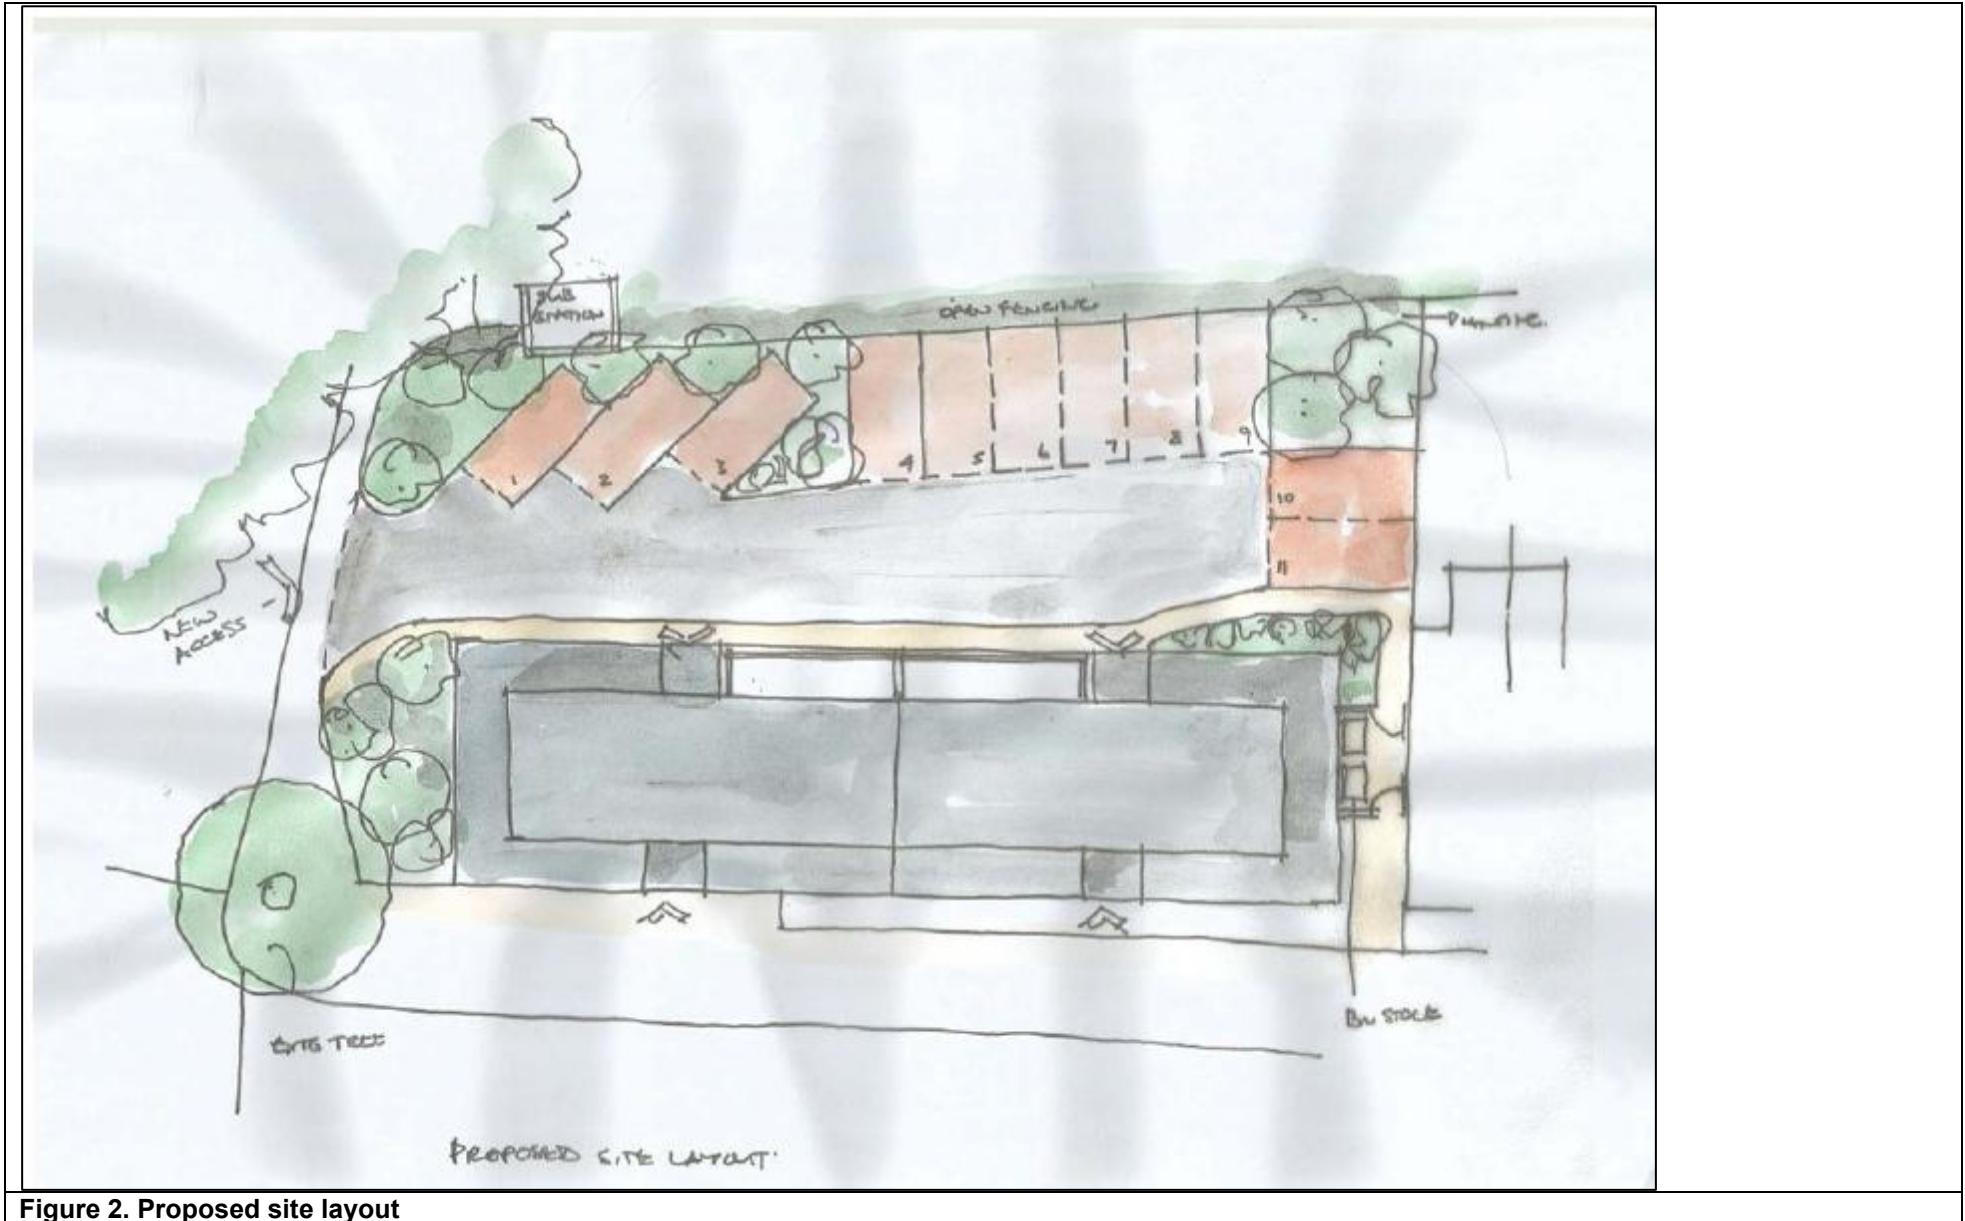
Figure 2. Proposed site layout

only dust inhalation is relevant. The provisional layout of the site indicates only minimal soft landscaping (figure 2) and those areas used for this purpose are likely to be used only as utility areas and therefore consumption of homegrown produce is unlikely.

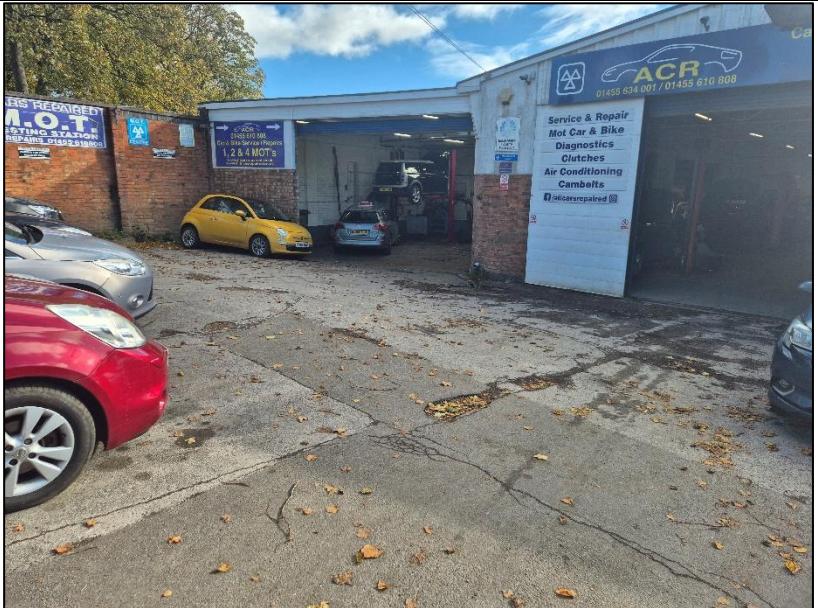
Figure 3. Exterior area

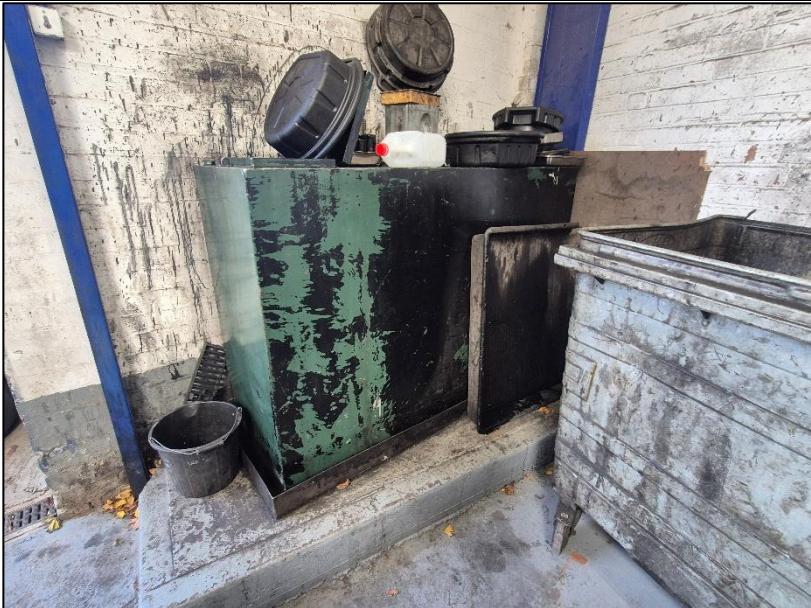
A waste oil tank was present within the north eastern part of the building. This was a single skinned metal tank and was situated within a drip tray that formed an external bund and this was in turn located on a raised concrete plinth which had very mild staining present. Engine oil drums and dispensers were present in the location shown in figure 1. No staining was observed in this area. On the remainder of the site only very minimal staining was evident on surfaces internally and none was observed on the external hardstanding.

Figure 4. Waste oil tank

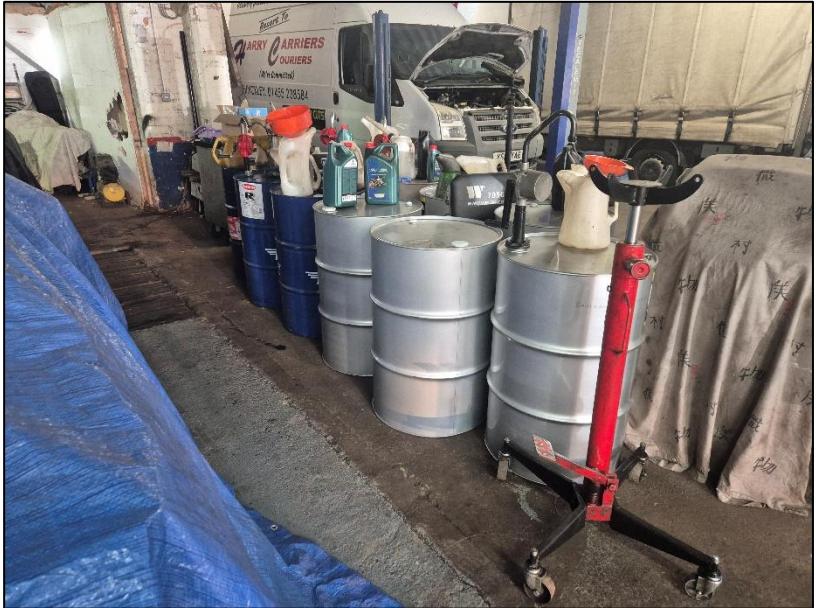
Figure 5. Oil storage/dispensers

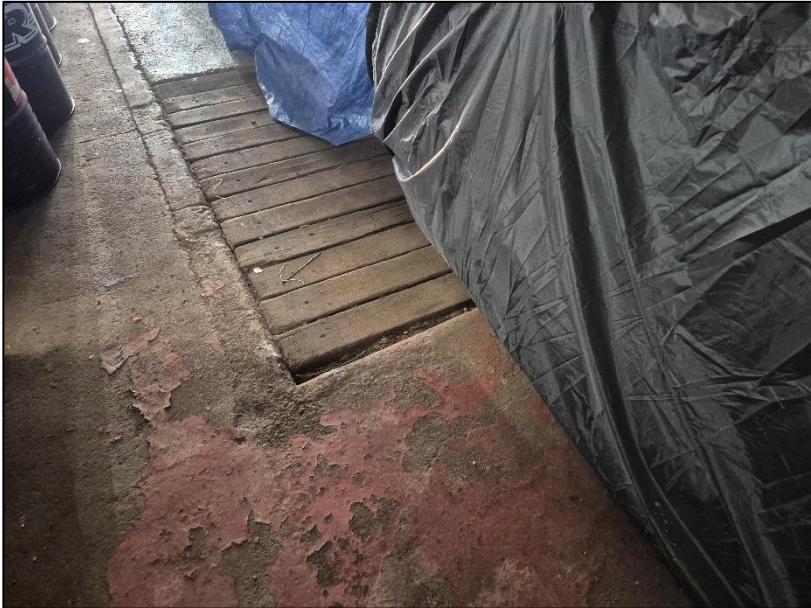
Figure 6. Inspection pit.

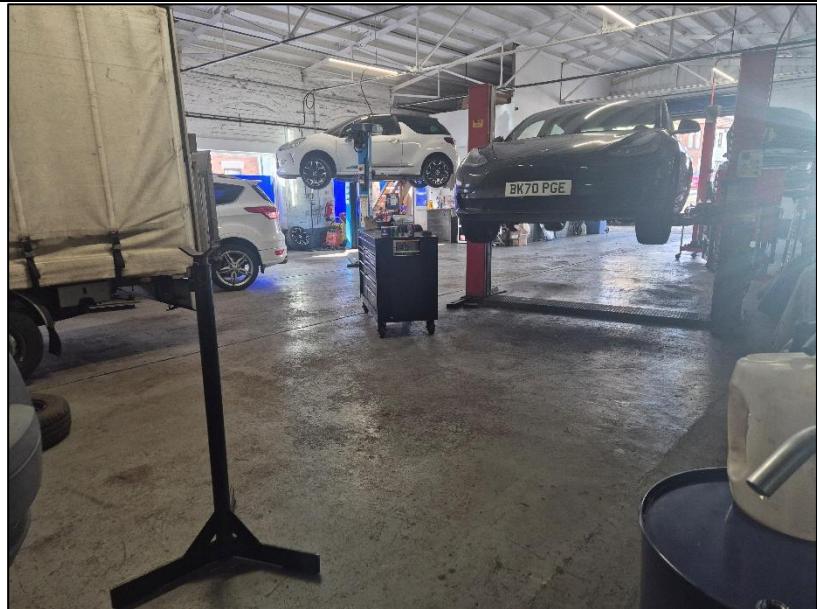
Figure 7. Interior, western part of site.

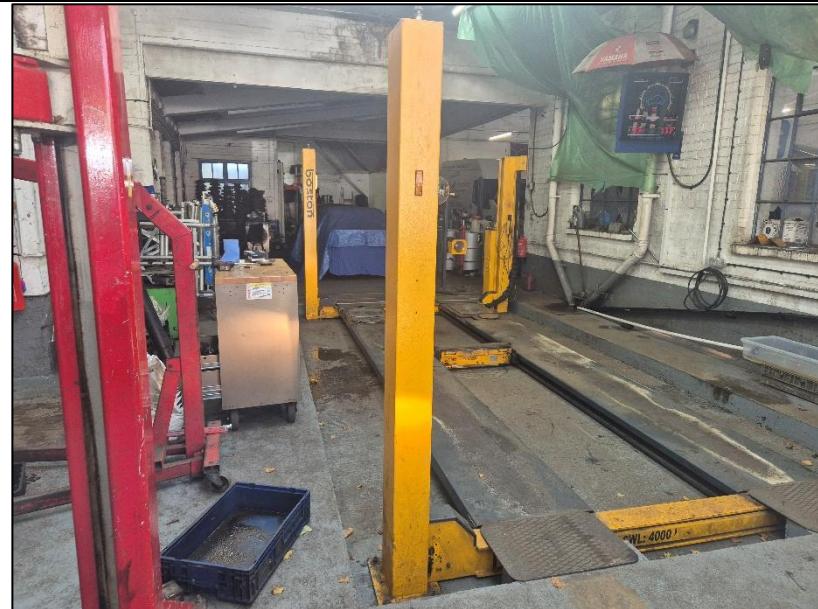
Figure 8. Interior eastern part of site.

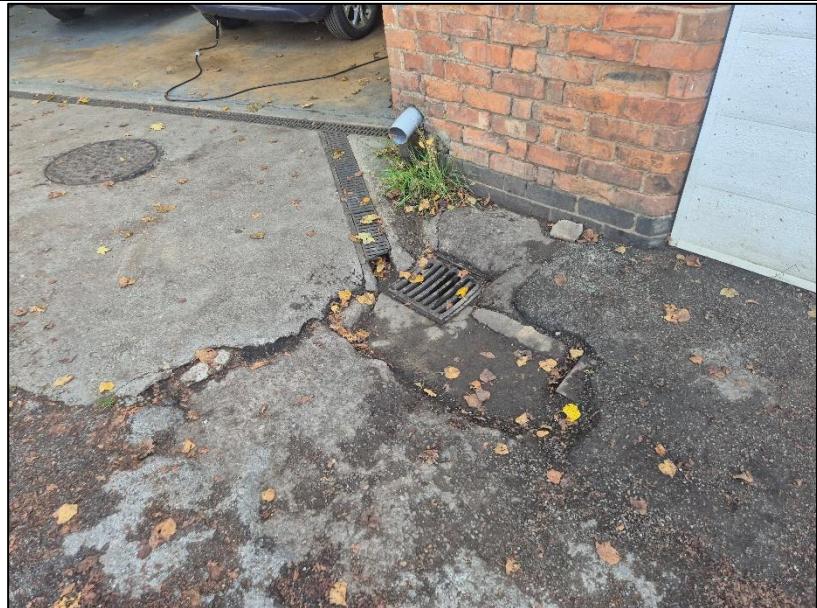
Slit drains were observed on the boundary of the building and external area which fed into gully pots. No fuel storage tanks were observed on the site. An electricity substation was confirmed to be present offsite adjacent to the eastern boundary. This was observed to be a modern unit located on a centred plinth with a metal housing. No evidence of staining was present in the vicinity of this feature.

Figure 9. Slit drain and associated gulley pot.

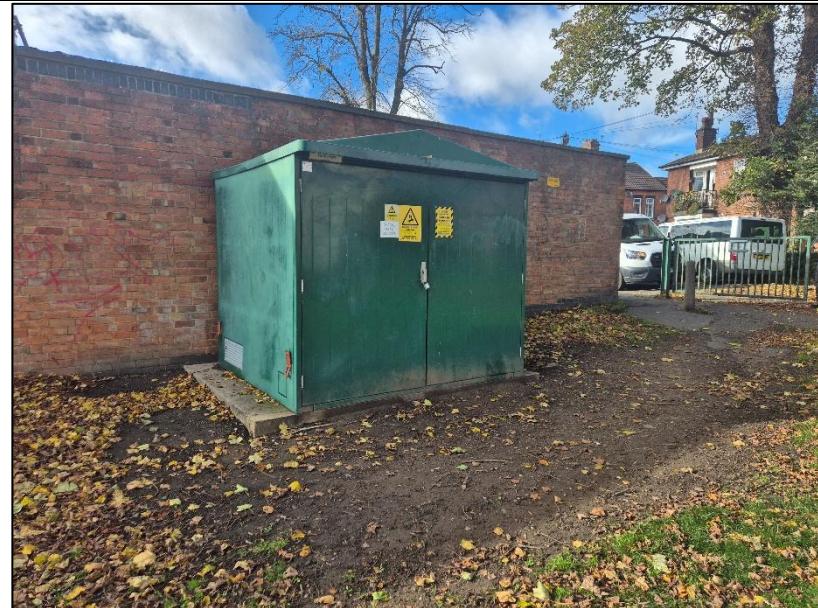
Figure 10. Electricity sub station adjacent to eastern boundary.
