## **BUILDING CONDITION REPORT**

Proposal: Change of use from Agriculture to Residential

Site: Barn Adjacent Wykin House Farm, Higham Lane,  
Wykin LE10 3EF

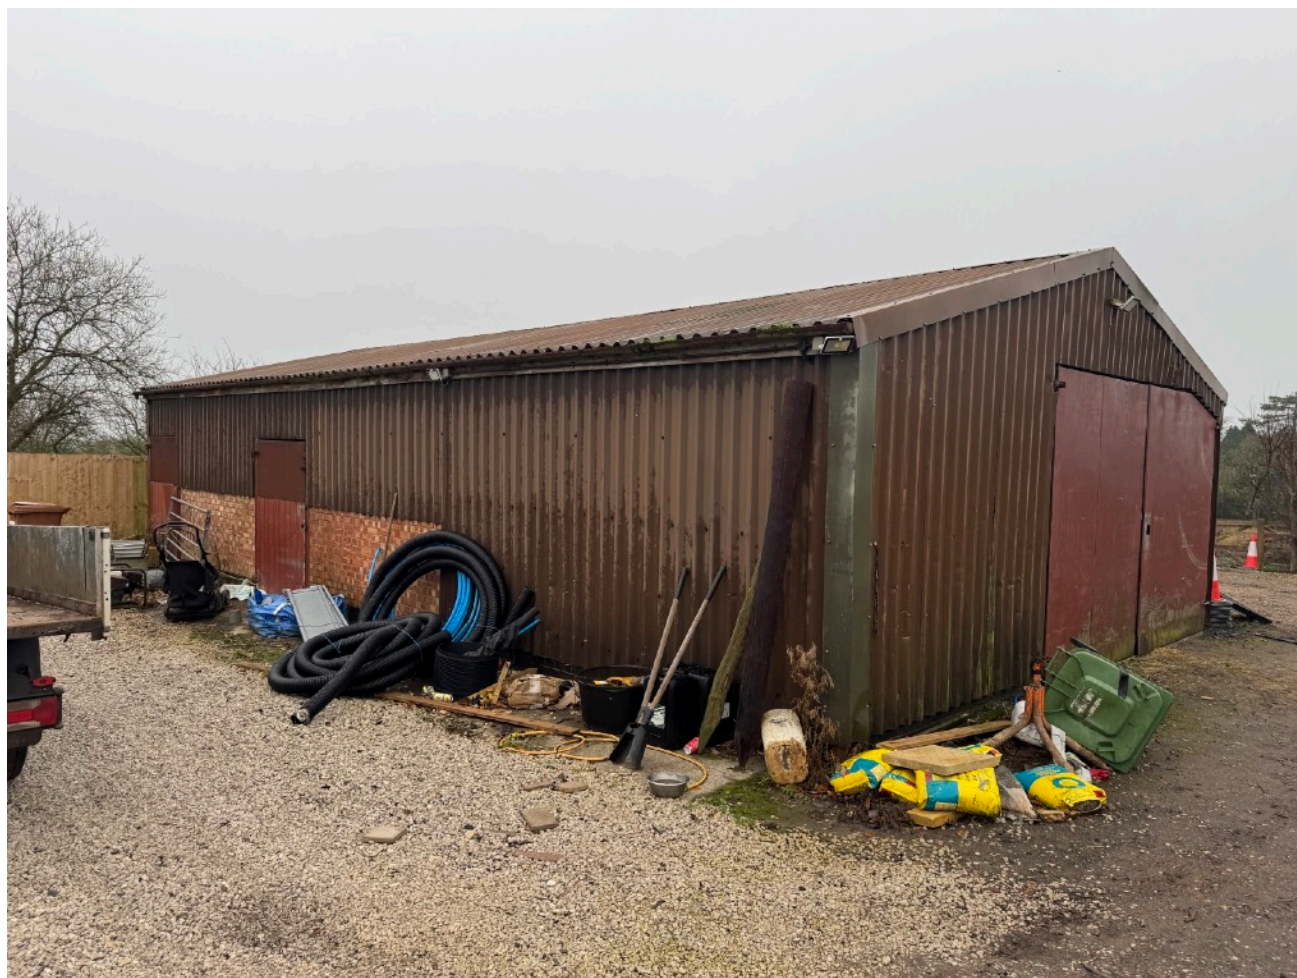
- 3.1. The existing barn consists of a steel portal frame structure, three bays in length with each bay being spaced at approximately 4.6m with an overall length of 14m and a span of 7.7m.

- 3.2. The portal frames consist of 178x102 Universal Beam sections, with an eaves height of approximately 2800mm and a ridge height of 5200mm. The portal frame is symmetrical, with the ridge line running along the centreline of the roof.

- 3.3. Eaves on both sides of the building are at the same height above the existing ground level. Wind bracing has been provided through short diagonal steel sections positioned between the portal frame columns and the timber purlins on the side elevations. Additionally, the sections of brick and block walls between the portal frame columns contribute to wind restraint.

- 3.4. Roof comprise of brown metal corrugated sheeting, supported on timber purlins at approximately 1500mm centres.

- 3.5. External masonry walls are constructed off the reinforced concrete floor slab.
- 3.6. The building features four personal access doors and a pair of double doors designated for vehicle access.
