# Drainage Report

**Arthur Street  
Arthur Street  
Barwell**

### 36913 Arthur Street - CCTV Survey Report : 25/09/20

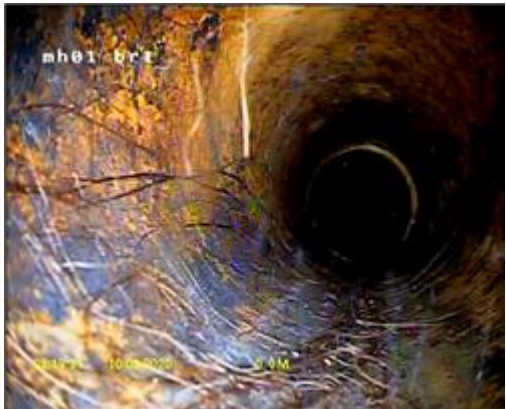
| Pos | Video Ref | Code | Cont. | Description | Image |
|---|---|---|---|---|---|
| 00.0m | 0:00:00 | RF | S1 | Roots fine 0m - 3.6m - Severity 1 | Image Provided - Ref: 0_1<br> |

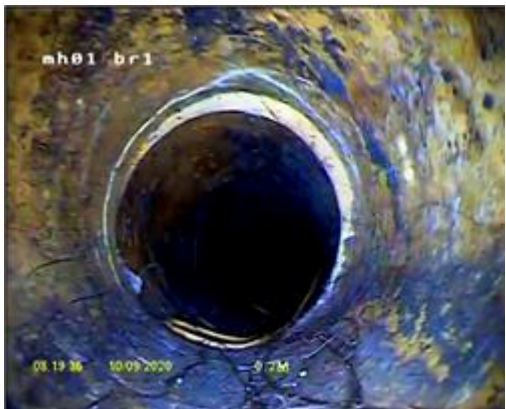
| Pos | Video Ref | Code | Cont. | Description | Image |
|---|---|---|---|---|---|
| 00.4m | 0:00:04 | FC | | Fracture circumferential from 12 o'clock to 12 o'clock - Severity 3 | Image Provided - Ref: 0_2<br> |

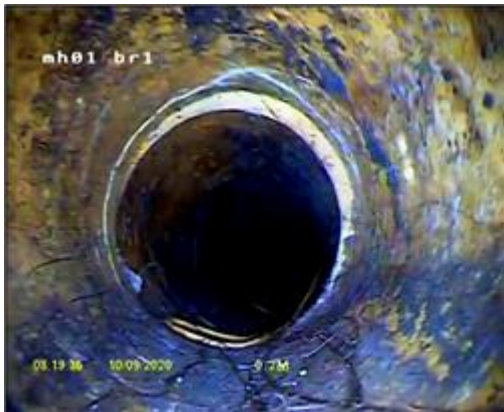
| Pos | Video Ref | Code | Cont. | Description | Image |
|---|---|---|---|---|---|
| 00.4m | 0:00:04 | RT | S2 | Roots tap 0.4m - 3.2m at joint - Severity 3 | Image Provided - Ref: 0_3<br> |

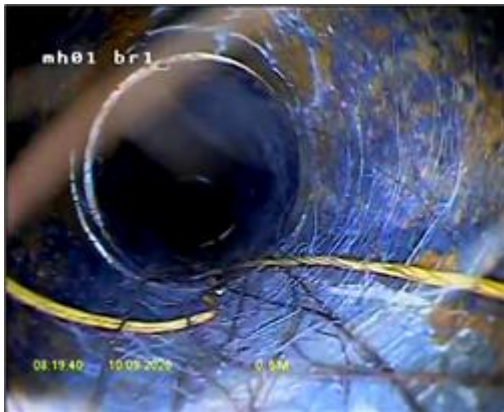
| Pos | Video Ref | Code | Cont. | Description | Image |
|---|---|---|---|---|---|
| 00.8m | 0:00:08 | FC | | Fracture circumferential from 12 o'clock to 12 o'clock - Severity 3 | Image Provided - Ref: 0_4<br> |

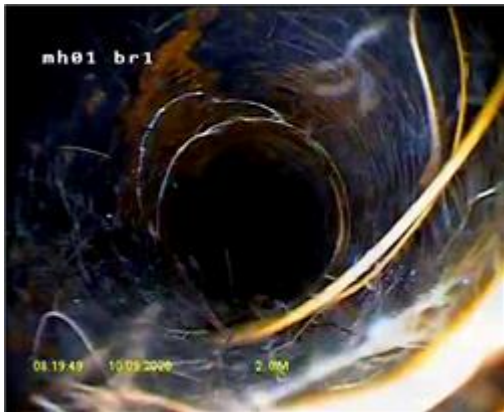
| Pos | Video Ref | Code | Cont. | Description | Image |
|---|---|---|---|---|---|
| 02.2m | 0:00:18 | FC | | Fracture circumferential from 12 o'clock to 12 o'clock - Severity 3 | Image Provided - Ref: 0_5<br> |

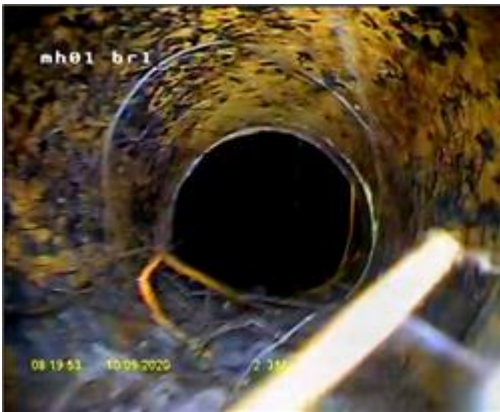
| Pos | Video Ref | Code | Cont. | Description | Image |
|---|---|---|---|---|---|
| 02.6m | 0:00:21 | FC | | Fracture circumferential from 12 o'clock to 12 o'clock - Severity 3 | Image Provided - Ref: 0_6<br> |

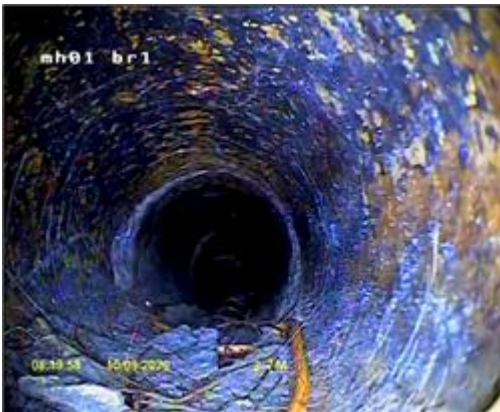
| Pos | Video Ref | Code | Cont. | Description | Image |
|---|---|---|---|---|---|
| 02.8m | 0:00:26 | DER | | Settled deposits coarse: 10% cross-sectional area loss - Severity 3 | Image Provided - Ref: 0_7<br> |

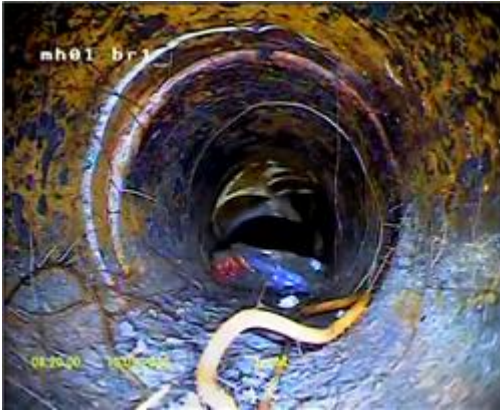
| Pos | Video Ref | Code | Cont. | Description | Image |
|---|---|---|---|---|---|
| 03.6m | 0:00:28 | FC | | Fracture circumferential from 12 o'clock to 12 o'clock - Severity 3 | Image Provided - Ref: 0_8<br> |

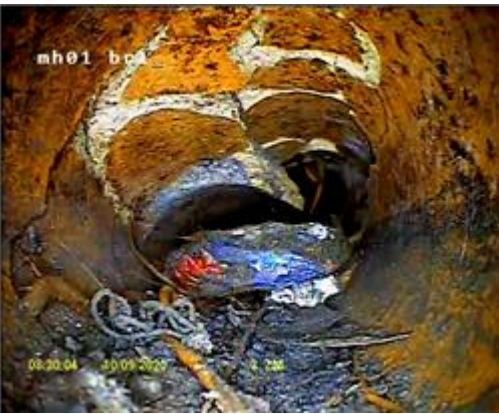
| Pos | Video Ref | Code | Cont. | Description | Image |
|---|---|---|---|---|---|
| 03.8m | 0:00:33 | XP | | Collapsed drain/sewer: 80%<br>Cross sectional area loss -<br>Severity 5 | Image Provided - Ref: 0_9<br> |

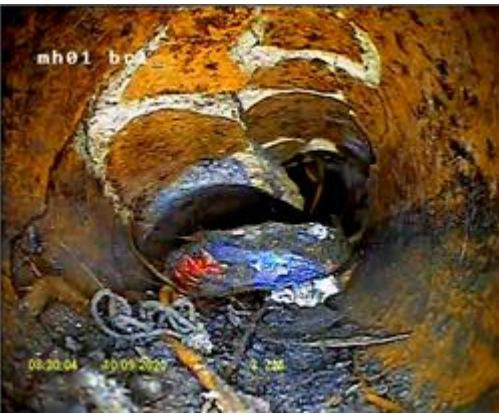
| Pos | Video Ref | Code | Cont. | Description | Image |
|---|---|---|---|---|---|
| 03.8m | 0:00:33 | SA | | Survey abandoned<br>Survey Abandoned - Unable to<br>Pass Collapse | Image Provided - Ref: 0_9999<br> |

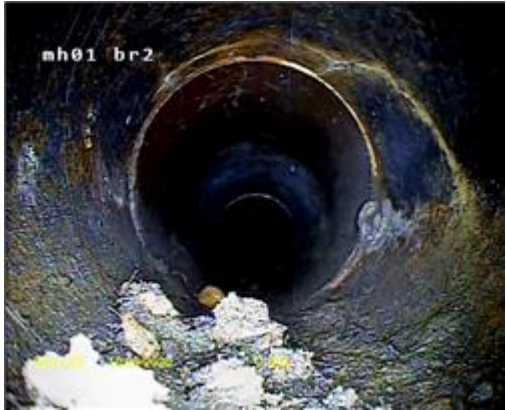
| Pos | Video Ref | Code | Cont. | Description | Image |
|---|---|---|---|---|---|
| 00.1m | 0:00:00 | CC | | Crack, circumferential from 10 o'clock to 03 o'clock - Severity 2 | Image Provided - Ref: 1_1<br> |

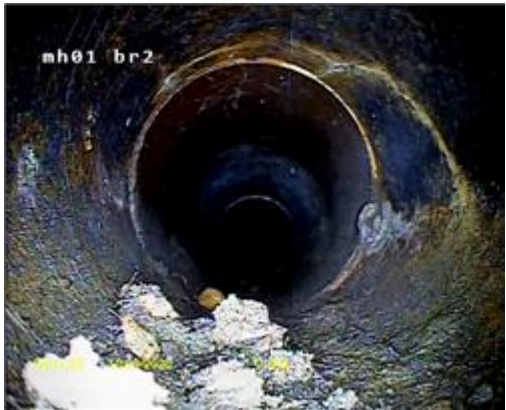
| Pos | Video Ref | Code | Cont. | Description | Image |
|---|---|---|---|---|---|
| 00.1m | 0:00:00 | DES | S1 | Settled deposits fine 0.1m - 6.4m: 10% cross-sectional area loss - Severity 2 | Image Provided - Ref: 1_2<br> |

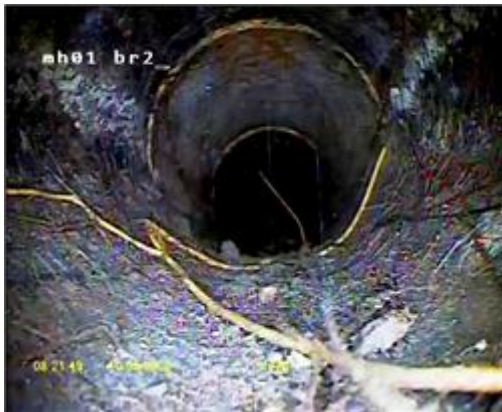
| Pos | Video Ref | Code | Cont. | Description | Image |
|---|---|---|---|---|---|
| 03.6m | 0:00:27 | RT | | Roots tap - Severity 3 | Image Provided - Ref: 1_5<br> |

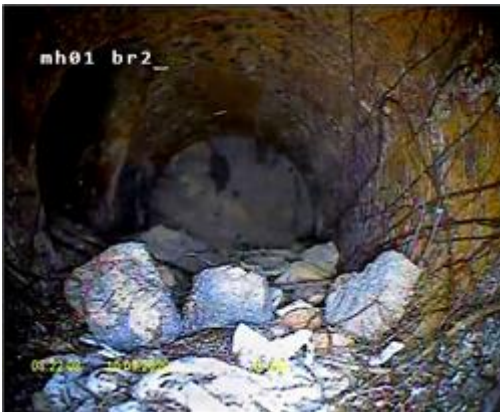
| Pos | Video Ref | Code | Cont. | Description | Image |
|---|---|---|---|---|---|
| 06.3m | 0:00:44 | DER | | Settled deposits coarse: 20% cross-sectional area loss - Severity 3 | Image Provided - Ref: 1_8<br> |

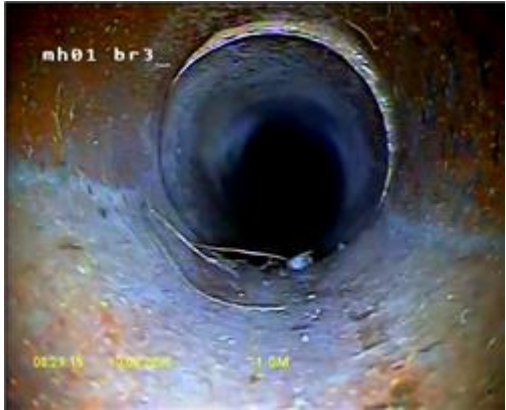
| Pos | Video Ref | Code | Cont. | Description | Image |
|---|---|---|---|---|---|
| 01.1m | 0:00:07 | RF | | Roots fine - Severity 1 | Image Provided - Ref: 2_1<br> |

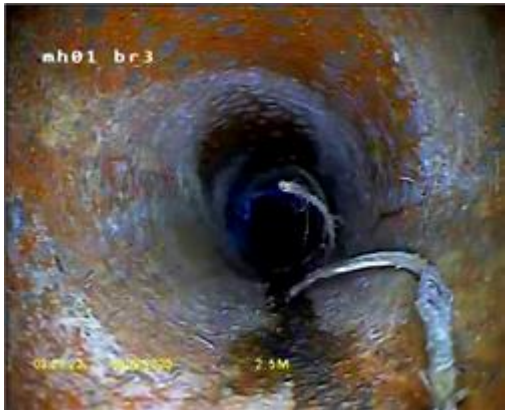
| Pos | Video Ref | Code | Cont. | Description | Image |
|---|---|---|---|---|---|
| 02.5m | 0:00:16 | RT | S1 | Roots tap 2.5m - 3.7m - Severity 3 | Image Provided - Ref: 2_2<br> |

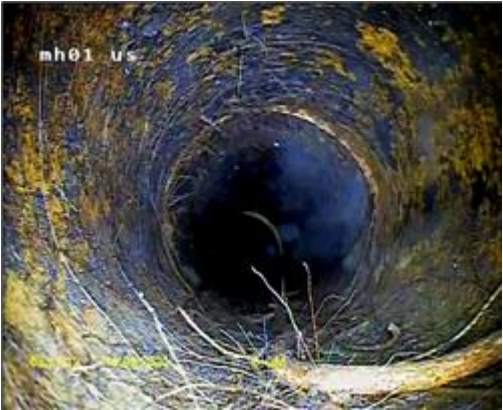
| Pos | Video Ref | Code | Cont. | Description | Image |
|---|---|---|---|---|---|
| 00.1m | 0:00:00 | RT | | Roots tap - Severity 3 | Image Provided - Ref: 3_1<br> |

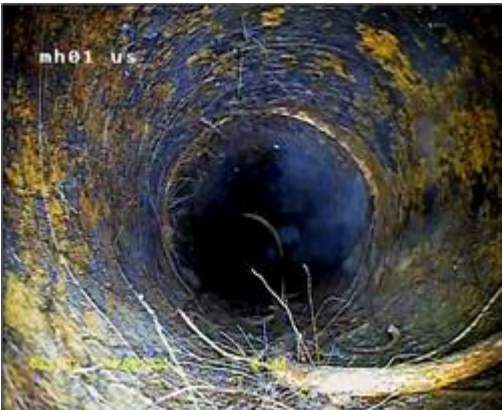
| Pos | Video Ref | Code | Cont. | Description | Image |
|---|---|---|---|---|---|
| 00.1m | 0:00:00 | RF | | Roots fine - Severity 1 | Image Provided - Ref: 3_2<br> |

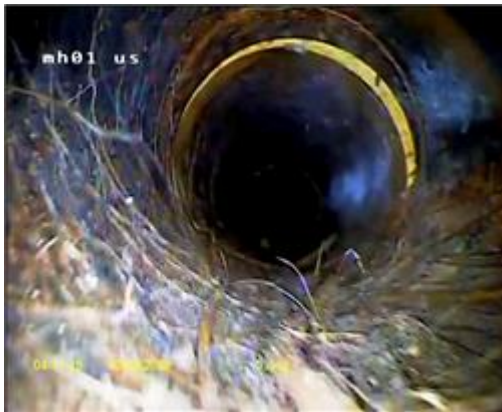
| Pos | Video Ref | Code | Cont. | Description | Image |
|---|---|---|---|---|---|
| 00.6m | 0:00:05 | CC | | Crack, circumferential from 12 o'clock to 03 o'clock - Severity 2 | Image Provided - Ref: 3_3<br> |

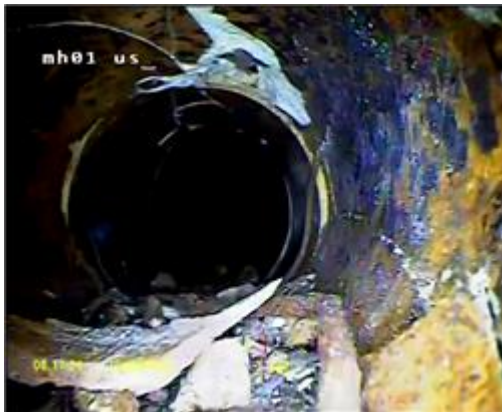
| Pos | Video Ref | Code | Cont. | Description | Image |
|---|---|---|---|---|---|
| 01.4m | 0:00:12 | DER | | Settled deposits coarse: 20% cross-sectional area loss - Severity 3 | Image Provided - Ref: 3_4<br> |

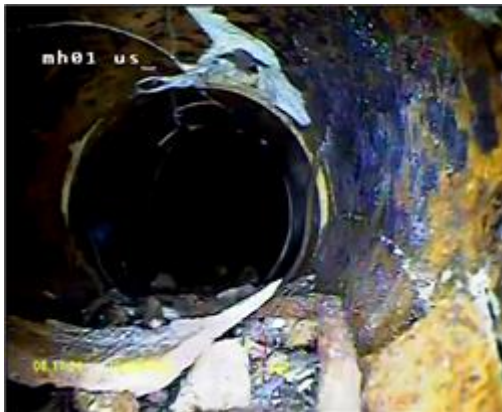
| Pos | Video Ref | Code | Cont. | Description | Image |
|---|---|---|---|---|---|
| 01.9m | 0:00:12 | B | | Broken pipe from 12 o'clock to 06 o'clock - Severity 4 | Image Provided - Ref: 3_5<br> |

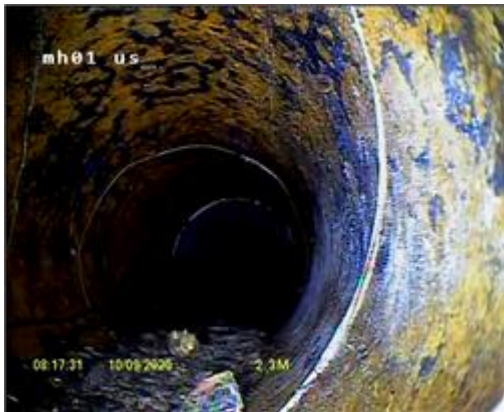
| Pos | Video Ref | Code | Cont. | Description | Image |
|---|---|---|---|---|---|
| 02.5m | 0:00:19 | FC | | Fracture circumferential from 12 o'clock to 12 o'clock - Severity 3 | Image Provided - Ref: 3_6<br> |

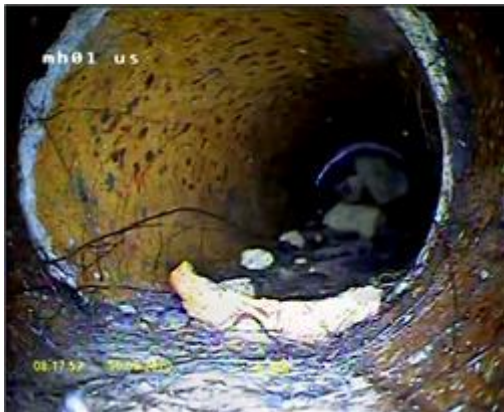
| Pos | Video Ref | Code | Cont. | Description | Image |
|---|---|---|---|---|---|
| 04.8m | 0:00:40 | DER | S1 | Settled deposits coarse 4.8m - 5.8m: 10% cross-sectional area loss - Severity 3 | Image Provided - Ref: 3_8<br> |

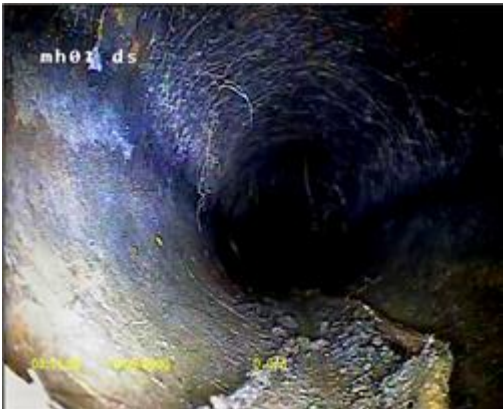
| Pos | Video Ref | Code | Cont. | Description | Image |
|---|---|---|---|---|---|
| 00.0m | 0:00:00 | RT | S1 | Roots tap 0m - 7m - Severity 3 | Image Provided - Ref: 4_1<br> |

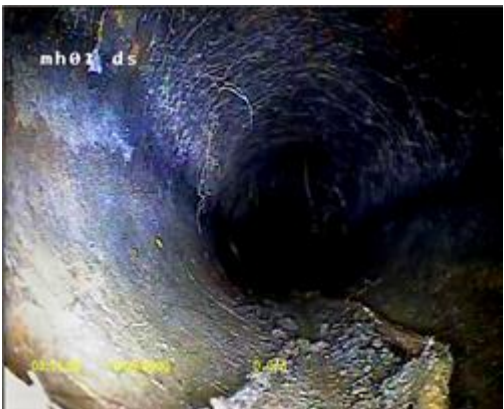
| Pos | Video Ref | Code | Cont. | Description | Image |
|---|---|---|---|---|---|
| 00.1m | 0:00:00 | RF | | Roots fine - Severity 1 | Image Provided - Ref: 4_2<br> |

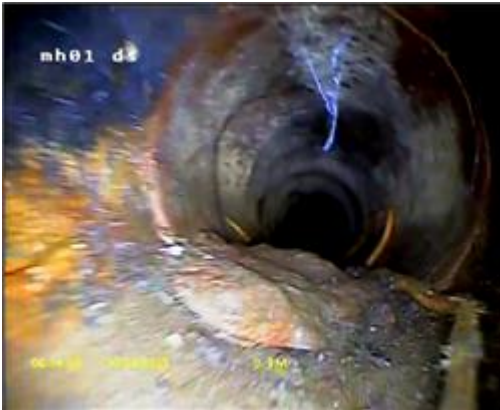
| Pos | Video Ref | Code | Cont. | Description | Image |
|---|---|---|---|---|---|
| 00.9m | 0:00:08 | DER | | Settled deposits coarse: 10% cross-sectional area loss - Severity 3 | Image Provided - Ref: 4_4<br> |

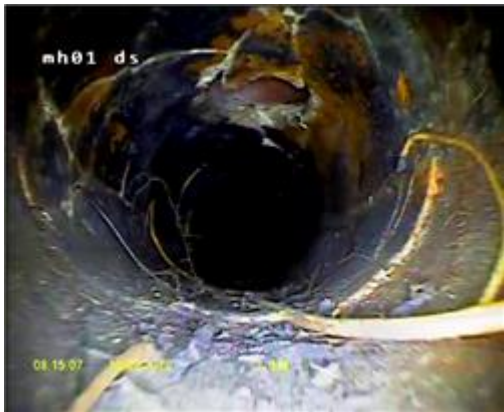
| Pos | Video Ref | Code | Cont. | Description | Image |
|---|---|---|---|---|---|
| 02.2m | 0:00:16 | FC | | Fracture circumferential from 09 o'clock to 02 o'clock - Severity 3 | Image Provided - Ref: 4_7<br> |

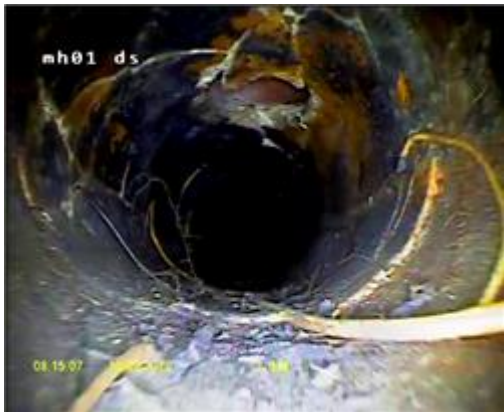
| Pos | Video Ref | Code | Cont. | Description | Image |
|---|---|---|---|---|---|
| 02.2m | 0:00:16 | CXI | | Connection intruding at 12 o'clock: 10% Intrusion : 100mm Diameter - Severity 2 | Image Provided - Ref: 4_8<br> |

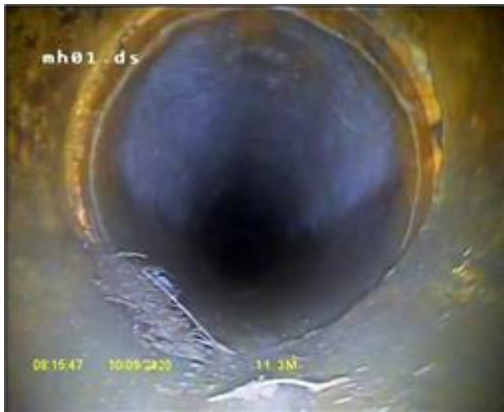
| Pos | Video Ref | Code | Cont. | Description | Image |
|---|---|---|---|---|---|
| 11.4m | 0:00:56 | CC | | Crack, circumferential from 08 o'clock to 04 o'clock - Severity 2 | Image Provided - Ref: 4_10<br> |

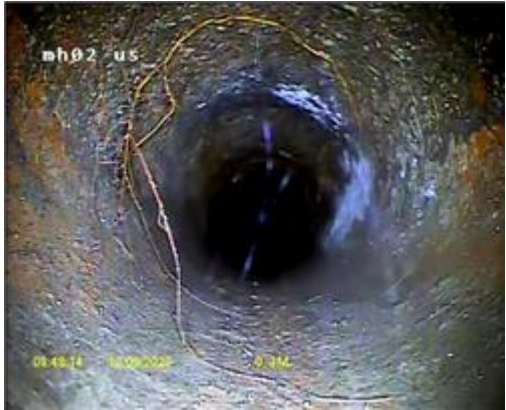
| Pos | Video Ref | Code | Cont. | Description | Image |
|---|---|---|---|---|---|
| 00.3m | 0:00:01 | RF | S1 | Roots fine 0.3m - 8.9m - Severity 1 | Image Provided - Ref: 6_1<br> |

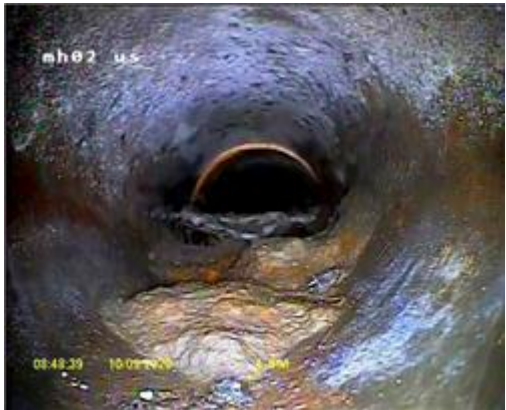
| Pos | Video Ref | Code | Cont. | Description | Image |
|---|---|---|---|---|---|
| 04.7m | 0:00:26 | DER | S2 | Settled deposits coarse 4.7m - 8.8m: 40% cross-sectional area loss - Severity 3 | Image Provided - Ref: 6_2<br> |

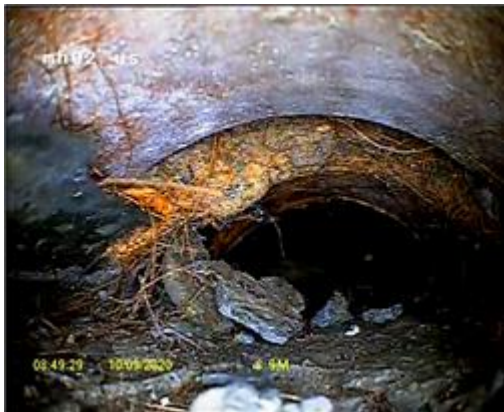
| Pos | Video Ref | Code | Cont. | Description | Image |
|---|---|---|---|---|---|
| 08.9m | 0:01:16 | DER | | Settled deposits coarse: 80% cross-sectional area loss - Severity 3 | Image Provided - Ref: 6_3<br> |

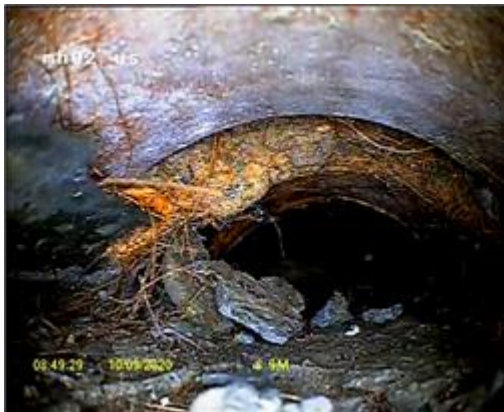
| Pos | Video Ref | Code | Cont. | Description | Image |
|---|---|---|---|---|---|
| 08.9m | 0:01:16 | RF | | Roots fine at joint - Severity 1 | Image Provided - Ref: 6_4<br> |

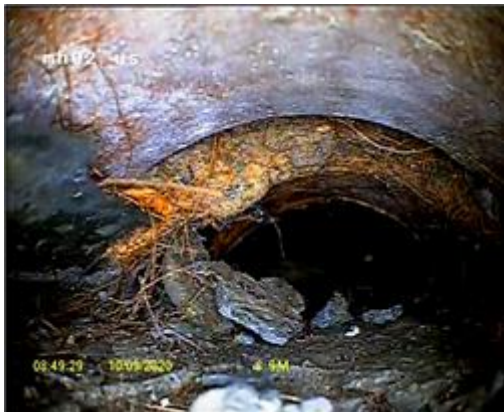
| Pos | Video Ref | Code | Cont. | Description | Image |
|---|---|---|---|---|---|
| 08.9m | 0:01:16 | JDM | | Joint displaced medium - Severity 2 | Image Provided - Ref: 6_5<br> |

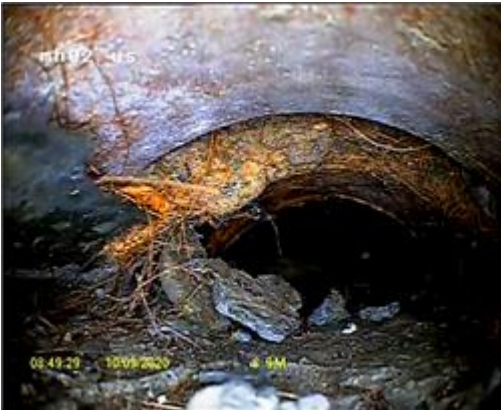
| Pos | Video Ref | Code | Cont. | Description | Image |
|---|---|---|---|---|---|
| 08.9m | 0:01:16 | SA | | Survey abandoned<br>Survey Abandoned - Unable to<br>Pass Debris | <div>Image Provided - Ref: 6_9999</div> |

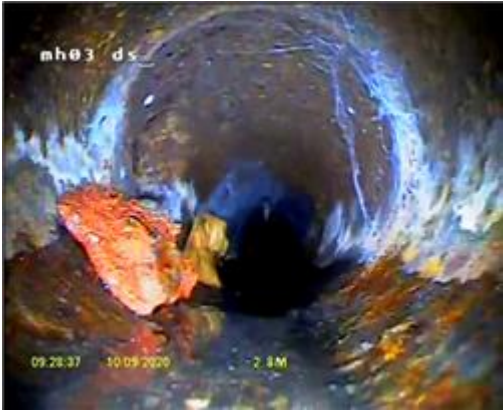
| Pos | Video Ref | Code | Cont. | Description | Image |
|---|---|---|---|---|---|
| 02.9m | 0:00:15 | DER | | Settled deposits coarse: 5% cross-sectional area loss - Severity 3 | Image Provided - Ref: 7_1<br> |

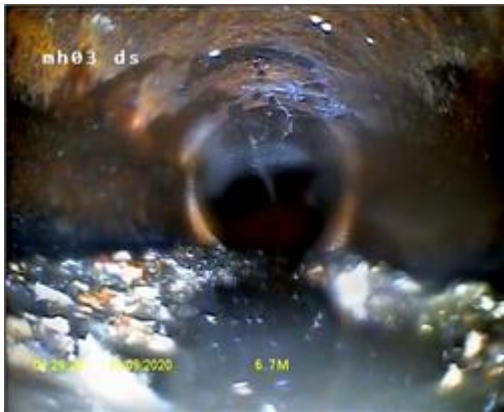
| Pos | Video Ref | Code | Cont. | Description | Image |
|---|---|---|---|---|---|
| 06.7m | 0:01:07 | DES | | Settled deposits fine: 10% cross-sectional area loss - Severity 2 | <p>Image Provided - Ref: 7_4</p> |

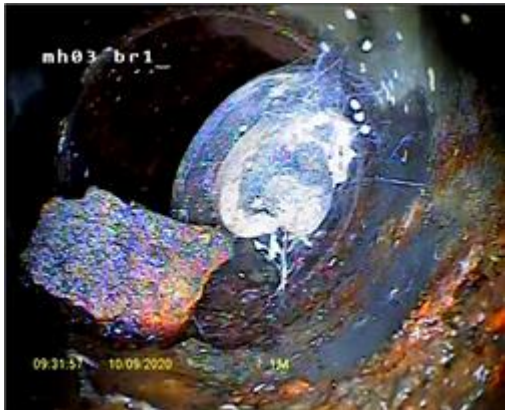
| Pos | Video Ref | Code | Cont. | Description | Image |
|---|---|---|---|---|---|
| 07.2m | 0:00:50 | OBX | | Other obstacles, other object in invert from 12 o'clock to 12 o'clock: 80% cross-sectional area loss - Severity 3<br>Broken Drainage Rod Plunger | Image Provided - Ref: 8_2<br> |

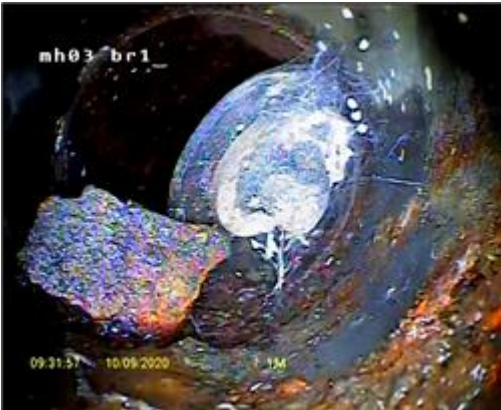
| Pos | Video Ref | Code | Cont. | Description | Image |
|---|---|---|---|---|---|
| 07.2m | 0:00:50 | SA | | Survey abandoned<br>Survey Abandoned - Unable to<br>Pass Obstruction. | Image Provided - Ref: 8_9999<br> |

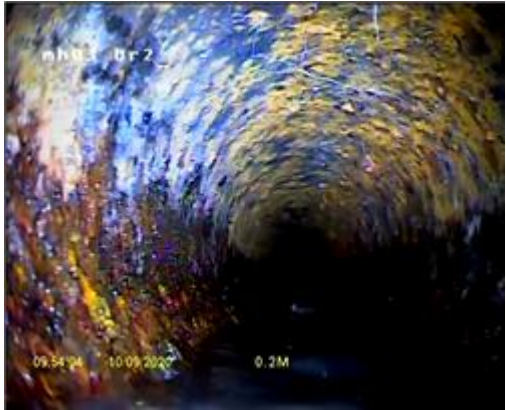
| Pos | Video Ref | Code | Cont. | Description | Image |
|---|---|---|---|---|---|
| 00.0m | 0:00:02 | DEZ | S1 | Other 0m - 6.8m from 12 o'clock to 12 o'clock: 5% cross-sectional area loss - Severity 2<br>Rust/Corrosion | Image Provided - Ref: 9_1<br> |

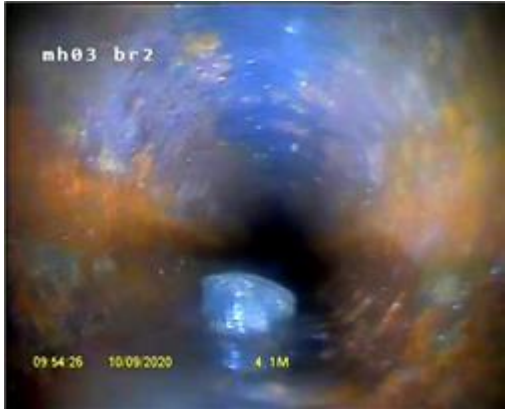
| Pos | Video Ref | Code | Cont. | Description | Image |
|---|---|---|---|---|---|
| 04.1m | 0:00:24 | DER | | Settled deposits coarse: 10% cross-sectional area loss - Severity 3 | Image Provided - Ref: 9_3<br> |
