# **Infiltration Test Report**

## **Kyngs Golf and Country Club, Station Road, Market Bosworth**

Reference: 82633-01

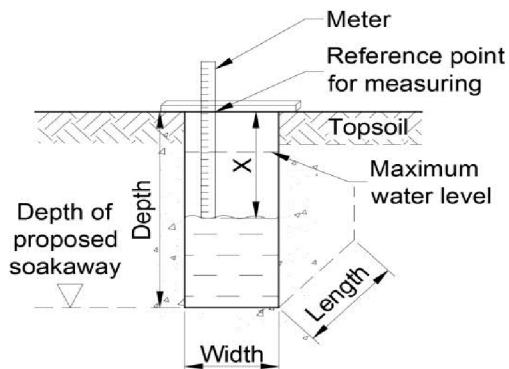
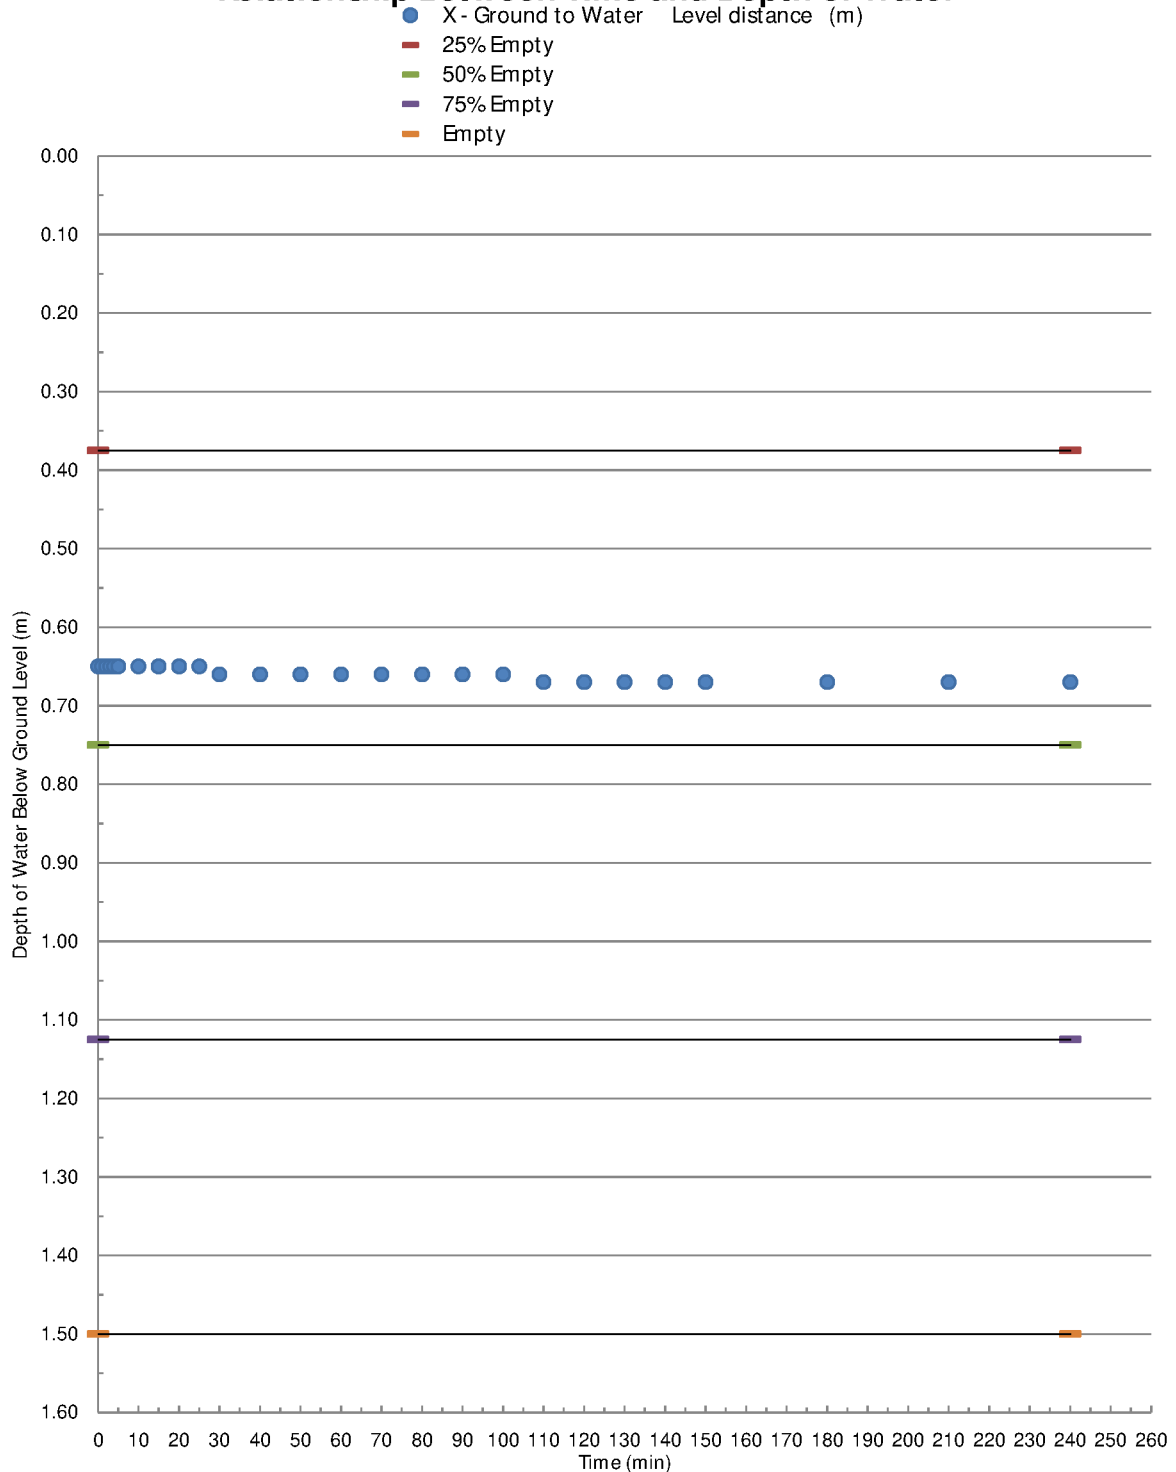
### Permeability Test SA1

Negligible fall in water. Strata classified as practically impermeable

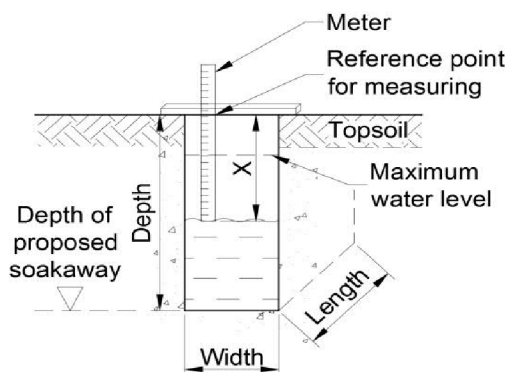
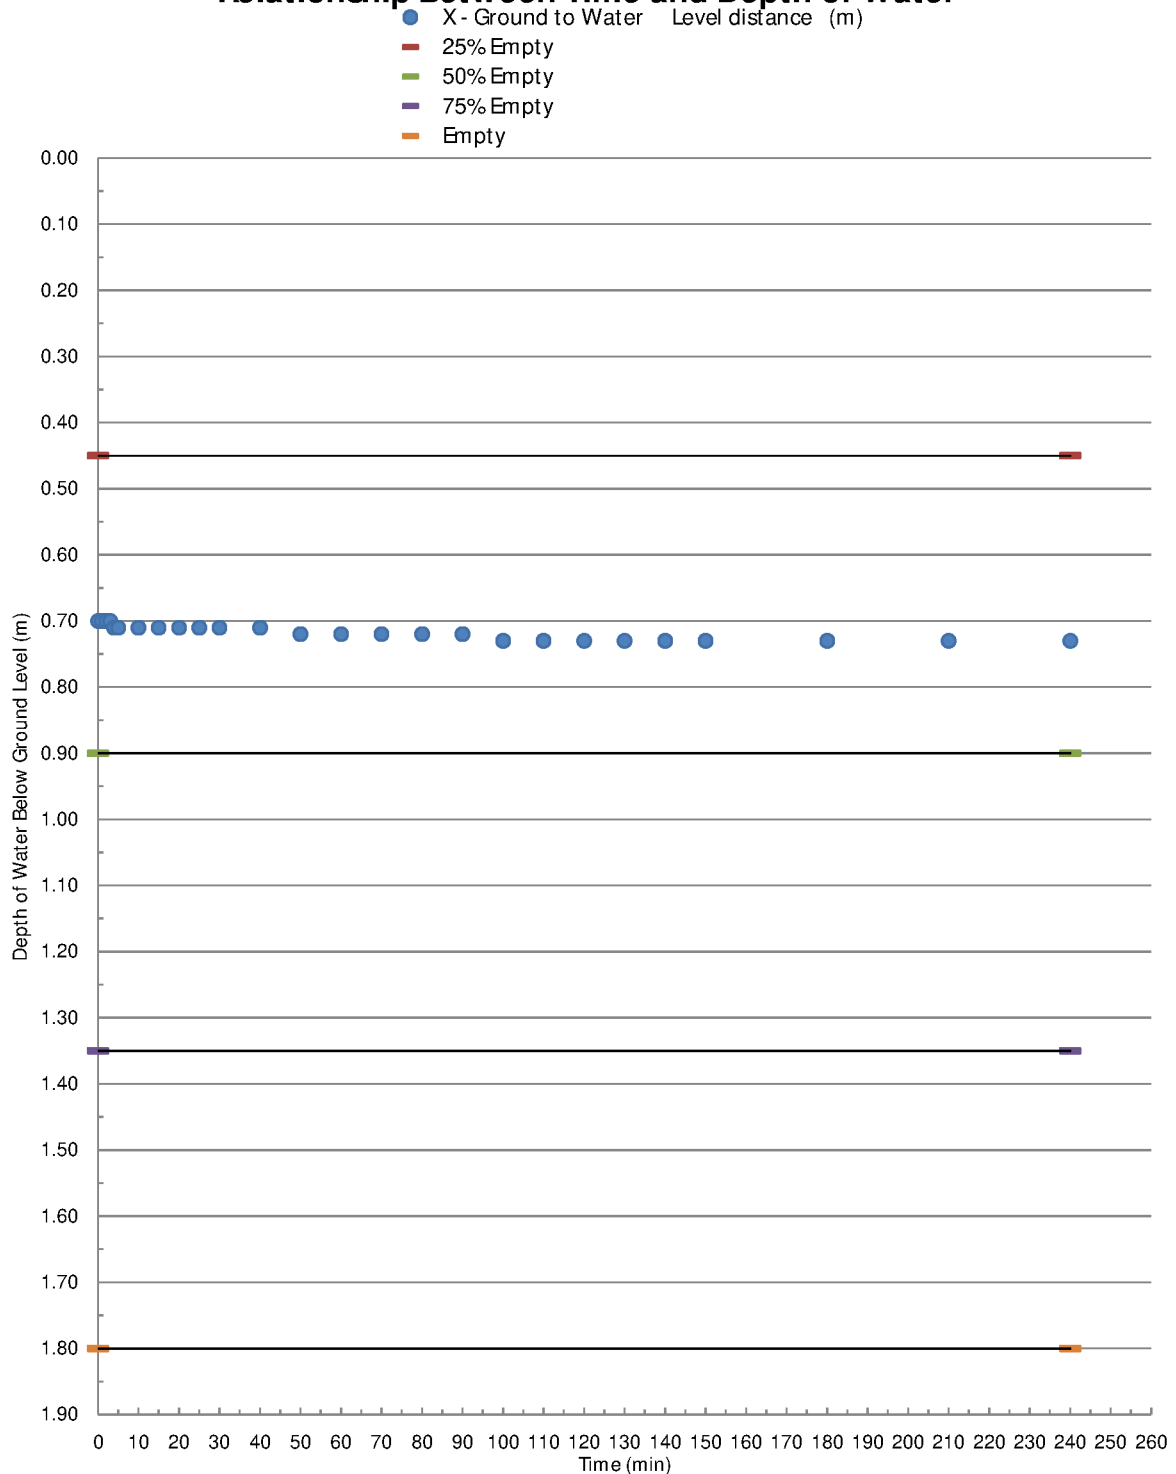
### Permeability Test SA2

Negligible fall in water. Strata classified as practically impermeable

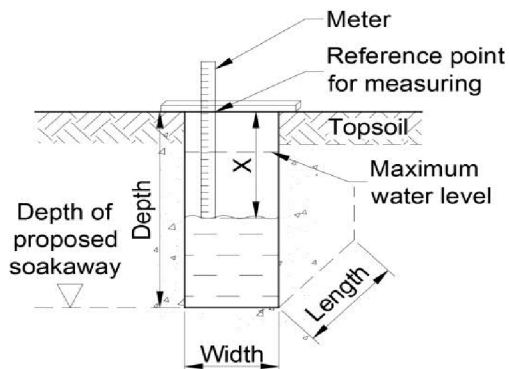
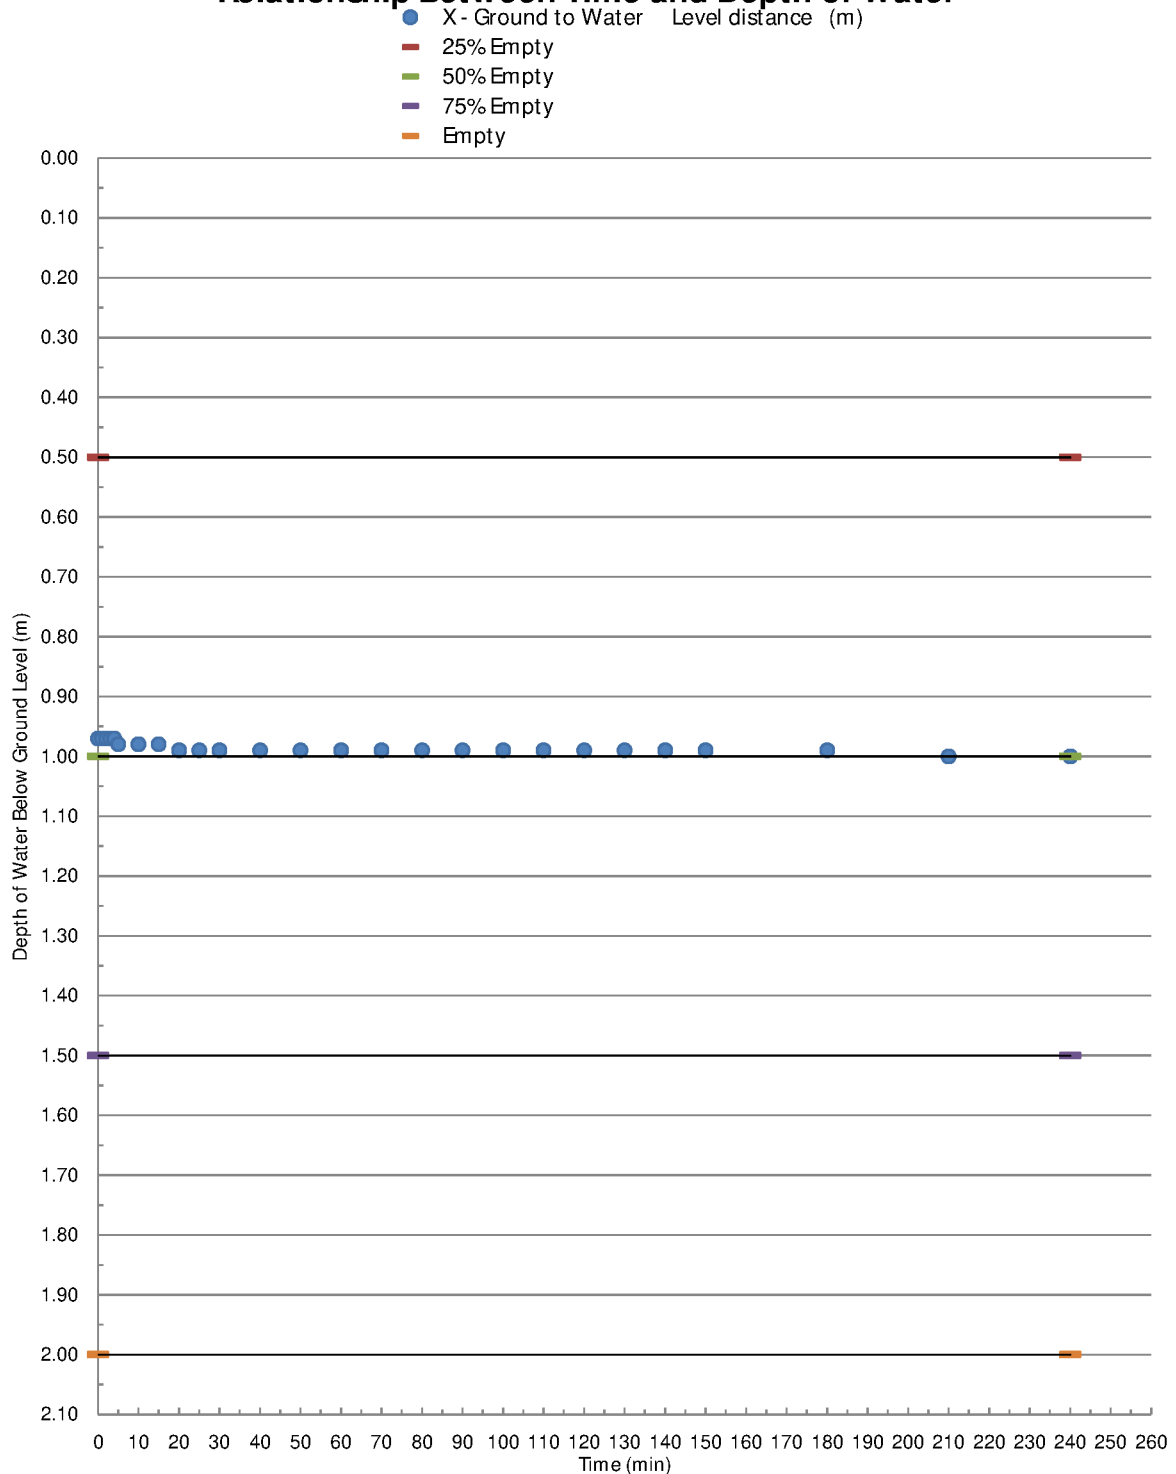
### Permeability Test SA3

Negligible fall in water. Strata classified as practically impermeable
