**File Note: River Condition Assessment**

**Site address:** Markfield Road, Ratby, Leicester, LE6 0LU

**Ref:** River Condition Assessment

**Proposal:** The construction of a small intimate glamping retreat.

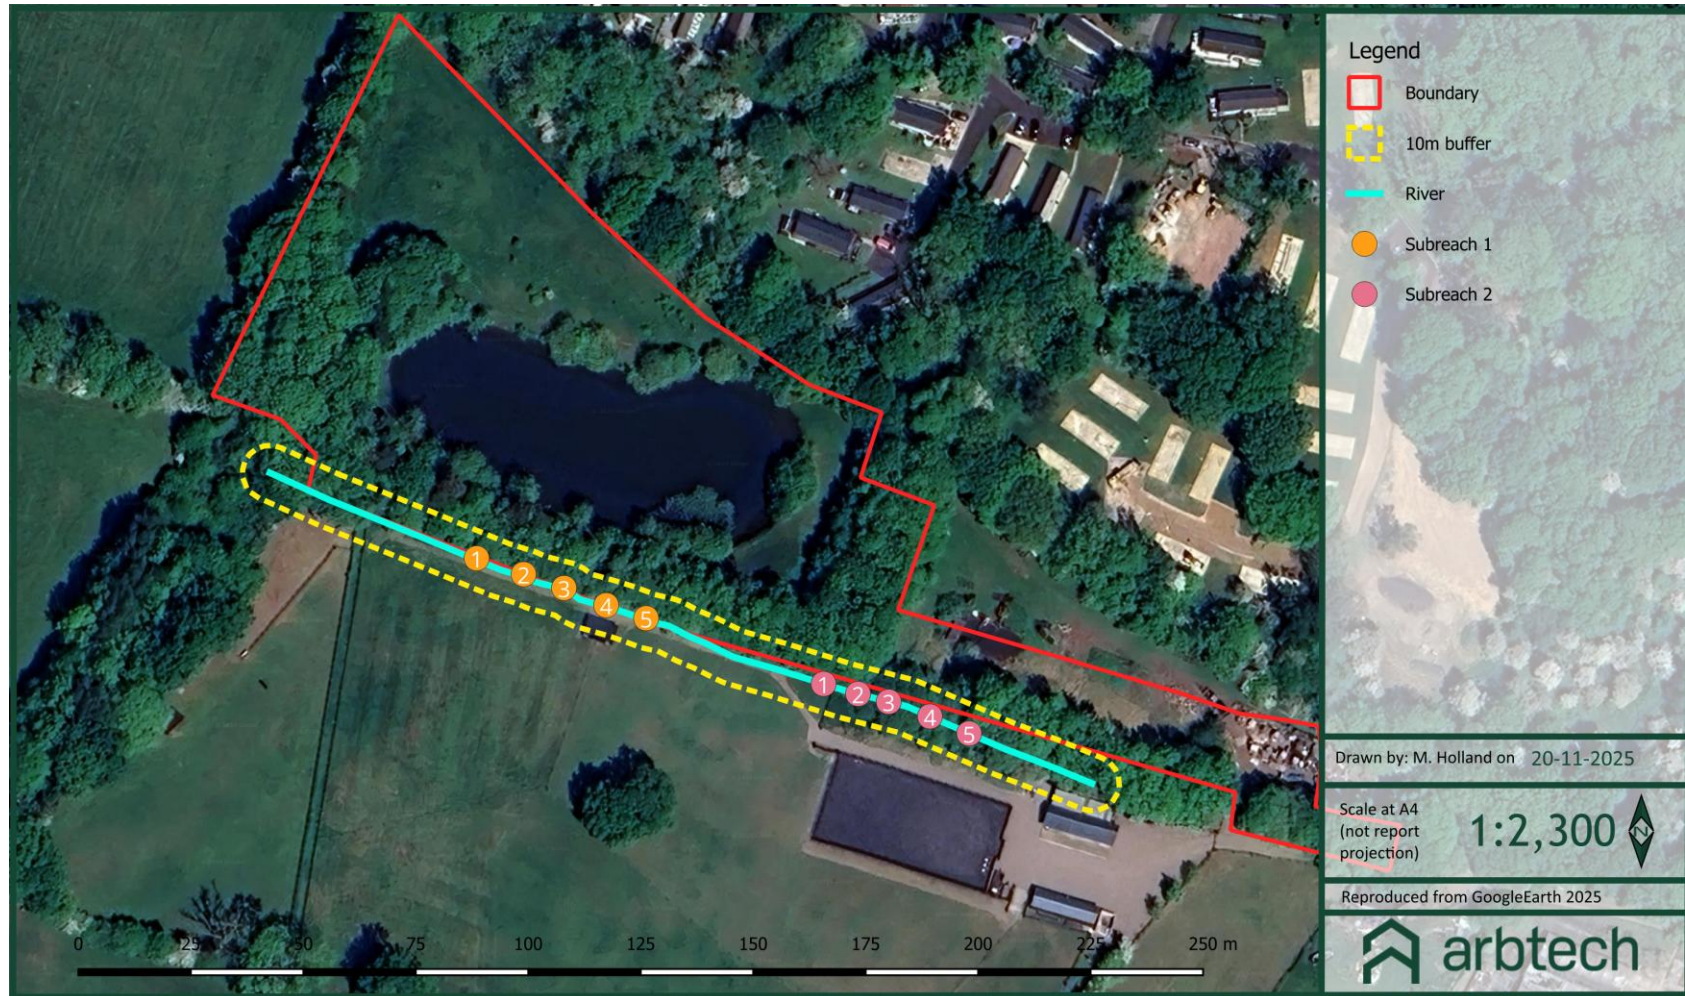
## Appendix 2: MoRPh Survey Locations

The watercourse subject to the RCA was Slate Brook, which lies along the southern red line site boundaries. One subreach consists of a total of 5 MoRPh modules equating to 50m or 100m for each length. The average width of the Slate Brook was under 5m wide and therefore the modules are comprised of 10m lengths.

Two 50m sub-reaches were carried out on the Slate Brook as such covering 100m of the 280m (covering 35%).

The MoRPh survey locations are shown at **Appendix 2**.
