# **Arboricultural Method Statement**

Brascote Lane, Newbold Verdon

Report Reference: BG24.292

**REV4 – February 2025**

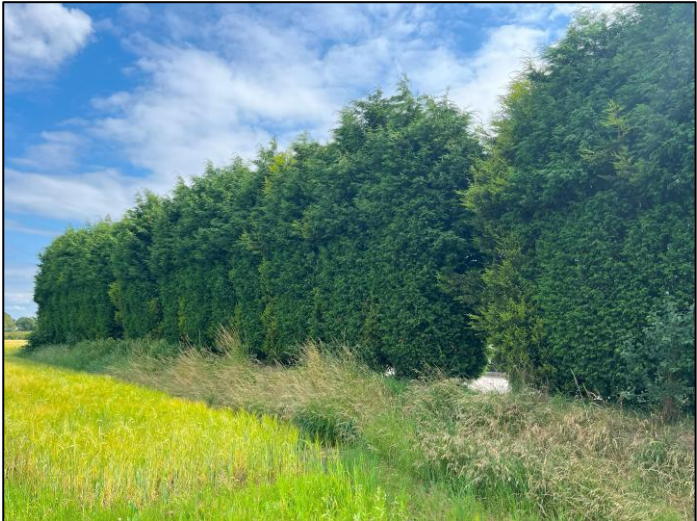
| Image | Description |
|---|---|
| | <p>G11, the linear line of Leyland cypress, providing screening value against the adjacent property.</p> |

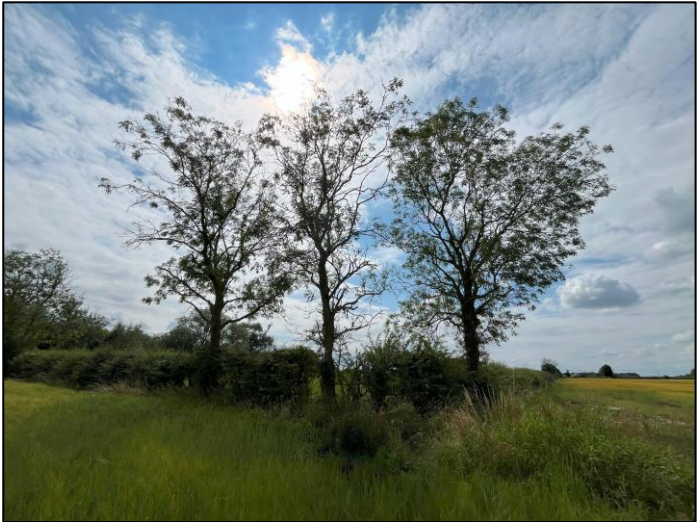
| Image | Description |
|---|---|
| | <p>G10, three ash trees exhibiting advanced symptoms of ash dieback, with limited future potential.</p> |

- 3.8.5 T6, T7, T23 – T25, and G10, are recommended for removal irrespective of development, due to their poor condition. T6, T7, T23 and T24 are Category U ash trees, while G10 is a Category C group. They all show physiological decline and exhibit symptoms indicative of advanced ash dieback (including significant crown decline and deadwood). The ash trees have a significantly limited future potential and are recommended for removal. T25, a standing dead tree within the boundary hedgerow, is recommended for removal.

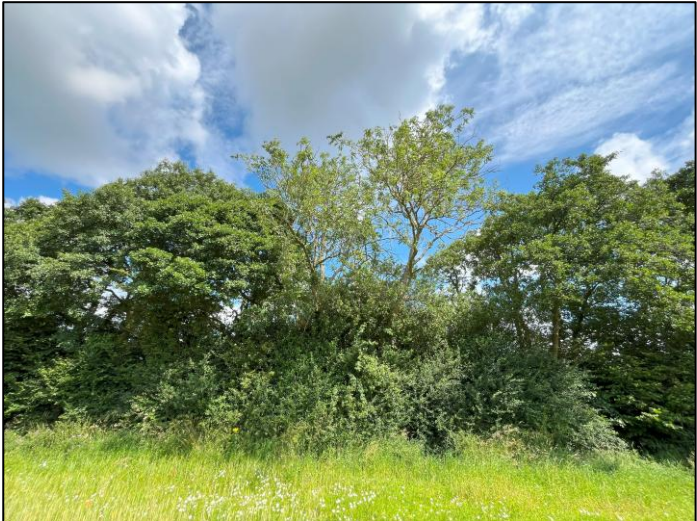
| Image | Description |
|---|---|
| | <p>T6, a Category U common ash within G2, exhibiting advanced symptoms of ash dieback.</p> |

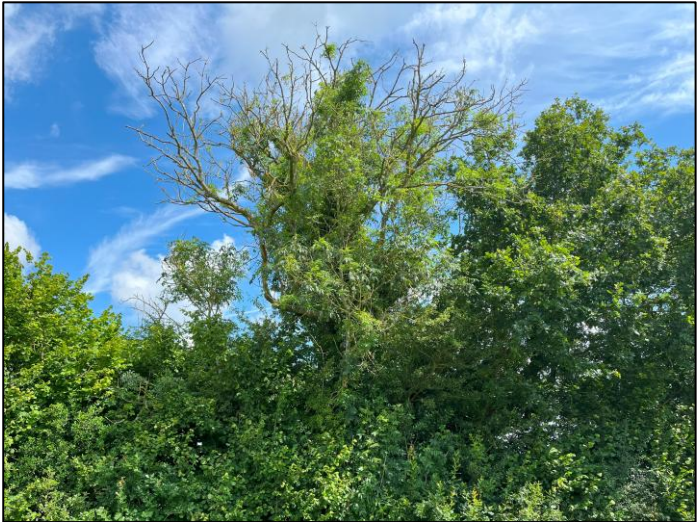
| Image | Description |
|---|---|
| | <p>T7, a Category U common ash, exhibiting advanced symptoms of ash dieback.</p> |
