## **Arboricultural Impact Assessment**

Land to the North of Leicester Road, Markfield

Report Reference: BG22.188.7

**October 2023**

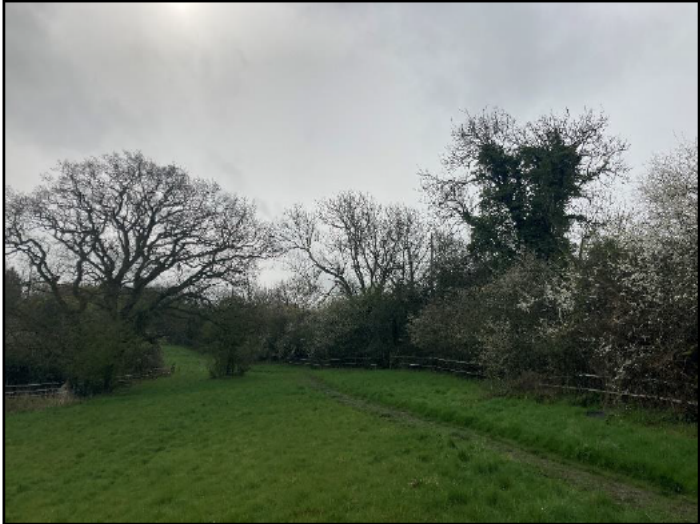
| Image | Description |
|---|---|
| <b>Eastern Site Extent</b> | |

| Image | Description |
|---|---|
| | <p>A site photograph, taken facing east, with T2 located to the left and G1, T1 and T3 located right.</p> |

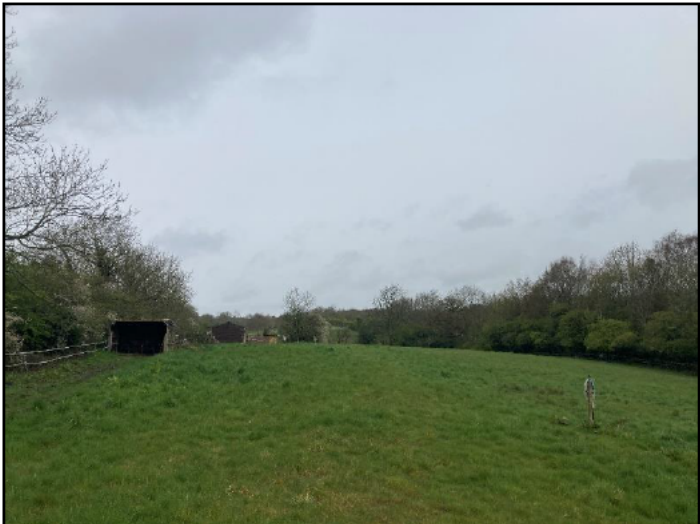
| Image | Description |
|---|---|
| <b>Western Site Extent</b> | |

| Image | Description |
|---|---|
| | <p>A site photograph of the western extent, with G1 located left, W1 located right, and G2 located in the central background.</p> |

- 4.5.1 G1, a Category C group along the southern boundary, is recommended for partial removal to facilitate the proposed access from Leicester Road. The length of removal is approximately 22m, with further thinning works required to an additional 10m along the southern face of the group to facilitate the proposed footpath. G1 is predominantly comprised of common hawthorn and blackthorn, with interspersed common holly and young common ash, and provides landscape value as a screening feature against Leicester Road.
