**Technical Note: Response to Comments from Planning Ecology Officer Michael McCoy  
Regarding Planning Application 26/00263/FUL**

The below comment(s) were received from Leicester County Council Ecology Officer Michael McCoy regarding a planning application located at Willow Farm, Stanton under Bardon (planning ref 26/00263/FUL). This document provides clarification for each comment individually.

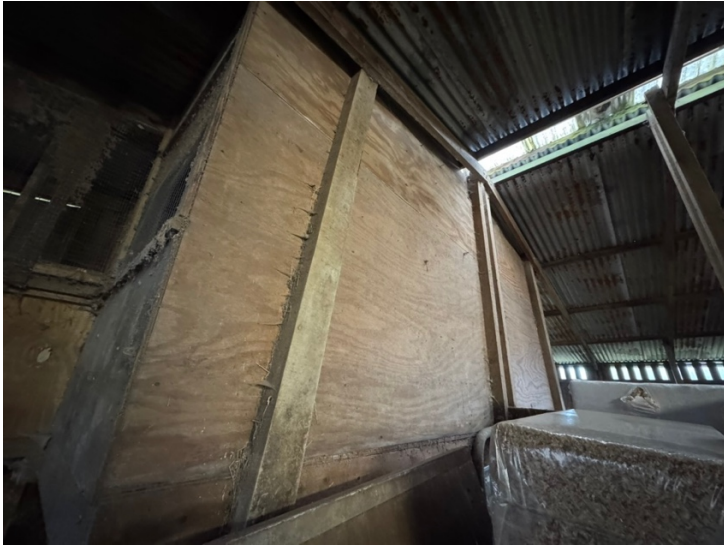
The apparent double-skinned area visible in Photo 4 shows an internal chicken house which was mentioned in para 4.43 of the PEA / BNG Report. This chicken house was built inside building B1 and itself was formed of a well-sealed, single skin of plywood, with no suitable PRFs. An internal inspection of the chicken house was carried out during the initial survey of the site on the 9<sup>th</sup> March 2026. During this inspection, no suitable PRFs were observed. The chicken house was also sealed with chicken wire which would prevent bats from entering.

Photo 1: External wall of chicken house (whole structure lies within B1)

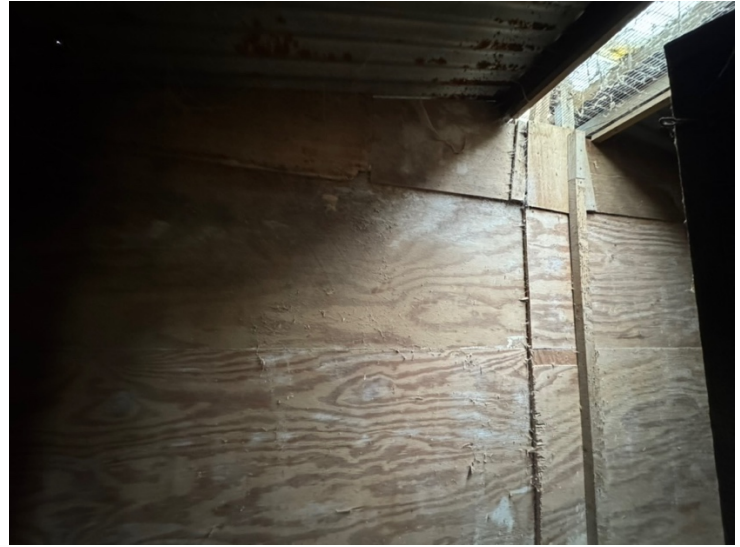
Photo 2: Internal portion of chicken house showing well-sealed, single skinned plywood

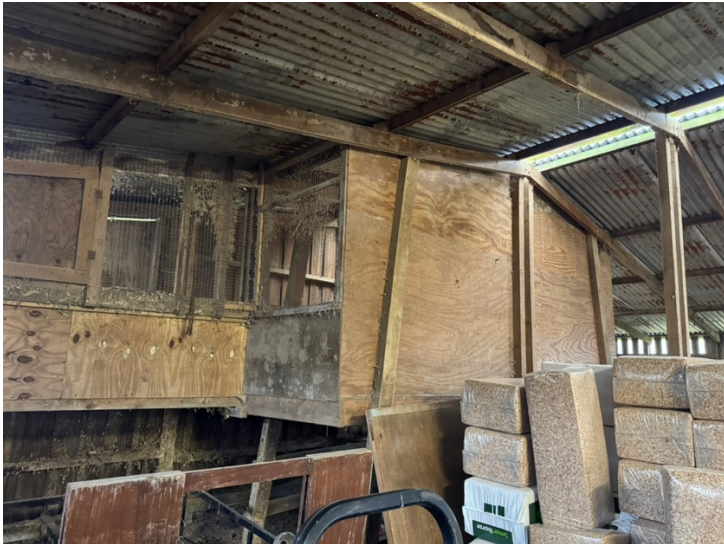
Photo 3: External view of chicken house showing chicken wire

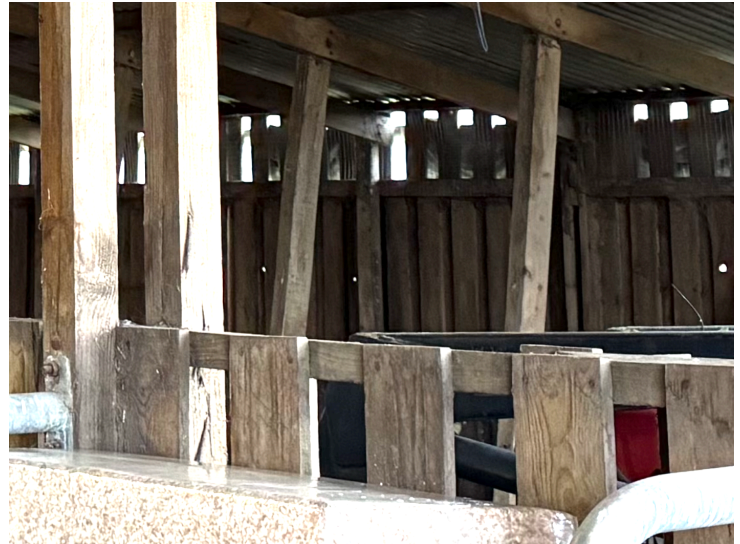
The remainder of the building is as described in the report, with walls constructed of a single skin of vertical timber slats that were slightly overlapped. No suitable crevices were recorded which would provide suitable roosting features. Additional photos taken on the 9<sup>th</sup> March are provided in Appendix 1.

Photo 4: Building B1 interior wall

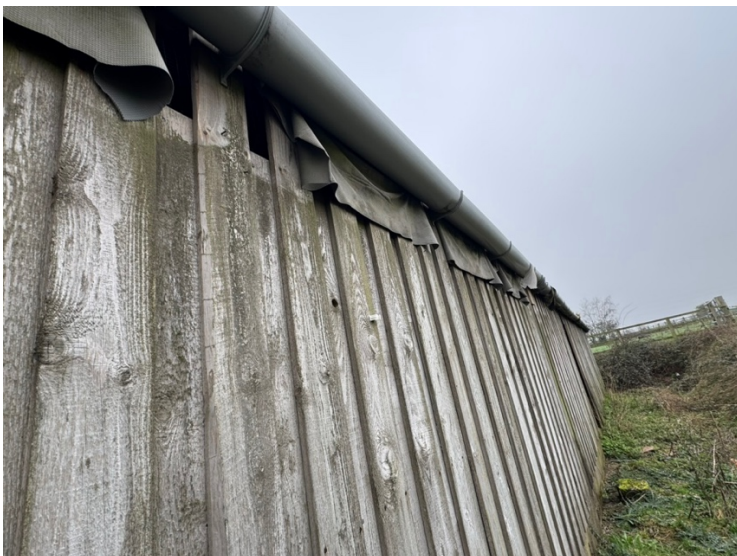
Photo 5: B1 exterior, showing same wall as Photo 4.
