**Arboricultural Impact Assessment:  
Hammonds Way, Hinckley, LE10 3EJ**

Document reference: 1021-AIA/25, Revision 0

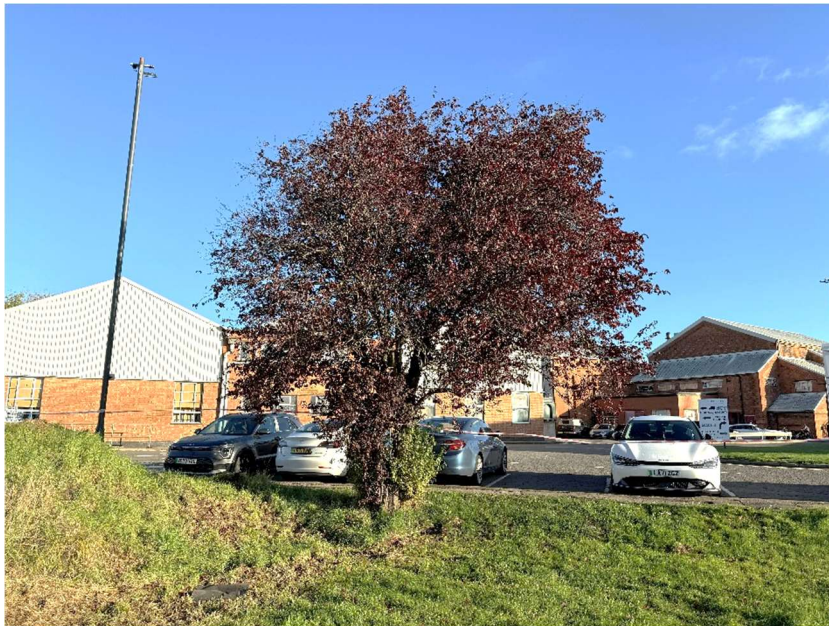
Photograph 1: Showing tree 1, the purple leafed plum, growing to the internal site boundary of the former sports pitch.

- 3.3 Trees 1 and 3 are only of mediocre value but are retained within dedicated landscape zones where locally they will add to the age diversity and structure of the new landscaping that will be invested around them, ensuring the long term continuity of tree cover.

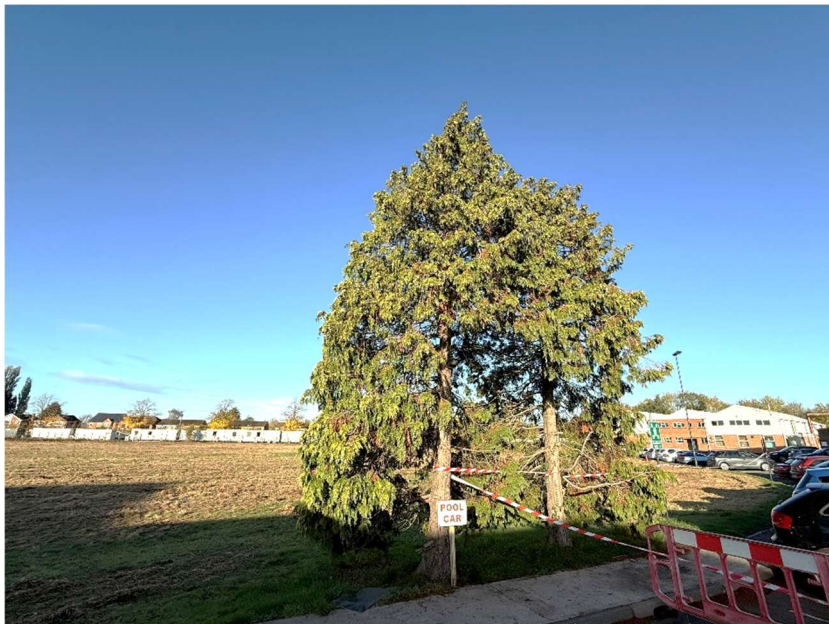
Photograph 2: Showing group G2 consisting of two Lawson cypress. The trees are of only mediocre arboricultural value with some conflict evident of the internal footway surface which was cracked due to the action of surface roots.

| Tree/<br>Group<br>number | Common name<br><i>Botanical name</i> | Tree<br>height<br>(m) | Stem<br>diameter<br>(mm) | Branch<br>spread<br>(m) | Height above ground<br>level (m) of: | | Life<br>stage | General observations, including preliminary management<br>recommendations | | | RC<br>(years) | Category |
|---|---|---|---|---|---|---|---|---|---|---|---|---|
| G2 | 2no Lawson<br>cypress<br><i>Chamaecyparis<br/>lawsoniana</i> | 7 | 270<br>Northern<br>tree<br>260<br>Southern<br>tree | Up to 2.5<br>in all<br>directions | 1 | 0.3–2.5 | SM | B/C | B | Trees planted adjacent to section of<br>footway that is surfaced in cast-in-situ<br>concrete that has become cracked<br>opposite the southernmost tree in the<br>group.<br><br>Trees grow at an offset of 0.3m to the<br>rear of the footway.<br><br>The southernmost tree has an<br>electricity feed and a downlighter<br>attached to the trunk at 2.6m, likely<br>defunct.<br><br>Both trees show slightly reduced<br>vigour with less than optimum foliage<br>density.<br><br><b>Monitor displacement of footway,<br/>which will be ongoing. Monitor<br/>vigour.</b> | 20–40 | (C) (2) |

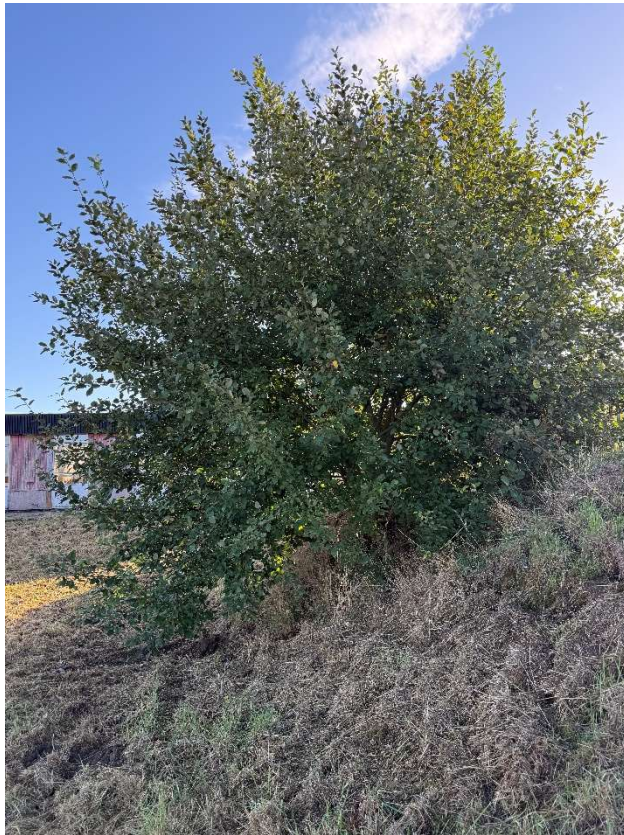
Photograph 3: Showing tree 3 growing from the base of the existing bund.

- 3.8 It will be necessary to retain some of the bunded area where within the root protection area of retained goat willow tree 3. However, this appears appropriate given that the surrounding area will be subject to thicket mix plantation in any event. Otherwise, all retained trees fall within dedicated landscaping zones, meaning that post-construction they will have every opportunity to reach their full potential in terms of size , stature and longevity.

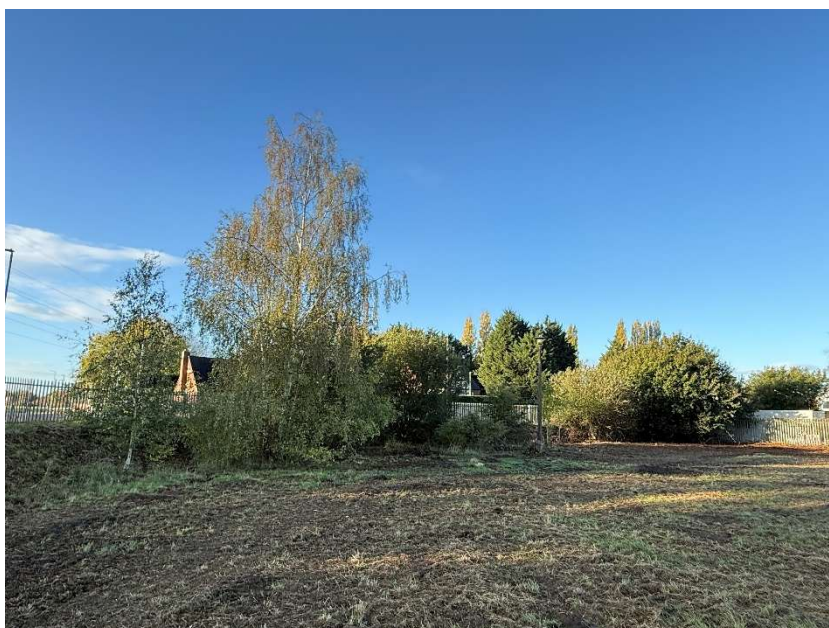
Photograph 4: Looking towards group G4, group G5, tree 6 and tree 7. Note the existing bund adjacent to the boundary on the left hand side of the image and the internal fencing segregating the open former playing field from the adjacent Eon compound.

| Tree/<br>Group<br>number | Common name<br><i>Botanical name</i> | Tree<br>height<br>(m) | Stem<br>diameter<br>(mm) | Branch<br>spread<br>(m) | Height above ground<br>level (m) of: | | Life<br>stage | General observations, including preliminary management<br>recommendations | | | RC<br>(years) | Category |
|---|---|---|---|---|---|---|---|---|---|---|---|---|
| G4 | Silver birch<br><i>Betula pendula</i> | Up to 10 | Up to 230 | Up to 4<br>2<br>(average) | 0.3 | 0 NW | Y/SM | B | B | Self-seeded trees dominated by single taller specimen.<br><br>Of average form but free from significant defect.<br><br><b>If group be retained, keep easternmost young tree and central largest stemmed specimen only such that they would have room for long term development.</b> | >40 | (C) (2+3) |

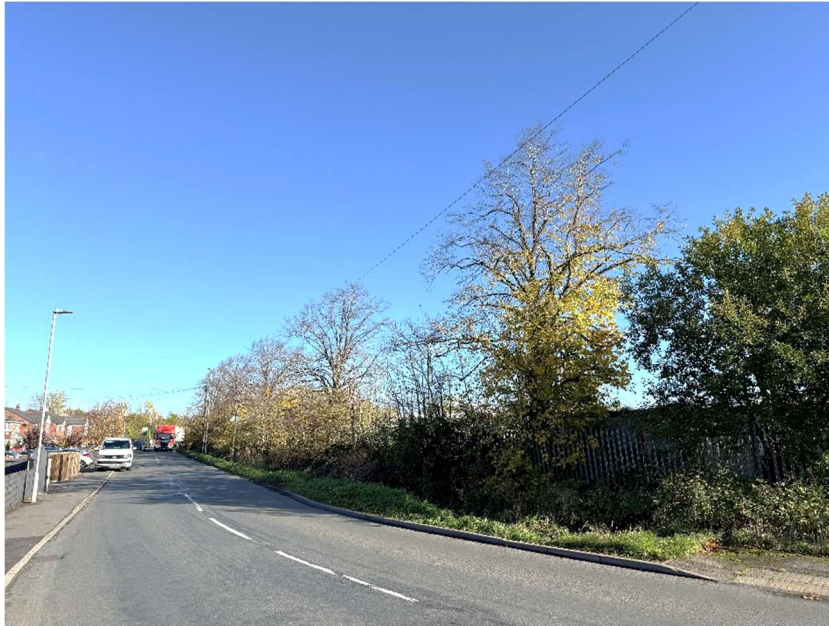
Photograph 5: View along the roadside frontage with mature lime trees 9 to 13 inclusive with hedge H15 on the road side.

- 3.4 The only significant tree to be removed is lime tree 9 that was provisionally assessed only and awarded a Category B retention value. This proposed removal is due to the car parking formation, and no arboricultural justification is provided.

- 3.5 Category A lime trees 10 to 13 inclusive are all retained within a dedicated landscape zone that fully encompasses their root protection areas. Noting that much of the root protection area on the eastern side is subject to existing hardstanding, storage containers etc then given that the wider landscaping zone will be remediated to remove any existing hardstanding and return to soft landscaped ground conditions, this is betterment in the long term.

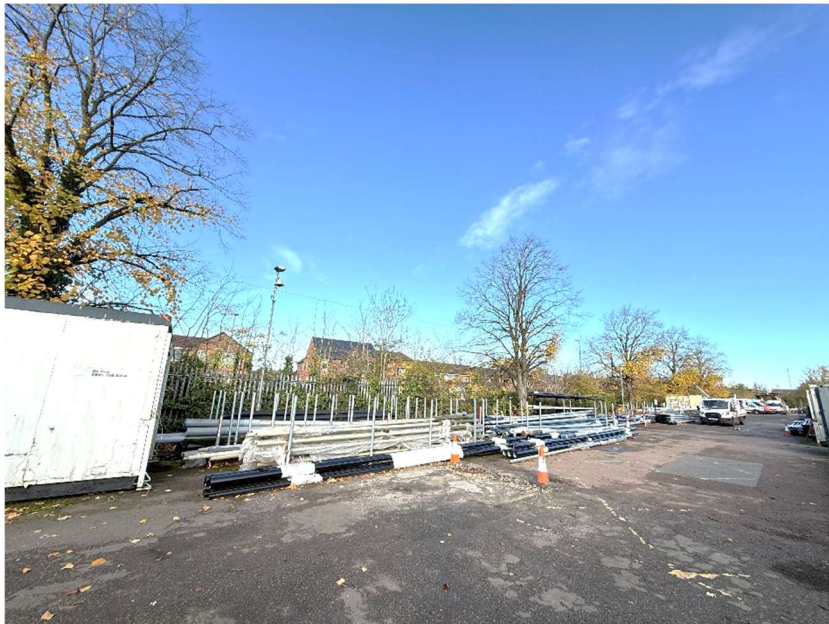
Photograph 6: Showing the same lime trees from within the compound, noting the existing hardstanding and storage in proximity.

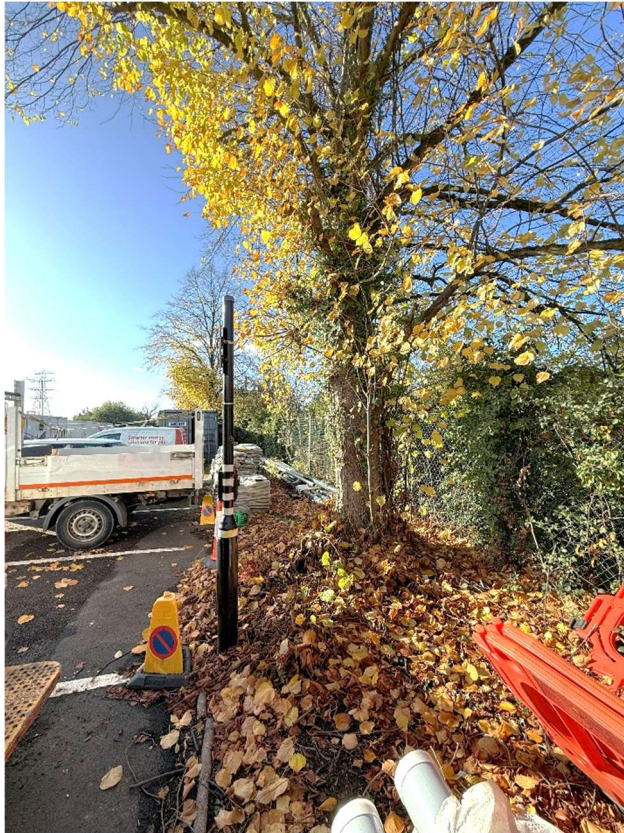
Photograph 7: Noting the narrow width soft verge in which the lime trees grow with existing parking within the root protection areas.

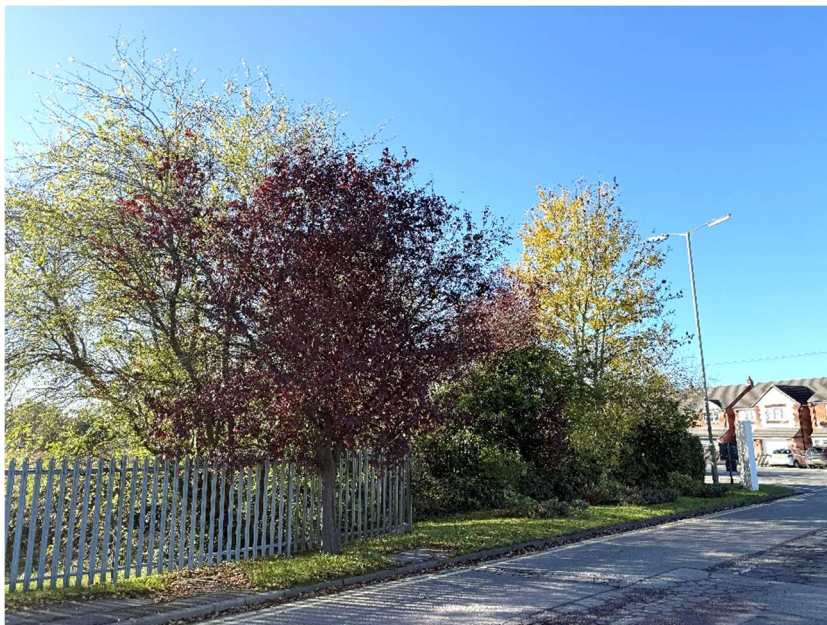
Photograph 8: Showing trees within group G16, trees 17 and 18 and group G19. Trees in group G19 grow from the base of the bund.

| Tree/<br>Group<br>number | Common name<br><i>Botanical name</i> | Tree<br>height<br>(m) | Stem<br>diameter<br>(mm) | Branch<br>spread<br>(m) | Height above ground<br>level (m) of: | | Life<br>stage | General observations, including preliminary management<br>recommendations | | | RC<br>(years) | Category |
|---|---|---|---|---|---|---|---|---|---|---|---|---|
| 18 | Damson<br><i>Prunus domestica</i> | 6.5 | 170 (mean)<br>X 6 | Up to 5 in<br>all<br>directions | N/A | 0 | M | B/C | C | Multi-stemmed plum. Partially clad in ivy limiting access and views for inspection. Minor defects upon old stems. Suspected weak main forks. Some minor previous wind damage.<br><b>Suitable for short to medium term retention only.</b> | 10–20 | C (2+3) |
