Precautionary Method of Working Strategy  
Barns at 102 Main Street  
Nailstone  
Nuneaton  
Leicestershire  
NGR SK41525 07053

| | Report prepared by:<br><b>C Barker ACIEEM CEnv</b> | Date Issued: 16 June 2025 |
| | Report ref:<br><b>P3019 /0625 /01</b> | C B E Consulting<br>Highbank, 5 Grantham Road, Navenby<br>Lincoln. LN5 0JJ.<br>Telephone (01522) 810086.<br><a href="http://www.cbeconsulting.co.uk">www.cbeconsulting.co.uk</a> |

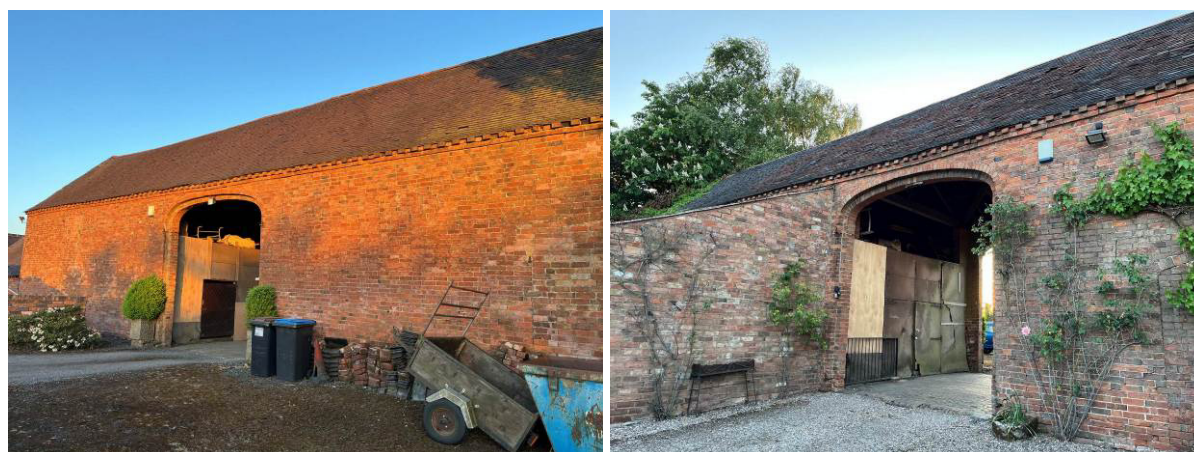
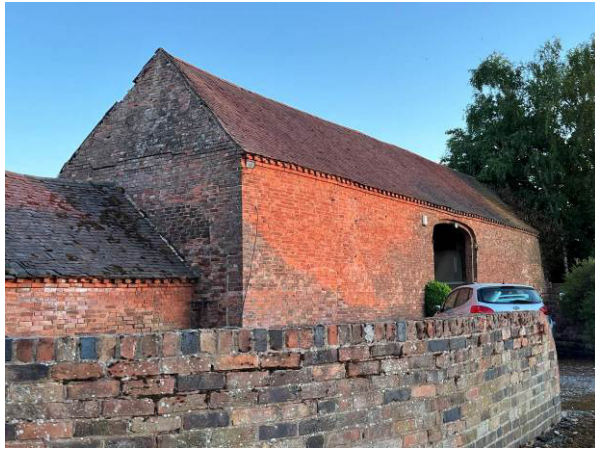
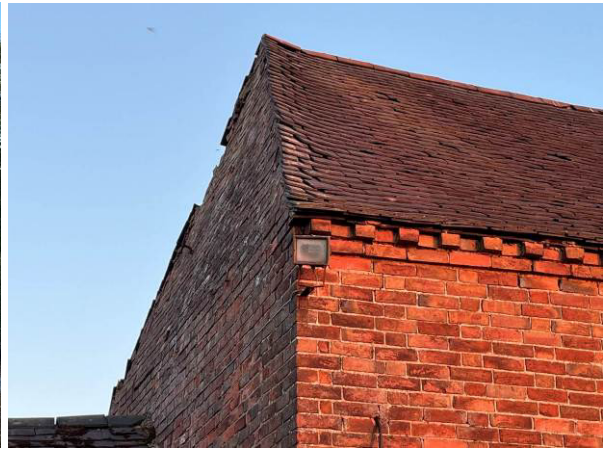
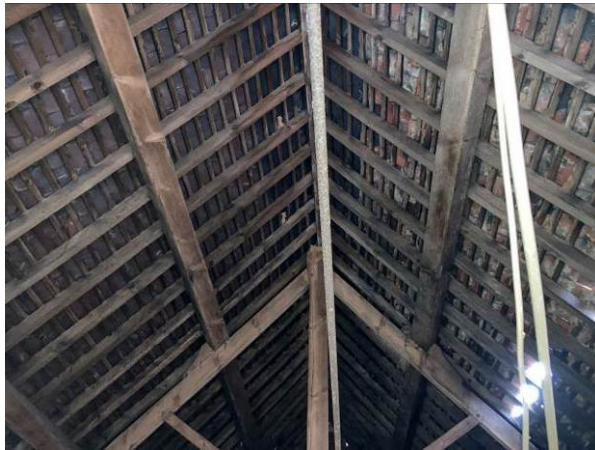
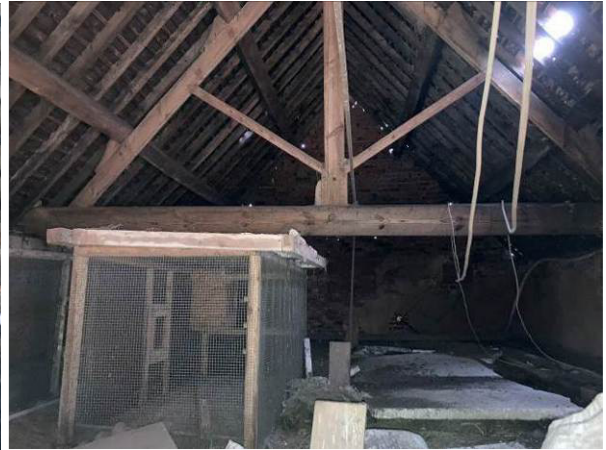
The building re-inspected is a large two-storey barn divided into two sections with an arched entrance leading between the courtyard and driveway. The red brick structure is showing significant signs of structural failure with the roof structure leaning noticeably to the west as was the case when it was previously inspected in 2023. The brickwork to the walls is still in reasonable condition but some cracks are present on the exterior and these were re-inspected where possible. The pitched red tile roof is not lined underneath and the roof space is open and accessible via the entranceway in the centre of the building. Timber roof beams in good condition but starting to lean precariously and this impeded access to insect certain sections of the roof. The ground floor storage areas were also reinspected.

The inspection, completed using torches, ladders and an endoscope where necessary was completed looking for any evidence of bat activity or nesting bird activity. ***No field signs such as droppings, urine spatter or feeding debris to indicate the presence of bats was found*** externally or internally within the building. However, since there are some external features present which could not be fully investigated due to height, and a full inspection of the internal loft structure was deemed unsafe, a precautionary dusk emergence survey was completed in compliance with the 2023 Bat Survey Guidelines.

During the reinspect, ***two Swallow nests were identified within the roof structure*** of the overhanging arched entrance.

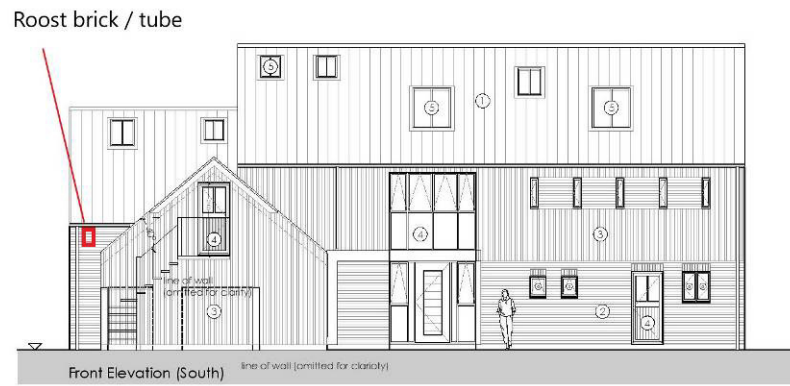
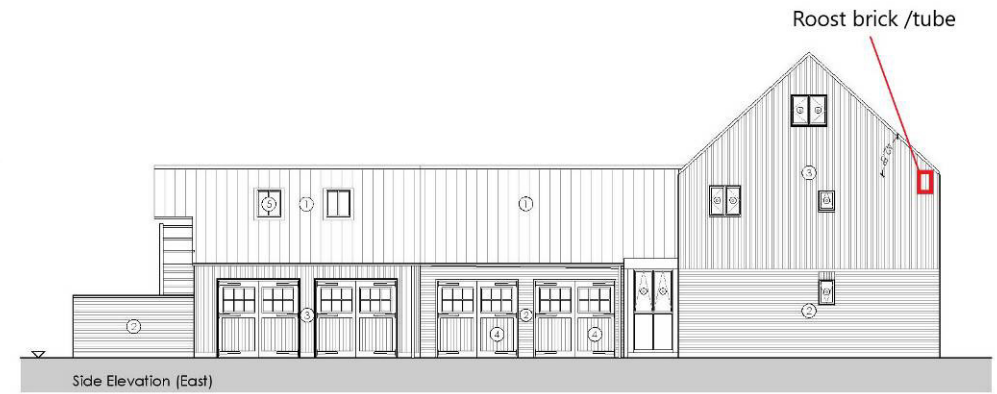
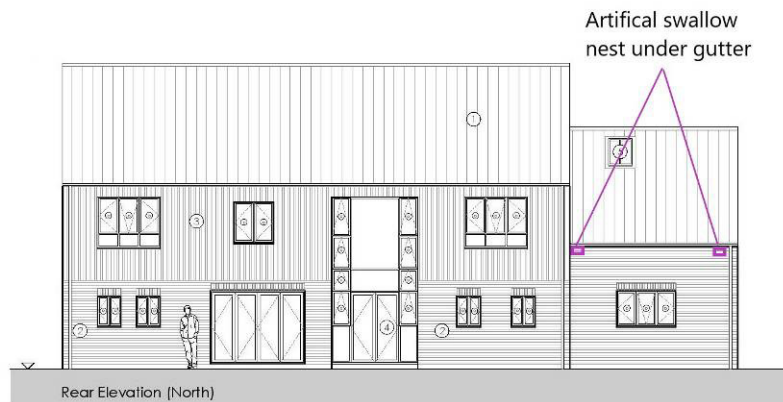
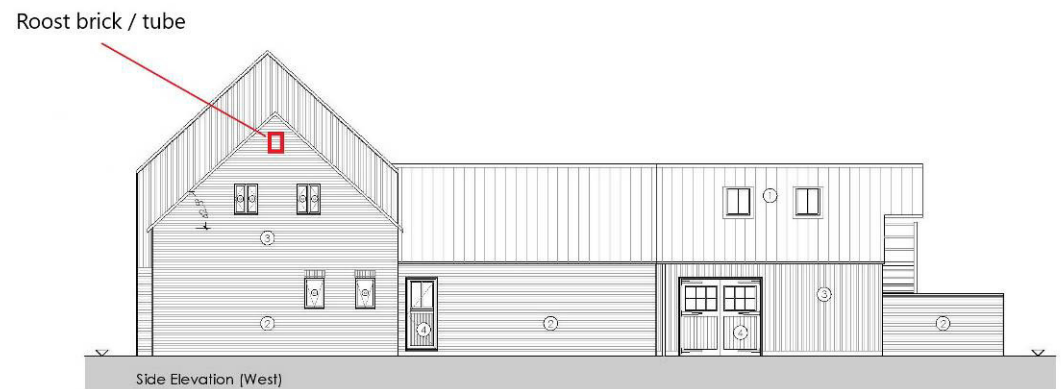
**Figure 3: Artificial Roost and nest locations**

These will be positioned where indicated in the plan below at a minimum of 4magl just under the roof line. One will be placed on the west elevation, one of the south elevation and one on the east elevation in the locations shown. Roost bricks / tubes will be constructed integral to the walls. Bat bricks come in a range of styles to suit whichever type of stone / brick is present on the building to enable these to blend in as permanent features within the structure of the building. If a rendered exterior surface is proposed it is more common to use bat tubes with a rendered finish.

In addition to the three artificial roosts, it is proposed that two artificial swallow nests are positioned under the roof edge gutter on the northern face of the building.

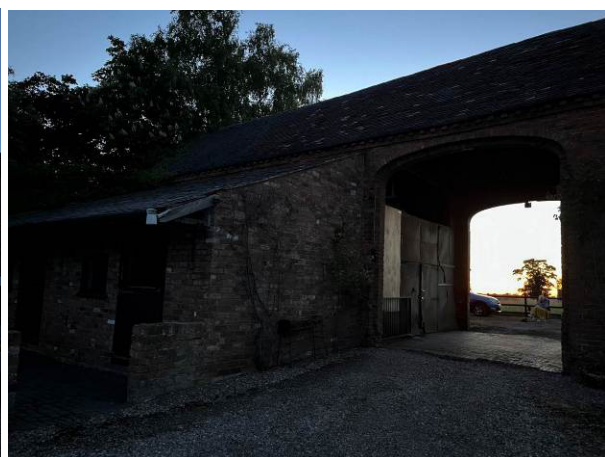
Surveyor position 1

| Date of Survey | Survey Time | Temperature and weather | | Comments | |
|---|---|---|---|---|--|
| <b>Surveyor S1</b> – positioned to the south side of the archway. Picked up Noctule from 20.59. The first bat pass seen was a Common Pipistrelle at 21.48 flying from the west into the courtyard and then through the archway heading north. Only individual flight by Pipistrelle bats were noted. The first Soprano Pipistrelle did not arrive on site until 21.54 in this location. | | | | | |

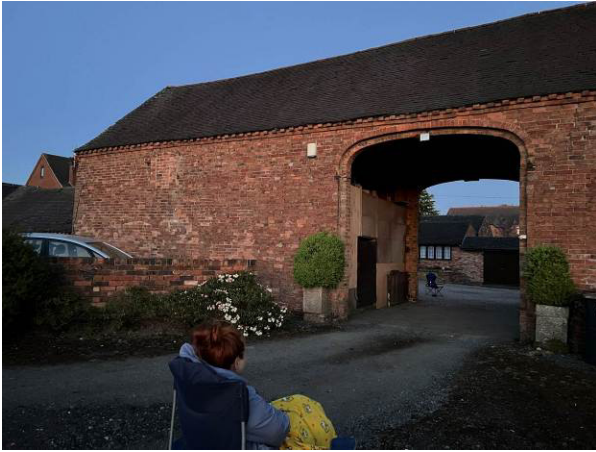
Surveyor position 2

| Date of Survey | Survey Time | Temperature and weather | | Comments | |
|---|---|---|---|---|--|
| <b>Surveyor S2</b> – positioned to the north side of the archway. Picked up Noctule from 20.58. The first bat pass seen was a Common Pipistrelle at 21.39 flying from the west past the building heading east. Only individual flights by Pipistrelle bats were noted in this position but bats regularly passed through the archway. No Soprano Pipistrelles were recorded in this position. | | | | | |

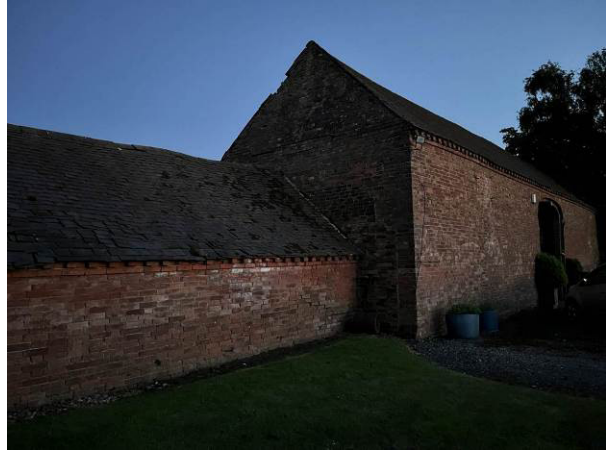
Surveyor position 3

| Date of Survey | Survey Time | Temperature and weather | | Comments | |
|---|---|---|---|---|--|
| <b>Surveyor S3</b> – Positioned to watch the damaged east gable. Noctule and Leislars passes were picked up early in the survey at 20.59 and 21.08. The first bat pass close to the building under observation was a Common Pipistrelle at 21.39 flying from the south coming over the roof of the stable building from the courtyard. The first Soprano Pipistrelle arrived at 21.54 coming from the west past the building. | | | | | |
