## Land Adjacent to Forest Hill Golf Club, Bagworth and Thornton

### BS5837:2012 Tree Survey

**November 2024**

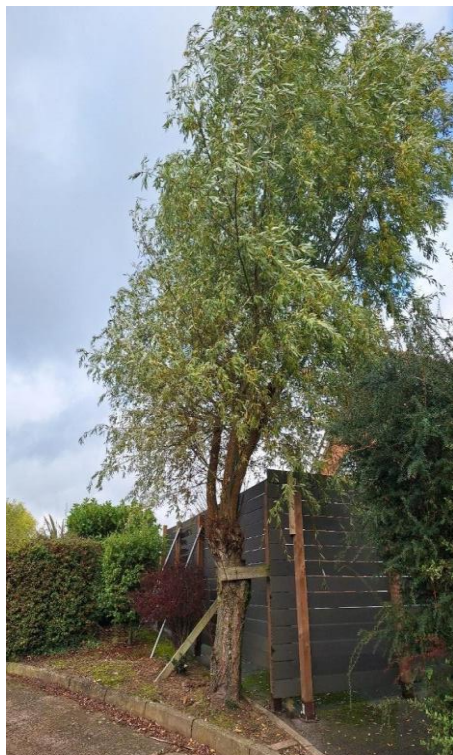
**Plate 1: T1.**

| Tree No. | Species | Tree Category (U/A/B/C) | Life Stage (Y/SM/EM/M/OM) | Condition (Good/Fair/Poor/Dead) | Number of Stems | Height (m) | Branch Spread (m) | | | | Lowest Significant First Branch (m) | Stem at Breast Height (mm) | Remaining Contribution (years*) | Root Protection Area (m <sup>2</sup> ) | Root Protection Radius (m) | Observations |
|---|---|---|---|---|---|---|---|---|---|---|---|---|---|---|---|---|
| T1 | Crack willow ( <i>Salix Fragilis</i> ) | B2 | SM | Good | 1 | 10 | 3 | 3 | 3 | 3 | 2.5S | 400 | 20+ | 72 | 4.8 | Previous pollarding works apparent. Reduced crown. |

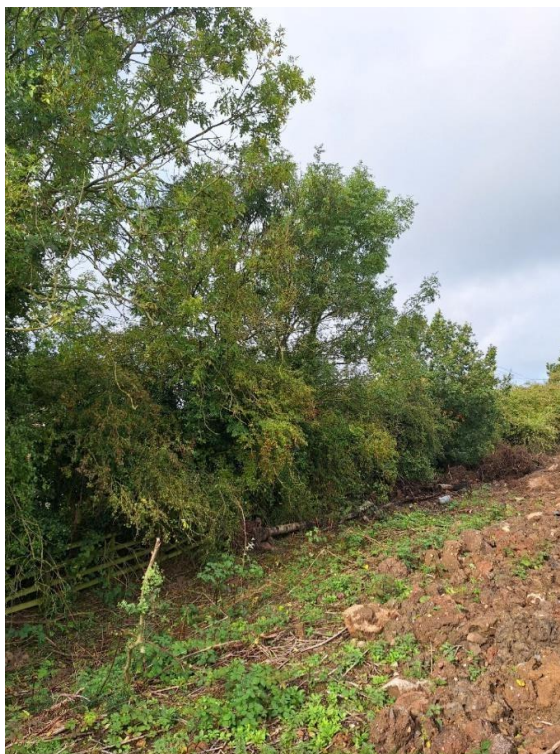
**Plate 5: G3** at the southern aspect of the site.

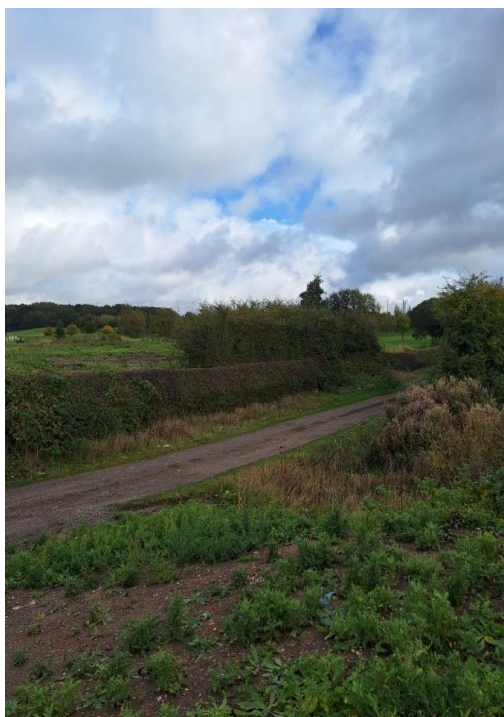
**Plate 8: H1.**

| <b>H1</b> | Common hawthorn ( <i>Crataegus monogyna</i> ) | - | SM | Good | - | RANGE 1.5-2.5 | 2 | 2 | 2 | 2 | - | 80 | - | - | - | Internal hedgerow.<br>2M buffer zone recommended |

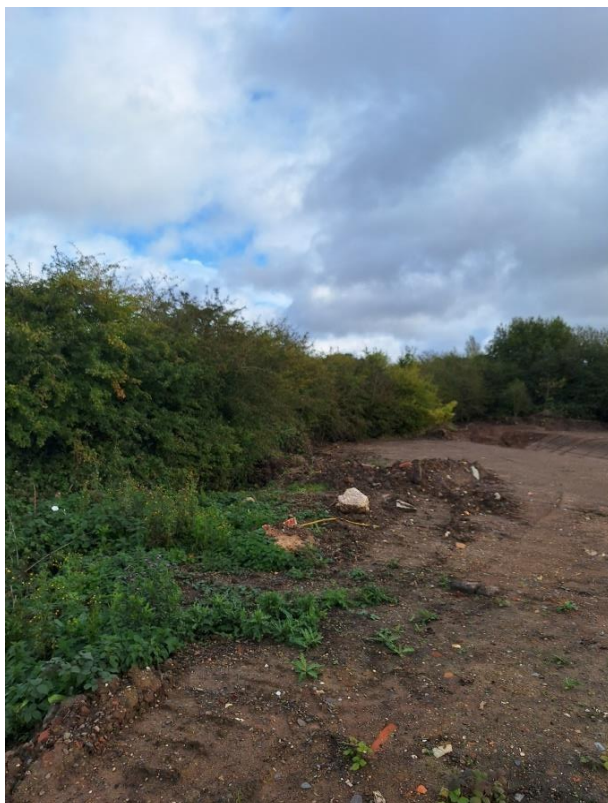
**Plate 9: H2.**

| <b>H2</b> | Common hawthorn<br>( <i>Crataegus monogyna</i> ) | - | SM | Good | - | RANGE<br>1.5-4 | 2 | 2 | 2 | 2 | - | 80 | - | - | - | Internal hedgerow.<br>2M buffer zone recommended |

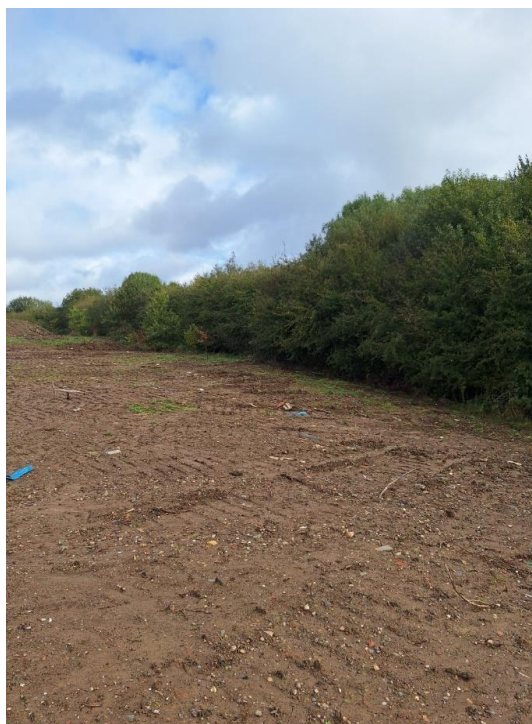
**Plate 10: H3.**

| <b>H3</b> | Common hawthorn<br>( <i>Crataegus monogyna</i> ) | - | SM | Good | - | RANGE<br>3-4 | 2 | 2 | 2 | 2 | - | 80 | - | - | - | Northern periphery boundary<br>hedgerow with mixed species<br>woodland behind.<br>2M buffer zone recommended |
