## Preliminary Ecological Appraisal and Roost Assessment

Land at Hinckley Road Burbage, Leicestershire LE10 2AQ

11<sup>th</sup> November 2025

The demolition of six existing buildings and the construction of six new residential dwellings in their place.

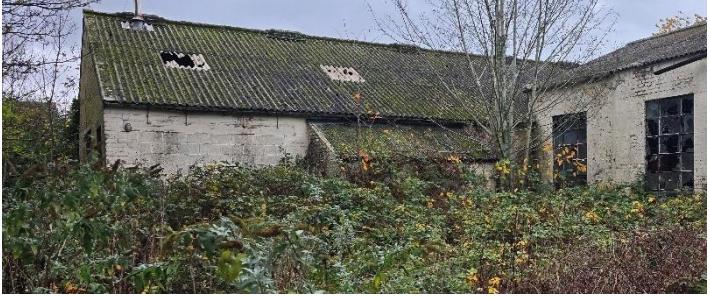
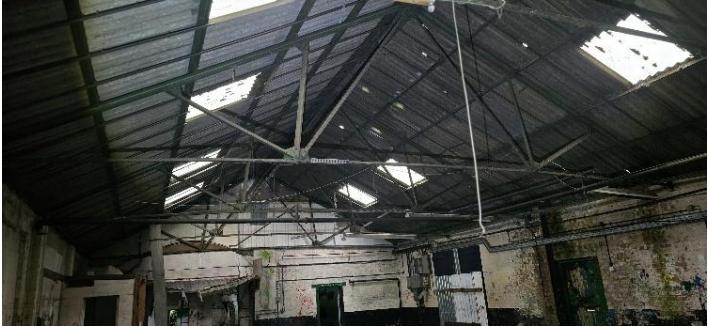
Roof	<p>The roof is comprised of asbestos sheet panels and multiple UPVC skylights, supported by a metal frame. The asbestos sheeting is in poor condition, with numerous visible gaps identified during the visual inspection. The UPVC skylights are also in poor condition, with many units broken or damaged. The overall roosting suitability is negligible. This is due to the high levels of light penetration, the absence of suitable crevices, and the metal framing.</p>

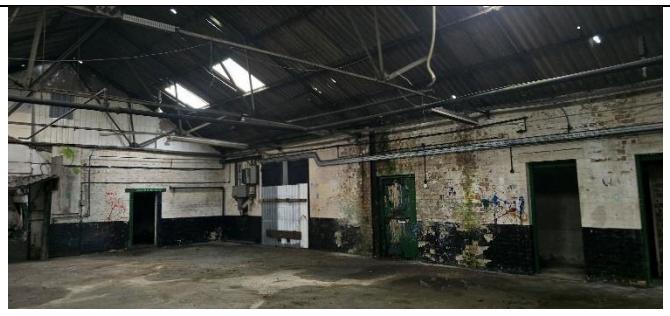
Walls	<p>The walls of B1 are brick built and although weathered, are in good condition. There are signs of frequent human disturbance due to graffiti and personal items found internally. This internal area is unsuitable for bats and therefore deemed negligible.</p>

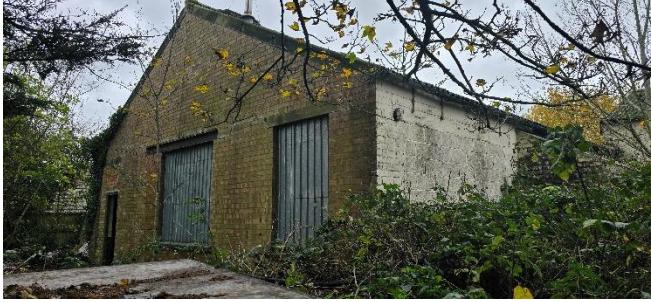
Doors	The existing metal doors on the barn sections are in good condition. They are tightly fitted within their frames and lack damage, ensuring minimal or non-existent gaps along the perimeters. As such, the doors do not provide suitable access vectors for crevice dwelling bats to enter the internal spaces, nor do they offer the secure, narrow fissures required for external crevice roosting. Therefore, the door fixtures are deemed negligible features in the overall roosting potential assessment.

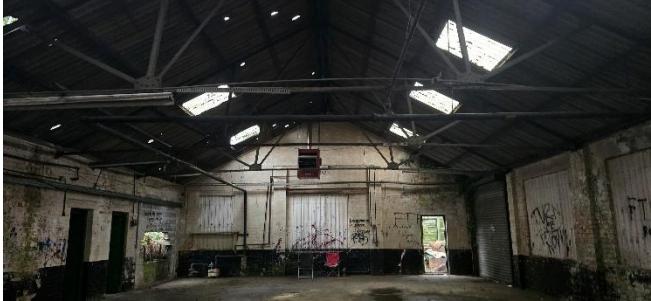
Internal	The internal cavity of B1 is structurally constrained by its predominant metal construction, which severely limits roosting potential as it lacks exposed timber or suitable brick surfaces for bats to cling to or form maternity colonies. Although no direct evidence of bat activity (e.g., droppings) was observed, the internal microclimate is compromised by significant light ingress through holes in the asbestos sheeting, and the construction results in unstable temperature and humidity fluctuations, rendering B1 itself unsuitable for a stable, long-term bat roost. B1 is connected to B2 and B3 internally, which also provides negligible bat roosting habitat.

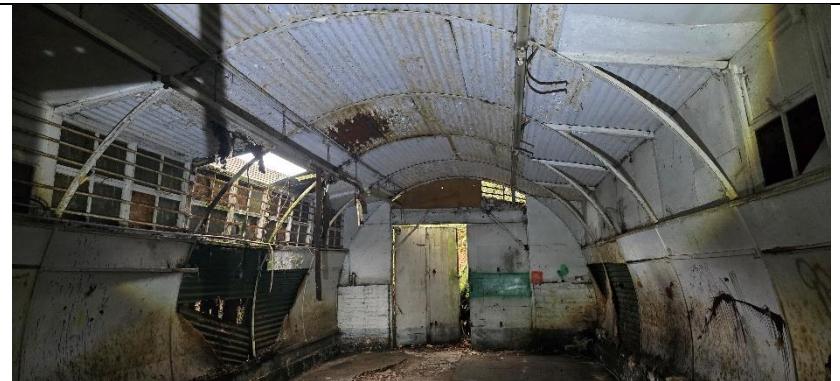
A domed building with internal only access, comprising a brick base and metal frame with a metal roof. The interior shows extensive damage. An external view of B2 was restricted by bramble.

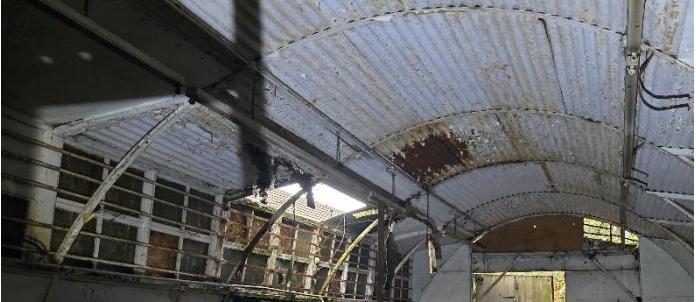
Structure	Suitability	Photo
Roof	The roof of B2 consists of corrugated metal in a dome shape, with a metal frame. The roof is in poor condition due to rust and damage, allowing daylight to spill into the internal area. Therefore, the roof fabric of B2 is considered to provide no habitat value for crevice dwelling bat species, or internal access for void dwelling species.

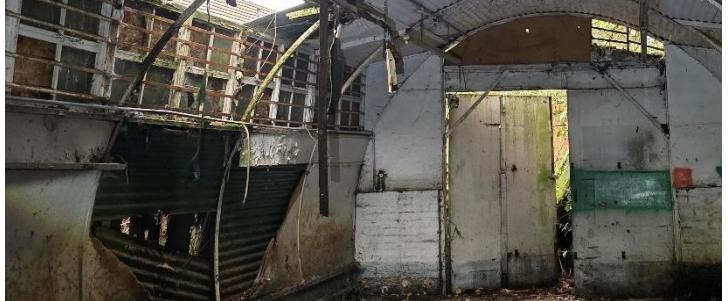
Walls	The walls of B2 consist of brick foundations with corrugated metal covered with a woodchip board. The brickwork appears to be in good condition; however, the corrugated metal is in poor condition. Therefore, there is no suitable habitat for crevice-dwelling bat species in the walls of B2.

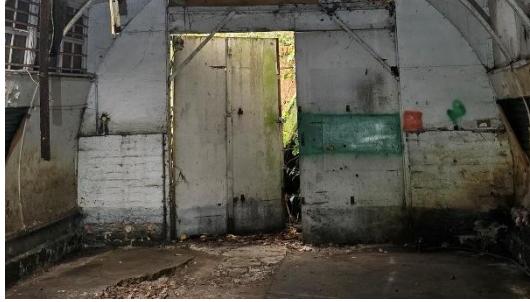
Doors	The door of B2 is made of timber and is in poor condition. The area above the door is also severely damaged. As such, the doors do not provide suitable access vectors for crevice dwelling bats to enter the internal spaces, nor do they offer the secure, narrow fissures required for external crevice roosting. Therefore, the door fixtures are deemed negligible features in the overall roosting potential assessment.

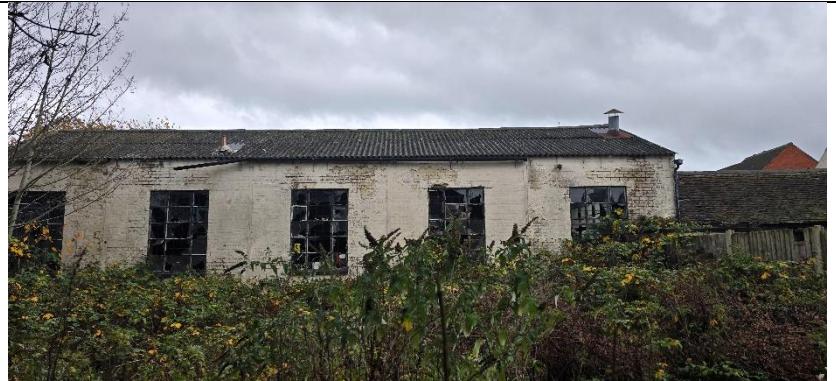
A brick built structure with an asbestos roof and two metal extraction fans. The windows are timber framed with metal security grids; several panes are broken. The building is attached to B1, but access is external only and restricted by dense brambles. There is one UPVC skylight. Ridge tiles are lifted, and external brickwork is weathered but not structurally compromised. A wooden garage door is in poor condition. The interior has been recently swept, so bat droppings would not be visible if present. B3 is connected to B1, B4 and B6a and B6b.

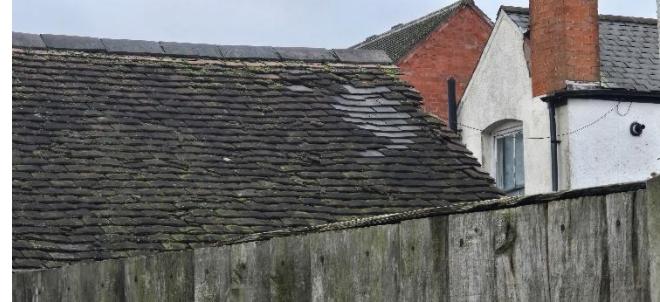
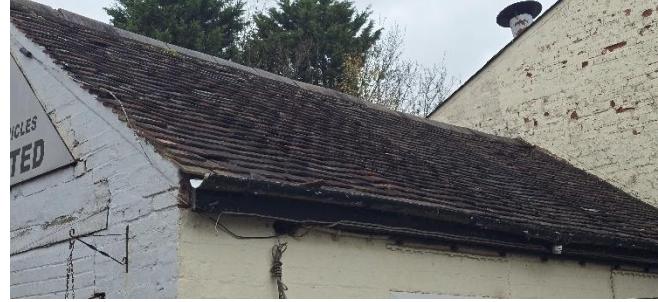
<b>Structure</b>	<b>Suitability</b>	<b>Photo</b>
Roof	The roof of B4 is made of clay tiles, there are a few loose and missing tiles on this roof which allows access for crevice dwelling bats. The soffit is timber and is in good condition.

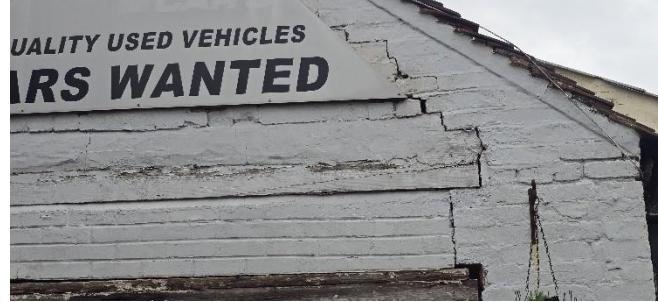
Walls	The walls of B4 are brick built. There is a significant amount of missing mortar allowing habitat for crevice dwelling bats.

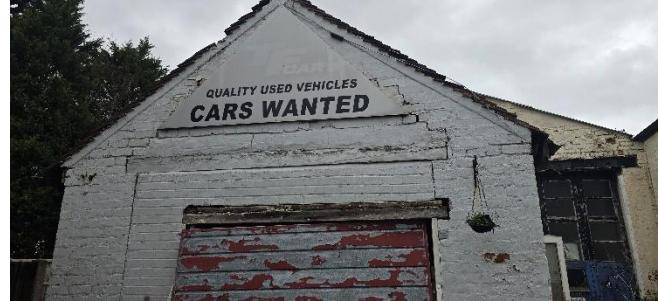
Doors	The doors of B4 are a garage door made of metal with a timber frame, and a UPVC door. The garage door is in poor condition, with multiple gaps around the frame which allows access for crevice dwelling bats. The UPVC side door is in good condition.

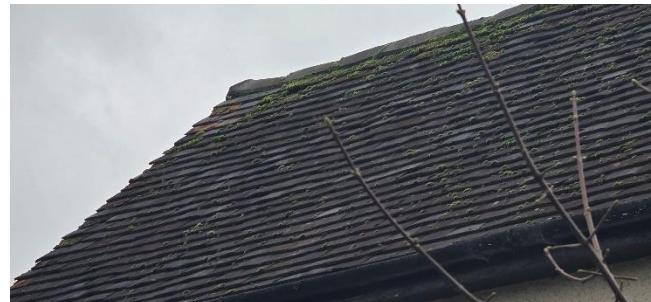
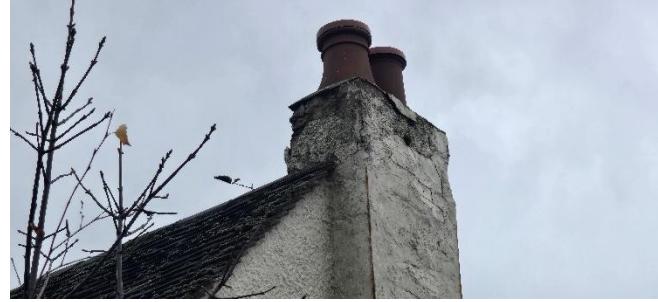
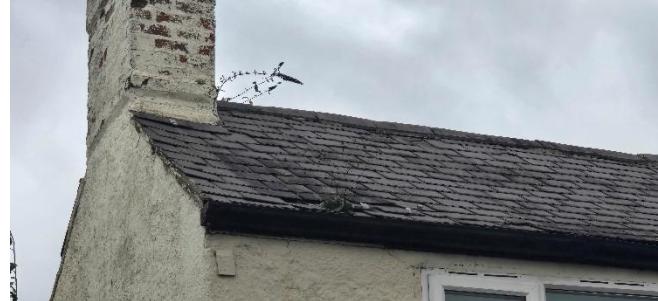
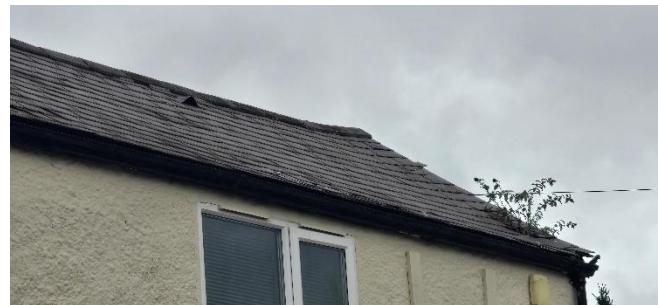
<b>Structure</b>	<b>Suitability</b>	<b>Photo</b>
Roof	<p>The main roof of B5 comprises two pitched sections: one with clay tiles and the other with slate. The clay tile roof is in moderate condition, with several missing tiles; however, approximately half of this roof slope is not visible from ground level and could not be fully assessed.</p> <p>The slate roof is in poor condition, with lifted and missing tiles providing access for both crevice dwelling and void dwelling bat species. A purposefully raised tile is present on this roof, offering additional potential access for crevice dwellers. The chimney is weathered but remains structurally sound. There is lead flashing</p>

<p>and some lifted clay tiles, with vegetation growing out of the chimney and the roof. The vegetation is Buddleia, also seen in the introduced scrub onsite.</p> <p>The slate roof on the southwest facing single storey extension is also in poor condition, with loose and missing tiles. The roof of a second southwest facing single storey element similarly displays lifted tiles.</p> <p>Given the extent of lifted and missing tiles across all roof sections, B5 provides multiple potential access points and suitable habitat for crevice dwelling and void dwelling bats. As a result, the roof is assessed as <b>high suitability</b> for roosting bats.</p>

<p>No recommendations.</p> <p><b>Roosting habitat</b></p> <p>Although B5 and B7 have high habitat value, the buildings are being retained; the lack of requirements for bat surveys are subject to exact plans being reviewed, as the above features must be retained post development to prevent further surveys. B1, B2, B3, B4, and B6 are being demolished. B1, B2 and B3 have negligible habitat value for bats, however B4 and B6 have <b>high</b> habitat value. Three bat emergence/re-entry surveys are required on B4, and B6 during the active bat season (May – September) to confirm presence/likely-absence of bats roosting in or on the building.</p> <p>These survey visits should be completed during the optimal survey period mid-May to August inclusive. The survey visits should be at least three weeks apart.</p> <p>Sub-optimal: early May and September. Would require greater justification of timing e.g., weather conditions, known local bat activity. One of the surveys could be a dawn re-entry survey, or all three can be at dusk if supported by night vision aids (NVA).</p> <p>5 surveyors are required to provide full coverage of the building's elevations to look for emerging/re-entering bats. An infrared camera should also be employed as part of the survey to see where any specific roost locations are located, further three internal IR cameras should be deployed. Lighting mitigation may be required based on the outcome of the night bat survey(s). If any bat roosts are confirmed from this survey schedule, a bat license would be required to demolish the buildings as it would involve the destruction of roosts. This is applied for with the help of a class 2 licensed bat ecologist after planning permission is granted, but before commencement of works.</p>

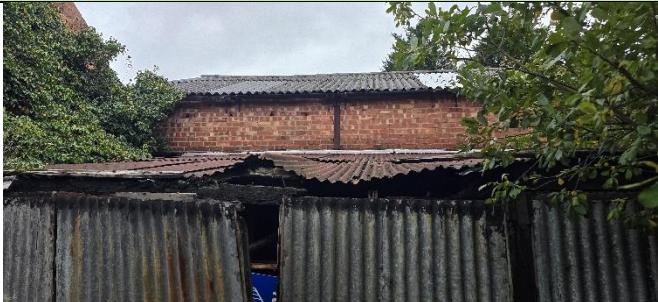
Walls	The walls of B6b are made of corrugated metal and are in poor condition leaving open access in the building.

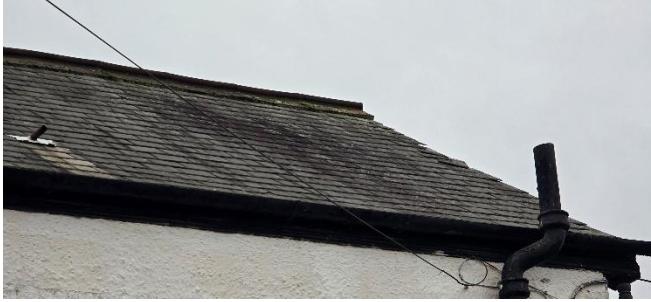
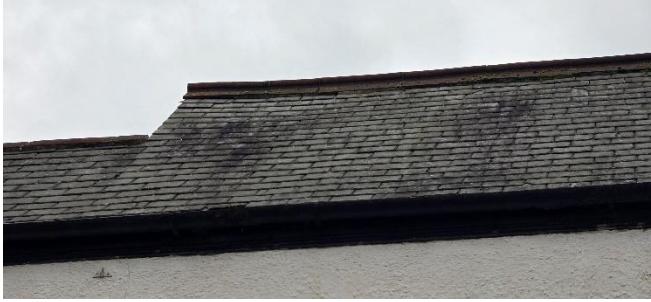
Roof	<p>The roof of B7a is in moderate condition with roof tiles on the southwest facing gable being loose, but the rest of the roof is in good condition. There are some gaps in the ridge tiles which will allow crevice dwelling bats habitat and potentially void dwelling bats access to the internal void. There are 2 chimneys in B7a, with lifted lead flashing allowing roosting habitat for crevice dwelling species.</p>

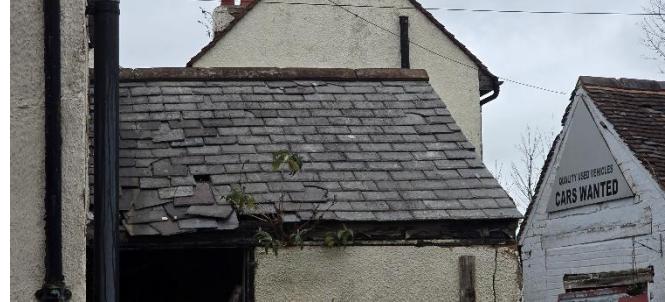
Internal	An internal inspection was not possible at the time of the survey.	
Structure	Suitability	Photo
Roof	The roof of B7c is a slate roof in poor condition, there are many loose and missing tiles allowing access underneath them. There is vegetation growing through the tiles too. Although this could allow access, the building is open, and the roof is not lined, meaning temperatures will fluctuate and the habitat is not as suitable.
