## Cold Comfort Farm, Rogues Lane Hinckley,

### Bat Mitigation Report July 2024

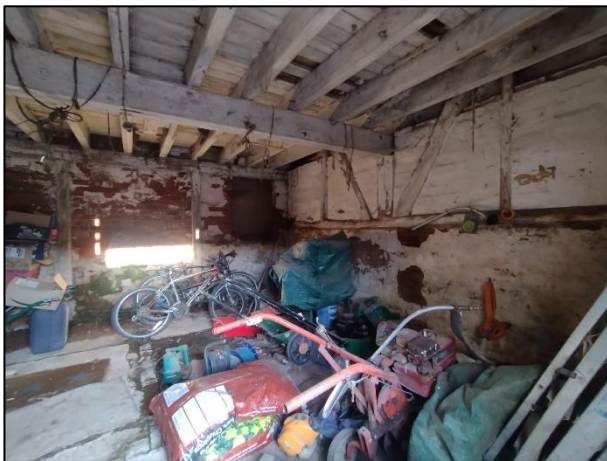
Photograph 3: Room of the lower level used for storage

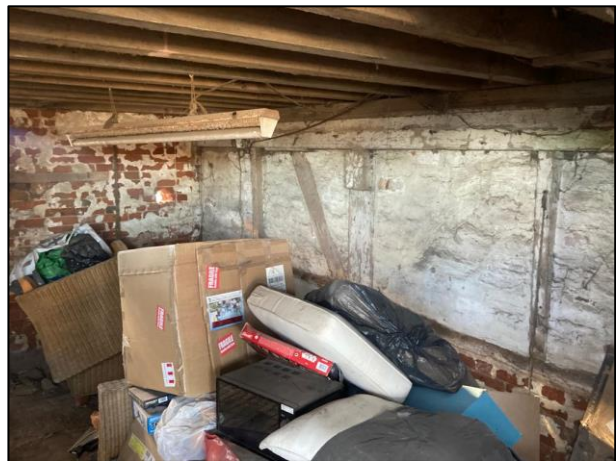
Photograph 4: Room of the lower level used for storage

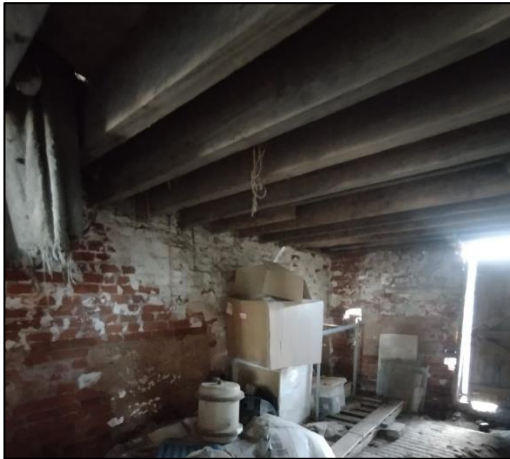
All sections of the lower floor spaces were inspected, several possible roost features were identified. Despite this, large quantities of cobwebs were observed in all areas of the lower level (**Photograph 5 & 6**) and the features were considered unsuitable for use by roosting bats due to the environmental conditions and level of disturbance within the lower level of the building.

**Photograph 5:** Representative image of the ceiling structure of the barns lower level.

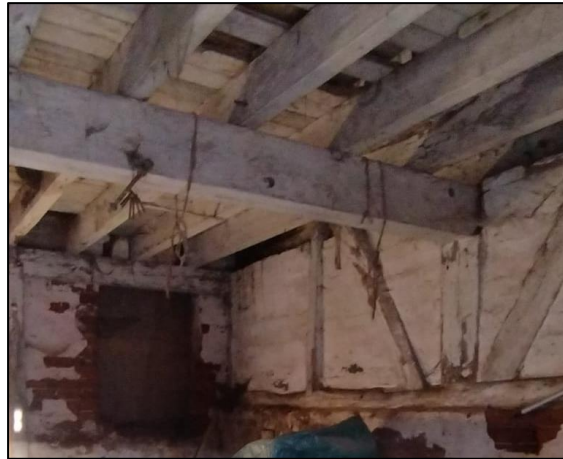
**Photograph 6:** Representative image of the cobwebbing of the ceiling structure in the barns lower level.

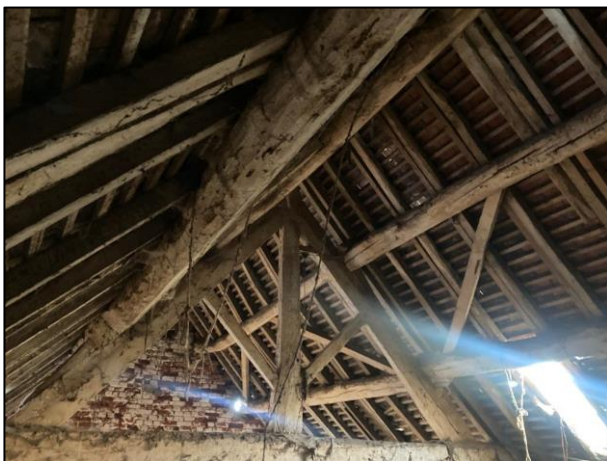
The upper level of the barn is also divided into three sections with the eastern and middle section sharing an open roof space (**Photograph 7**), the western most section of the upper level is partially isolated by a non-weight bearing partition wall with bitumen underfelt (**Photograph 8**). There are multiple open access points for bats into the building at both the upper and lower levels, these include open doorways, windows, missing masonry and missing roofing tiles.

Bats have free movement within the building, between all spaces within the upper level of the building, and access via open doorways, missing masonry, internal windows and over the non-weight bearing wall separating the western roof space. This generally led to the eastern section of the roof space being light and airy, with lower potential for roosting.

**Photograph 7:** Roof structure of the eastern and midsection of the upper floor of the barn.

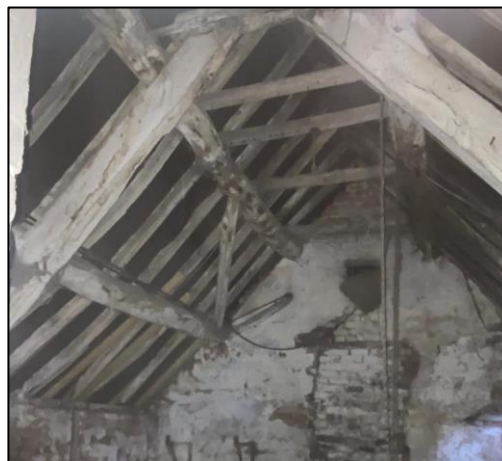
**Photograph 8:** Roof structure of the western section of the upper floor of the barn, with bitumen felt present.

However the roof structure of the western section of the barn was considered to provide good roost opportunity for roosting bats. The roof was lined with bitumen felt, open ridge board with very few cobwebs observed within the roof space, also conditions within this space were considered favourable to roosting bats with low light levels and subject to very infrequent human disturbance.
