Protected Species Survey  
Buildings at Main Street  
Nailstone  
Leicestershire  
NGR sk41525 07053

Report prepared by:  
Christopher Barker CEnv  
Ecologist and Licensed Bat Consultant

| | Report ref:<br><b>P2706 /0223 /01</b> | |

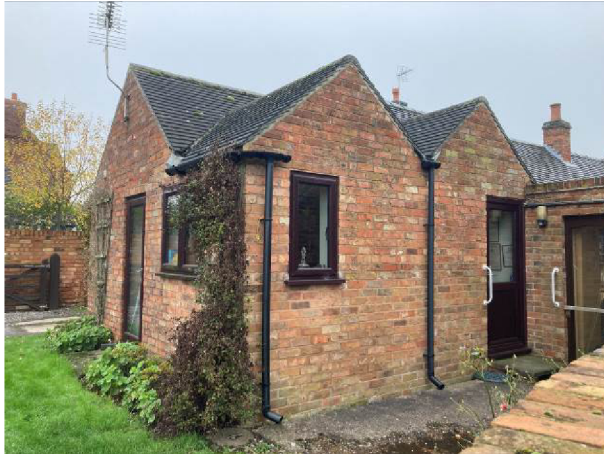
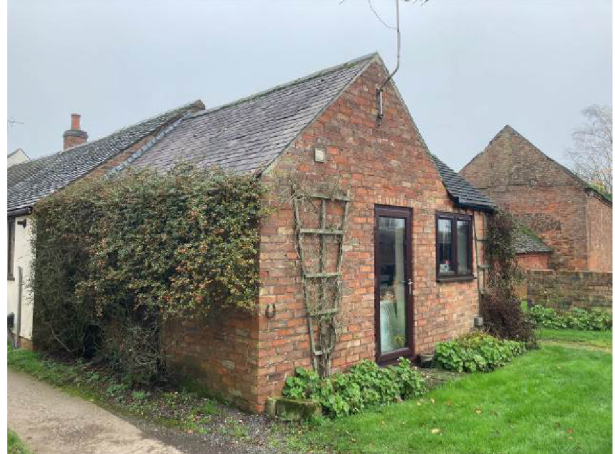
| Building | Description | Features present | Roost category |
|---|---|---|---|
| B1 | Bungalow extension. Red brick in excellent condition with a pitched rosemary tile roof on the west face and a slate roof on the east face. Roof in excellent condition with no gaps, holes or cavities noted. Roof edges appear effectively sealed. Underside of roof lined with bituminous felt. Enclose internal loft space accessible via loft hatch. Brown uPVC windows throughout tightly fitting. This building will be renovated and extended. | No obvious features identified on the exterior or within the interior roof space of potential interest to bats. No field signs of bats or evidence of nesting birds associated within this small structure. | Negligible |

Front (north and west side)

Rear ( north and east side)

1. **Building B1** is a small part of a larger bungalow. No evidence of bat or bird activity was found associated with this building and there are no structural features identified that would be of potential interest to bats. ***This building has negligible roost potential and no further surveys are required.***

During the works to B1, B5 and B6, the roof structures should be carefully lifted by hand to allow the underside to be inspected. If any evidence or indication of bats is found work should stop to allow further assessment to be carried out but a suitably licensed and qualified Ecologist.

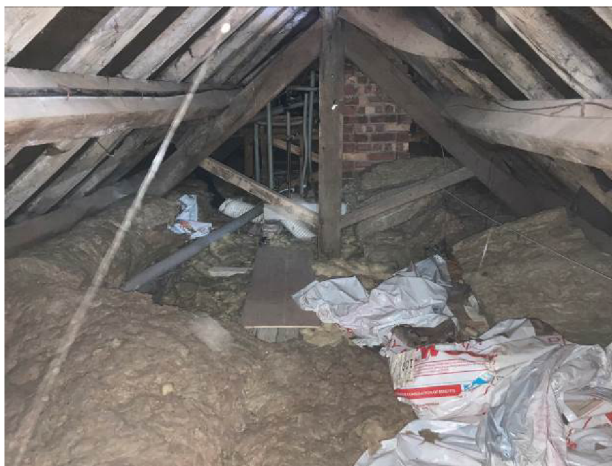
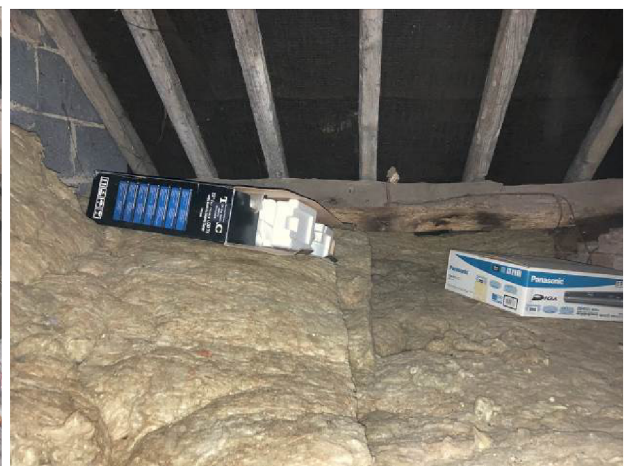
Bungalow loft interior

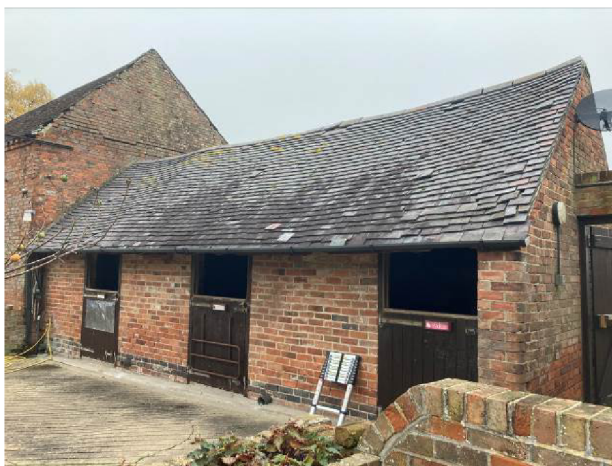
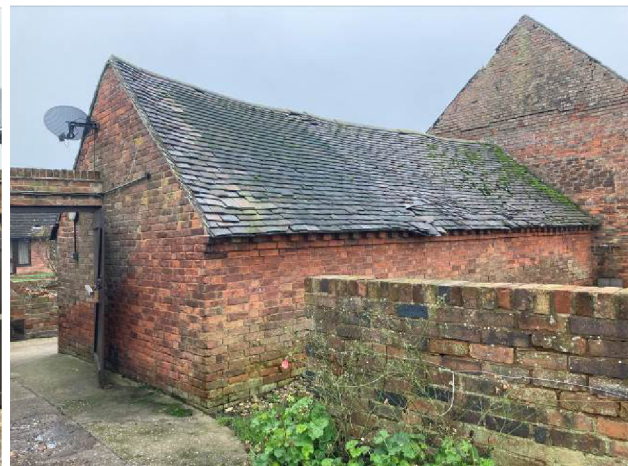
| Building | Description | Features present | Roost category |
|---|---|---|---|
| B2 | Single storey stable block. Red brick construction with the brickwork in good condition throughout. Pitched roof constructed from rosemary tiles in reasonable condition but with numerous small gaps. Timber doors with significant gaps at the top along the south face of the building and internally divided into three stalls, all linked within the open roof space. Underside of roof not enclosed and the majority of the roof is not lined. One section has clear plastic sheet lining through which the roof beams and tiles can be seen. Concrete floor throughout. This building will be demolished. | Numerous gaps noted on the roof exterior, some under the lifted ridge tiles but the roof is not lined. No other obvious features identified on the structure of potential interest to bats. No field signs of bats or evidence of nesting birds associated within this small structure. | Low |

Front (south face) of B2

Rear (north face) of B2

2. **Building B2** is a stable block attached to the eastern end of B3. This building will be demolished and whilst no physical evidence of bat or bird activity was identified, there are structural features present within the roof such as lifted tiles along the ridge and wall tops, which may be of potential interest to bats. Taking into consideration the location of this building it is assessed as having ***low roost potential***. To comply with the 2016 Bat Survey Guidelines it is recommended that ***this building should be the subject of a dusk or dawn activity survey carried out*** during the optimum survey season (May – August)

Buildings B2 and B4 have been recommended for a dusk or dawn activity survey to determine if any bats are using the structural features identified in these buildings. It is recognised that no physical evidence of any bat activity was identified during the inspection but a further survey is needed to fully comply with the Bat Survey Guidelines. Building B4 also has two swallow nests attached to the underside of the roof beams and it is likely that nesting activity will take place in the future. Any works to this building should therefore take place outside of the nesting season to avoid any disturbance to nesting birds. Alternatively the structure should be inspected by a suitable qualified and experienced ecologist to confirm no nesting activity is taking place prior to works starting to remove the existing roof.

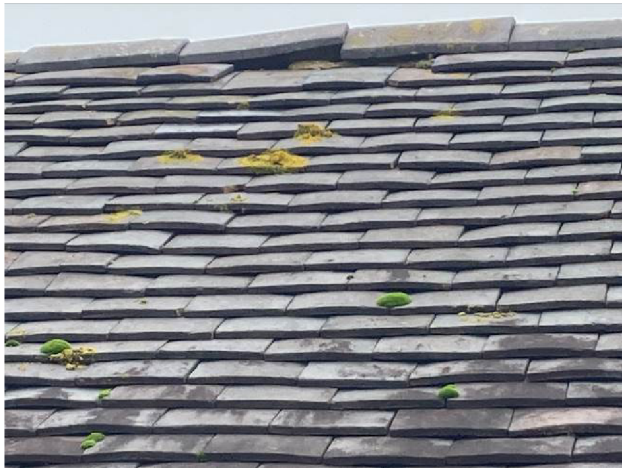
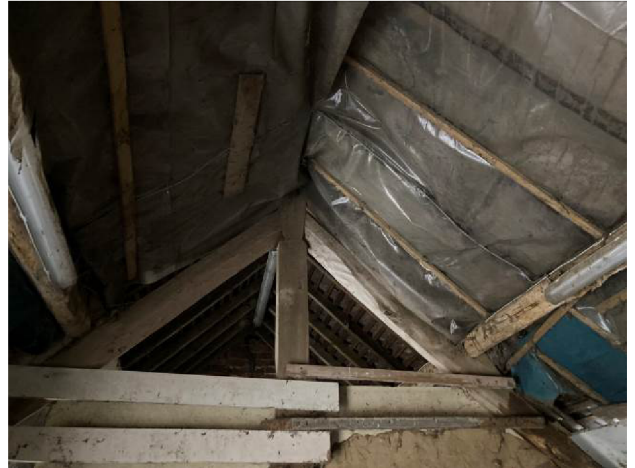
Close up of tiled roof B2

Open underside of roof B2

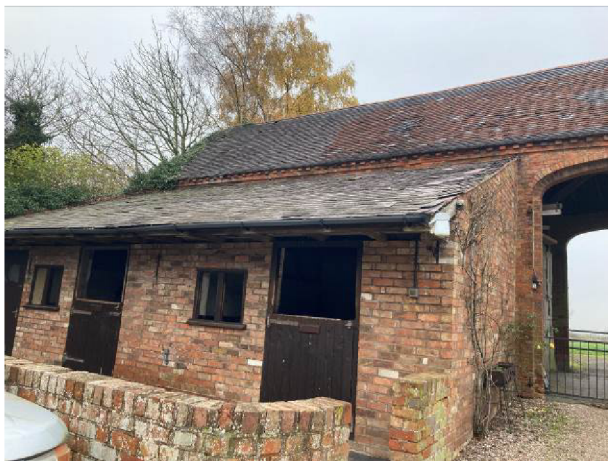
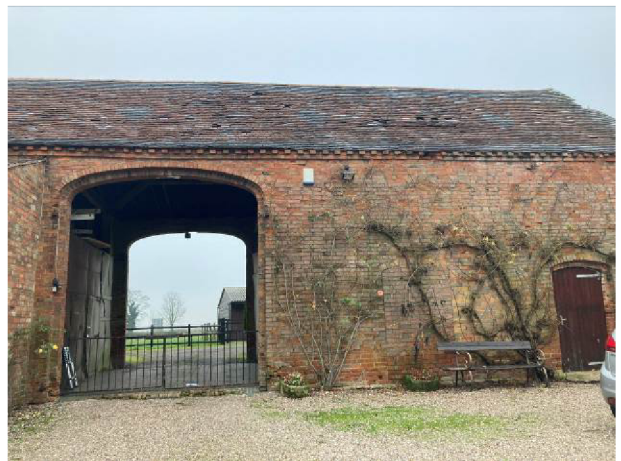
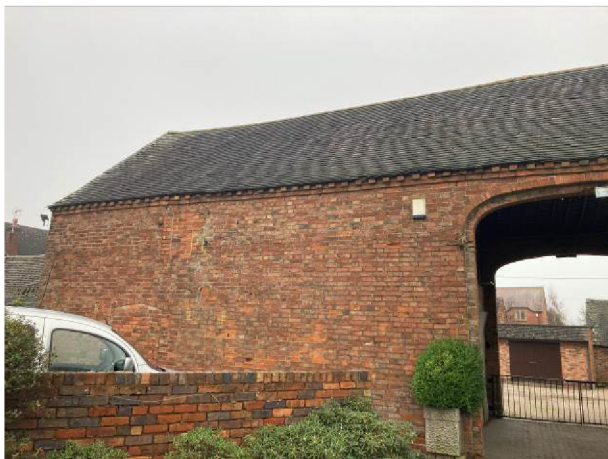
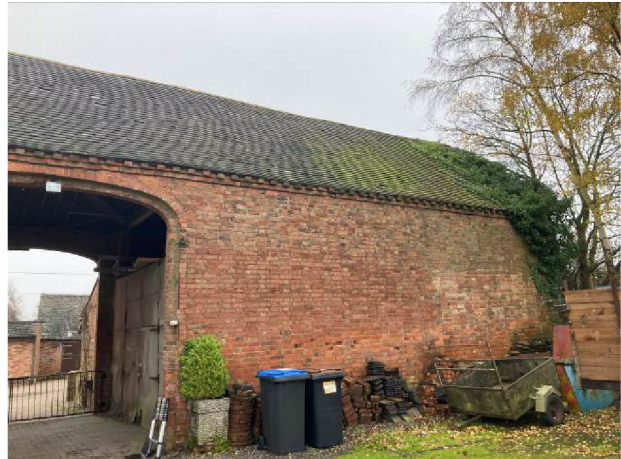
| Building | Description | Features present | Roost category |
|---|---|---|---|
| B3 | Large two-storey barn divided into two sections but an entrance leading between the courtyard and driveway. Red brick structure showing signs of structural failure with the roof structure leaning noticeably to the west. Brickwork in reasonable condition but some cracks noted on the exterior and inspected where possible. Pitched red tile roof is not lined underneath and the roof space is open and accessible via the entranceway in the centre of the building. Timber roof beams in good condition but starting to lean precariously. Ground floor storage areas inspected, concrete floor throughout. This building will be converted. | Open roof space has gaps and crack present and some areas are fairly dark. Cracks on brickwork to east gable end and north face of building may be of interest to bats. No field signs of bats or evidence of nesting birds associated within this small structure. | Moderate |

South west side B3 and B4

South east side B3

North east side B3

North west side B3

3. **Building B3** is a very large barn divided into two parts by a access which runs through the centre of the building. The roof of the building is in very poor structural repair. This building will be converted which will require the existing roof to be removed and repaired and also works will be needed to reconstruct the gable ends where the brickwork is badly damaged. Whilst no physical evidence of bat or bird activity was identified, there are a number of structural features present within the roof and walls such as lifted tiles, gaps around beams and deep cracks in walls, which may be of potential interest to bats. Taking into consideration the location of this building it is assessed as having ***moderate roost potential***. To comply with the 2016 Bat Survey Guidelines it is recommended that ***this building should be the subject of a dusk and dawn activity surveys carried out*** during the optimum survey season (May – August)

Building B3 has the greatest potential of the building inspected as there is a large accessible roof void which is quite dark in places. Due to structural concerns, the far ends of the interior roof of this building could not be inspected closely. This structure has moderate roost potential due to the structural features identified. It is recognised that no physical evidence of any bat activity was identified during the inspection but dusk and dawn survey carried out a minimum of two weeks apart are required to fully comply with the Bat Survey Guidelines.

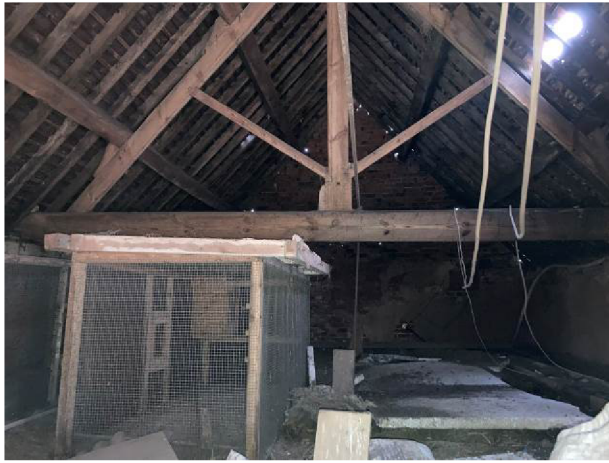
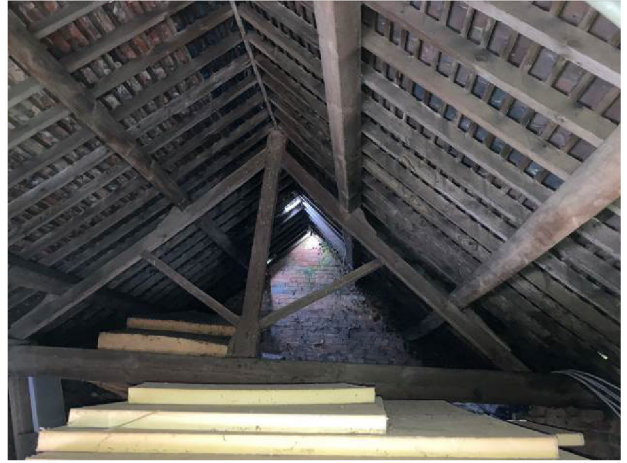
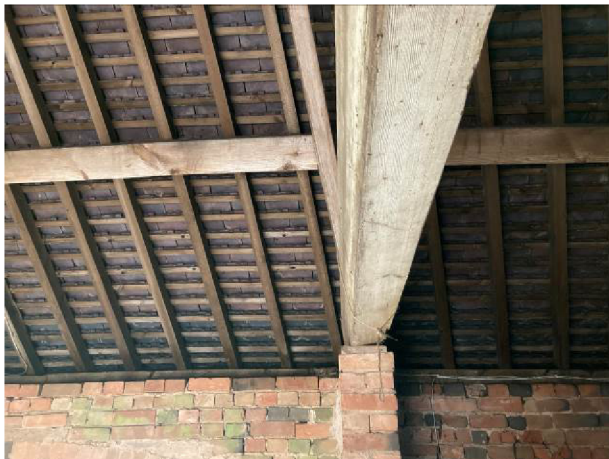
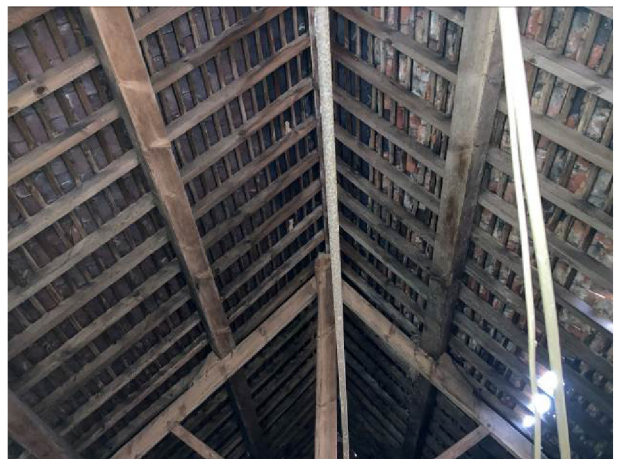
Roof space interior east side

Roof space interior west side

Underside of roof east side

Underside of roof west side

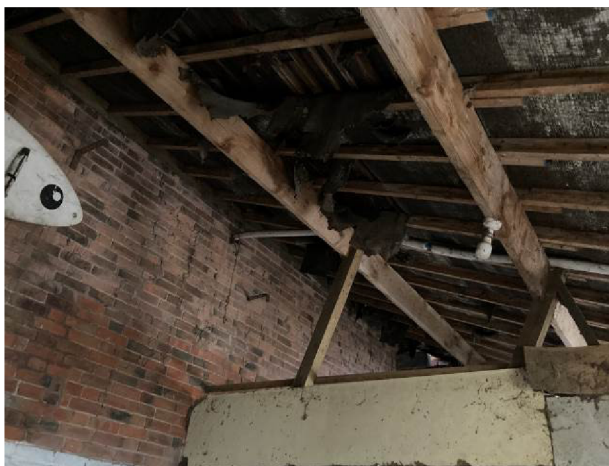
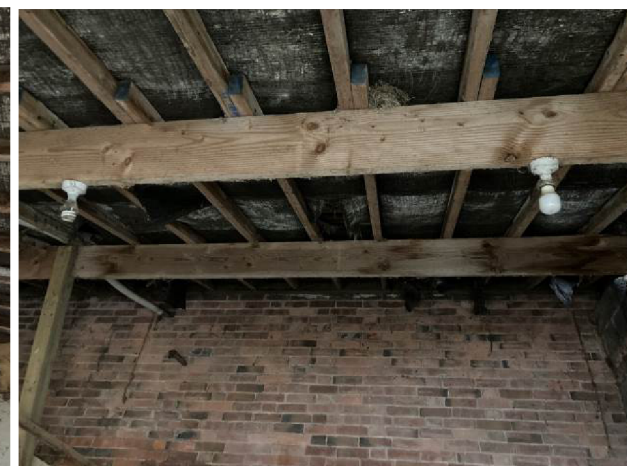
| Building | Description | Features present | Roost category |
|---|---|---|---|
| B4 | Lean-to extension on the south side of B3. Red brick construction with good brickwork and a sloping roof of rosemary tiles laid over timber beams. Roof in good condition with no missing or broken riles. Bituminous lining under the roof and no enclosed loft space. Timber roof beams fully exposed. Concrete floor throughout. Building has timber doors on the south side which are not tightly fitting with significant open gaps and windows / doorways. This building will be demolished. | Roof is lined and there will be a gap between the tiles and lining which may be accessible. No field signs of bats. Swallows nesting under roof beams accessing from the open stable doors. | Low |

Interior of B4 lean to extension

4. **Building B4** is a lean-to store / workshop structure attached to the south western side of B3. This building will be demolished and whilst no physical evidence of bat or bird activity was identified, there are structural features present within the roof such as lifted tiles and gaps along the roof beams, which may be of potential interest to bats. Taking into consideration the location of this building it is assessed as having ***low roost potential***. To comply with the 2016 Bat Survey Guidelines it is recommended that ***this building should be the subject of a dusk or dawn activity survey carried out*** during the optimum survey season (May – August)

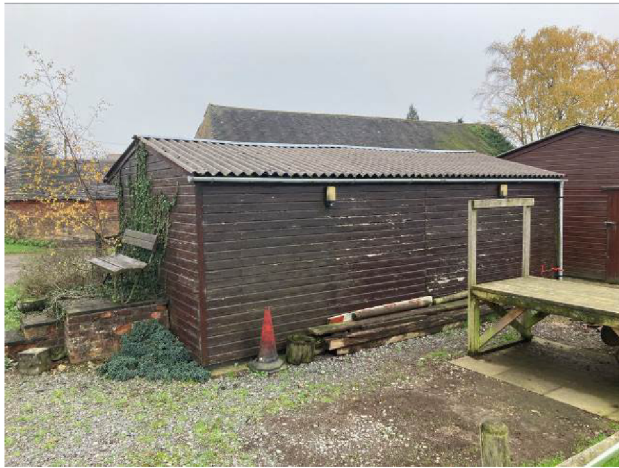
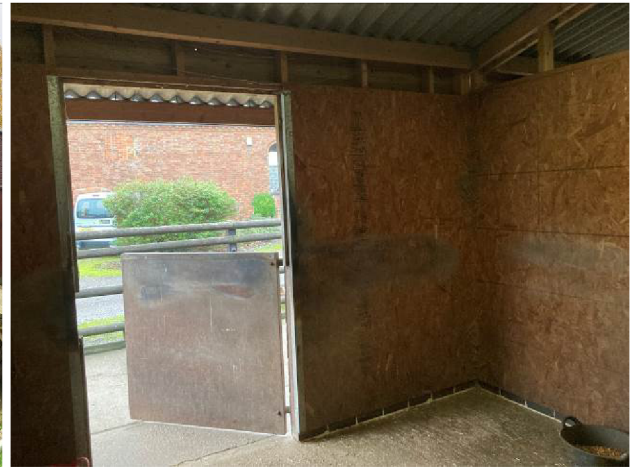
| Building | Description | Features present | Roost category |
|---|---|---|---|
| B5 | Horse stall – timber framed and clad in corrugated fibreboard. No lining with timber roof beams fully exposed. Timber stable door on front. This building will be removed and reconstructed in a new position. | No structural features identified of potential interest to bats or birds. No field evidence of roosting bats or nesting birds. | Negligible |

Exterior of B5

Interior of B5

5. **Building B5** is a timber framed and corrugated steel-clad stable. This building will be dismantled and reconstructed in a new position. No evidence of bat or bird activity was found associated with this building and there are no structural features identified that would be of potential interest to bats. ***This building has negligible roost potential and no further surveys are required.***

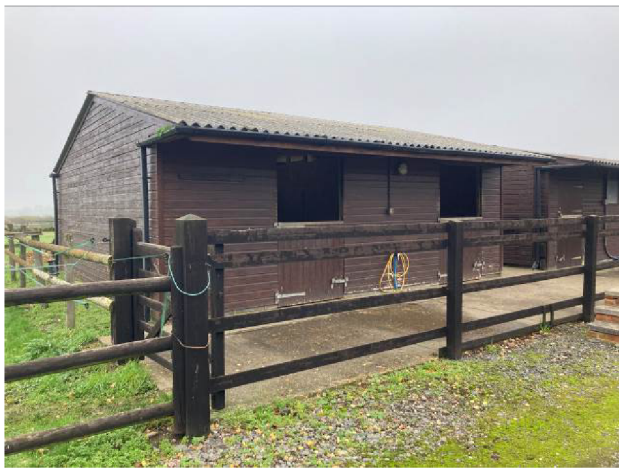
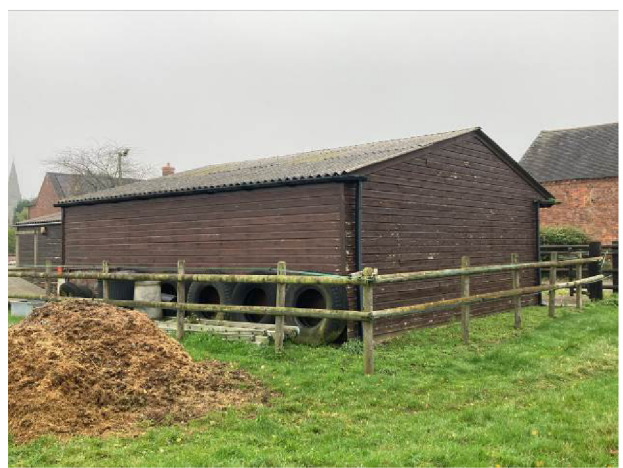
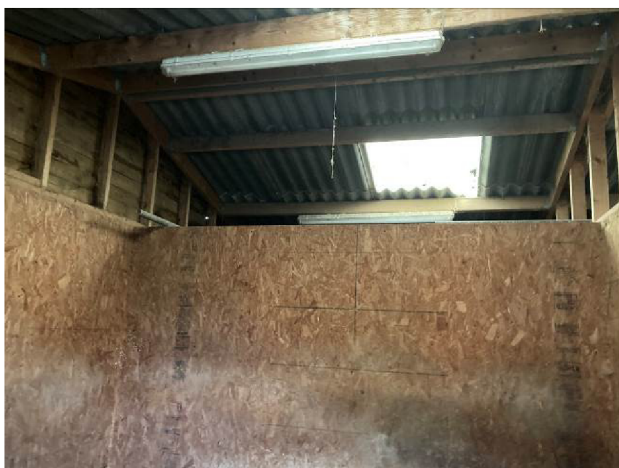
| Building | Description | Features present | Roost category |
|---|---|---|---|
| B6 | Horse stall – timber framed and clad in corrugated fibreboard. No lining with timber roof beams fully exposed. Two timber stable door on front. This building will be removed and reconstructed in a new position. | No structural features identified of potential interest to bats or birds. No field evidence of roosting bats or nesting birds. | Negligible |

Exterior south face B6

Exterior north face B6

Interior of B6

6. **Building B6** is a timber framed and corrugated steel-clad stable. This building will be dismantled and reconstructed in a new position. No evidence of bat or bird activity was found associated with this building and there are no structural features identified that would be of potential interest to bats. ***This building has negligible roost potential and no further surveys are required.***
