# Bosworth Lodges

British Standards 5837:2012 Tree  
Survey: Arboricultural Impact  
Assessment, Method Statement and  
Tree Protection Plan

RSE\_7615\_R2\_V2\_ARB

January 2025

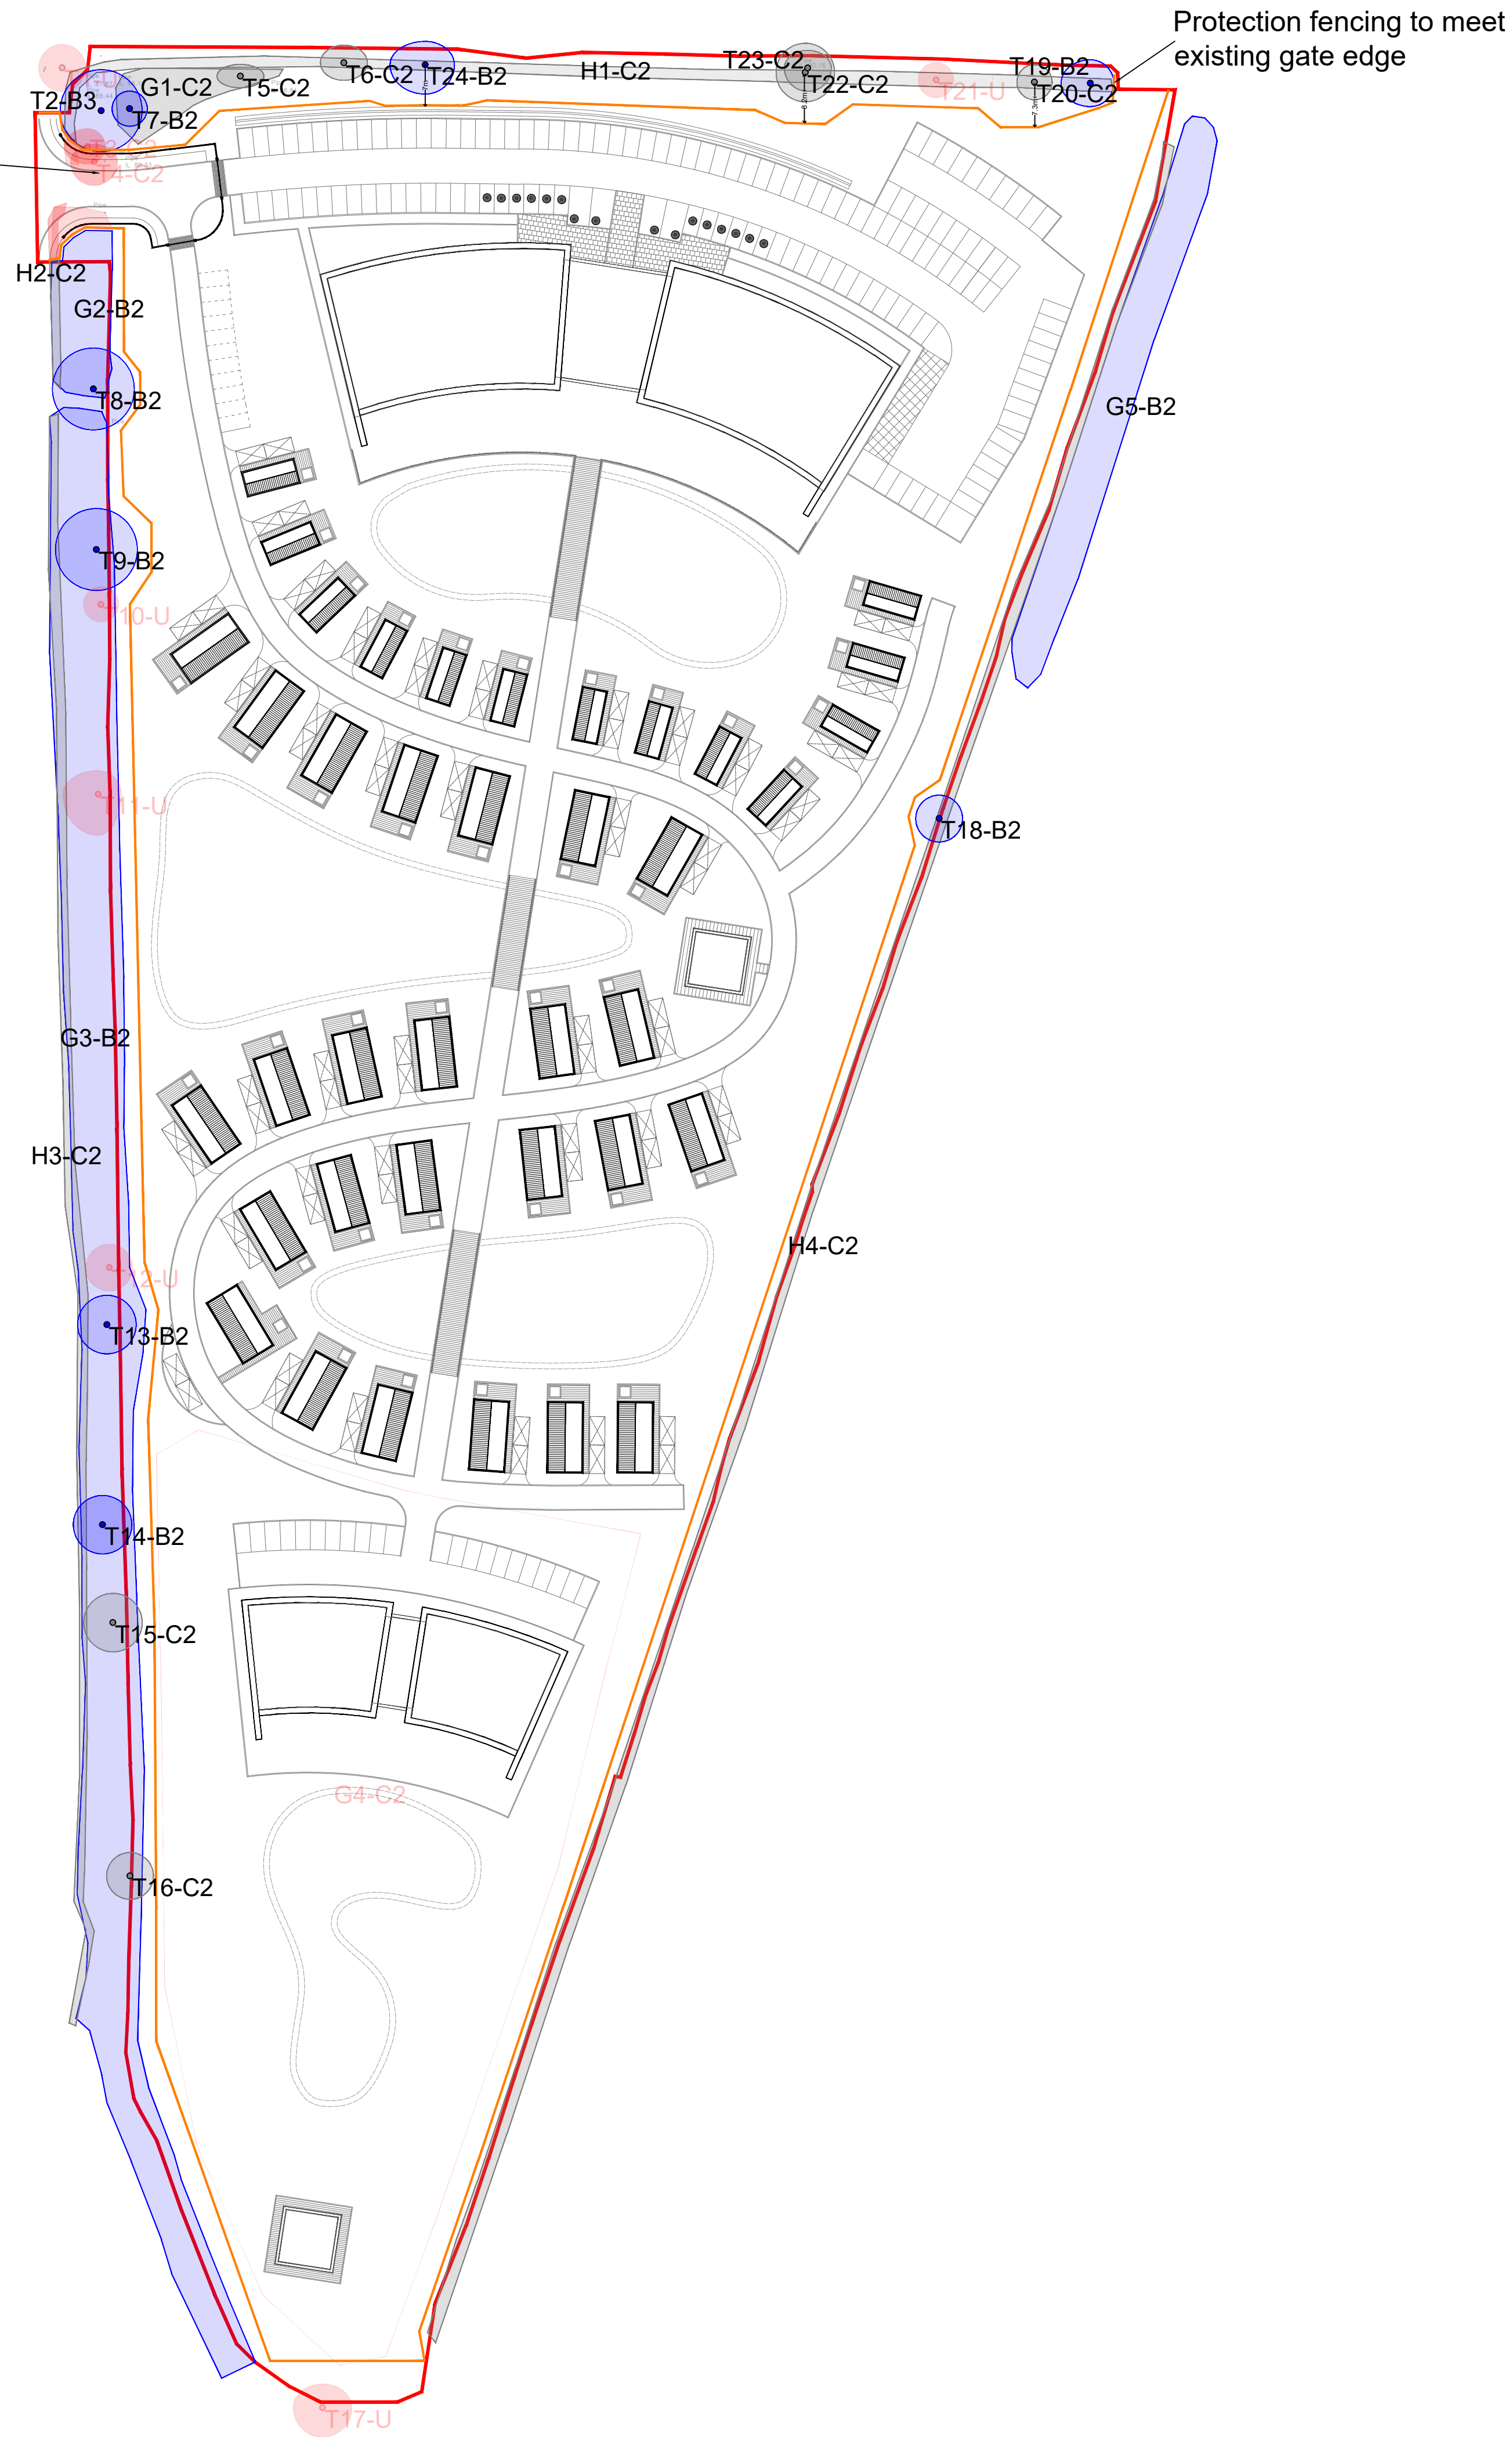
Existing hard surfacing access in place to an extent for new access. Where in place, the existing sub-base of the hard surfacing is to be retained to minimise new impacts to tree T2 root system.
