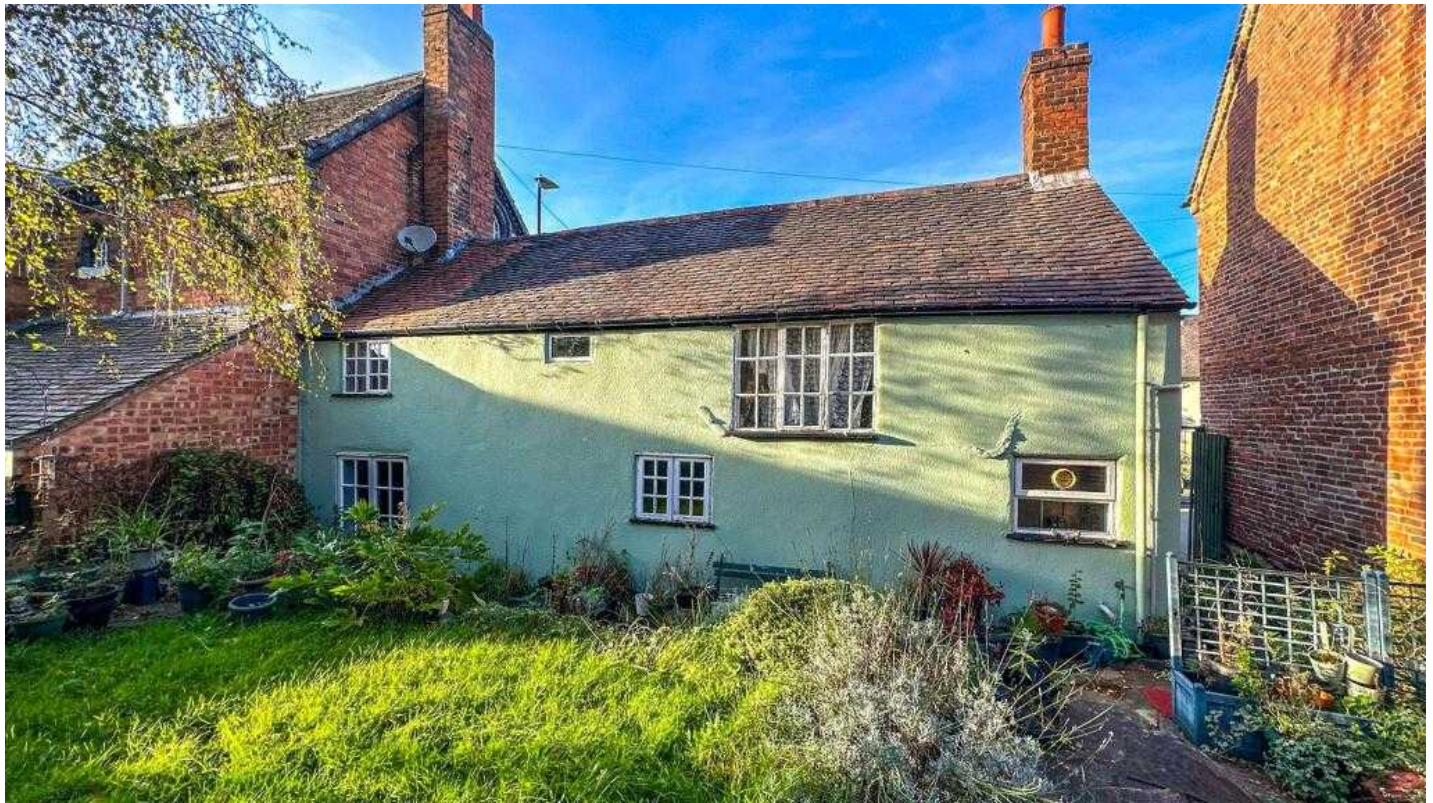
Rear view of cottage. All windows to be replaced due to rotting. French door proposal to replace middle window into utility room for access and natural light/ ventilation.

3 x Velux windows, one for each upstairs room, not changing structure or elevation of existing roof.

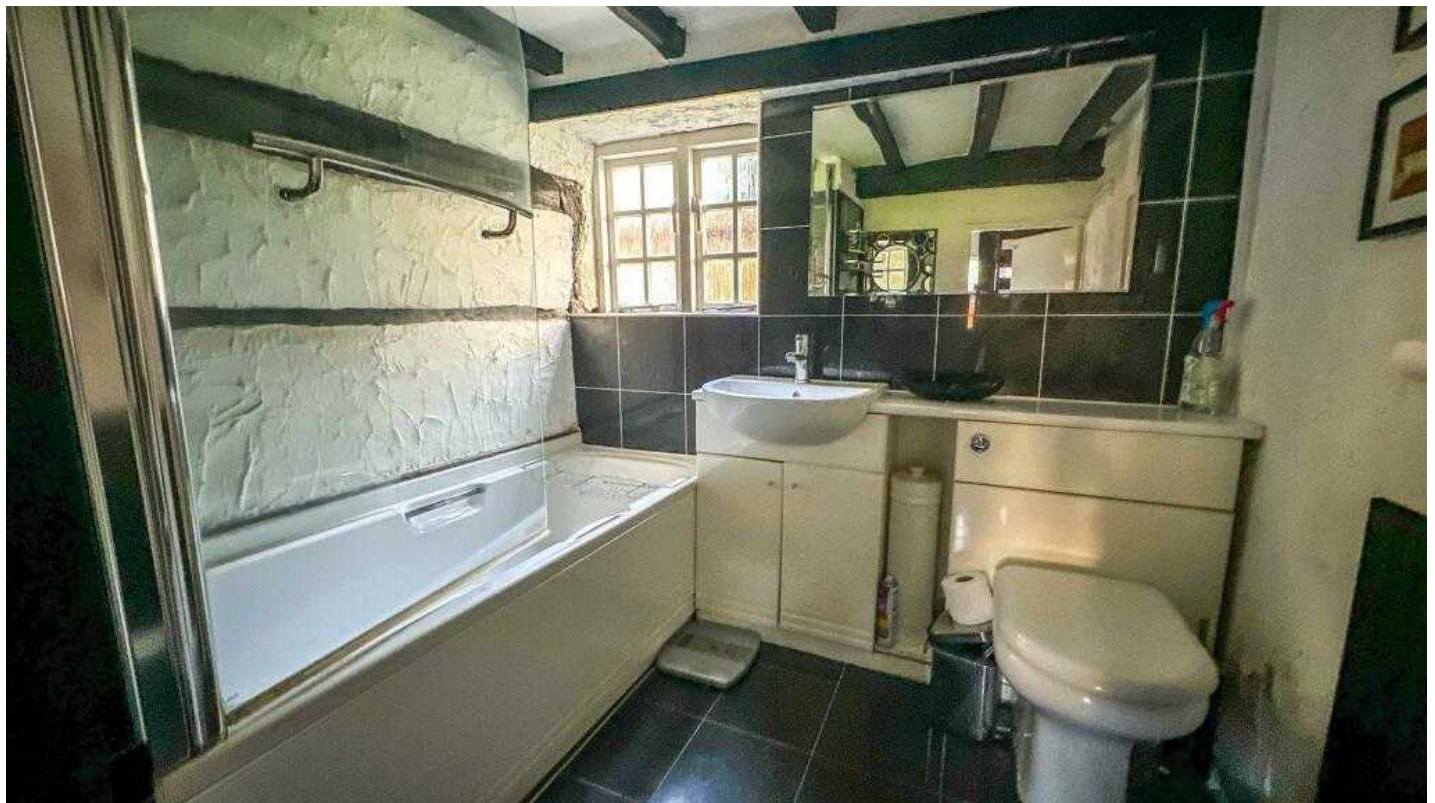
Interior view of current bathroom window to be replaced with French doors. Showing ability to avoid removing any historic fabric.

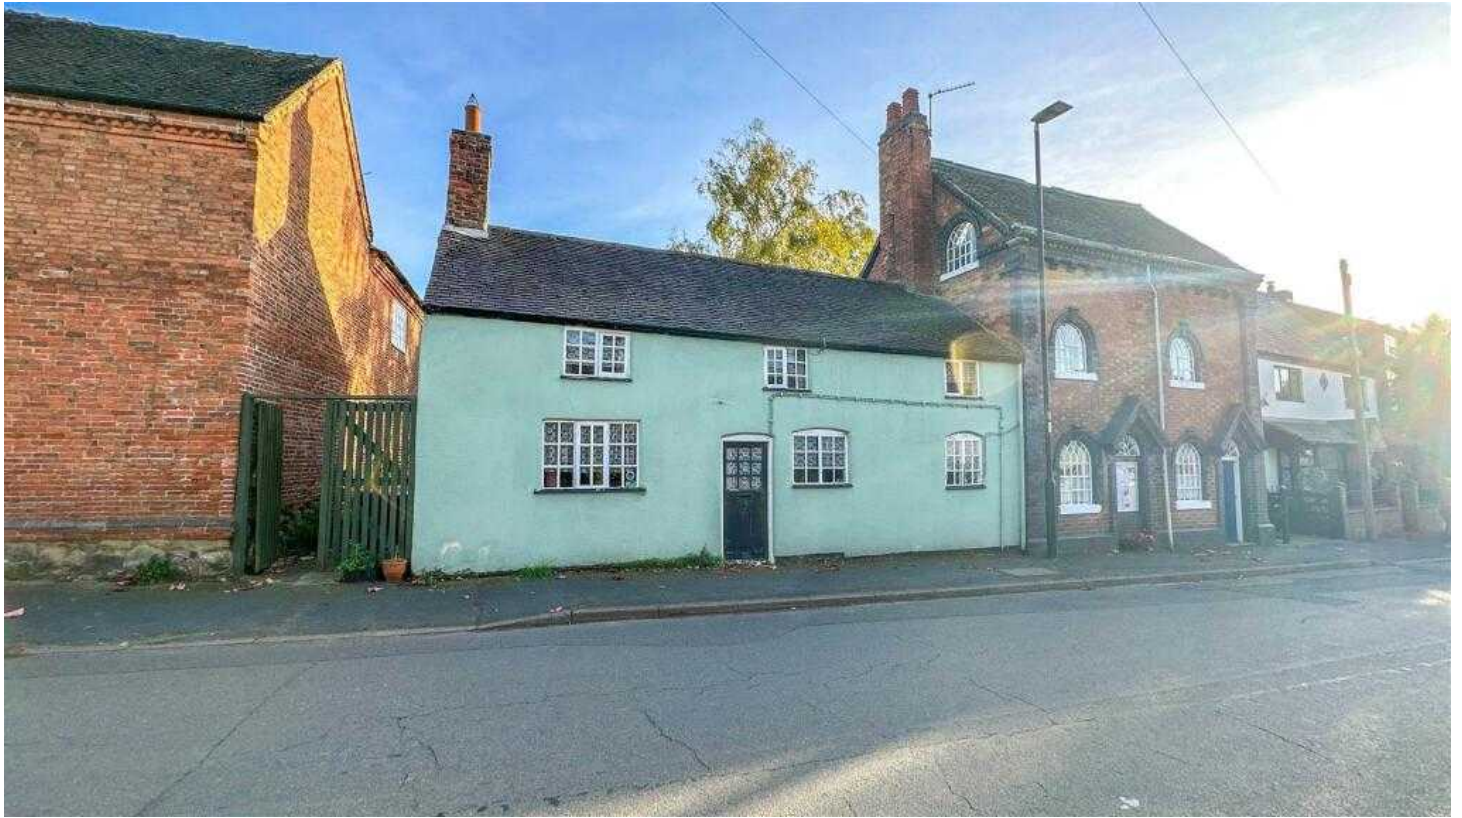
Front view of cottage showing 6 x windows and 1 x door in need of replacement due to rot.

Chimney stack unstable, requesting permission to rebuild with existing bricks to make safe and prolong life.
