**MIRA TECHNOLOGY PARK SOUTH SITE  
WATLING STREET, WARWICKSHIRE**

**BAT SURVEYS**

Report No: RT-MME-154920-04 Rev B

Date: August 2022

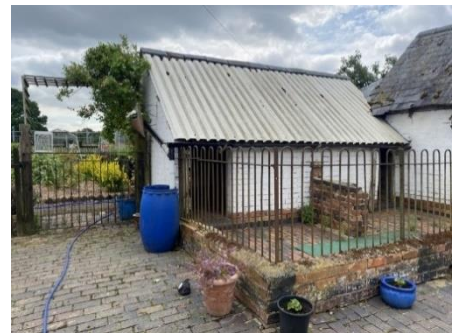
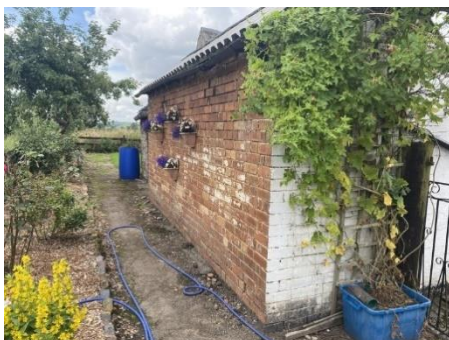
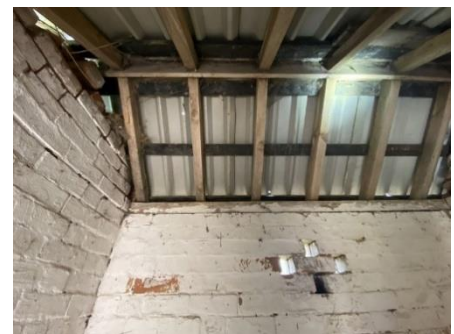
Plate 8.6: Section 1

This section of the farm complex was a former pigsty and was of brick construction with a pitched roof. It had two low entrances with no doors that provided flight access to the structure from the courtyard. The brickwork was generally in good condition, however some decorative bricks were missing on the southern elevation. Some gaps were noted at the top of the wall plate where the roof overhung the brickwork. These provided access into the structure from the south. The roof was pitched and made out of corrugated metal with a tile ridge. Gaps were noted under the tile ridge that may provide bat access along the ridge.

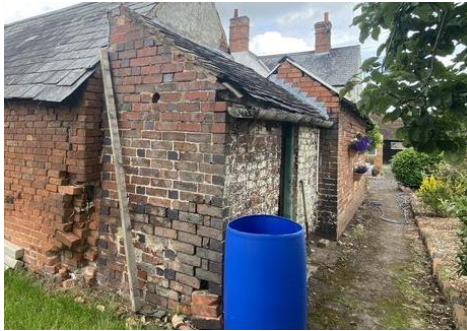
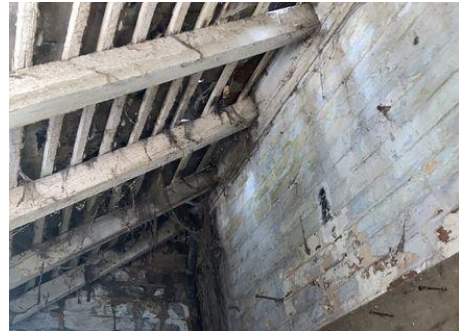
Plate 8.9: Section 2

This was a brick section which was generally in good condition, however there were missing bricks on the western elevation which had been partially blocked with chicken wire. This would provide access to the internal area in this section. The roof was pitched with slate tiles with many gaps noted under the tiles. Lead flashing was present on the roof and this was noted to be lifted in places creating potential roosting locations which were not able to be assessed due to their height.

No loft space or sarking were present within this section. A timber frame supported the bare tile roof. The internal space was very dusty with old bird nests noted. Potential roosting locations in this building comprised only of gaps between the bare slate tiles and wooden frame.

Roosting potential was considered to be low and no evidence of bats or bat activity was found present.

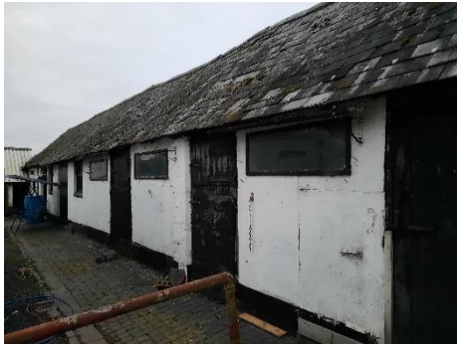
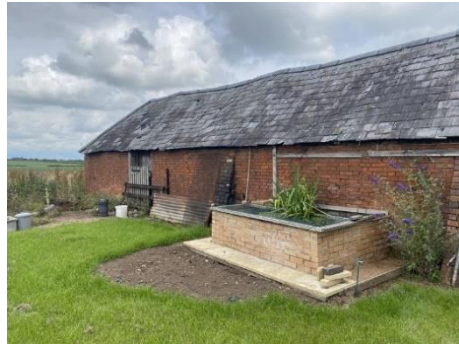
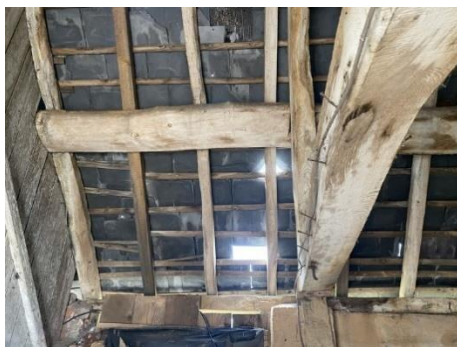
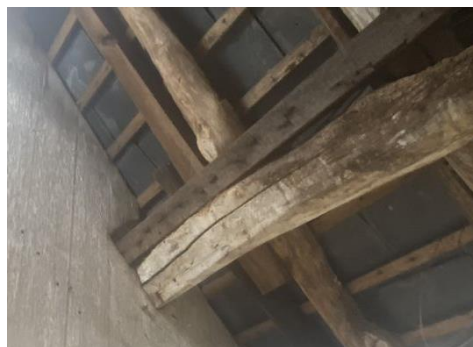
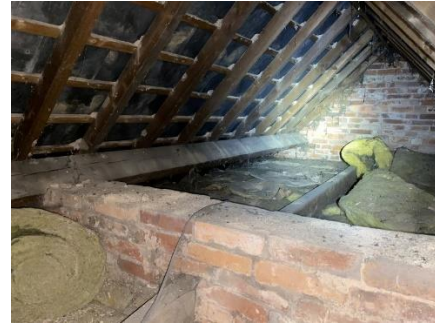
Plate 8.11: Section 3

This section comprised a long single-story building that formed the entire western side of the courtyard. It was of brick construction with a pitched, slate roof. The mortar between much of the brickwork was perished and was noted to form deep gaps in some of the accessible areas around the building buttresses. It was not possible to fully inspect these crevices due to their location and depth. The slate roof had many missing tiles which created potential roosting locations and ingress opportunities to the internal areas of the building. In addition, gaps were noted between the ridge tiles where the mortar had perished. These gaps created ingress points into potential roosting features that were not able to be inspected due to their height. Wooden framed glass windows were present in the northern part of this building. These were in good condition and provided no bat access. Wooden shuttered windows into the courtyard in the southern part of this building provided bat access into the building.

Internal Section 3.2 had a wooden frame. No sarking was present. The wooden frame included gaps between beams and small cracks in beams. These provide potential roosting features for bats.

Ten bat droppings were found within this section. Whilst these were scattered throughout the room, a few were noted in the southeast corner of the room near a shuttered window that would provide bat access and also in the vicinity of a crack in a beam. These bat droppings were old making it difficult to determine the species due to their composition and degradation.

Internal Section 3.3 was linked to Sections 3.2 and 3.4. Partial dividing walls were present but flight access was present through doorways. This had a similar structure to Section 3.2. Five bat droppings were found that resembled those of brown long-eared bat. A few butterfly wings were present, which could be feeding remains from bats or from swallows, which were nesting in the barn.

Section 3.5 was separated from Section 3.4 by a wooden dividing wall, although it is considered likely that gaps would be present around this that would provide bat access. It was similar in construction to the other sections, with no sarking noted and some cracks in the wooden beams providing potential roosting locations. Two old bat droppings were found adjacent to the wall separating this section from Section 4.4. These bat droppings were old making it difficult to determine the species due to their composition and degradation.

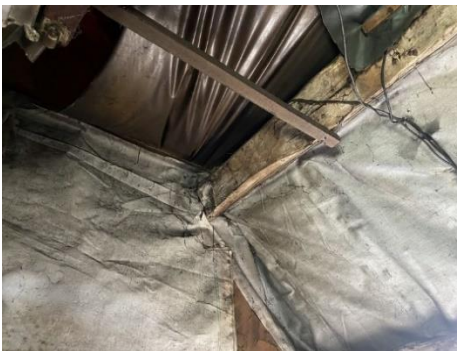
Plate 8.13: Section 3.1

Internal Section 3.1 had tarpaulins suspended from the ceiling, obscuring all visual inspections of the roof structure. The room was dusty and mouse dropping were observed. No bat droppings or signs of bats were recorded.

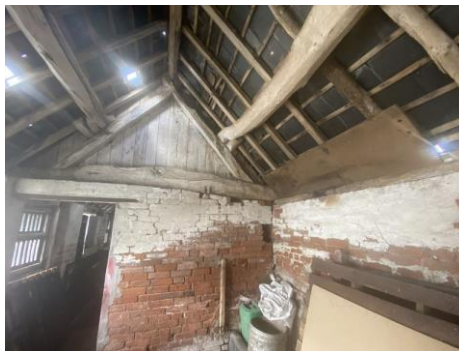
Plate 8.14: Section 3.4

Section 3.4 linked to Section 3.3 and was similar in construction. This section had glass windows that would not allow bat access but was otherwise similar in construction to the other sections. No droppings or other evidence of bat activity was noted. A swallow nest was present in this section.

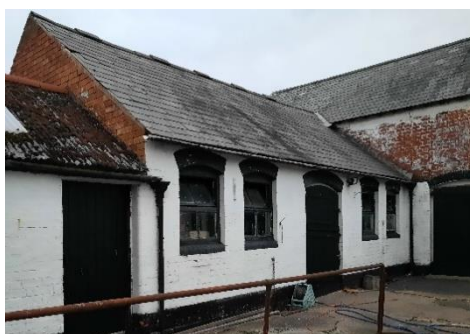
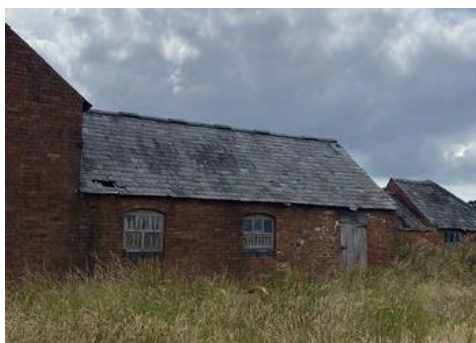
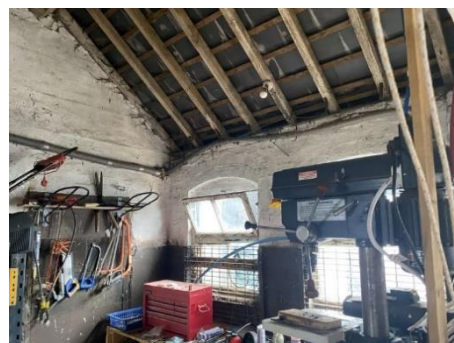
Plate 8.20: Section 5

This was a building of brick construction with a slate tiled roof. The roof was generally in good condition but a hole with missing tiles on the northern pitch provided flight access for bats, gaps were present on the southern pitch where tiles had slipped and gaps were present under lifted ridge tiles. Gaps were present under the eaves and around extruding roof beams. These gaps all provide ingress opportunities for bats into the building. Wooden doors and wooden and glass shutters were present around the building which were in good condition, but the windows were open at the time of the survey, providing flight access for nesting swallows and it is anticipated these are left open throughout the summer at least.

No loft space or sarking were present within this section. A timber frame supported the bare tile roof. Potential roosting locations in this building comprised only of gaps between the bare slate tiles and wooden frame. Only a brief internal inspection was made as nesting swallows were present in this section of the building, but no bat droppings or other signs of bat activity were noted.

The current site plans require that all buildings will be demolished. A Natural England Licence will be required to undertake any work that would damage, destroy or block access to the confirmed roost in Section 5, or disturb bats within those roosts. As all sections of the farm complex are interconnected it is considered likely that any uncontrolled building demolition has the potential to disturb the identified bat roost in Section 5. In addition, whilst no confirmed roosts have been identified within other sections of the farm complex during the dusk emergence or dawn re-entry surveys, evidence of bat activity (scattered droppings and feeding remains) has been identified and it is considered that bats could roost in these sections on an occasional basis. A recommendation has been made in relation to obtaining a Natural England Licence to avoid breaches in legislation.

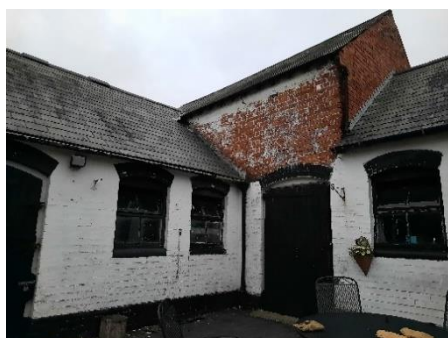
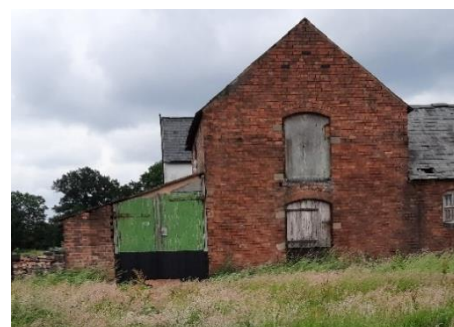
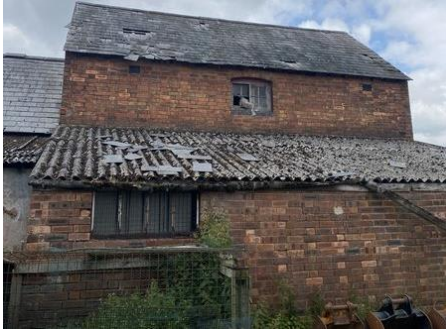
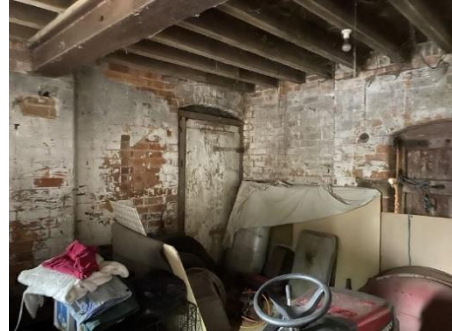
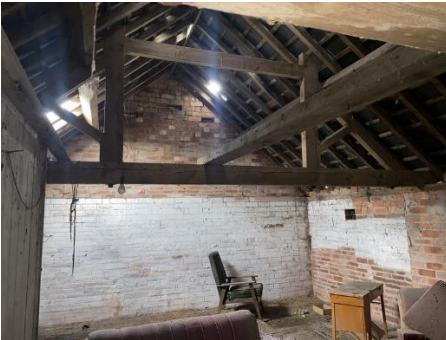
Plate 8.23: Section 6

This was a two-storey brick building with a gable ended pitched slate tile roof. The brickwork was in good condition, however potential locations that provided access for bats included two ventilation bricks on the gable end, gaps under the eaves and around roof beams extending beyond the brickwork on the eastern elevation. A large number of missing and slipped tiles were noted where flight access would be possible for bats. A broken window pane also had potential to allow flight access for bats.

A single-storey lean-to was present on the eastern elevation constructed from bricks with a corrugated asbestos (or similar) roof. The pitched roof had gaps under the eaves which create potential ingress points into the lean-to. The weather board around this section was fitted tightly to the brickwork and no potential roosting locations or ingress points were noted.

The features observed in the building were considered to have a low-moderate suitability for roosting bats. Two bat droppings were noted to be present on the stairs within this section. This was approximately underneath the window with a broken glass pane. These were considered likely to be pipistrelle droppings.

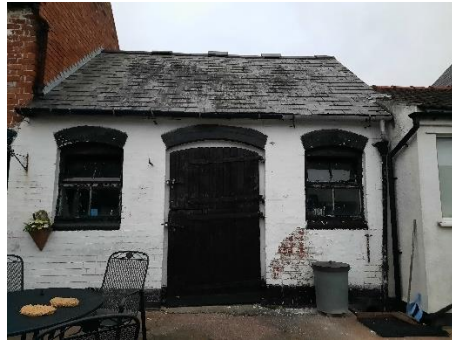
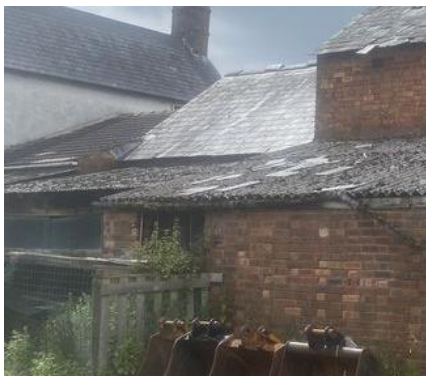
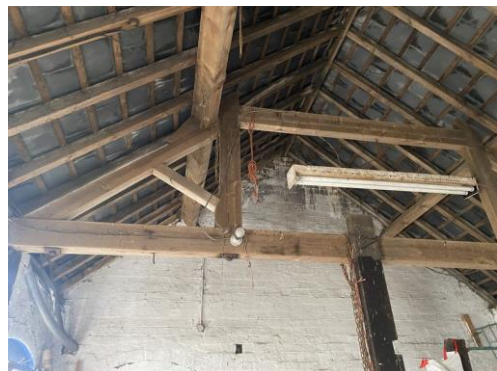
Plate 8.29: Section 7

This brick-built section had a slate, pitched roof with ridge tiles. The roof and ridge tiles were in good condition with no missing or slipped tiles noted. The ridge tiles, however, included raised tiles that created potential ingress points into the building. The gable end of this building was in good condition with no gaps noted.

A lean-to was present on the eastern elevation. This was constructed from a combination of wood, metal and plastic panels with a wooden frame. Gaps were noted at the edges of the roof and over the window which allow internal access into the lean-to.

No loft space or sarking were present within this section. A timber frame supported the bare tile roof. The timber frame appeared more modern than in other sections and the woodwork was in good condition with limited roosting opportunities noted. The gaps between the tiles and supporting wood frame could provide roosting opportunities. This section was considered to provide low to moderate roosting potential. Two wooden framed windows were present, both left open at the time of the survey. A small number of scattered bat droppings were present throughout the internal space with the majority being old and partially decomposed, making it difficult to determine the species due to their composition and degradation. One fresh bat dropping was noted and resembled that of brown long-eared bat.

No features were noted within the lean-to with roosting potential. No evidence of bats or bat activity were noted within the lean-to.

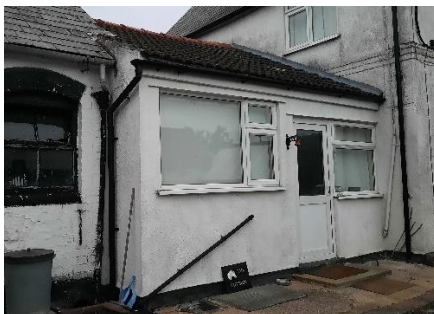
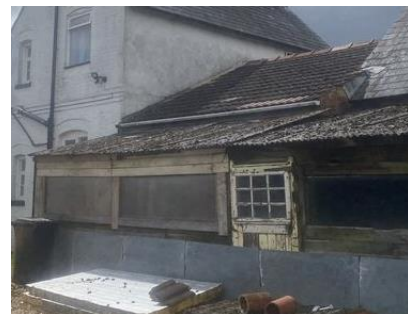
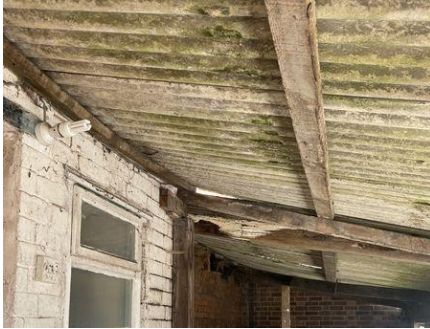
Plate 8.32: Section 8

Section 8 formed part of the residential house and was inhabited. No access points were present to inspect the cavity between the ceiling and the roof. Given the presence of a cavity, the location above a heated residential area and the access points noted into this roof, Section 8 is deemed to have high potential to support roosting bats as it could be used for a maternity colony.

No features were noted within the lean-to with roosting potential. No evidence of bats or bat activity were noted within the lean-to.

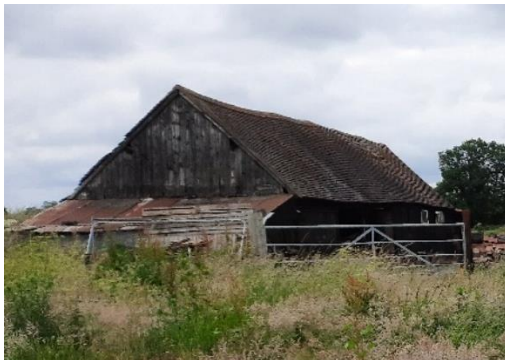
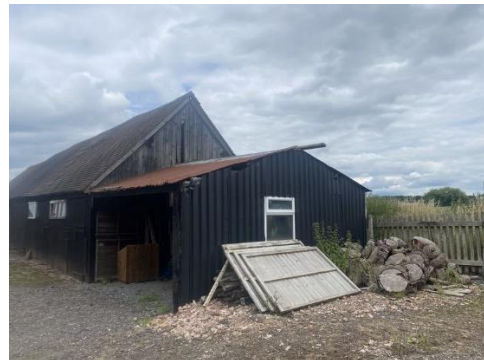
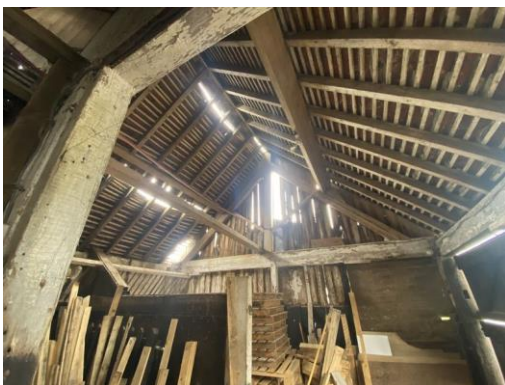
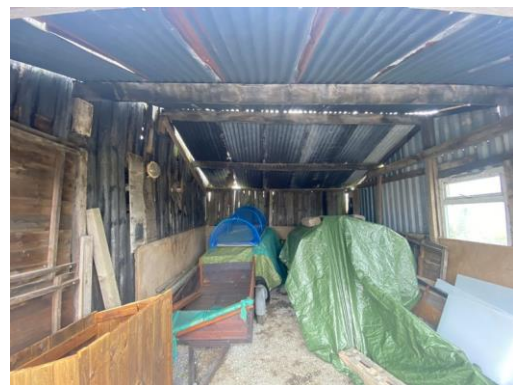
Plate 8.38: Barn 1

This was a long wooden structure with a pitched tiled roof. Missing roof tiles created direct flight access into the building. Missing and broken timbers on both gable ends provided access, including flight access into either end of the barn. Doors into the structure included some that had been left open at the time of the survey and one that was usually left closed and locked. Open doors will provide flight access for bats.

Open-sided lean-tos were present on both gable ends. These were corrugated metal structures with no bat potential noted.

No loft space was present within this barn with the underside of the roof visible from the internal space. The tiled roof was supported by a wooden frame. No sarking or torching were present on the underside of the roof tiles. Small gaps were noted around the woodwork and cracks were present in the beams. These had potential to provide suitable roosting locations for bats. It was not possible to fully inspect these features due to their heights and locations. This internal space is sub-divided by wooden walls into three compartments used for a chicken house, garage and timber storage. No bat droppings or other evidence of bat activity were recorded in the barn.
