## Arboricultural Appraisal Report

Impact Assessment & Method Statement to Inform Development

Lindridge Lane  
Desford  
LE9 9GN

CLIENT:	XL Designs (Midlands) Ltd
MWA REF:	DEV251031-1356
MWA CONSULTANT:	Ben Edmonds <i>BSc MA ArborA</i>
REPORT DATE:	17/11/2025

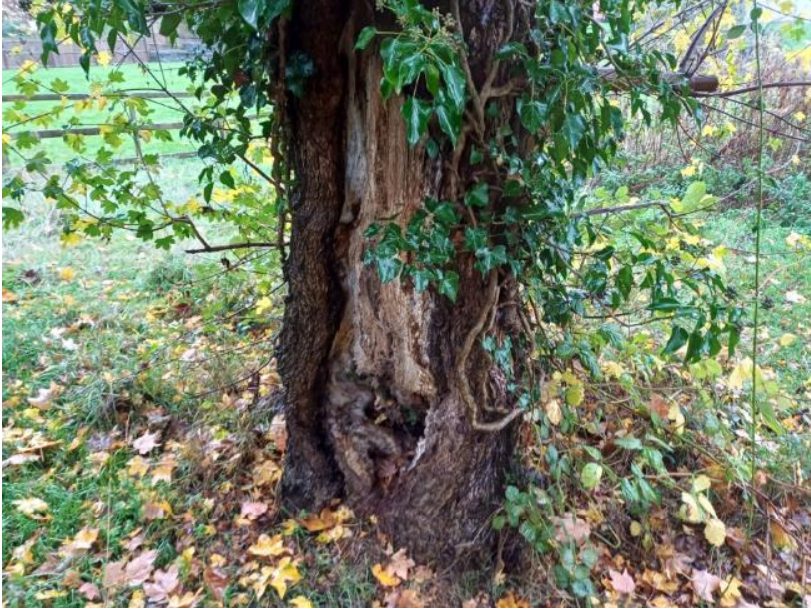
Field Maple T20

9.4 Five trees have been recommended to be removed, four trees to enable the development (T01, T20, T21 & T22) and one tree (T18) because it is in poor condition. Of the five trees four are in poor condition and have been recommended to be removed irrespective of the development. The crab apple tree T22 has been classified as a C category tree and while in a reasonable condition should not be seen as a restraint on development.

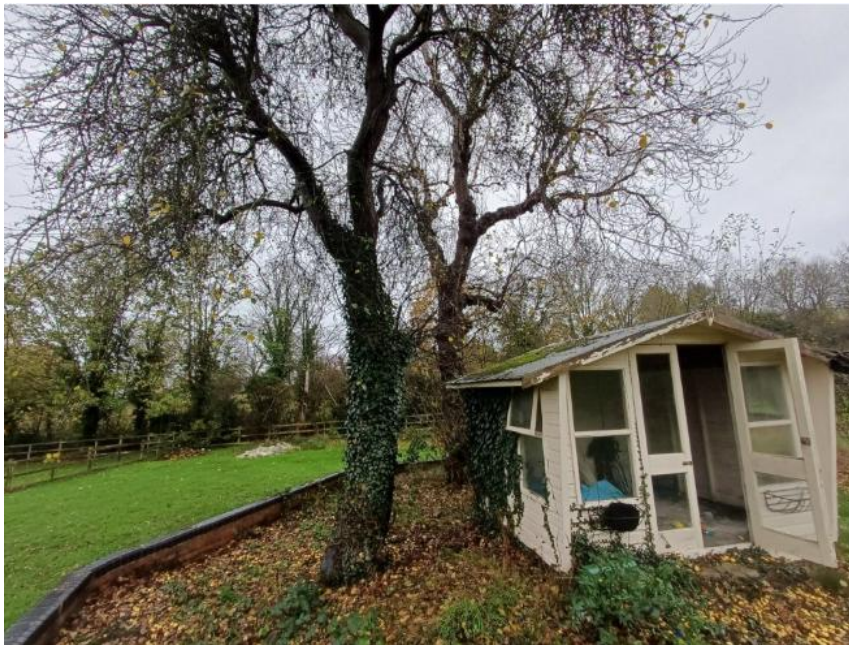
Crab apple T22 and Ash Tree T21

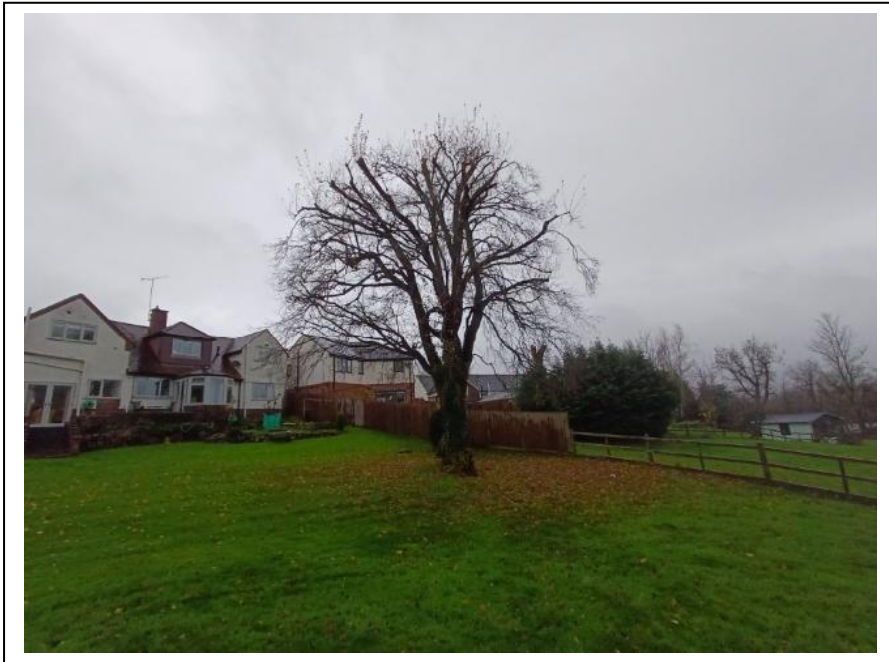
- 11.2 The proposed drive and turning area, positioned opposite Units C and D, is designed to encroach into the Root Protection Area (RPA) of Tree T23. The proposal impacts an area equivalent to approximately 10–15% of T23's RPA. This minor encroachment is considered tolerable, especially given the recent significant reduction in the tree's crown, which is assumed to have resulted in a proportionate reduction of the functional root zone.

Maple T23 and Leylandii H1

- 11.3 To ensure the long-term health and integrity of the tree's roots, the drive within the RPA will be constructed using a non-dig cellular confinement system. This technique will be employed specifically to avoid the need for any excavation or ground works, thereby eliminating potential damage to the rooting environment and providing additional, long-term protection to Tree T23.
