## **Preliminary Roost Assessment Survey Report – Danilo Cinema, Hinckley**

**Wigston Estates Ltd**

**November 2023**

**CHIMA\_015\_01\_R1\_22112023**

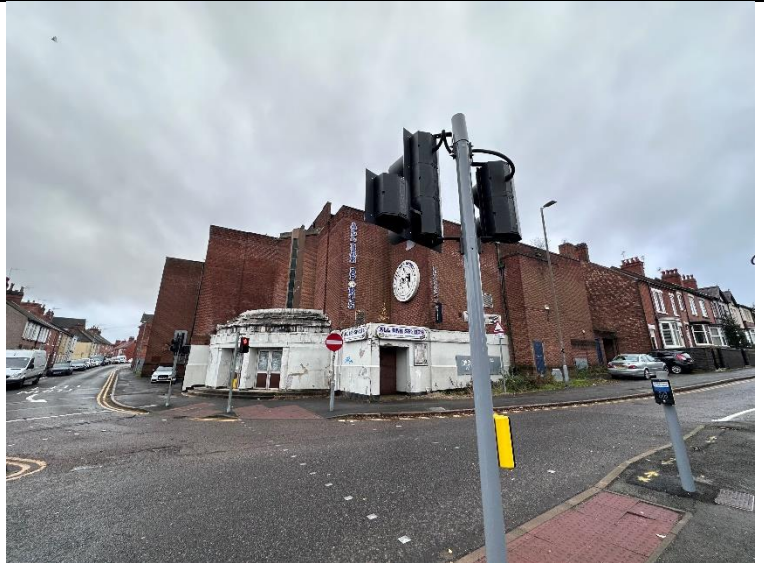
- 4.2.13. The building would be heavily lit on the northern and eastern aspects along Hollycroft Road and Trinity Lane (respectively), see Appendix 1, Images 1, 2 & 5.
- 4.2.14. The building represents a Low suitability in respect to potential flight-paths to suitable habitats in the wider environment as defined in Table 4.1 of Collins (2023). It is also considered to provide Negligible foraging habitats in respect to foraging habitats as defined in Table 4.1 of Collins (2023).

**Image 1:** Image looking at northern aspect of the building.

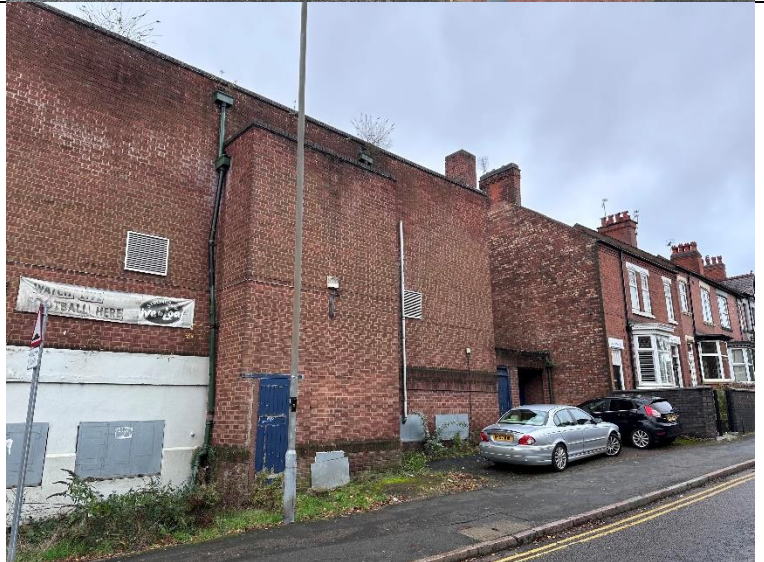
**Image 2:** Image looking at central section of the northern aspect of the building.

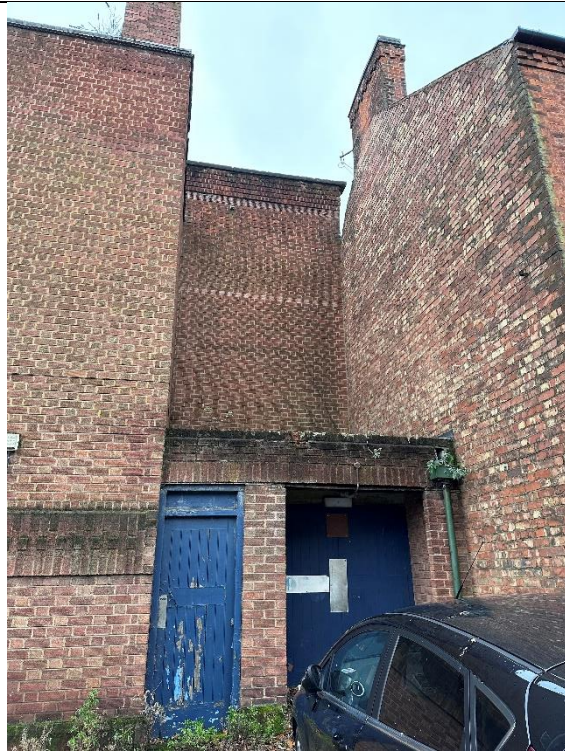
**Image 3:** Image looking at right most section of the northern aspect of the building.

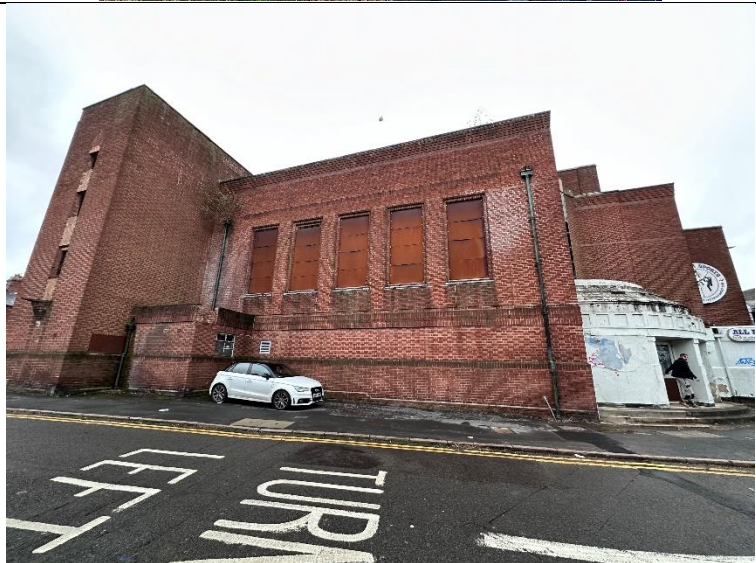
**Image 4:** Image looking at eastern aspect of the building.

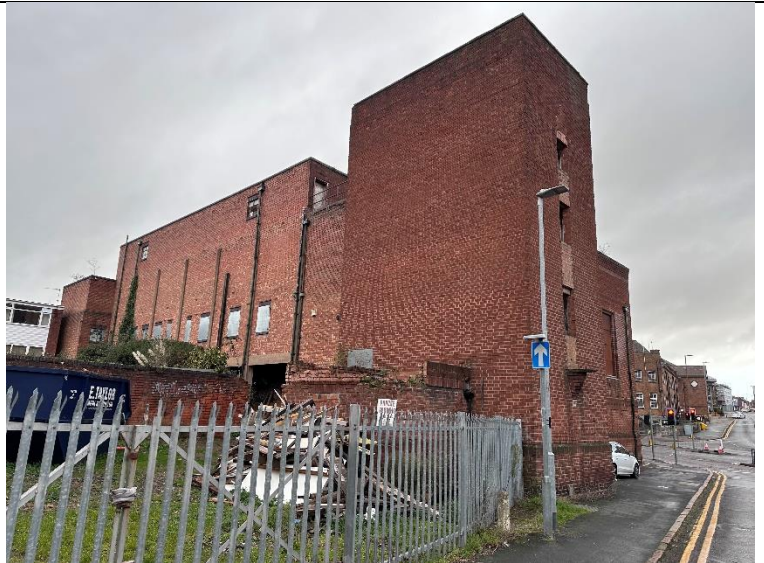
**Image 5:** Image looking at southern aspect of the building.

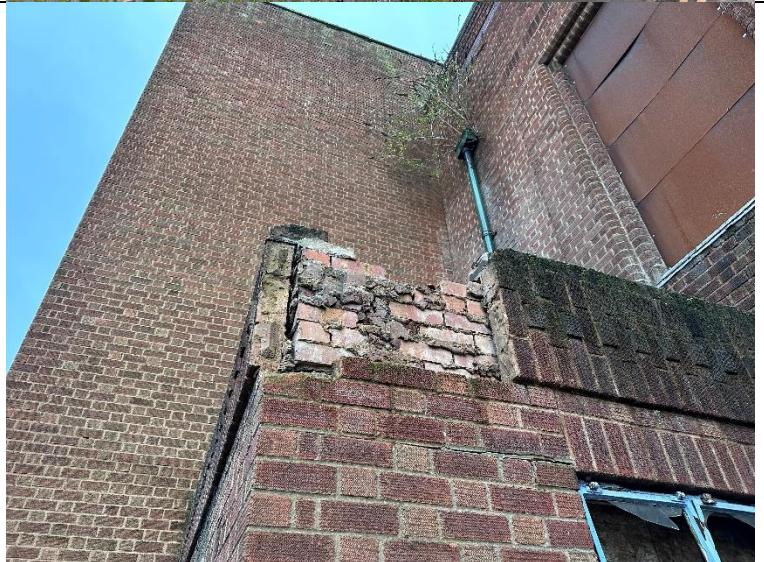
**Image 6:** Image showing small opening in brickwork on eastern aspect of the building.

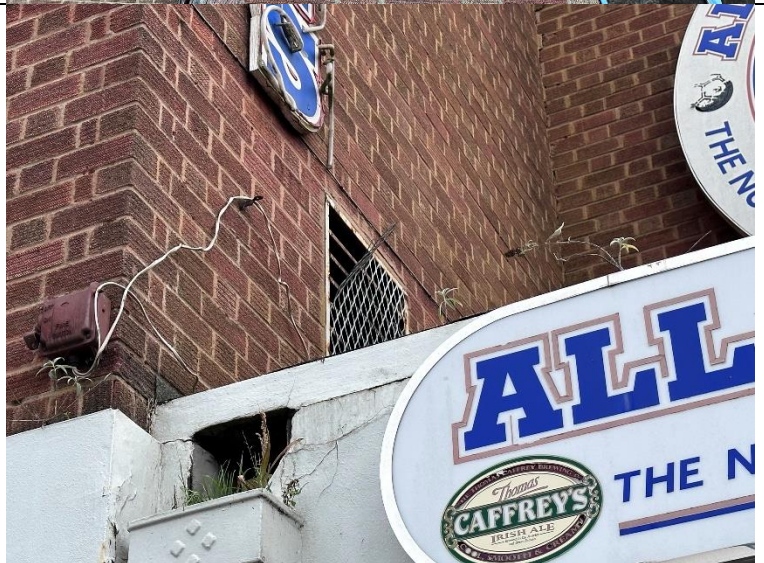
- 4.2.4. There are numerous possible entry / egress points into the building through vents on the northern and eastern aspects (see Appendix 1, Image 7 for example) as well as gaps in the window boards on the eastern and southern aspects. The missing central section of the solid slab main roof provides the largest entry / egress possibilities for bats (see Appendix 1, Images 8 & 9).

**Image 7:** Image showing indicative open vent on northern aspect of the building.

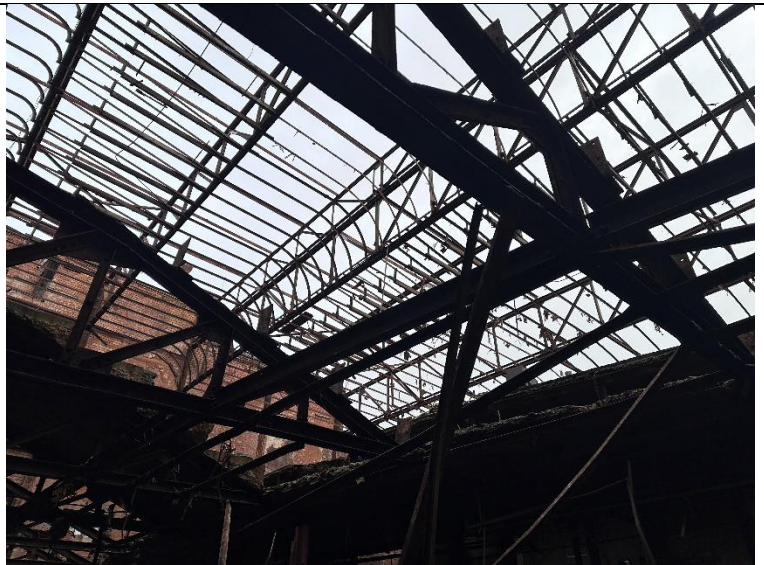
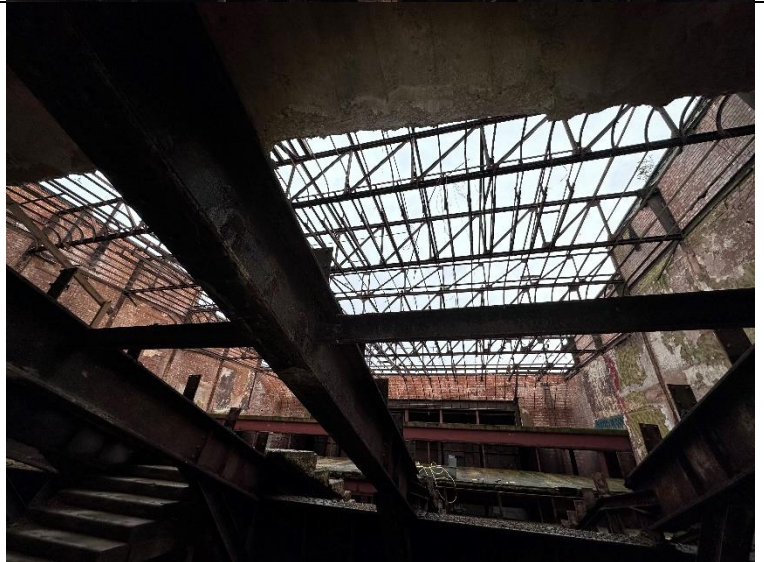
**Image 8:** Image showing missing roof within main flat roofed section of the building.

**Image 9:** Image showing missing roof within main flat roofed section of the building.

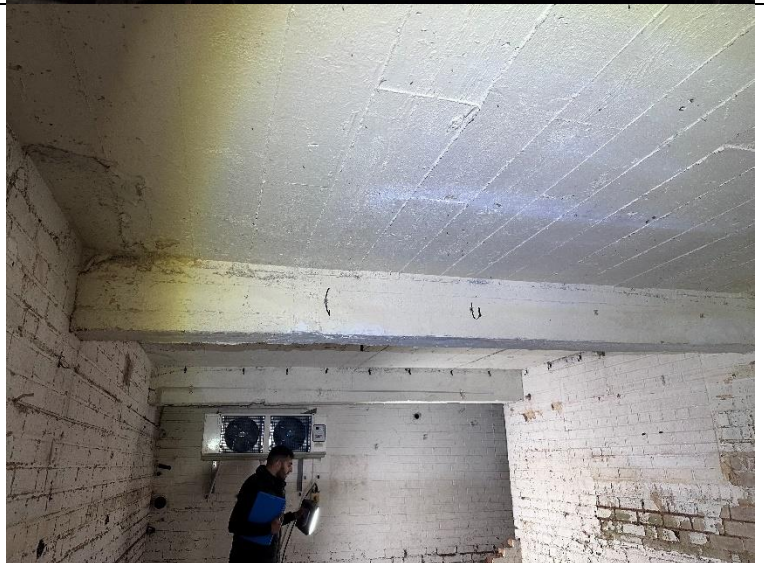
**Image 10:** Image showing condition of typical flat roofed section of the building.

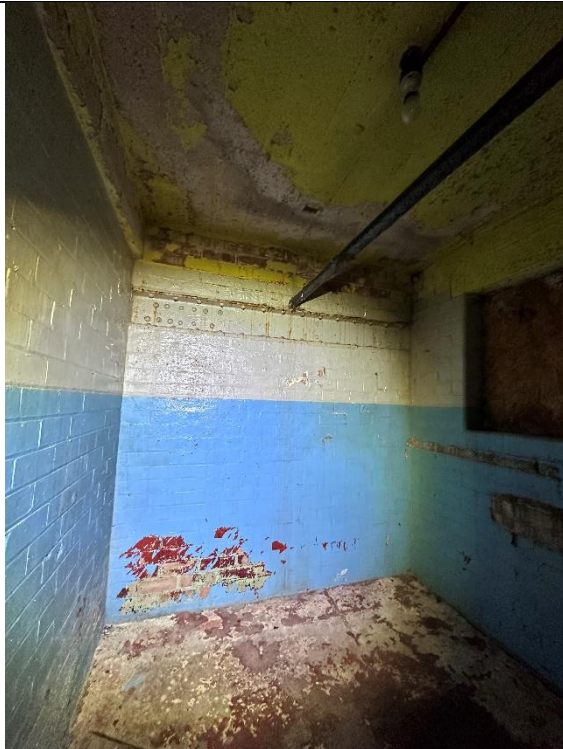
**Image 11:** Image showing typical small room within the building.

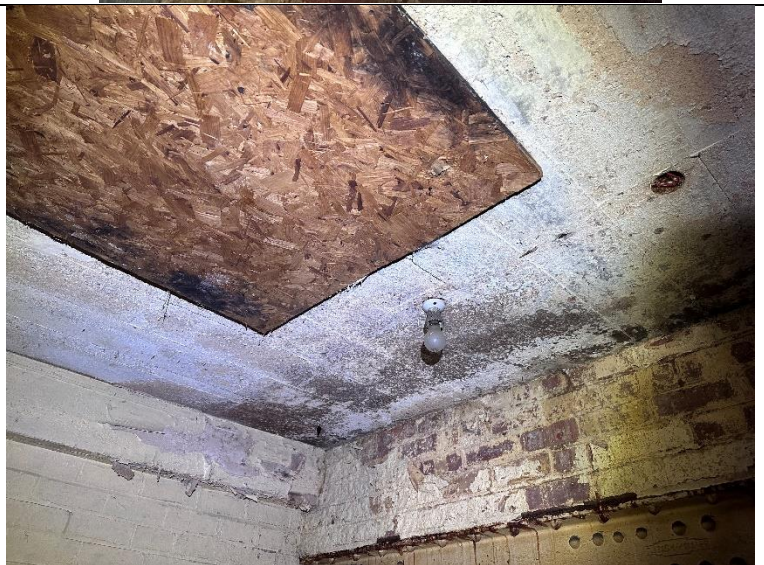
**Image 12:** Image showing condition of typical flat roofed section of the building.

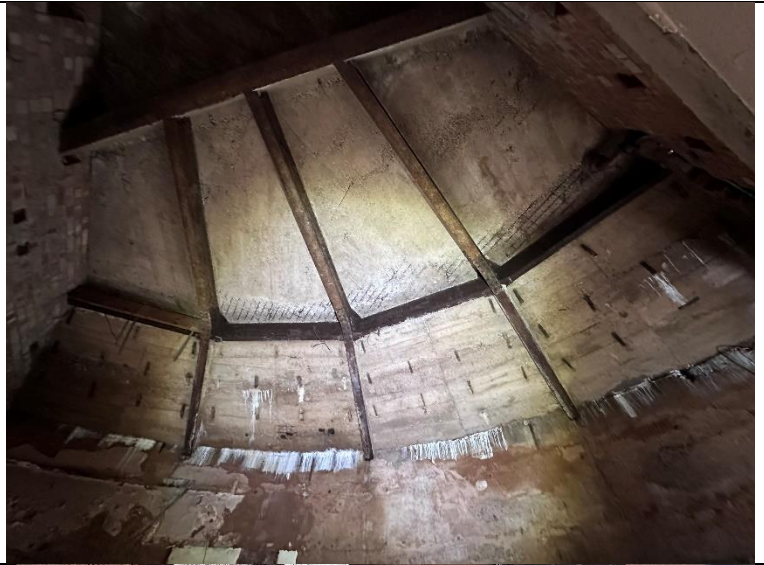
**Image 13:** Image showing roofed section of the entrance to the building.

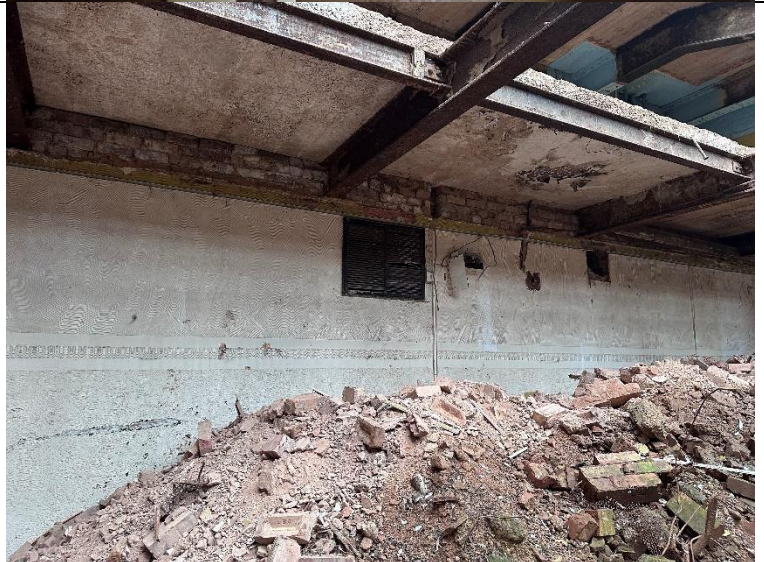
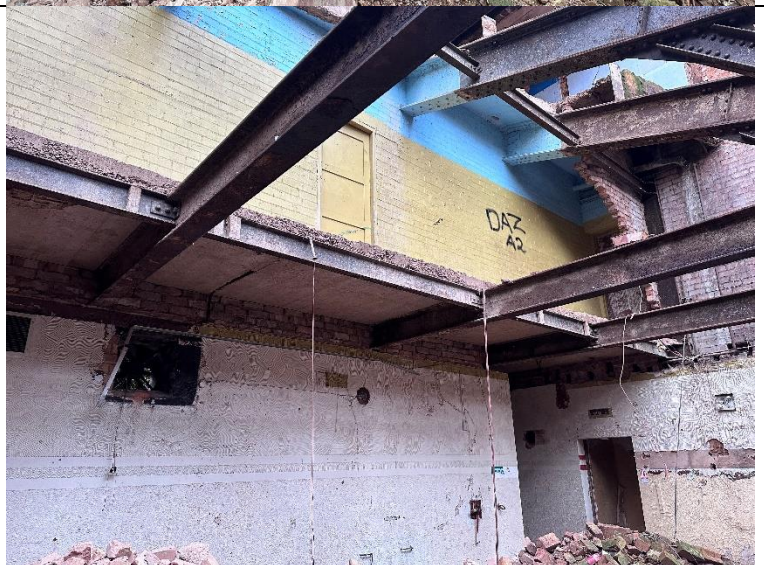
**Image 14:** Image showing internal condition of main section of the building.

**Image 15:** Image showing internal condition of main section of the building.

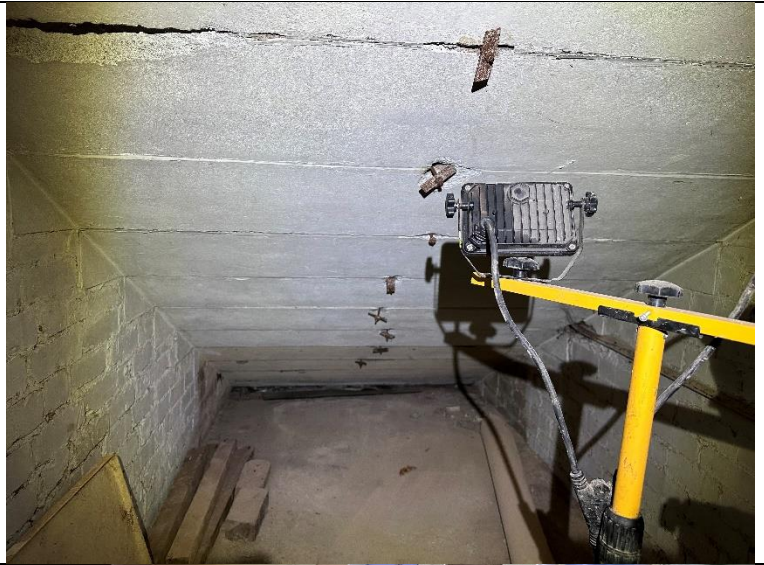
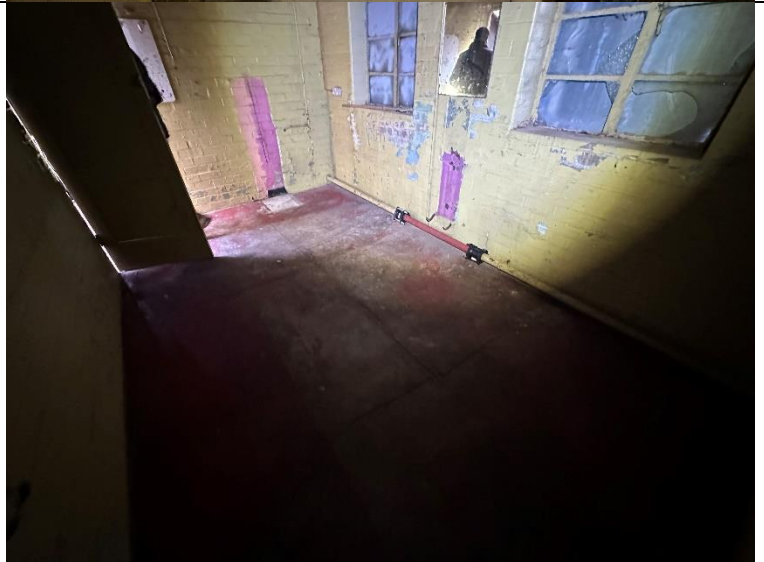
**Image 16:** Image showing internal condition of small room within the building.

**Image 17:** Image showing internal condition of small room within the building.

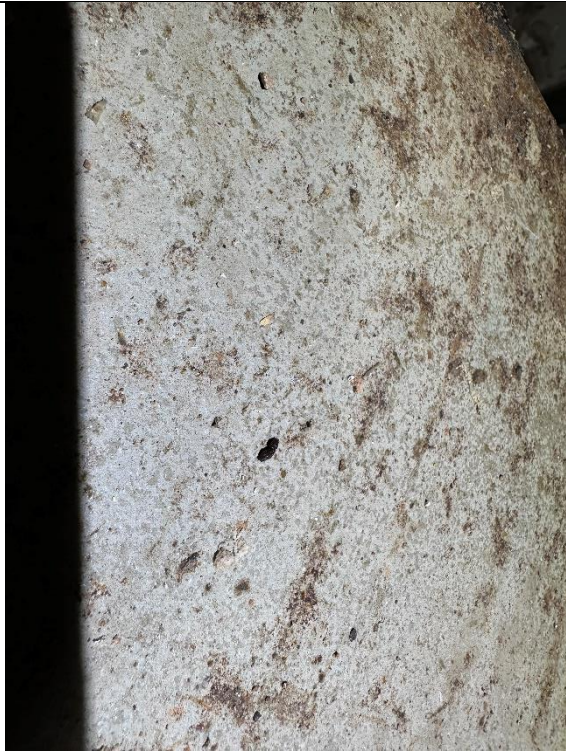
- 4.2.7. All small side rooms are well sealed with the doors shut, with the exception of a small downstairs room where a single bat dropping was found on top of an old safe. The surface was oily meaning that the dropping could not be aged. The bat dropping was indicative of that from *Pipistrellus* sp. bats. Being the only dropping found within any room of the Project, it is anticipated that this was the result of an opportunistic foraging even by a single bat.

**Image 18:** Image showing a single bat dropping found on an old safe within a small ground floor room. Bat dropping was sat on an oily surface meaning age was impossible to establish. Dropping indicative of a *Pipistrellus* sp. bat.

- 5.1.7. In line with BCT Guidance (Collins, 2023) and the UK Bat Mitigation Guidelines (Reason, P.F. and Wray, S, 2023), it is recommended that works should be undertaken under a Precautionary Works Method Statement (PWMS) approach. The PWMS should detail legal responsibilities to all contractors, bat and bat features identification, appropriate working methodologies and procedures in the eventuality a bat is identified during works (including emergency care). ecologists contact details. This should be disseminated to all contractors through a "Tool Box Talk" (TBT) ahead of an individual's commencement on site.
