## **Arboricultural Impact Assessment & Draft Arboricultural Method Statement**

**Site:** 39 Station Road, Desford, New Bungalow.

**Ref:** AIA-25-01-001NB

**Date:** 30/01/2025

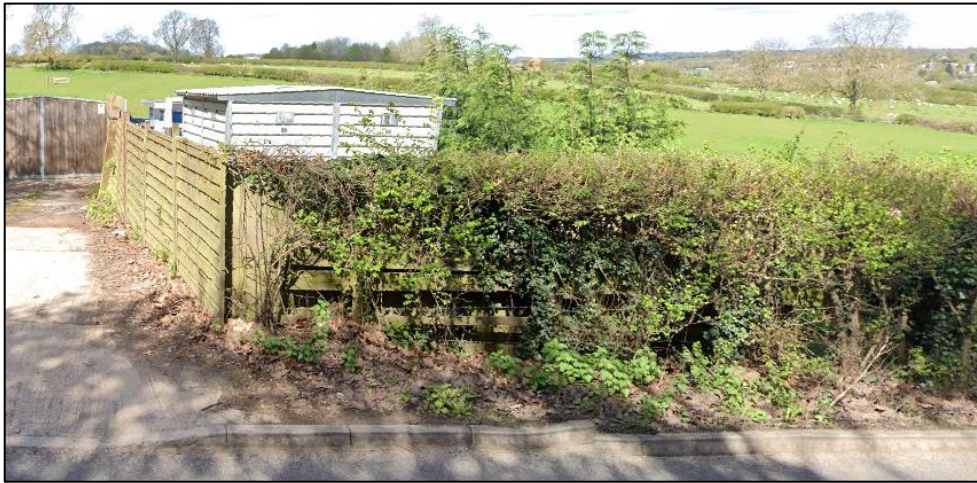
3.4.

- 3.3. The proposal will require the removal of a short section of hedge to widen the existing access. This is shown on the AIP-25-01-001 rev 2

Section of hedge to be removed, image from google Streetview.

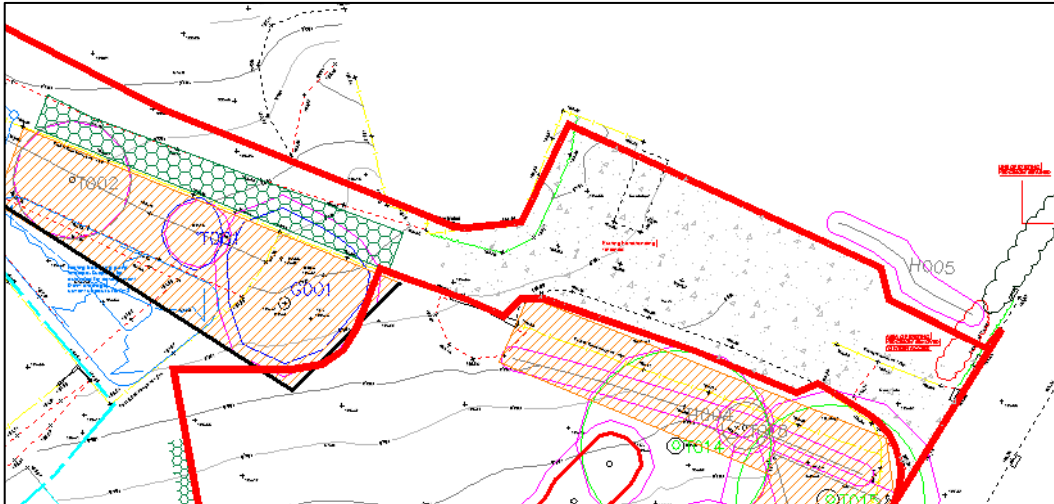
- 3.5. There is some encroachment into the root protection area of tree T002 and group G001 however there is an existing historical track in the location of the proposed access.
- 3.6. No dig construction must be used if improvement is required.
- 3.7. There is existing tarmac and gravel drive in the RPA of T014 and T015.

If improvement is required to the access for the new bungalow in the RPA of G001 and T002 a no dig cellular construction must be used.

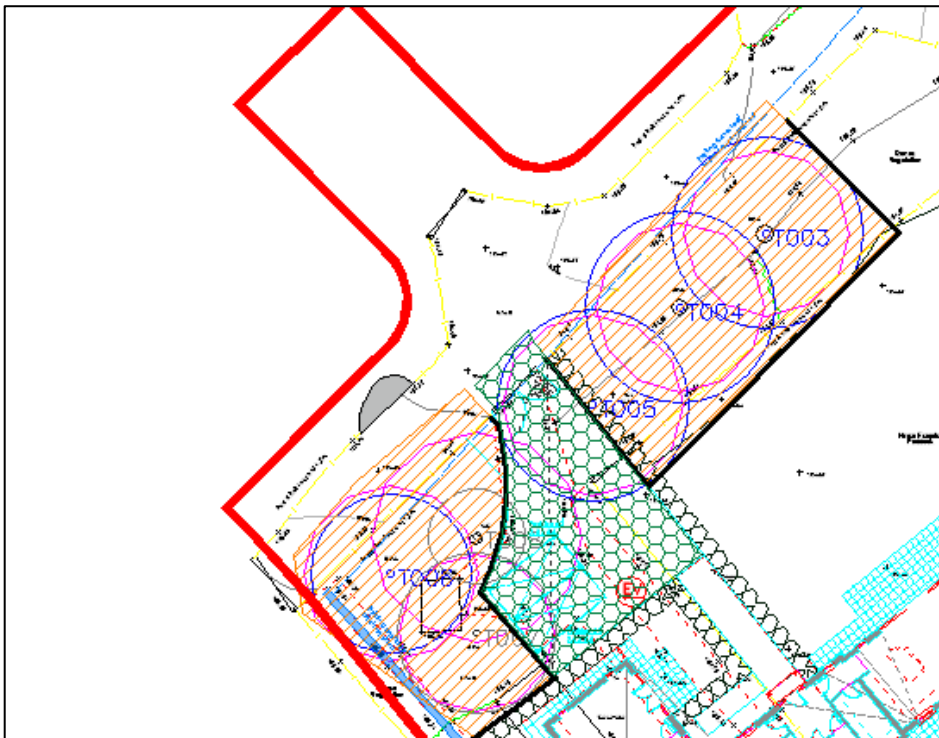
- 3.12.

- 3.8.
- 3.9. There is minor encroachment into the RPA of tree T003 and T004.
- 3.10. The impact on trees T003 and T004, is minimal and no additional measures are required as the area affected can be easily offset.
- 3.11. No dig cellular construction is required within the RPA of trees T005, T007, and T008 to provide new parking and turning space for the bungalow.

No dig cellular construction is required within the RPA of trees T005, T007, and T008 to provide new parking and turning space for the bungalow.

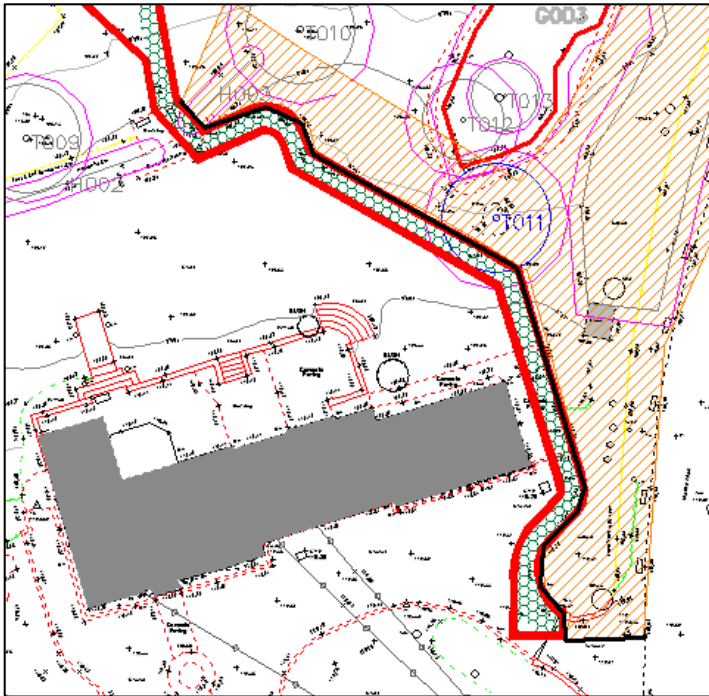
3.14.

- 3.13. The new footpath will pass through the RPA of both surveyed and unsurveyed trees. However the path will be installed using a no dig construction to protect the rooting environment of these trees so is assessed to not have any long term detrimental impact.

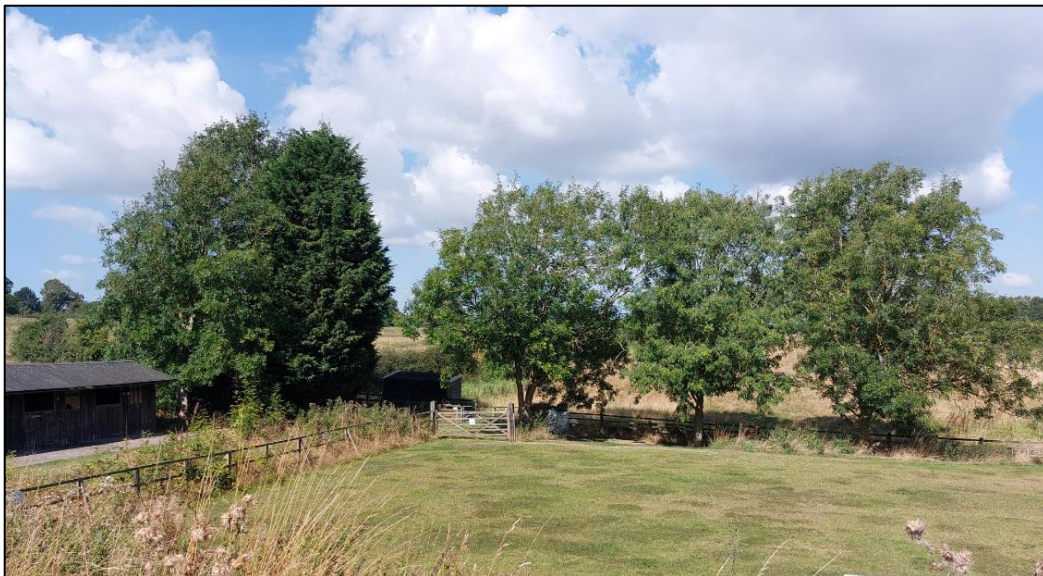
3.17.

- 3.15. Crown lifting to approximately 4-5m above ground level is required to trees T007 and T008.
- 3.16. Low branches over the access on trees T002 – T005 and G001 may also be required to prevent accidental damage from traffic.

**Trees T003 – T008 will require crown lifting.**

- 3.18. All works must be in accordance to BS3998 Tree Work recommendation 2010.
