## **Arboricultural Impact Assessment**

**Ashby Road, Hinckley**

**Report Reference: BG24.214**

**REV3 – August 2025**

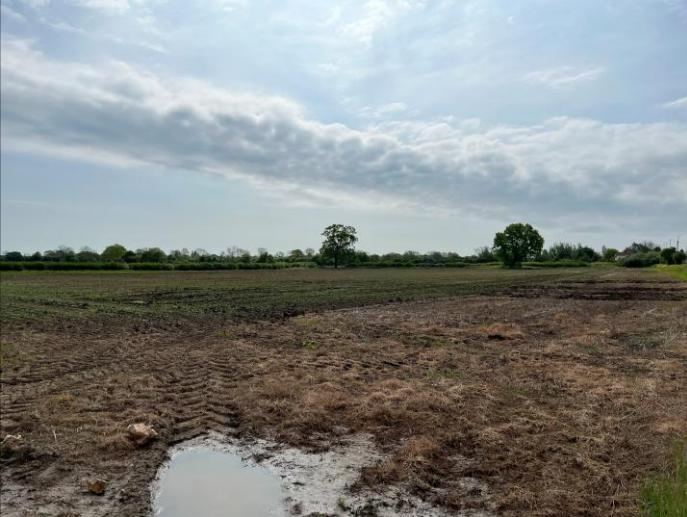
Looking south, from the northern end of the site, with T8 and T9 visible in the central background.

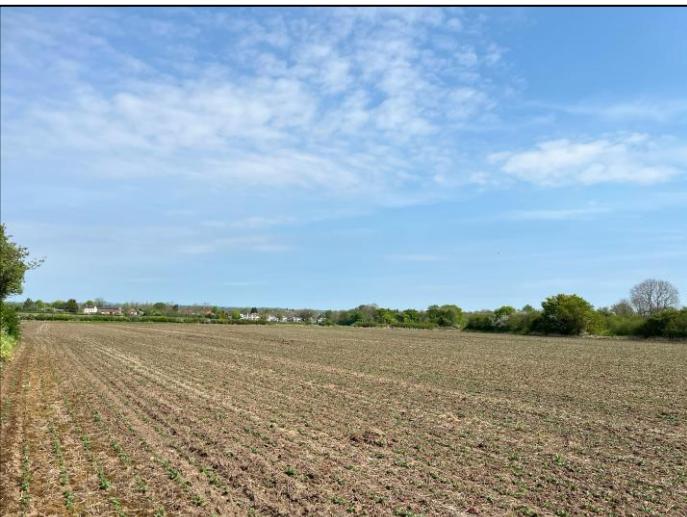
Looking east, in the southern extent of the site, with G10 visible to the right.

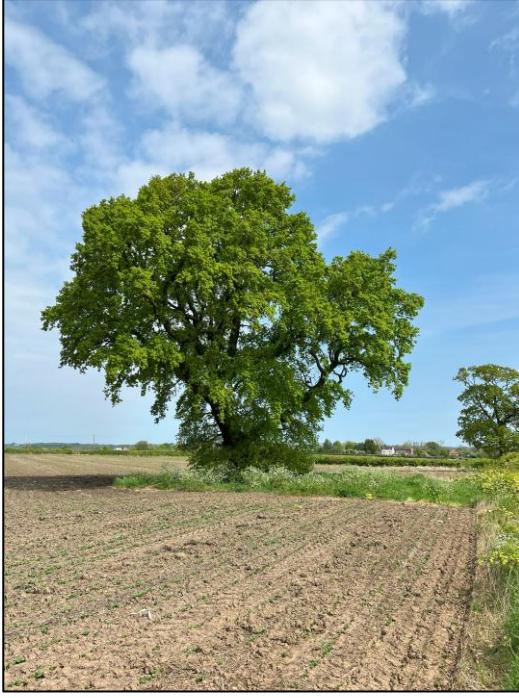
T8, a Category A common oak.

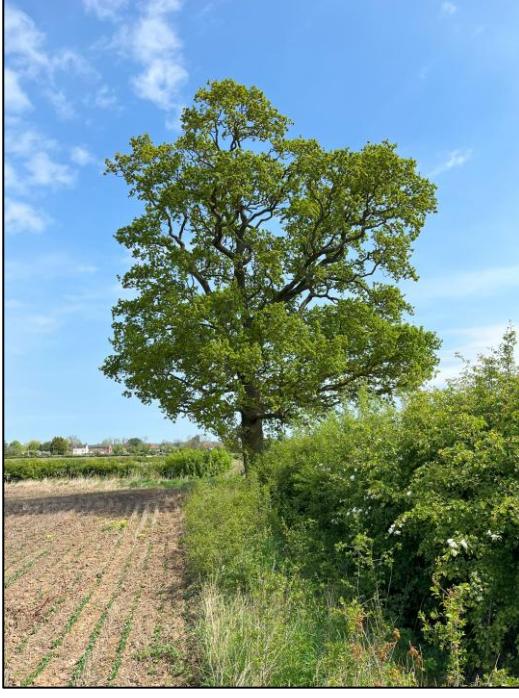
T9, a Category B common oak.
