BS5837:2012 Tree Survey  
Land at 60 Main Street  
Carlton  
Leicestershire  
NGR SK40003 05120

| | Report ref:<br><b>P2801 /0823 /02</b> | C B E Consulting<br>Highbank, 5 Grantham Road, Navenby<br>Lincoln. LN5 0JJ.<br>Telephone (01522) 810086.<br><a href="http://www.cbeconsulting.co.uk">www.cbeconsulting.co.uk</a> |

# **BS5837 Tree Survey, Land at 60 Main Street, Carlton**

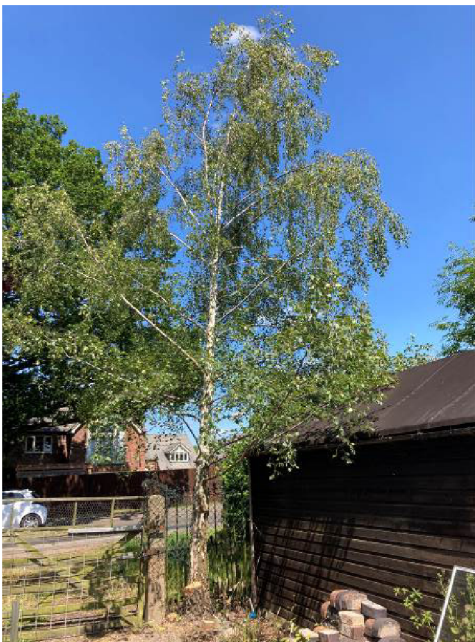
Birch T1

**Birch T1 and Lilac / Damson G2** are situated either side of the existing access facing Main Street. Both are very close to the gated entrance and show evidence of trimming back with T1 having had one trunk removed entirely. Both T1 and G2 are placed within Category C2.

| Tree No | Species | Ht (m) | Stem Diam mm@ 1.5m | Canopy Spread (m) | Height of Crown Clearance | Age Class | Est yrs | Overall Condition | Structural condition | Recommendations | BS 5837 Category | RPA Radius (m) |
|---|---|---|---|---|---|---|---|---|---|---|---|---|
| T1 | Birch<br><i>Betula pendula</i> | 8 | 155 | N-5<br>S-3<br>E-3<br>W-3 | 1 | Y | 10+ | F | One trunk removed at 250mm agl. Single remaining trunk growing through fence and crowding access. Open irregular lightly branching crown. | Damage to fence and crowding of access will require work to this tree if retained. | C2 | 1.9 |

| Ref | Tree | Category | Impact of development |
|---|---|---|---|
| 1 | Birch | C2 | Not shown on the development plan and presumably removed. |

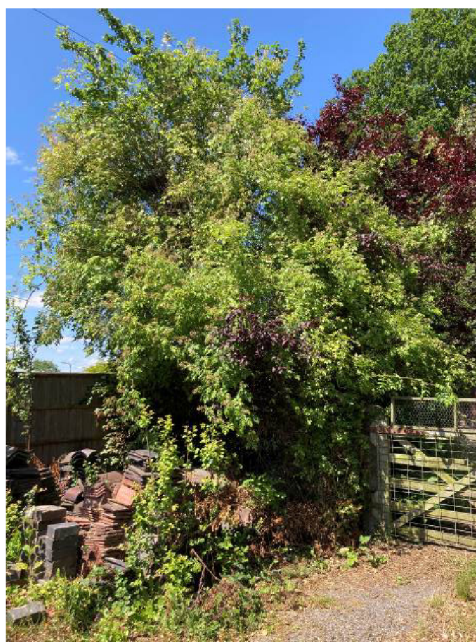
Lilac Damson G2

| Tree No | Species | Ht (m) | Stem Diam mm@ 1.5m | Canopy Spread (m) | Height of Crown Clearance | Age Class | Est yrs | Overall Condition | Structural condition | Recommendations | BS 5837 Category | RPA Radius (m) |
|---|---|---|---|---|---|---|---|---|---|---|---|---|
| G2 | Lilac<br><i>Syringa vulgaris</i><br>Damson<br><i>Prunus domestica</i> | 5/6 | <175 | Varies up to 3m | 0 | Y | 10 | F | Very dense merging growth trimmed back adjacent to the access. No structural faults visible from ground level | None | C2 | 2.1 |

| Ref | Tree | Category | Impact of development |
|---|---|---|---|
| G2 | Lilac / Damson | C2 | Not shown on the development plan and presumably removed. |

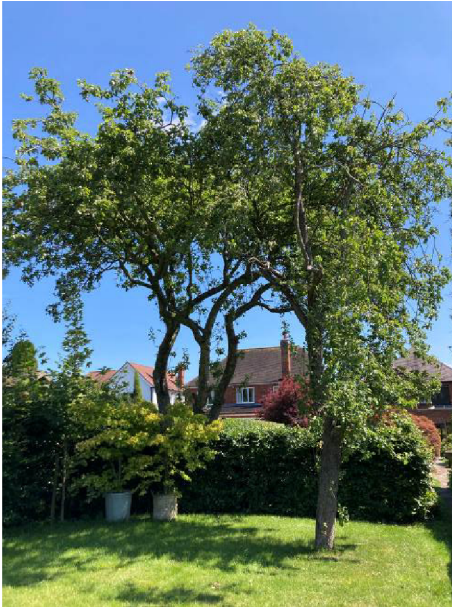
Damson T3 and Apple T4

**Trees T3 and T4** are fruit trees within the interior of the garden. Damson T3 is in poor condition and appears to be in decline and has been placed into Category U as a result. Apple T4 is larger and whilst quite old appear in good condition and has been placed into Category C2.

| Tree No | Species | Ht (m) | Stem Diam mm@ 1.5m | Canopy Spread (m) | Height of Crown Clearance | Age Class | Est yrs | Overall Condition | Structural condition | Recommendations | BS 5837 Category | RPA Radius (m) |
|---|---|---|---|---|---|---|---|---|---|---|---|---|
| T3 | Damson<br><i>Prunus domestica</i> | 6 | 230 | N-1<br>S-1<br>E-1<br>W-2 | 2 | SM | 10 | P | Irregular lifted crown with basal epicormic growth. Appears to be in decline. | In decline. Consider removal and replacement | U | 2.7 |
| T4 | Apple<br><i>Malus domestica</i> | 6 | 310<br>280<br>240 | N-4<br>S-5<br>E-3<br>W-5 | 3 | M | 10+ | F | Very open and irregular crown. No structural faults visible from ground level | None | C2 | 5.7 |

| Ref | Tree | Category | Impact of development |
|---|---|---|---|
| 3 | Damson | U | Shown as being retained within the garden of Plot 2. RPA and canopy can be fully protected by fencing during any construction works |
| 4 | Apple | C2 | Shown as being retained outside of the garden of Plot 2. RPA and canopy can be fully protected by fencing during any construction works |

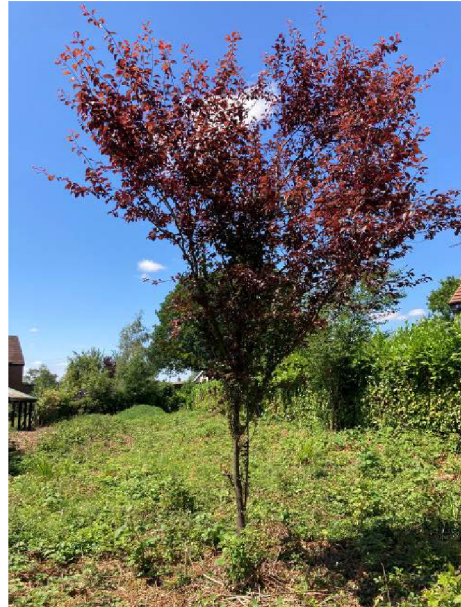
Purple Damson T5

**Purple Damson T5 and Cherry T6** are juvenile trees of small stature located within the former garden area comprising the northern part of the survey area. T5 is a solitary specimen tree within the central part of the former garden but T6 is a Cherry which is crowded by the large Cherry Laurel hedge to the north and may be a result of suckering. Both trees are placed within Category C2. **Ash T8** is a similar small sapling positioned at the western end of this former garden growing out of the hedgerow (H12) and also placed within Category C2.

| Tree No | Species | Ht (m) | Stem Diam mm@ 1.5m | Canopy Spread (m) | Height of Crown Clearance | Age Class | Est yrs | Overall Condition | Structural condition | Recommendations | BS 5837 Category | RPA Radius (m) |
|---|---|---|---|---|---|---|---|---|---|---|---|---|
| T5 | Purple Damson<br><i>Prunus domestica</i> | 3 | 50 | N-1<br>S-1<br>E-1<br>W-1 | 1 | Y | 10 | F | Lightly branching ascending crown. No structural faults visible from ground level | None | C2 | 1.8 |

| Ref | Tree | Category | Impact of development |
|---|---|---|---|
| 5 | Purple Damson | C2 | This tree will presumably be removed as it is not shown within the garden of Plot 1. |

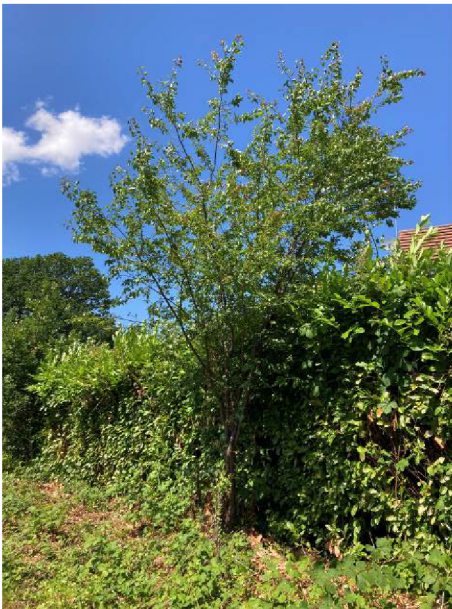
Cherry T6

| Tree No | Species | Ht (m) | Stem Diam mm@ 1.5m | Canopy Spread (m) | Height of Crown Clearance | Age Class | Est yrs | Overall Condition | Structural condition | Recommendations | BS 5837 Category | RPA Radius (m) |
|---|---|---|---|---|---|---|---|---|---|---|---|---|
| T6 | Cherry<br><i>Prunus avium</i> | 3 | 50<br>50<br>40<br>30 | N-1<br>S-1<br>E-1<br>W-1 | 1 | Y | 10 | F | Crowded by the hedge. No structural faults visible from ground level | None | C2 | 1.8 |

| Ref | Tree | Category | Impact of development |
|---|---|---|---|
| 6 | Cherry | C2 | This tree will presumably be removed as it is not shown within the garden of Plot 1. |

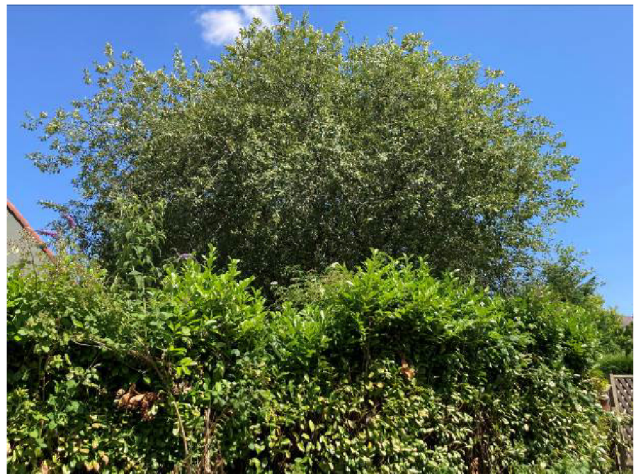
Goat Willow T7 behind H11

**Goat Willow T7** is situated in the garden to the north of the survey area behind the Cherry Laurel hedge (H11). This has a large, dense round crown which is visible from the survey area and appears to be around 4-5m back from the hedge. The crown of this tree does not extend past the hedge and the tree has been placed into Category B2.

| Tree No | Species | Ht (m) | Stem Diam mm@ 1.5m | Canopy Spread (m) | Height of Crown Clearance | Age Class | Est yrs | Overall Condition | Structural condition | Recommendations | BS 5837 Category | RPA Radius (m) |
|---|---|---|---|---|---|---|---|---|---|---|---|---|
| T7 | Goat Willow<br><i>Salix caprea</i> | 7 | 300est | N-4<br>S-3<br>E-3<br>W-4 | 1 | SM | 20 | F | Dense round crown reaching the boundary hedge but not extending across this. No structural faults visible from ground level | None | B2 | 3.6 |

| Ref | Tree | Category | Impact of development |
|---|---|---|---|
| 7 | Goat Willow | | Shown as being retained outside of the garden of Plot . RPA and canopy not impacted by any construction works |

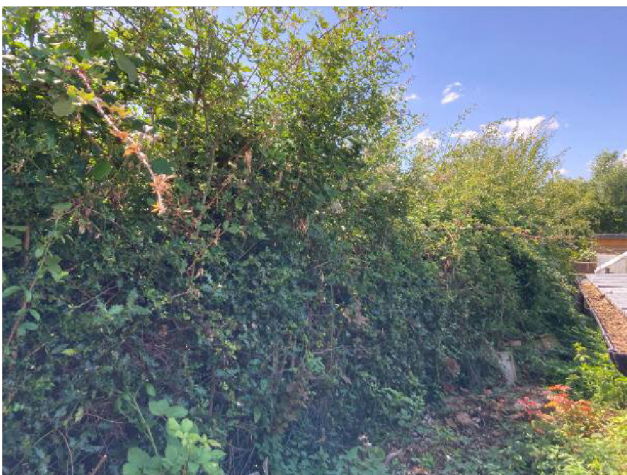
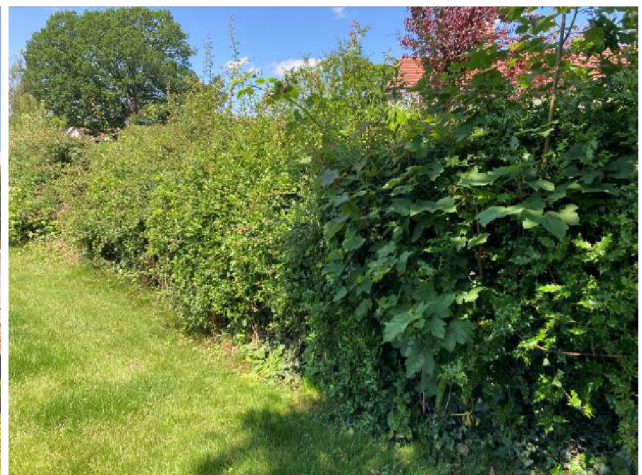
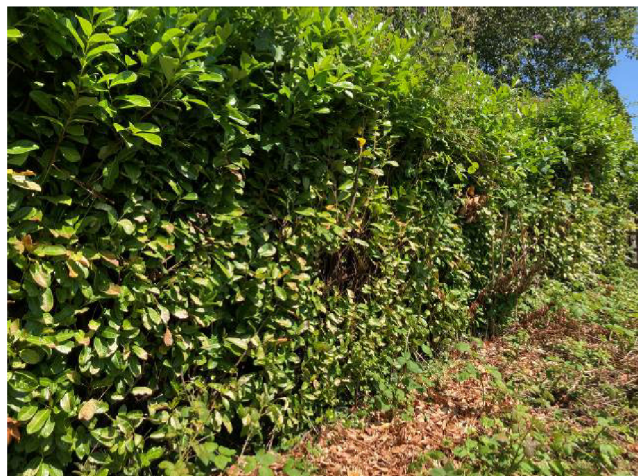
There are three hedgerows around the boundaries of the survey area and one crossing the centre. H9 and H12 comprise Hawthorn and Blackthorn with other species such as Elm and Beech present. H10 and H11 are dominated by Cherry Laurel with some Holly and Hawthorn.

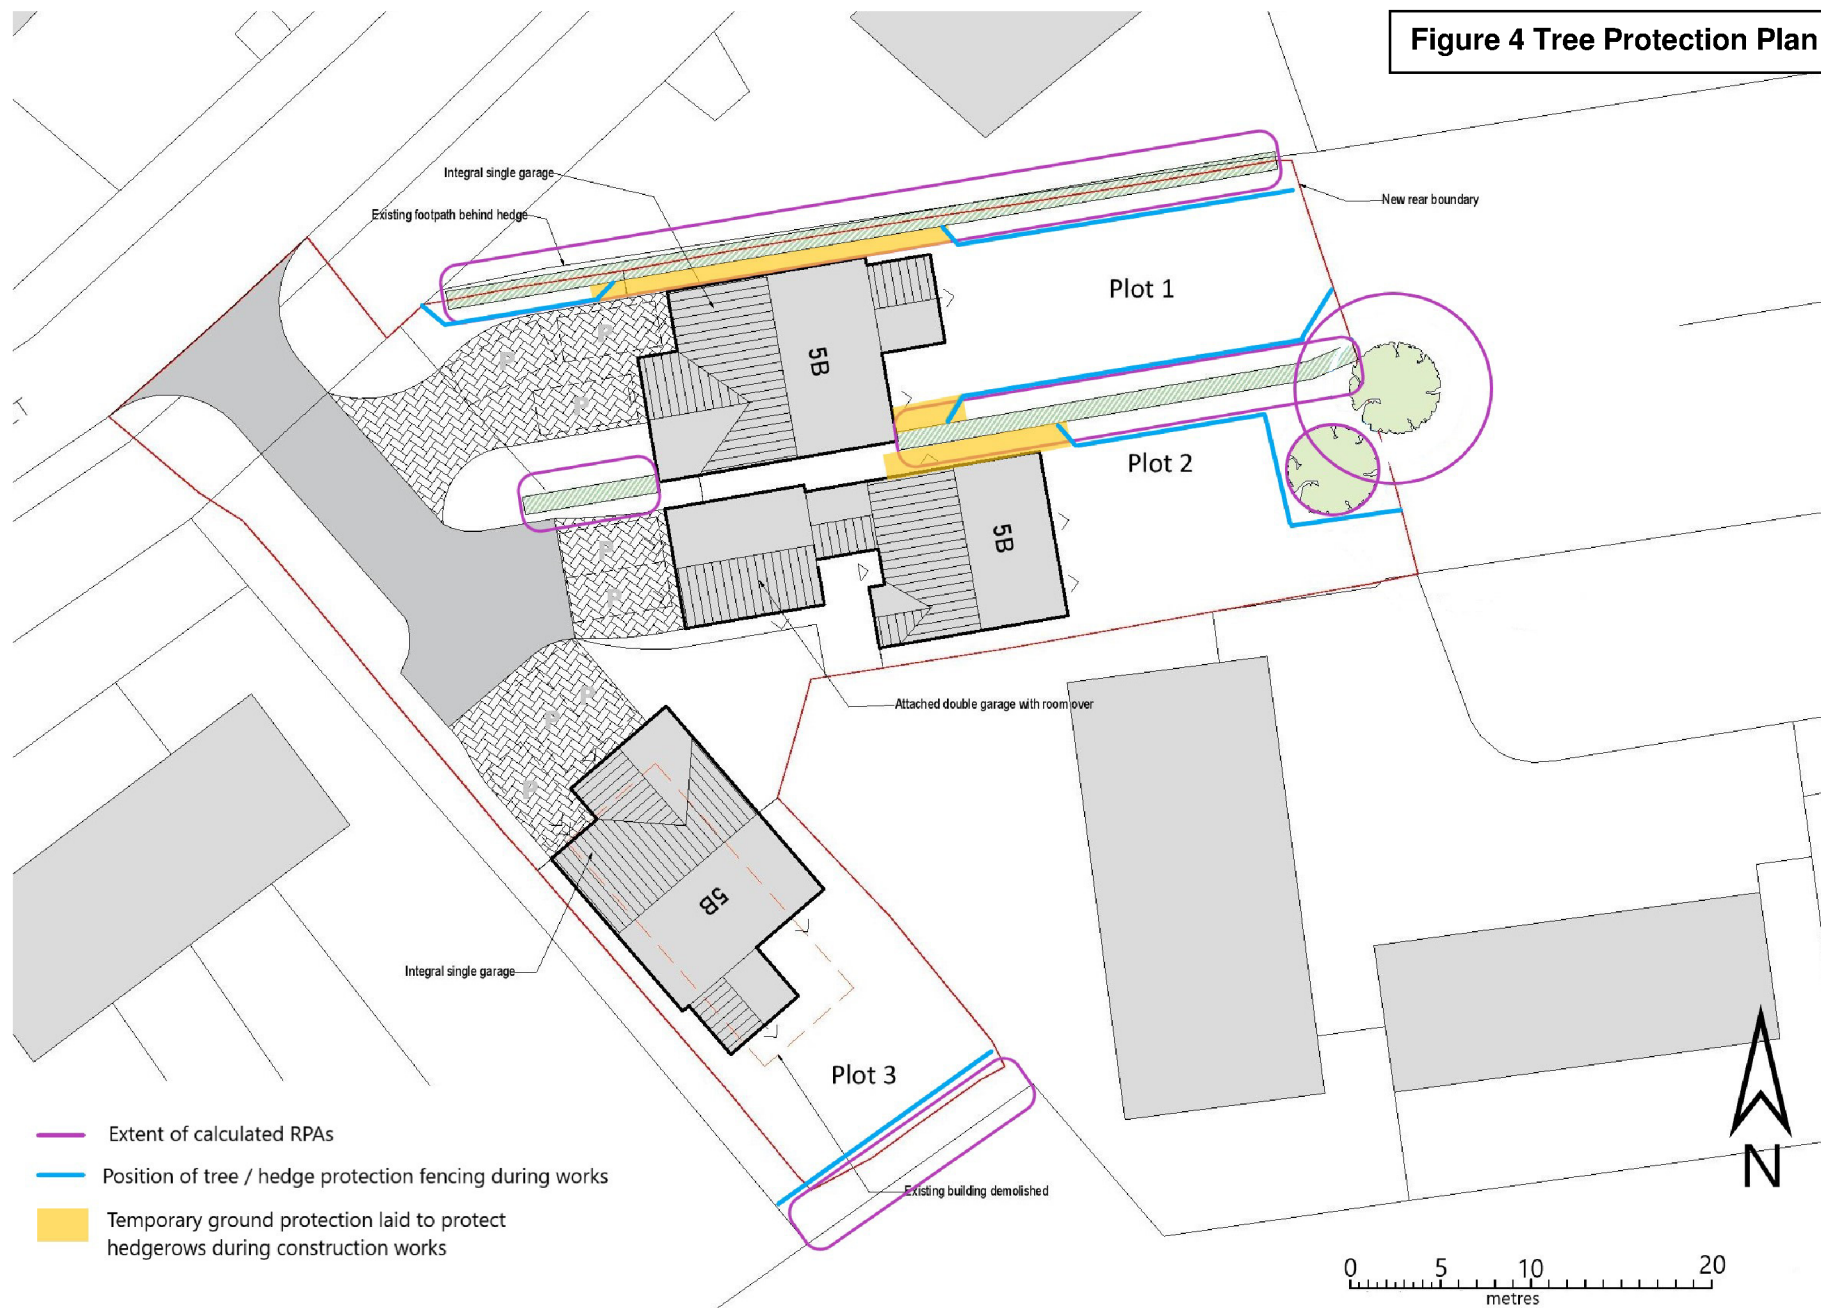
Figure 4 Tree Protection Plan

In the context of this site the proposed development is shown within **Figure 4** and this has been used to assess the impact of the development and determine the protection measures that will be required. The table below summarises the potential impact of the proposed development on the trees and hedgerows present within the area surveyed.
