BS5837:2012 Tree Survey  
Land at 82 Main Street  
Carlton  
Leicestershire  
NGR SK40003 05120

Survey by  
Christopher Barker CEnv dipHort ACIEEM

# **BS5837 Tree Survey, Land at 60 Main Street, Carlton**

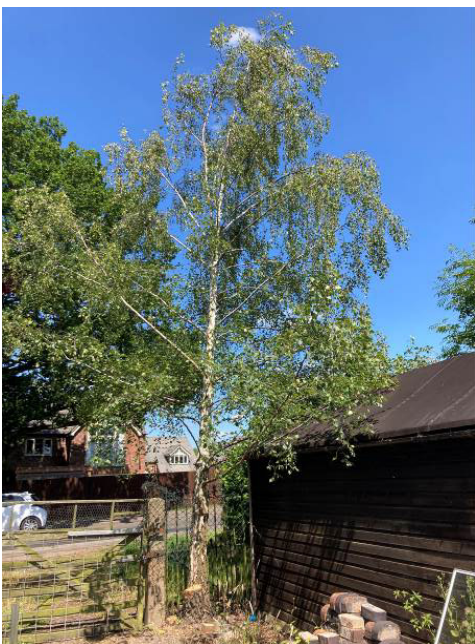
Birch T1

**Birch T1 and Lilac / Damson G2** are situated either side of the existing access facing Main Street. Both are very close to the gated entrance and show evidence of trimming back with T1 having had one trunk removed entirely. Both T1 and G2 are placed within Category C2.

| Tree No | Species | Ht (m) | Stem Diam mm@ 1.5m | Canopy Spread (m) | Height of Crown Clearance | Age Class | Est yrs | Overall Condition | Structural condition | Recommendations | BS 5837 Category | RPA Radius (m) |
|---|---|---|---|---|---|---|---|---|---|---|---|---|
| T1 | Birch<br><i>Betula pendula</i> | 8 | 155 | N-5<br>S-3<br>E-3<br>W-3 | 1 | Y | 10+ | F | One trunk removed at 250mm agl. Single remaining trunk growing through fence and crowding access. Open irregular lightly branching crown. | Damage to fence and crowding of access will require work to this tree if retained. | C2 | 1.9 |

| Ref | Tree | Category | Impact of development |
|---|---|---|---|
| 1 | Birch | C2 | Not shown on the development plan and presumably removed. |

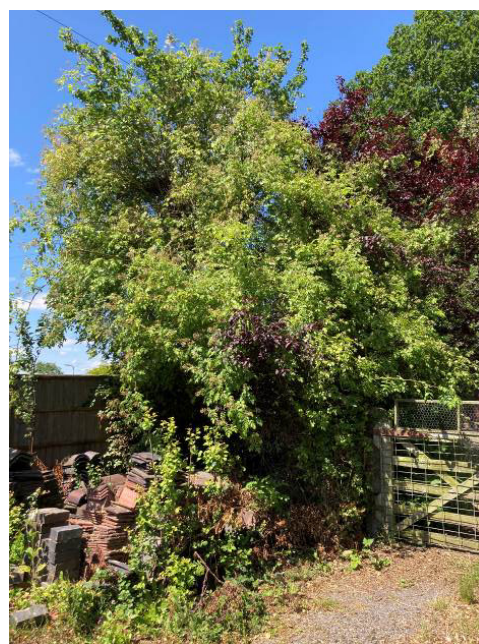
Lilac Damson G2

| Tree No | Species | Ht (m) | Stem Diam mm@ 1.5m | Canopy Spread (m) | Height of Crown Clearance | Age Class | Est yrs | Overall Condition | Structural condition | Recommendations | BS 5837 Category | RPA Radius (m) |
|---|---|---|---|---|---|---|---|---|---|---|---|---|
| G2 | Lilac<br><i>Syringa vulgaris</i><br>Damson<br><i>Prunus domestica</i> | 5/6 | <175 | Varies up to 3m | 0 | Y | 10 | F | Very dense merging growth trimmed back adjacent to the access. No structural faults visible from ground level | None | C2 | 2.1 |

| Ref | Tree | Category | Impact of development |
|---|---|---|---|
| G2 | Lilac / Damson | C2 | Not shown on the development plan and presumably removed. |

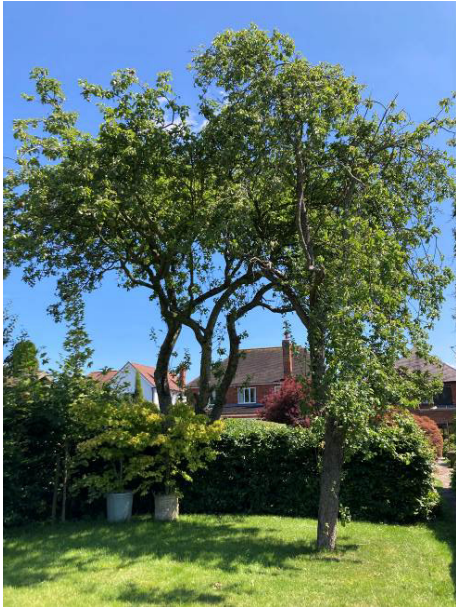
Damson T3 and Apple T4

**Trees T3 and T4** are fruit trees within the interior of the garden. Damson T3 is in poor condition and appears to be in decline and has been placed into Category U as a result. Apple T4 is larger and whilst quite old appear in good condition and has been placed into Category C2.

| Tree No | Species | Ht (m) | Stem Diam mm@ 1.5m | Canopy Spread (m) | Height of Crown Clearance | Age Class | Est yrs | Overall Condition | Structural condition | Recommendations | BS 5837 Category | RPA Radius (m) |
|---|---|---|---|---|---|---|---|---|---|---|---|---|
| T3 | Damson<br><i>Prunus domestica</i> | 6 | 230 | N-1<br>S-1<br>E-1<br>W-2 | 2 | SM | 10 | P | Irregular lifted crown with basal epicormic growth. Appears to be in decline. | In decline. Consider removal and replacement | U | 2.7 |
| T4 | Apple<br><i>Malus domestica</i> | 6 | 310<br>280<br>240 | N-4<br>S-5<br>E-3<br>W-5 | 3 | M | 10+ | F | Very open and irregular crown. No structural faults visible from ground level | None | C2 | 5.7 |

| Ref | Tree | Category | Impact of development |
|---|---|---|---|
| 3 | Damson | U | Shown as being retained within the garden of Plot 2. RPA and canopy can be fully protected by fencing during any construction works |
| 4 | Apple | C2 | Shown as being retained outside of the garden of Plot 2. RPA and canopy can be fully protected by fencing during any construction works |

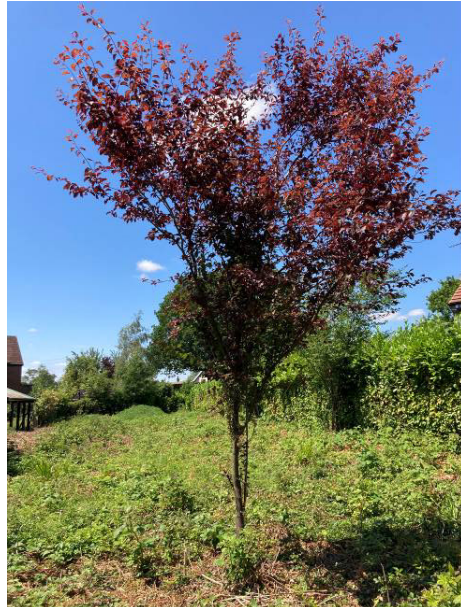
Purple Damson T5

**Purple Damson T5 and Cherry T6** are juvenile trees of small stature located within the former garden area comprising the northern part of the survey area. T5 is a solitary specimen tree within the central part of the former garden but T6 is a Cherry which is crowded by the large Cherry Laurel hedge to the north and may be a result of suckering. Both trees are placed within Category C2. **Ash T8** is a similar small sapling positioned at the western end of this former garden growing out of the hedgerow (H12) and also placed within Category C2.

| Tree No | Species | Ht (m) | Stem Diam mm@ 1.5m | Canopy Spread (m) | Height of Crown Clearance | Age Class | Est yrs | Overall Condition | Structural condition | Recommendations | BS 5837 Category | RPA Radius (m) |
|---|---|---|---|---|---|---|---|---|---|---|---|---|
| T5 | Purple Damson<br><i>Prunus domestica</i> | 3 | 50 | N-1<br>S-1<br>E-1<br>W-1 | 1 | Y | 10 | F | Lightly branching ascending crown. No structural faults visible from ground level | None | C2 | 1.8 |

| Ref | Tree | Category | Impact of development |
|---|---|---|---|
| 5 | Purple Damson | C2 | This tree will presumably be removed as it is not shown within the garden of Plot 1. |

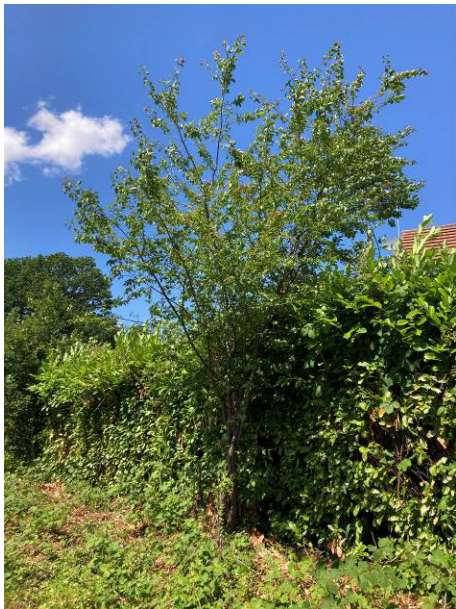
Cherry T6

| Tree No | Species | Ht (m) | Stem Diam mm@ 1.5m | Canopy Spread (m) | Height of Crown Clearance | Age Class | Est yrs | Overall Condition | Structural condition | Recommendations | BS 5837 Category | RPA Radius (m) |
|---|---|---|---|---|---|---|---|---|---|---|---|---|
| T6 | Cherry<br><i>Prunus avium</i> | 3 | 50<br>50<br>40<br>30 | N-1<br>S-1<br>E-1<br>W-1 | 1 | Y | 10 | F | Crowded by the hedge. No structural faults visible from ground level | None | C2 | 1.8 |

| Ref | Tree | Category | Impact of development |
|---|---|---|---|
| 6 | Cherry | C2 | This tree will presumably be removed as it is not shown within the garden of Plot 1. |

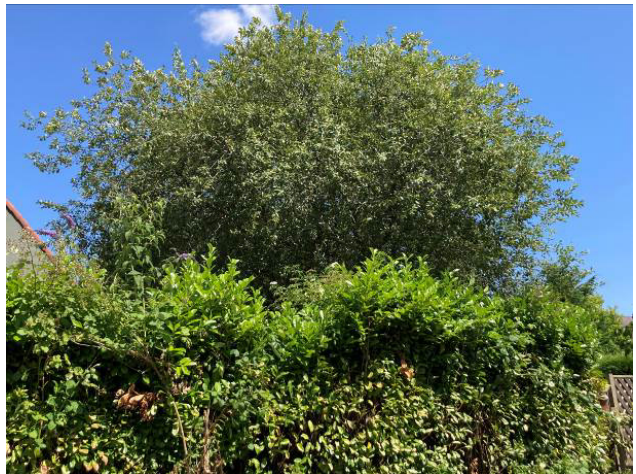
Goat Willow T7 behind H11

**Goat Willow T7** is situated in the garden to the north of the survey area behind the Cherry Laurel hedge (H11). This has a large, dense round crown which is visible from the survey area and appears to be around 4-5m back from the hedge. The crown of this tree does not extend past the hedge and the tree has been placed into Category B2.

| Tree No | Species | Ht (m) | Stem Diam mm@ 1.5m | Canopy Spread (m) | Height of Crown Clearance | Age Class | Est yrs | Overall Condition | Structural condition | Recommendations | BS 5837 Category | RPA Radius (m) |
|---|---|---|---|---|---|---|---|---|---|---|---|---|
| T7 | Goat Willow<br><i>Salix caprea</i> | 7 | 300est | N-4<br>S-3<br>E-3<br>W-4 | 1 | SM | 20 | F | Dense round crown reaching the boundary hedge but not extending across this. No structural faults visible from ground level | None | B2 | 3.6 |

| Ref | Tree | Category | Impact of development |
|---|---|---|---|
| 7 | Goat Willow | | Shown as being retained outside of the garden of Plot . RPA and canopy not impacted by any construction works |

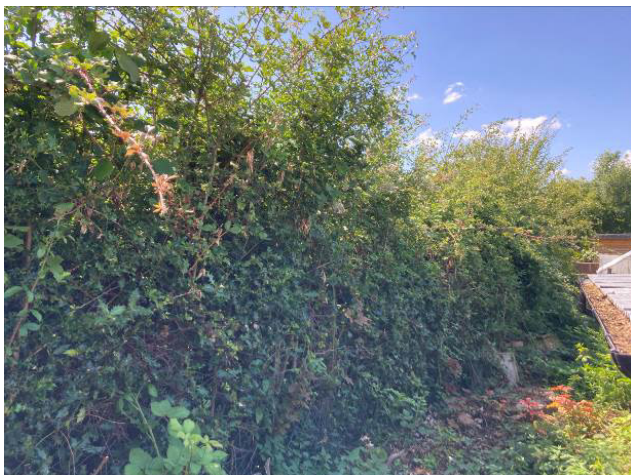
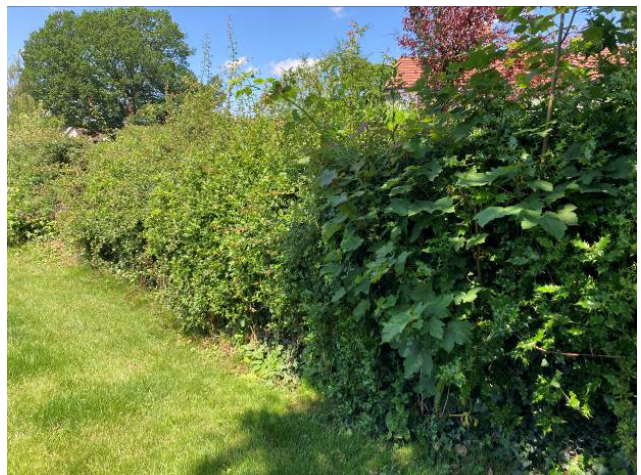
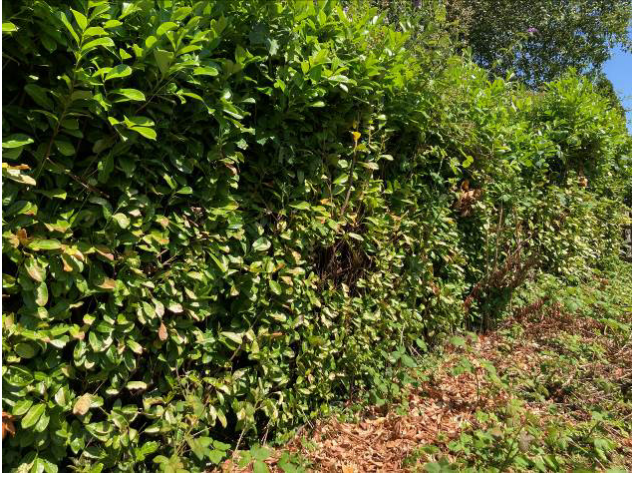
There are three hedgerows around the boundaries of the survey area and one crossing the centre. H9 and H12 comprise Hawthorn and Blackthorn with other species such as Elm and Beech present. H10 and H11 are dominated by Cherry Laurel with some Holly and Hawthorn.

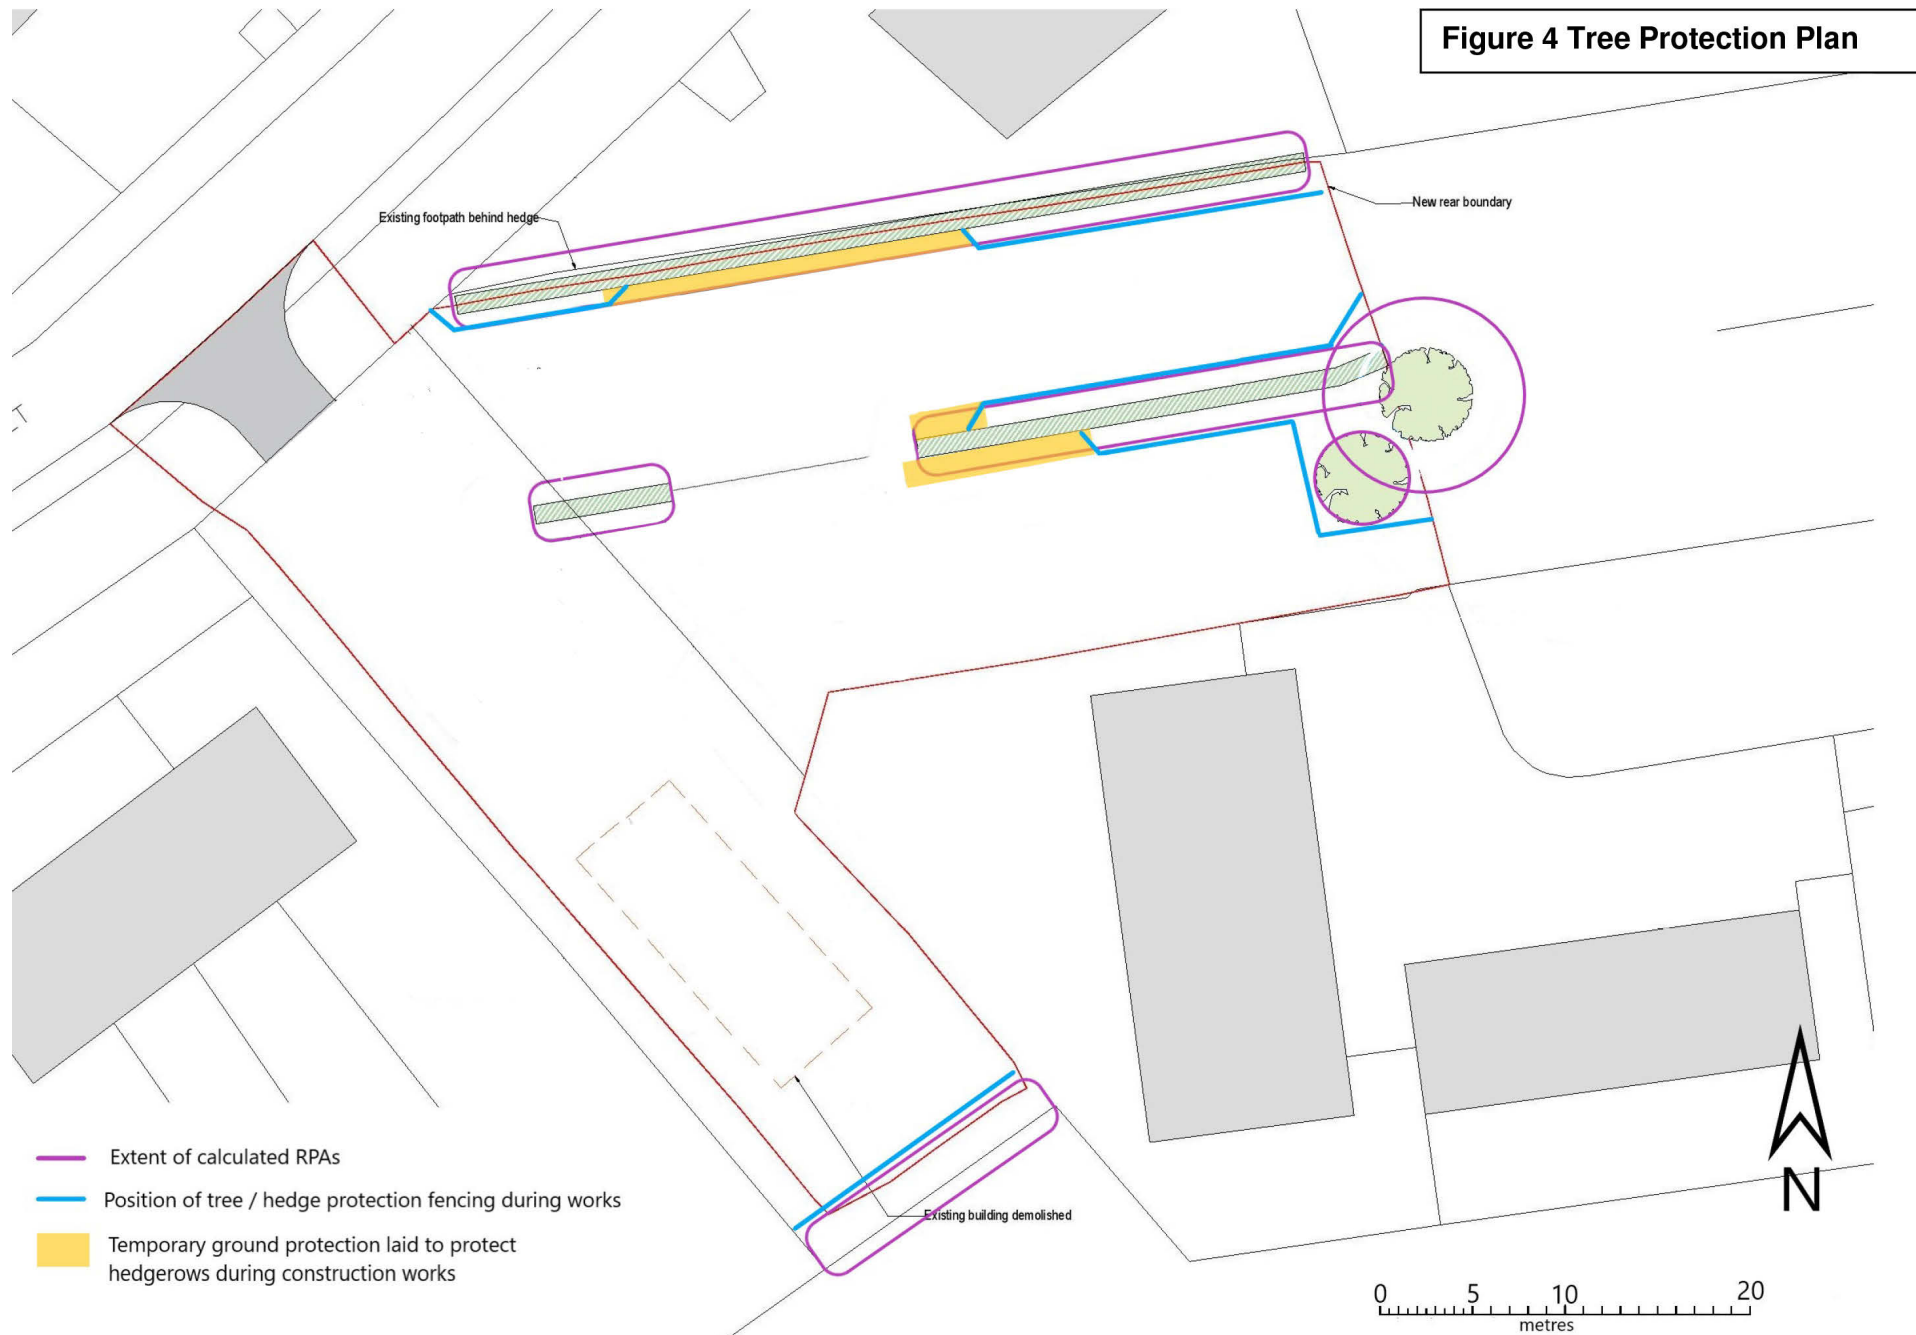
**Figure 4 Tree Protection Plan**

In the context of this site the proposed development is shown within **Figure 4** and this has been used to assess the impact of the development and determine the protection measures that will be required. The table below summarises the potential impact of the proposed development on the trees and hedgerows present within the area surveyed.
