## **PHASE 1 BAT & NESTING BIRD SURVEY**

**Poplars Farm, Sutton Lane, Dadlington,  
Nuneaton, Warwickshire, CV13 6JA**

20<sup>th</sup> October 2025

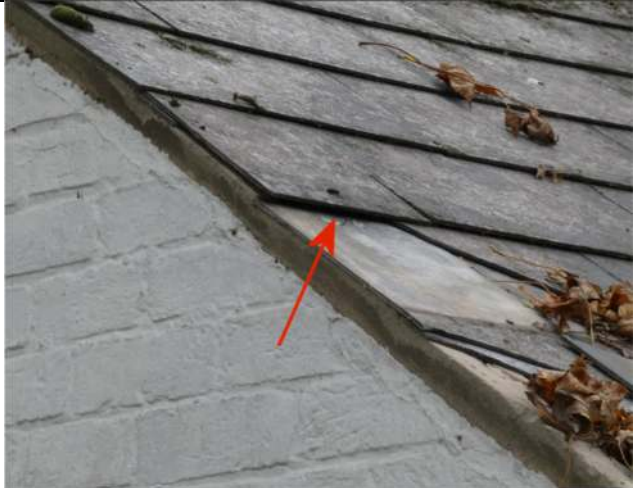
Photograph 13. Slip tile on the 2 section at the north-west end of the Farmhouse

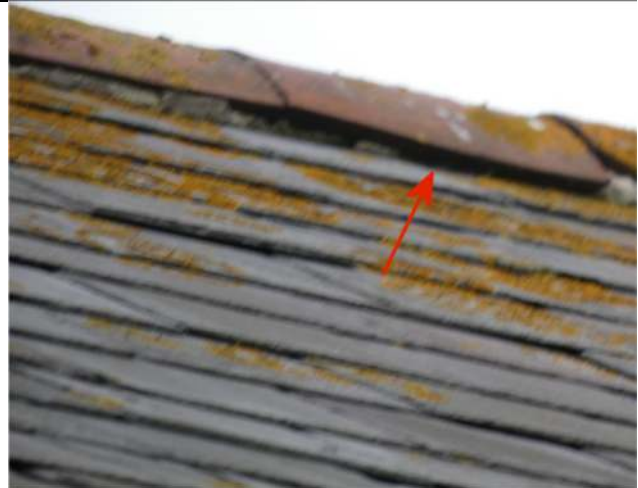
Photograph 14. Possible opening under a ridge tile on the north-east facing roof pitch of the main part of the Farmhouse

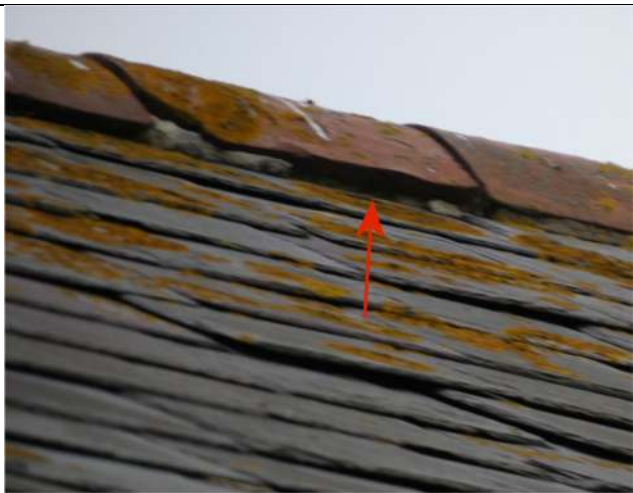
Photograph 15. Further example of a possible opening under a ridge tile on the north-east facing roof pitch of the main part of the Farmhouse

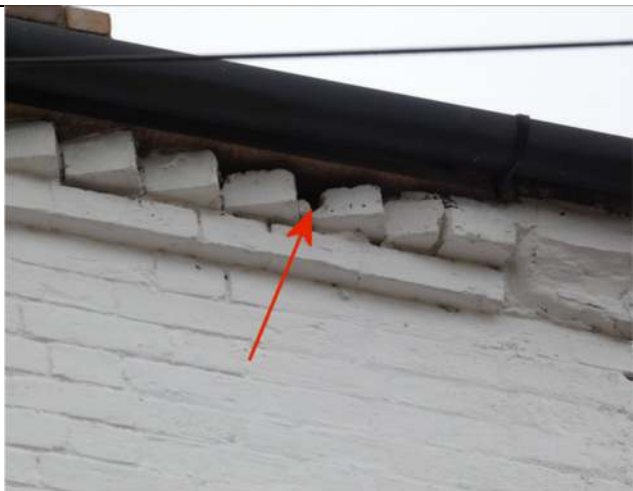
Photograph 17. Opening in the corbelling at the south-east end of the south-west side of the Farmhouse

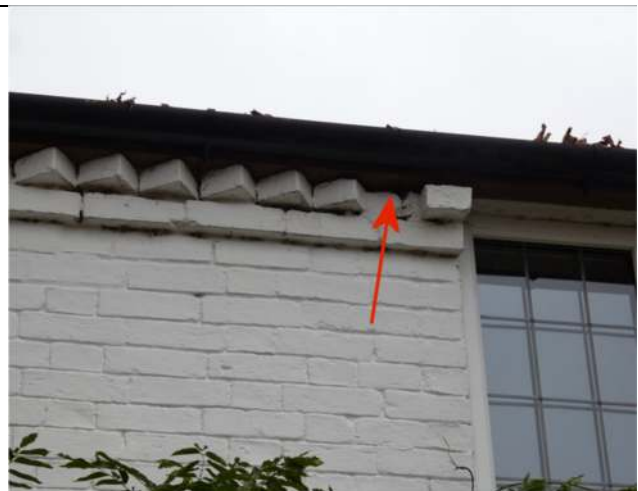
Photograph 18. Opening in the corbelling on the two-section at the north-west end of the Farmhouse

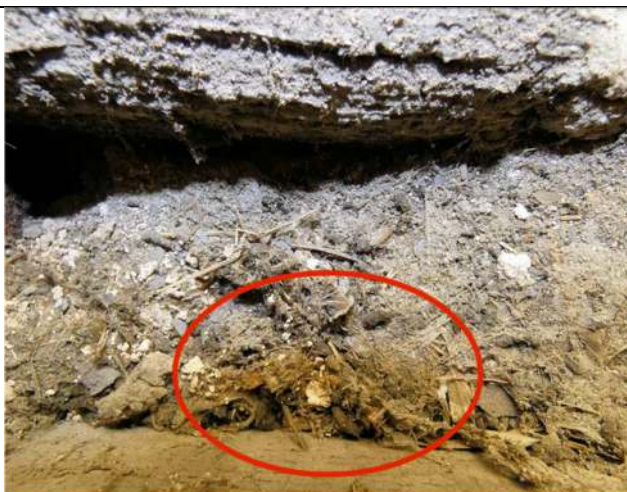
Photograph 23. Old bat droppings at the edge of the enclosed roof void in the south-east half of the main part of the Farmhouse

- A licensed ecologist will be appointed by the owner/developer before work starts to oversee re-roofing.
- Contractors will be given a “toolbox talk” by the licensed ecologist at the commencement of works so that they are aware of the particular issues relating to bats at this site and their responsibilities in the event of a bat being found in the absence of a licensed ecologist.

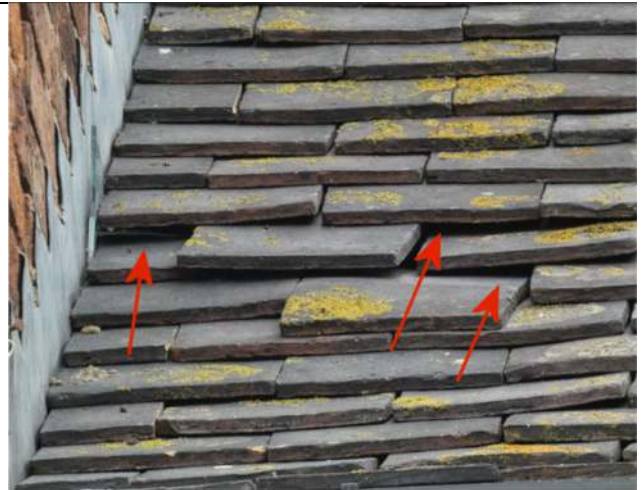
Photograph 32. Example of openings under tiles on the roof of The Granary (south-west facing roof pitch)

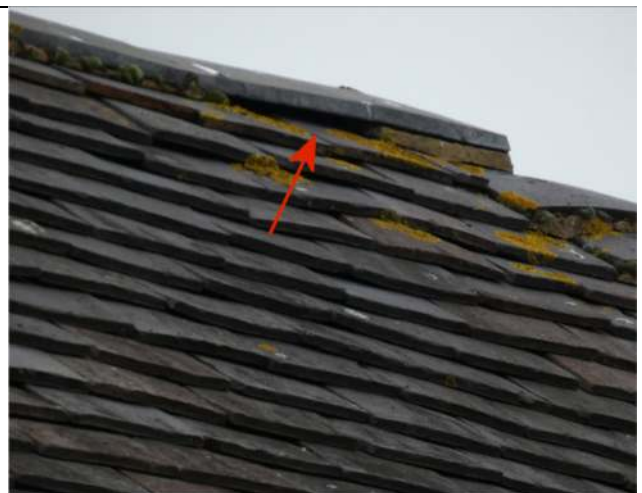
Photograph 34. Example of an opening under a ridge tile on the south-east facing roof pitch of the Granary

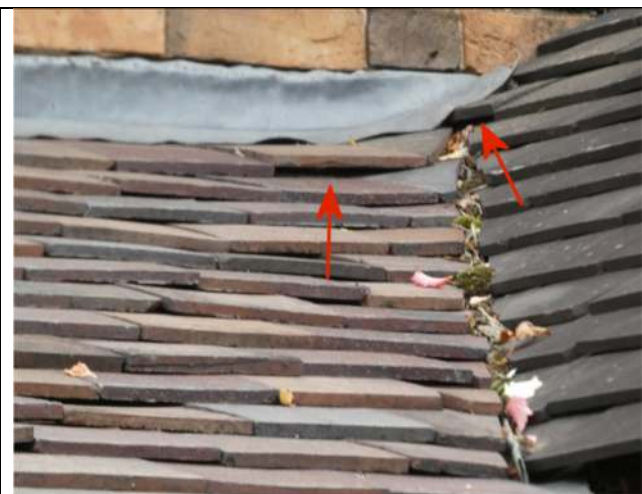
Photograph 35. Example of openings under tiles on the single-storey section at the south-east end of The Granary

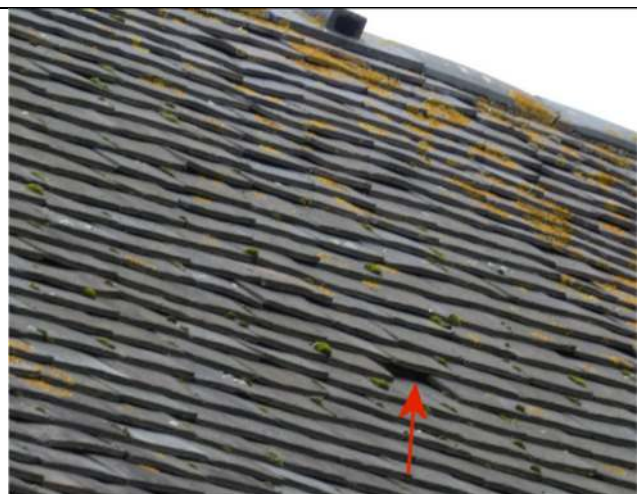
Photograph 36. Example of a missing tile on the north-east facing roof pitch of The Granary

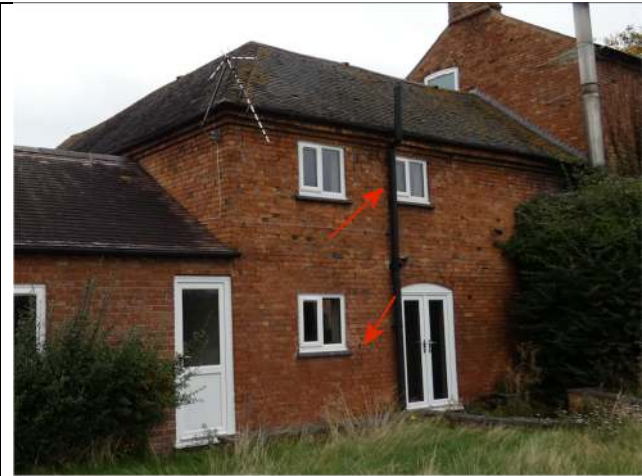
Photograph 37. Location of crevices in the brickwork on the north-east side of The Granary

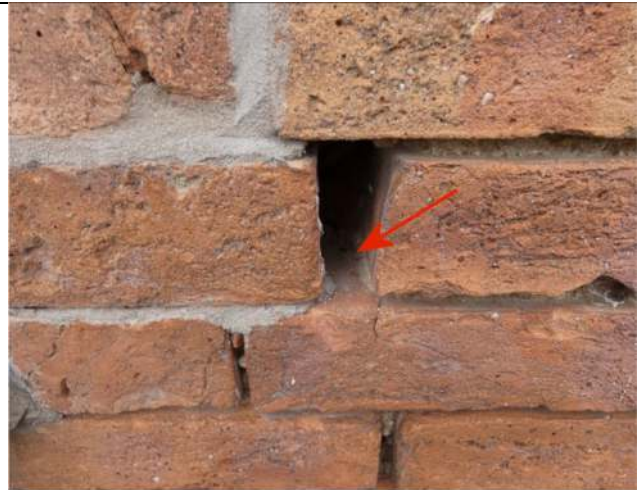
Photograph 38. Single bat dropping in a crevice in the brickwork on the north-east side of The Granary

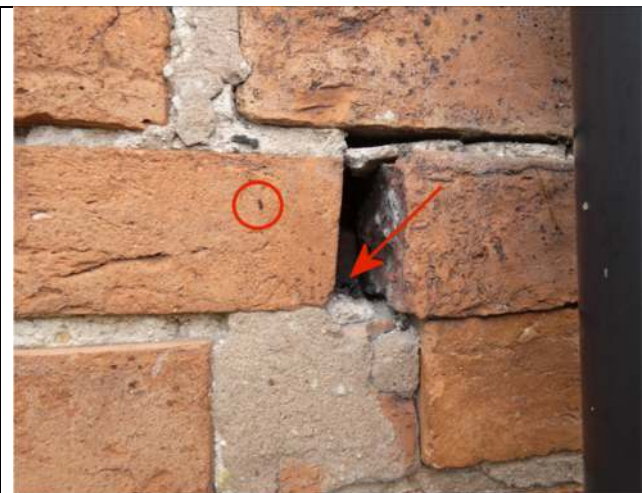
Photograph 39. Bat droppings in a crevice in the brickwork on the north-east side of The Granary

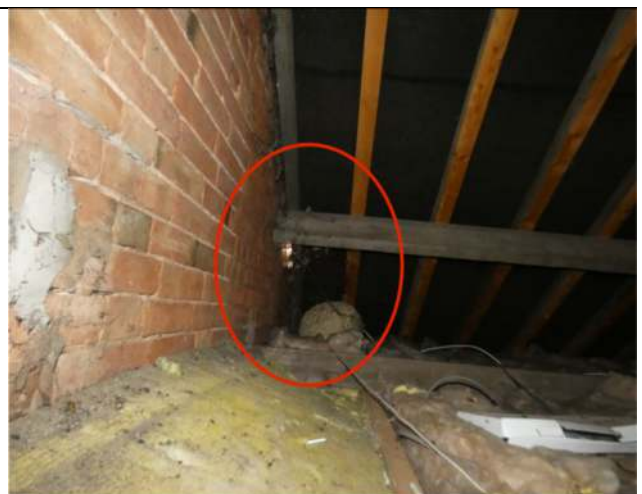
Photograph 42. Active wasp nest within the enclosed roof void within the single-storey section at the north-east end of The Granary

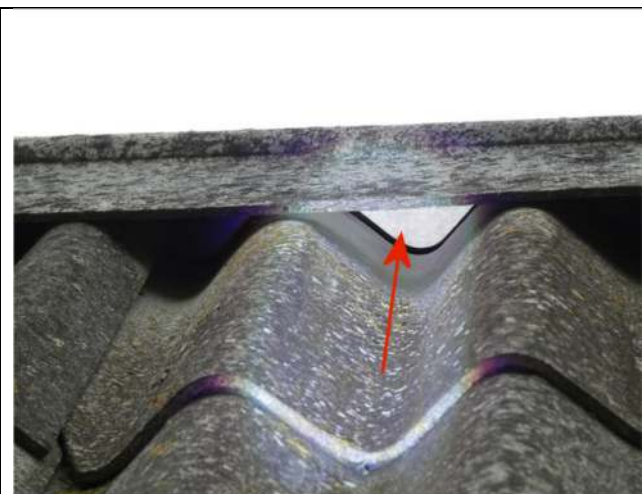
Photograph 47. Example of a shallow cavity under the ridge covering on Barn 3

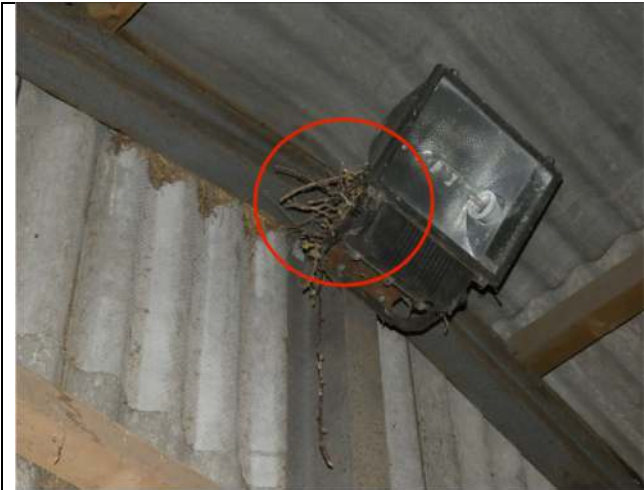
The proposed work to Barns 3, 5, 8 and 17 will result in the loss of wren and pigeon nesting. In Britain, all wild birds are granted legal protection under the Wildlife & Countryside Act 1981 (as amended), the Bern Convention and the EC Birds Directive. The legislation protects the birds and their eggs and nests while being built or in use. This protection makes it an offence to intentionally kill, injure, take or have in possession any wild bird or egg. It is also an offence to intentionally damage or destroy the nest of any wild bird while it is being built or in use. Therefore, the following must be adhered to:

Photograph 49. Pigeon nest within the interior of Barn 3

- Work to the barns must not be carried out between March and September unless it can be proved that breeding birds and their young are absent when works commence or a suitable buffer zone can be implemented. Consequently, an inspection of the building must be carried out by an ecologist prior to work commencing during this period to assess the status of any nesting sites. If nesting birds are observed when a qualified ecologist is not present, work will stop and they will be contacted for advice.
- The bird nesting potential of the site should be improved by tree planting and/or by attaching appropriate nesting boxes on the north side of trees and buildings. Recommended boxes include:
  - Vivara Pro WoodStone House Sparrow Nest Boxes
  - Vivara Pro WoodStone 32mm Nest Boxes
  - Vivara Pro WoodStone 28mm Nest Boxes.

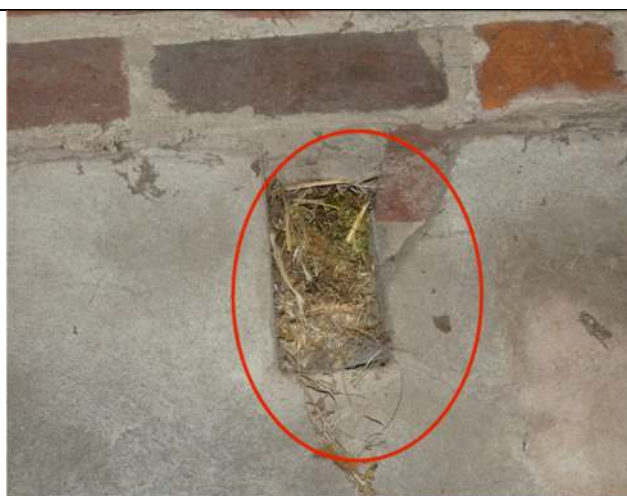
Photograph 60. Wrens nest within the interior of Barn 5

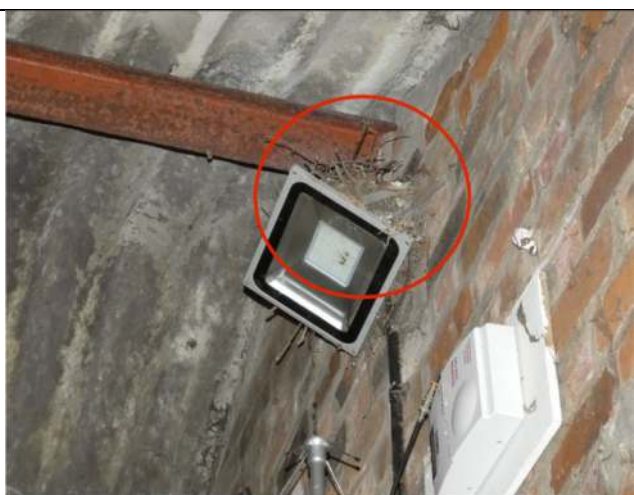
Photograph 61. Pigeons nest within the interior of Barn 5

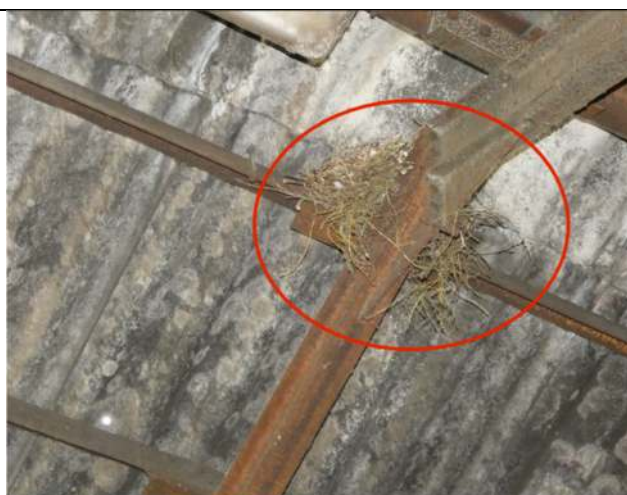
Photograph 62. Pigeons nest within the interior of Barn 8

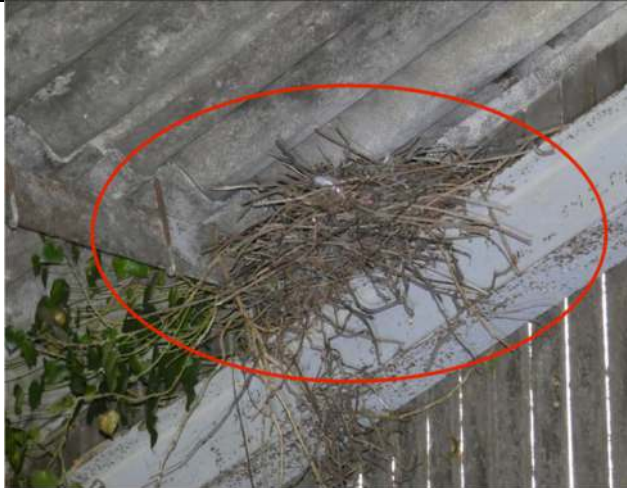
Photograph 63. Pigeons nest within the interior of Barn 17
