Tree report P 051

Land to the rear
84 Leicester Road
Hinckley
LE10 1LT

05 September 2024

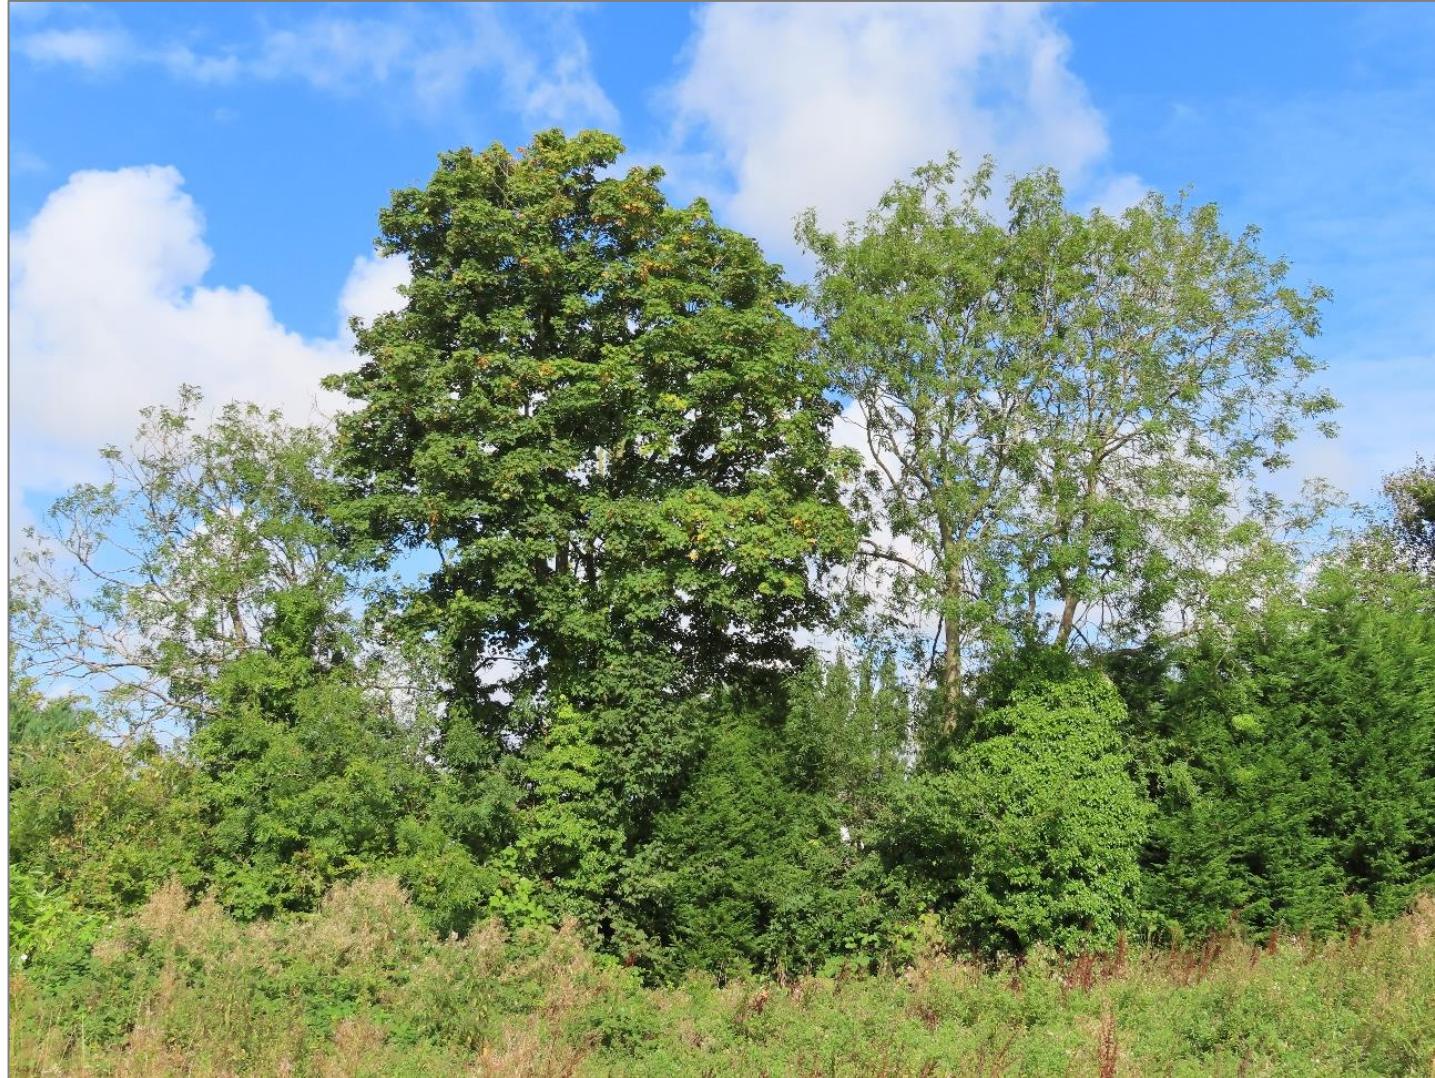
Photo 1

21 There were three ash trees close together in the centre of the boundary, only one of which was covered by the Order, see photo 1. The two rearmost trees, referred to here as T2 and T3, were in the height range of 10 – 12m, the third tree, referred to here as T4, was only some 8 – 10m tall.

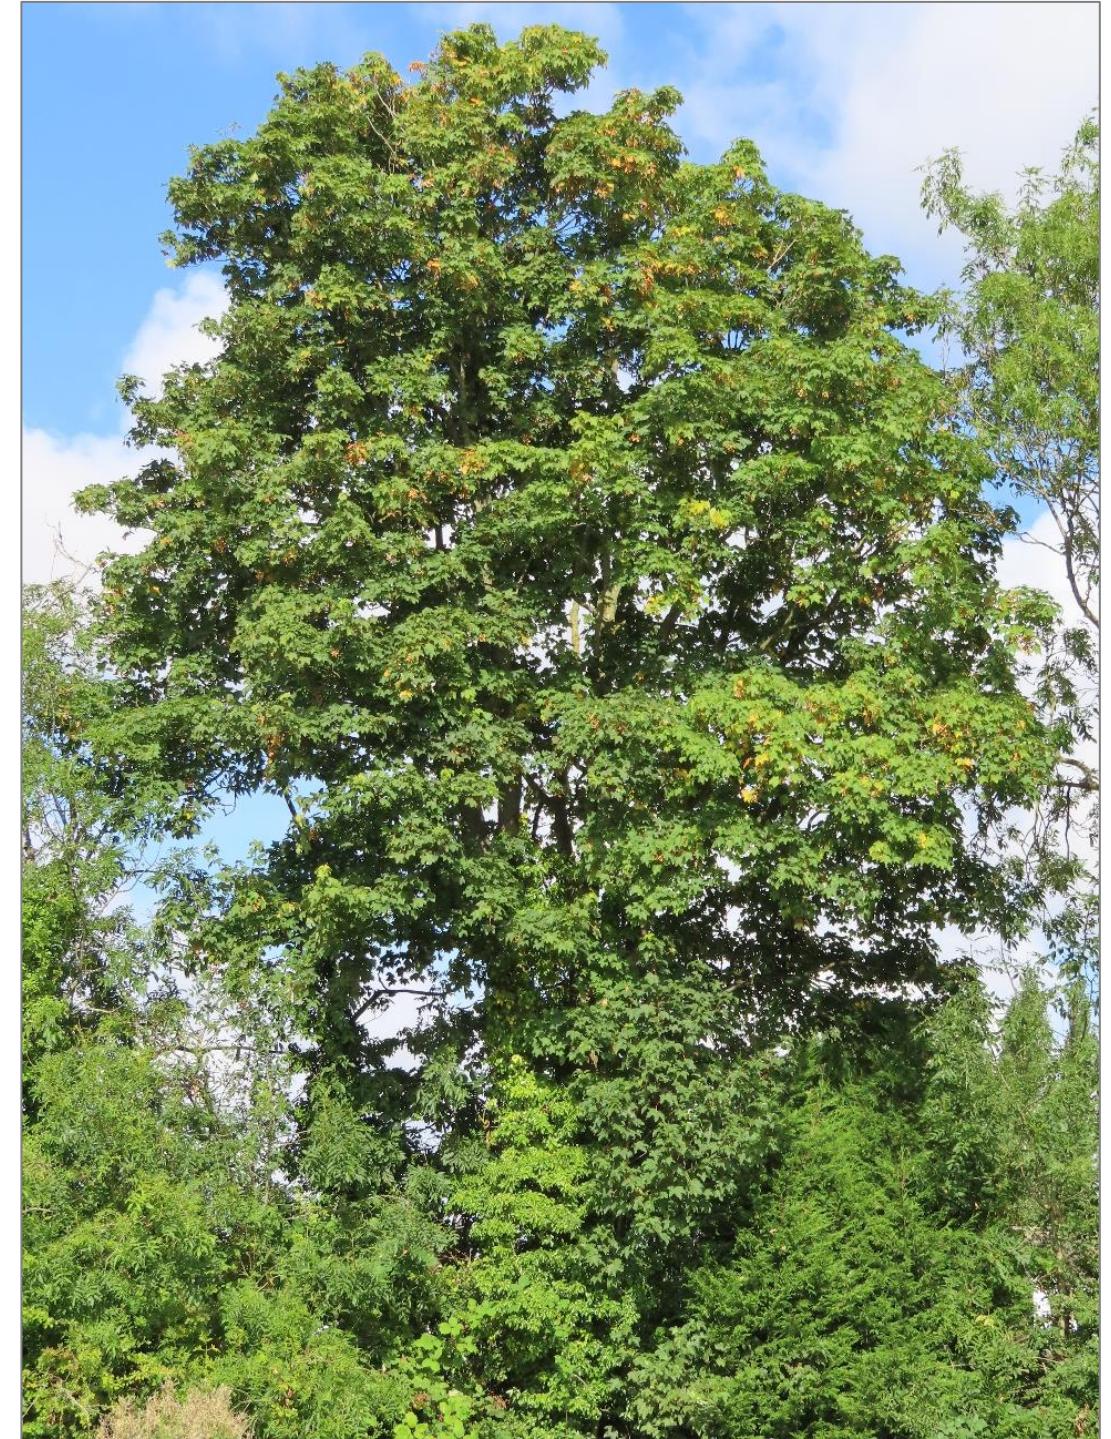
Photo 2

20 The sycamore T1 seen in photo 2 had a stem diameter estimated to be around 600mm (it was impossible to access the tree), and so a **Root Protection Area**¹ (referred to here as the RPA) as defined in **BS 5837:2012 Trees in relation to design, demolition and construction – Recommendations** (referred to here as BS 5837) of 7.2m in radius: the tree was in the range of 10 – 12m tall, crown spread to the east was around 4.5m, to the south (into the site) the spread was some 2.5m and to the west the spread was approximately 4m. The stem forked at around 4m to give two co-dominant stems, there was ivy to around 6m, but the tree was apparently free from squirrel damage, symptoms of which can be seen on so many sycamore trees this autumn. Beneath the tree to the west was a patch of broadleaved scrub, primarily hawthorn growing to around 4 – 6m tall, all smothered in ivy.

28 The sycamore tree, referred to here and in the Order as T1, was placed into Category B1:

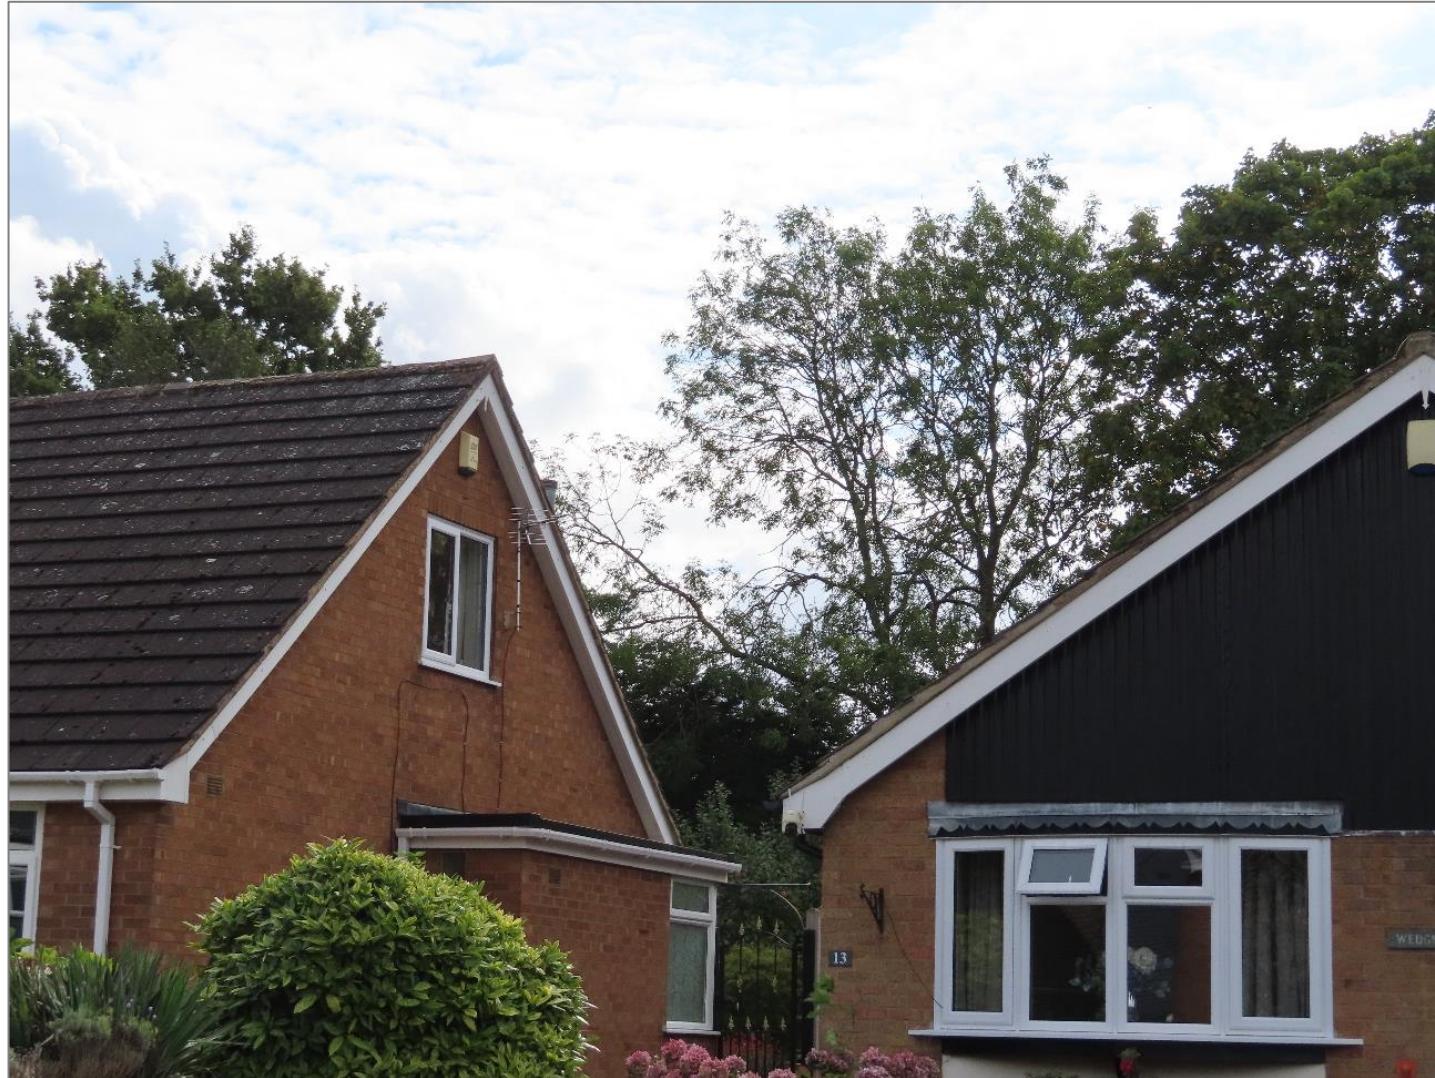
Photo 3

25 The canopy cover of each of the three trees seemed poor, perhaps a symptom of ash dieback disease, see for example photos 3 (taken from Island Close) and 4.

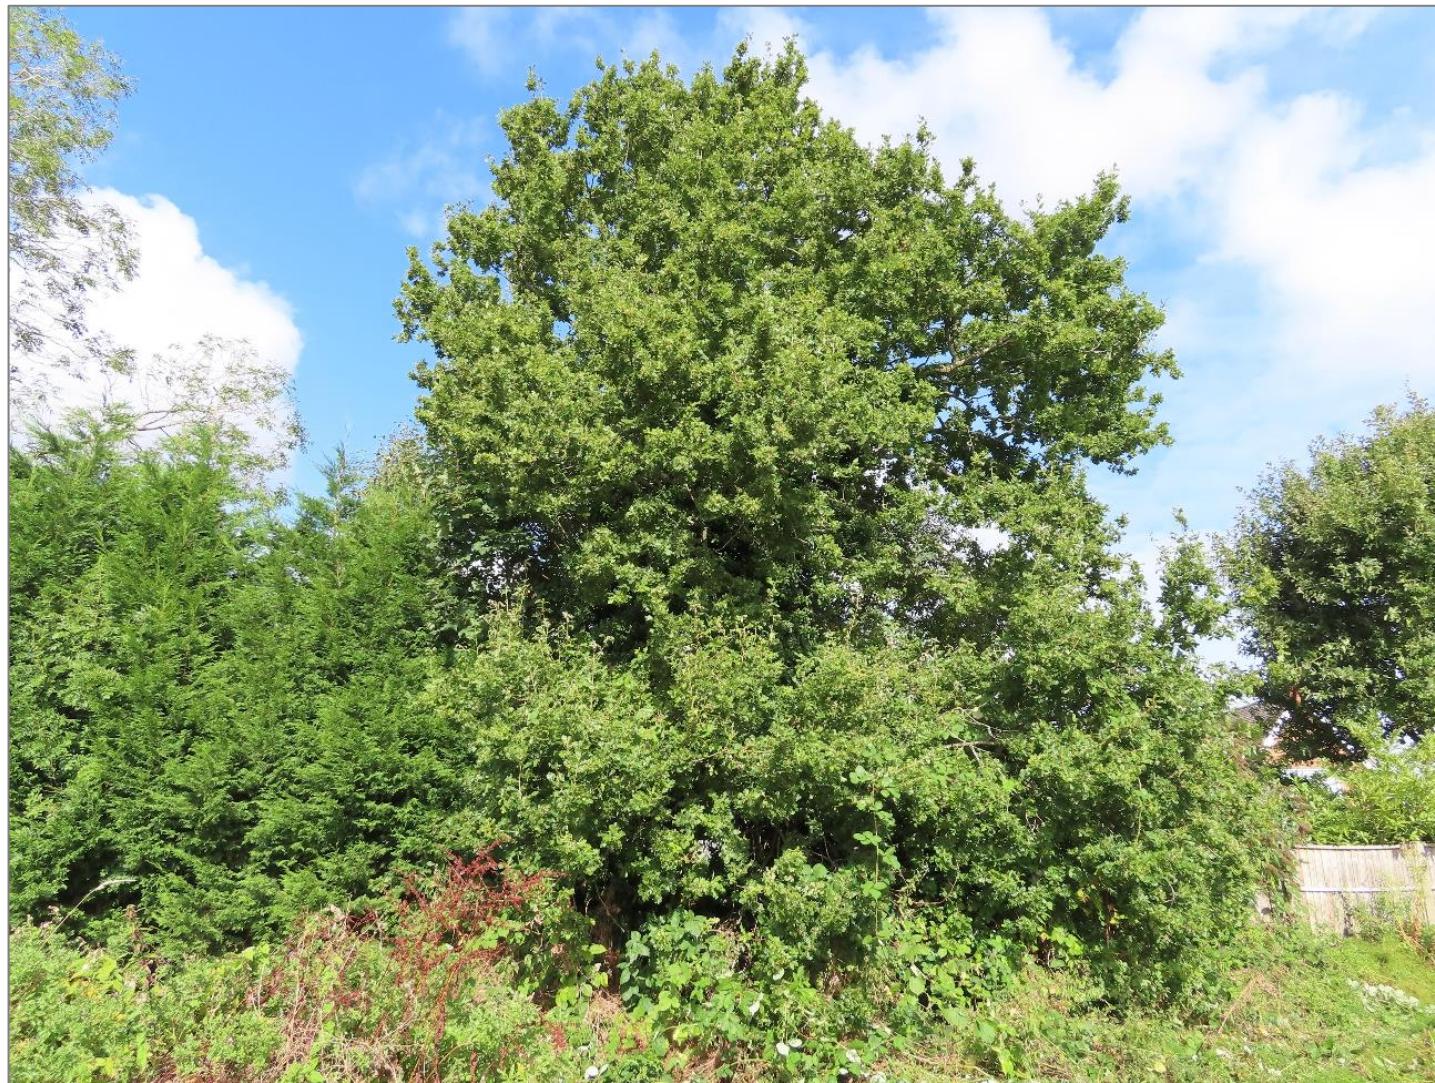
Photo 5

26 The fifth tree to be assessed, the oak seen in photo 5, had a stem diameter of 500mm, and so an RPA of 6.0m radius, and the tree's height was in the range of 10 – 12m, radial crown spread to the east was around 5m, to the south some 4m. A significant limb had developed on the eastern side of the stem at around 1.2m. The tree was smothered by ivy to around the mid-crown.

27 Under the parameters of **Table 1 Cascade chart for tree quality assessment** (referred to here as Table 1) of BS 5837 the oak tree, referred to here as T5 (but T3 in the Order), was placed into Category A1 because of its age:

- severing the ivy growing on all the retained trees, and once it has died and dried it should be stripped from the trees' stems and crowns, and
- pruning to lift the canopies and to reduce the crown spreads to provide adequate clearance for work activity, and
- removing any dead wood and stubs from the crowns of the retained trees.
