# Tree survey and report

84 Leicester Road  
Hinckley  
LE10 1LT

**Report number 390 prepared by:**

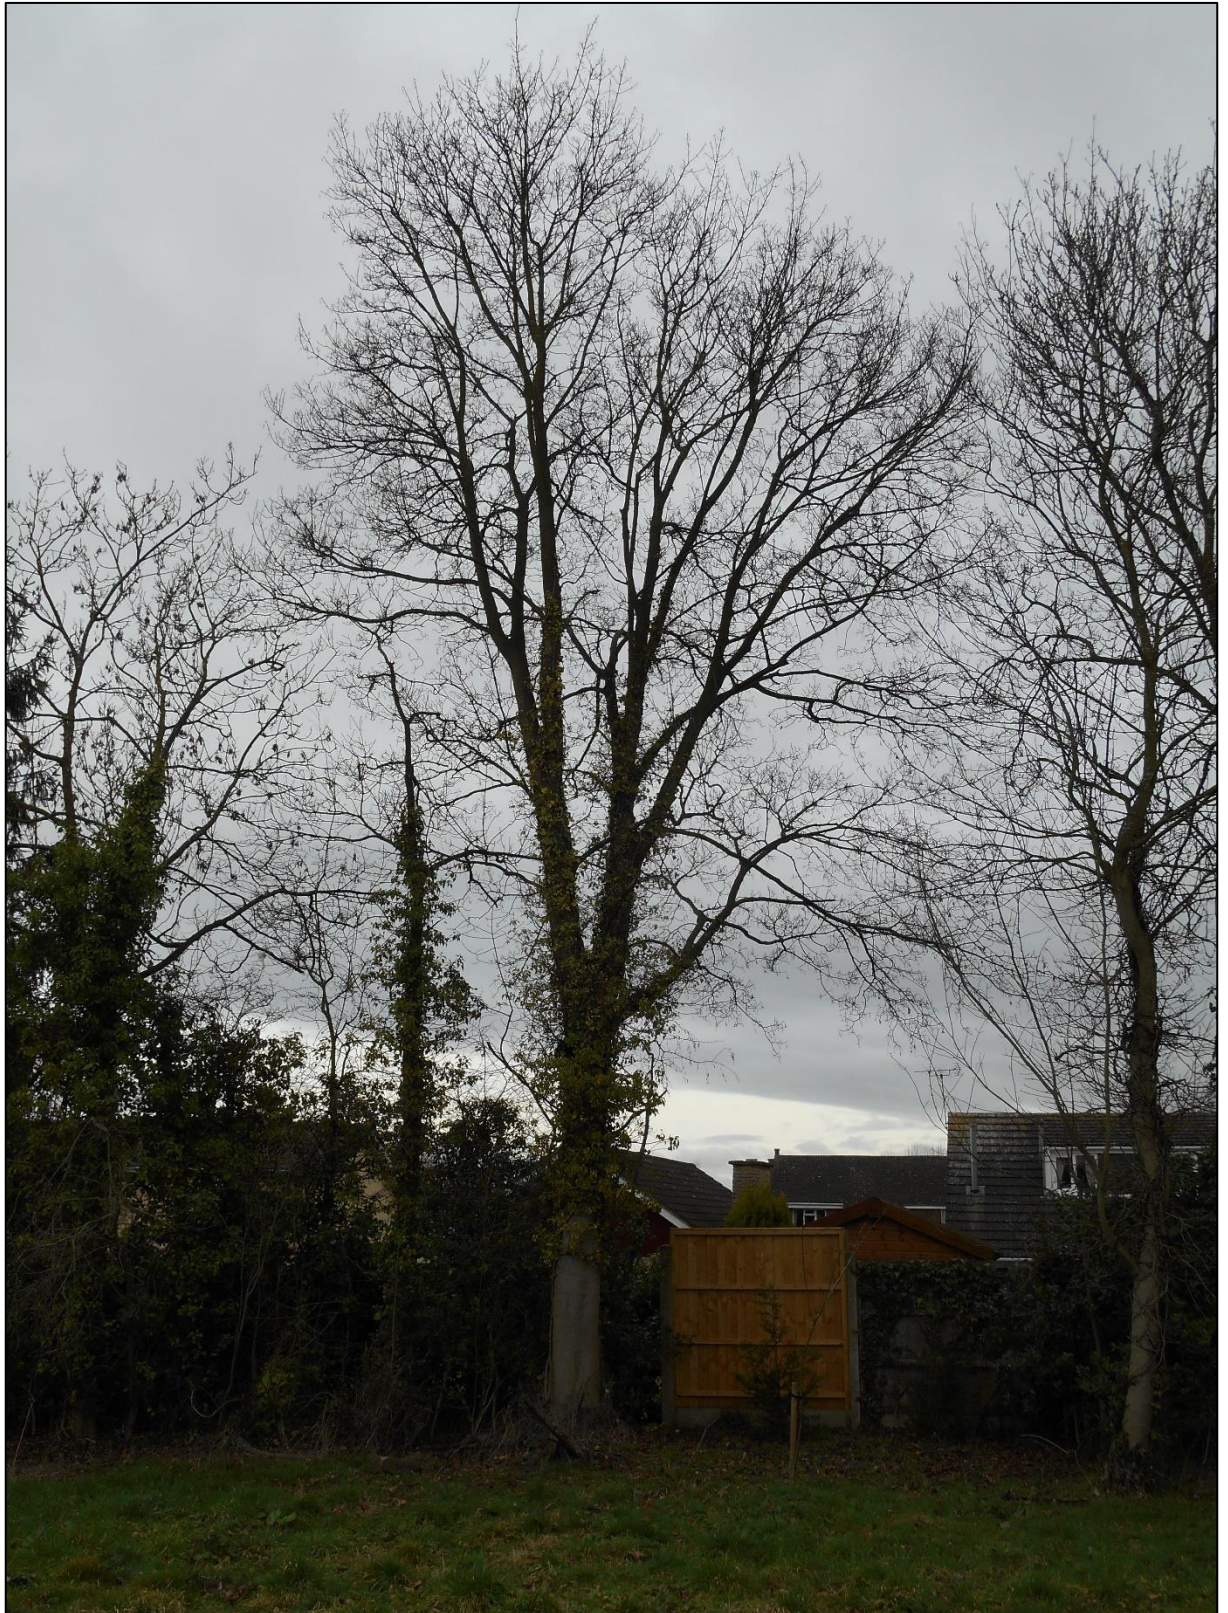
3.3 The sycamore had a dbh of 500 mm, and so an RPA of 6.00 m in radius, an area of 113 m<sup>2</sup>: the tree was in the range of 10 – 12 m tall, crown spread to the east was around 4 m, to the south (into the site) the spread was some 2 m and to the west the spread was approximately 3.5 m, see photo 1 In Appendix 1. The stem forked at around 4 m to give two co-dominant stems, there was ivy to around 6 m. Beneath the tree to the west was a patch of broadleaved scrub, primarily hawthorn growing to around 4 – 6 m tall, all smothered in ivy.

*Photo 1: the sycamore tree*

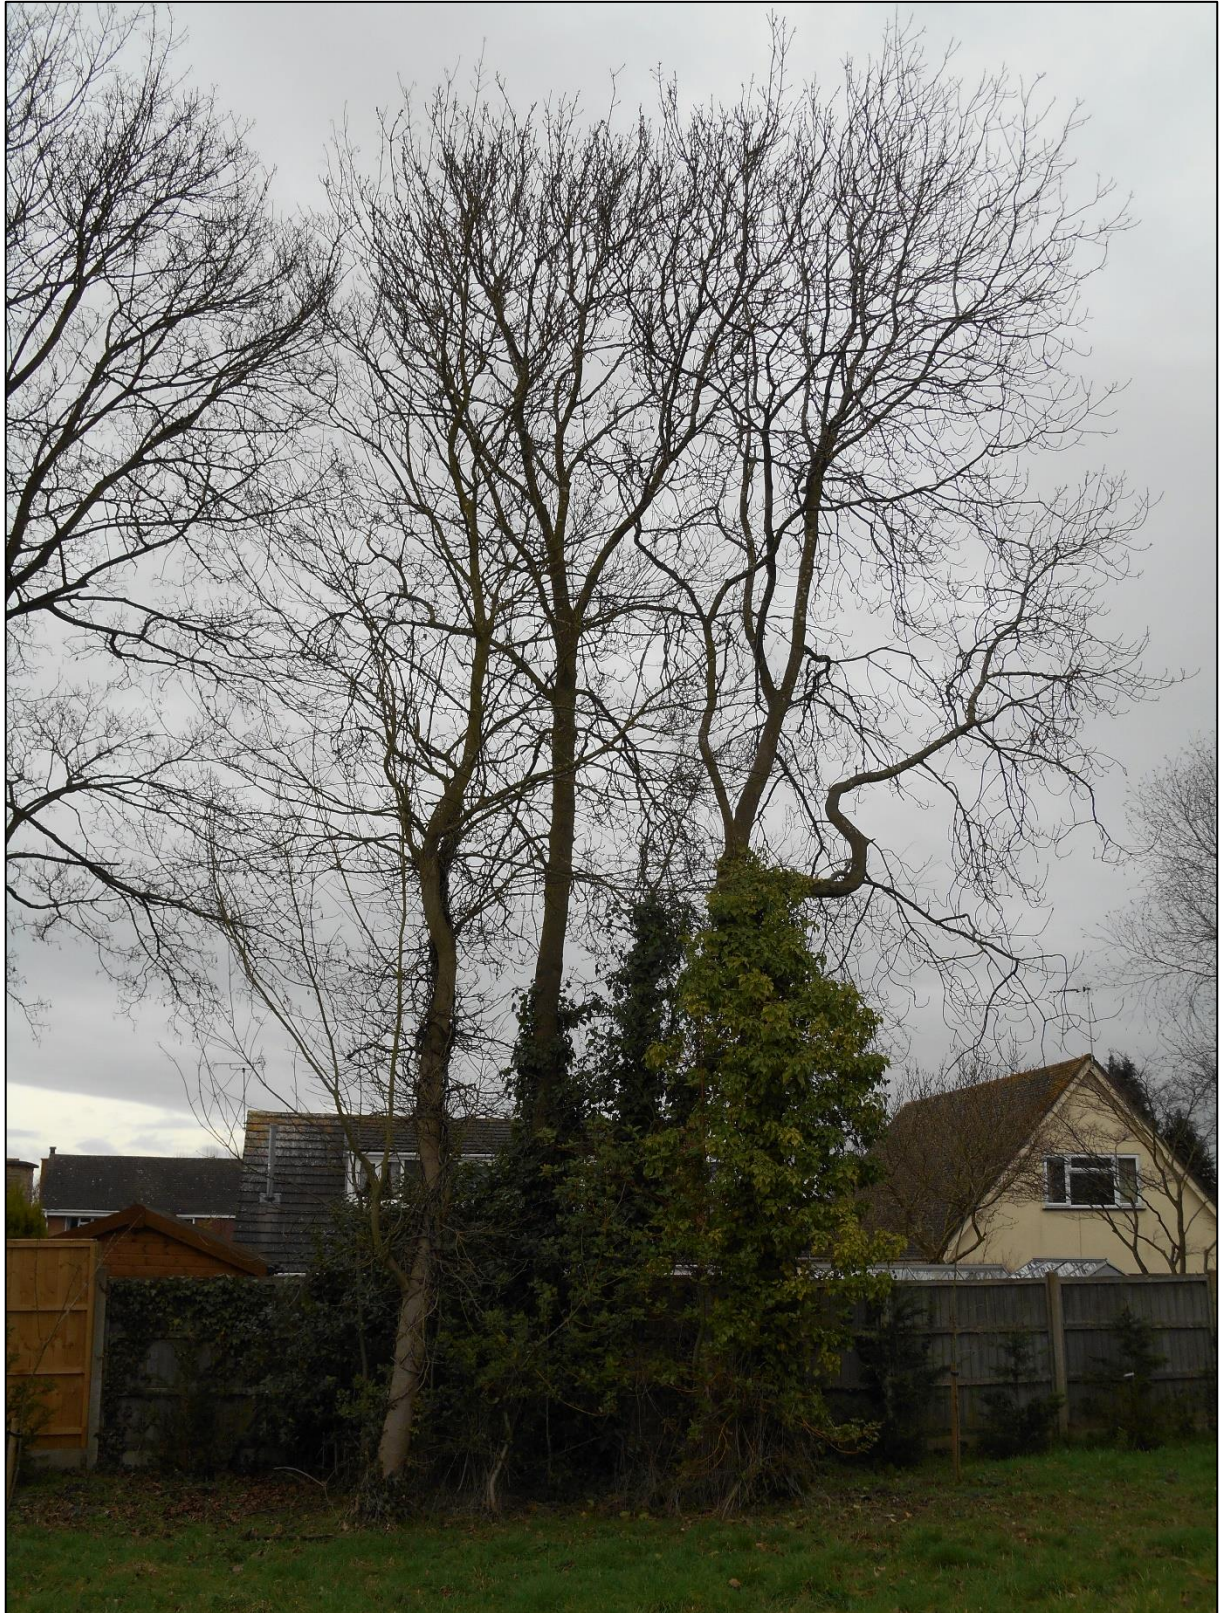
3.4 There were three ash trees close together in the centre of the boundary, only one of which is covered by the TPO, see photo 2. One tree was close to the boundary fence with the Island Close property, the two others were at a similar distance from the boundary fence either side of this tree in a triangular pattern. Two of the trees were in the height range of 10 – 12 m. According to the neighbours in Island Close the trees dropped frequently dead wood into their garden.

3.5 The tree closest to the boundary fence with the Island Close property had a dbh of 300 + mm: there were holly and hawthorn developing beneath the crown.

3.6 The tree to the west showed a narrow fork at 3 m with co-dominant stems, ivy had been severed but was still clinging, dead, to the stem. The tree's crown radial spread was a uniform 2 m.

3.7 The tree on the east of the group had the largest dbh of 400 mm, and so an RPA of 4.8 m in radius, an area of 72 m<sup>2</sup>: the tree's height was in the range 8 – 10 m tall, the crown spread was eccentric, some 5 m to the east, 2 m to the south and little if any development to the west because of the neighbouring trees. The tree was of poor overall form with no obvious leader, and there was ivy into the lower crown, to about 4 m.

***Photo 2: the three ash trees***

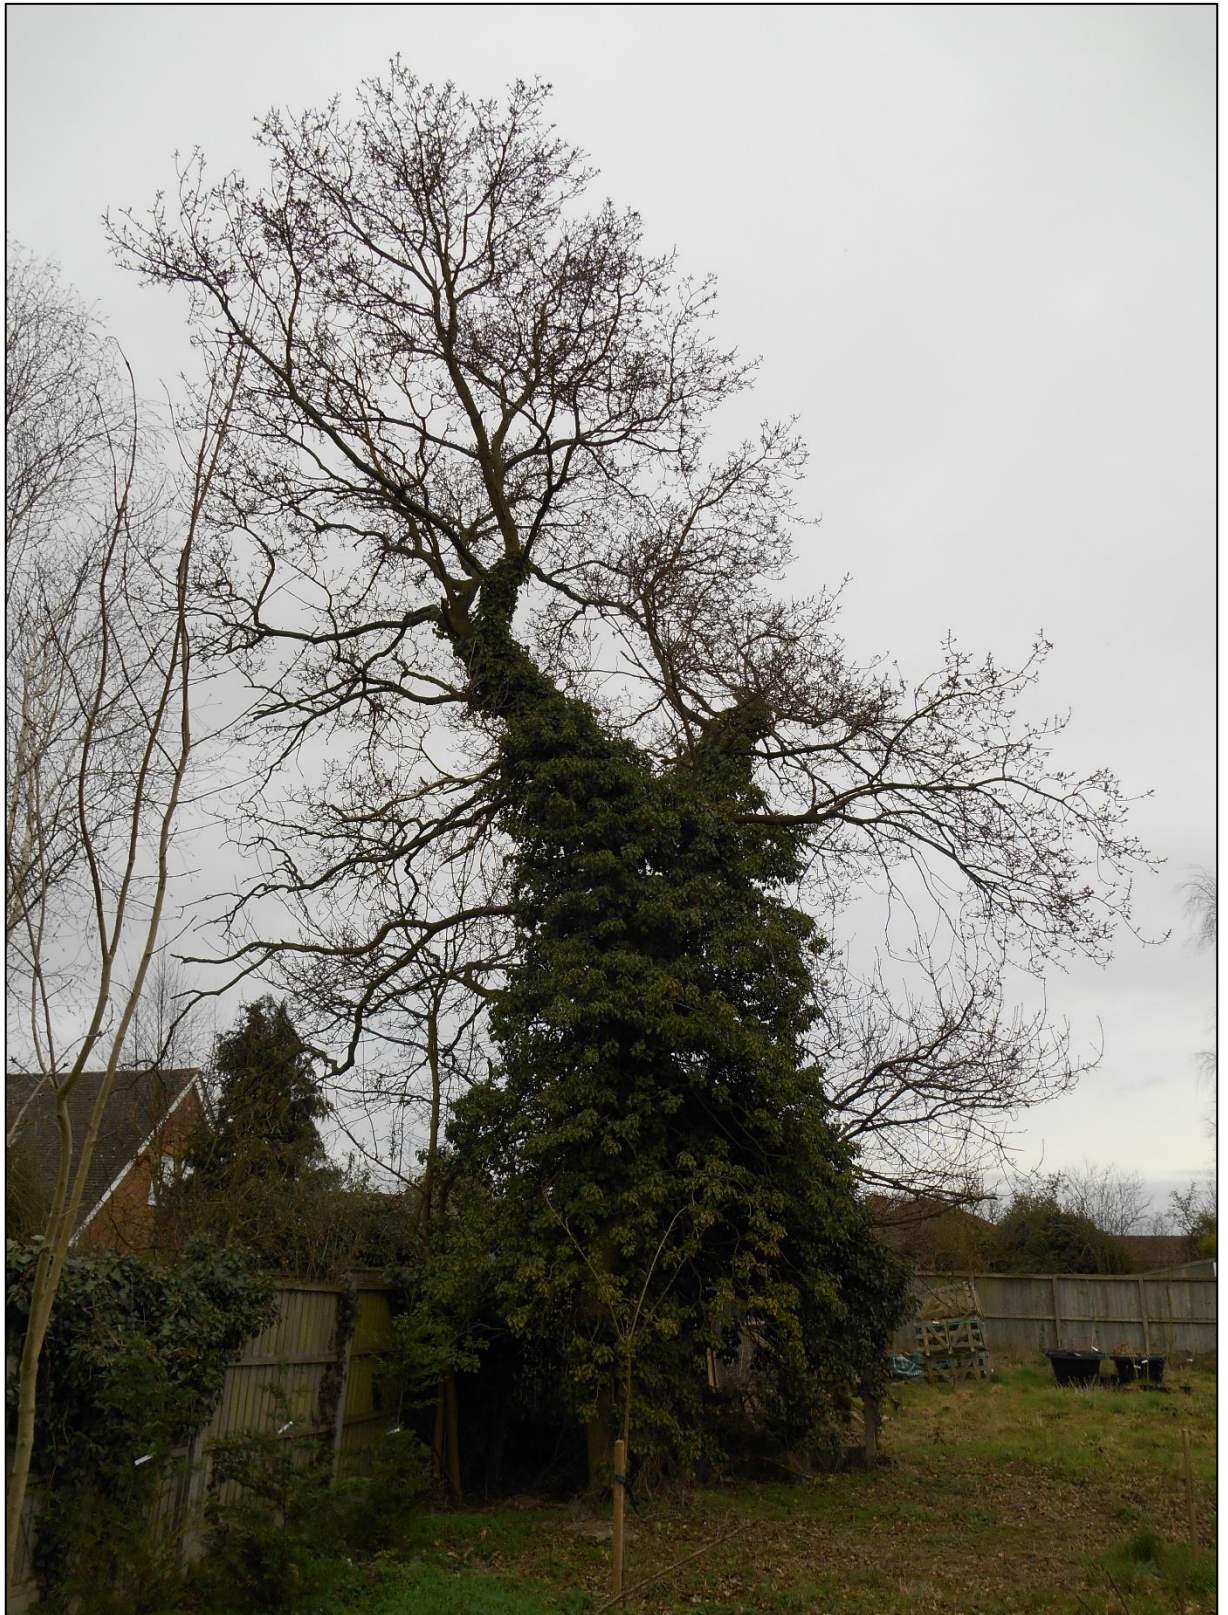
3.8 The third tree, the oak, had a dbh of 475 mm, and so an RPA of 5.7 m radius, an area of 102 m<sup>2</sup>: the tree's height was in the range of 10 – 12 m, radial crown spread to the east was around 5 m, to the south some 3 m only. A significant limb had developed on the eastern side of the stem at around 1.2 m. The tree was smothered by ivy to mid-crown, dead wood and stubs were evident in the crown that could be assessed.

***Photo 3: the oak tree***
