# **ARBORICULTURAL IMPACT ASSESSMENT**

The Hayloft, Cadeby

250619 25076 AIA V1

19<sup>th</sup> June 2025

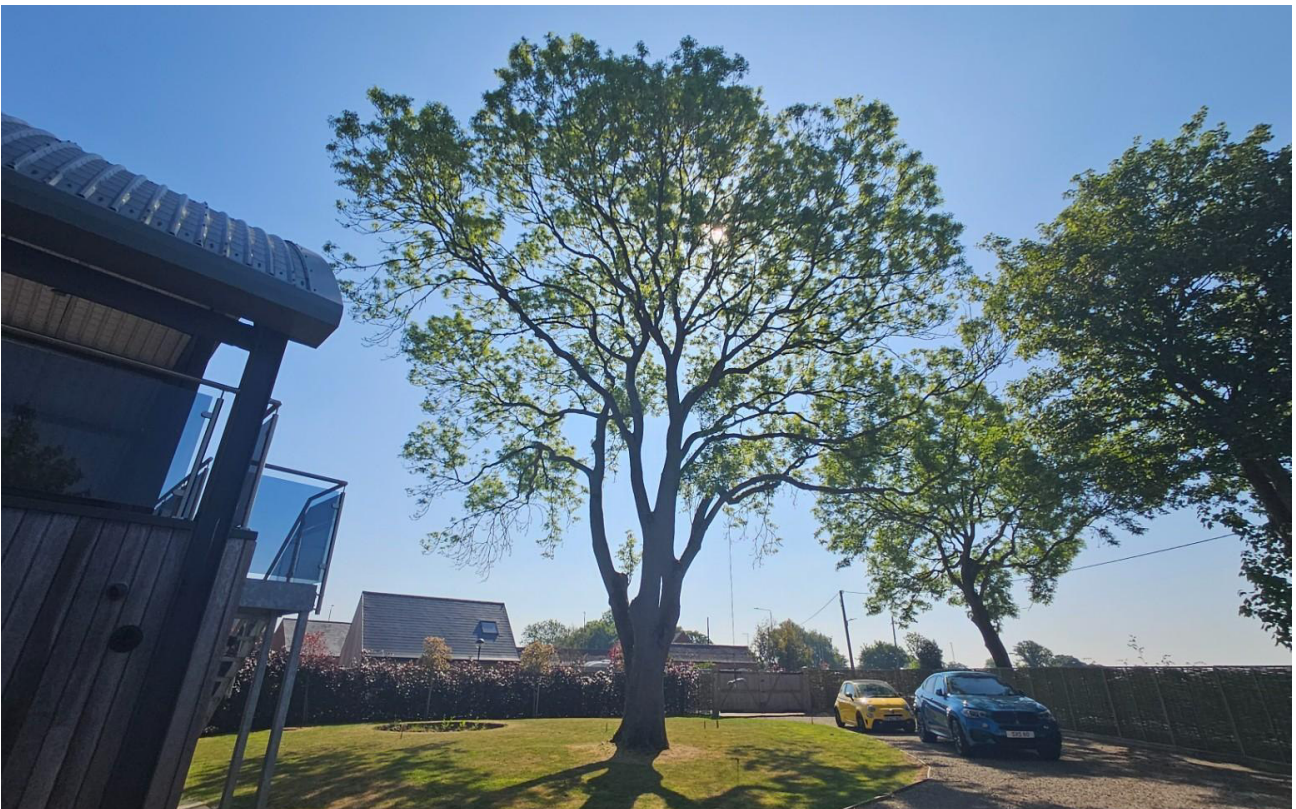
- 4.3.3 T1 (common ash) is the most prominent specimen within the Site, located within a small area of lawn towards the southern boundary. T1 is a mature category B specimen that forms a single stem, with a large, widespread canopy. T1 shows signs of decline, with a slightly sparse canopy at the time of assessment. As shown below in Figure 1.

*Figure 1 - View of T1 from the northwest.*

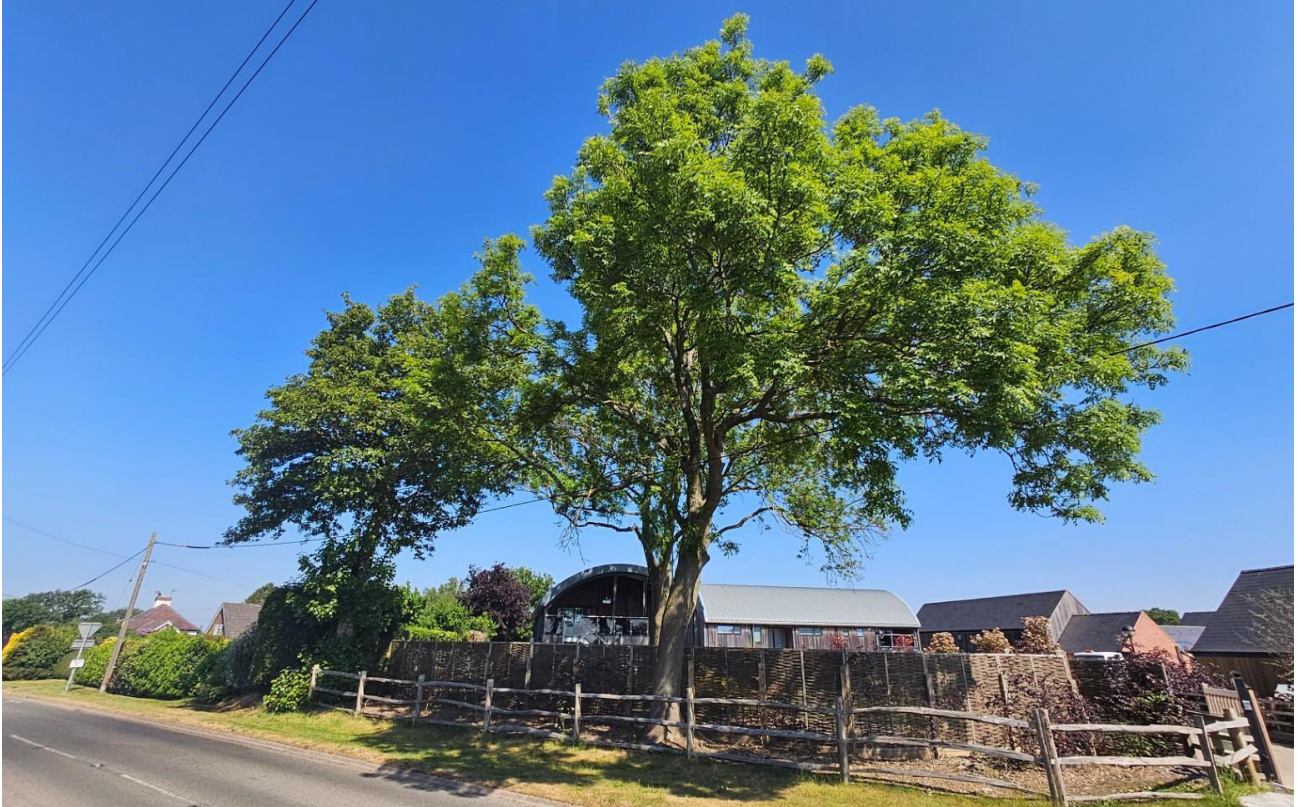
- 4.3.4 T3 (sycamore) and T4 (common ash) are a pair of early mature trees framing the southern boundary of the Site. These trees are prominent along the roadside, providing elements of screening value. As shown below in Figure 2.

Figure2 - View of T3 & T4 from the south.

- 6.1.4 Beyond the southwest boundary of the Site is T3 (sycamore); the northeastern extent of its canopy overextends into the Site. To avoid conflict with the proposed development, it has been recommended that a sympathetic reduction of its canopy north and east be carried out. The canopy north should be reduced from 4.5m to 3.5m, and east from 4m to 3.5m in line with past management. This is illustrated in the Tree Protection Plan (OE-004) at Appendix 4.
