Desk Study Report

Richborough

Newbold Verdon Phase 2

Ref: PJS24-0012-DOC-0001

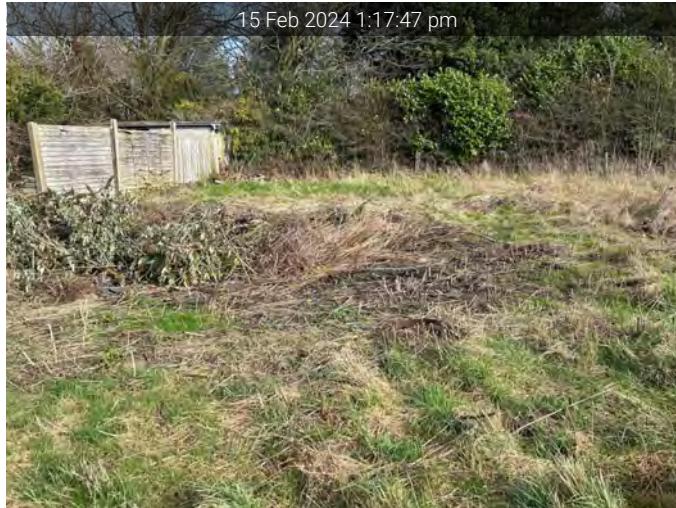
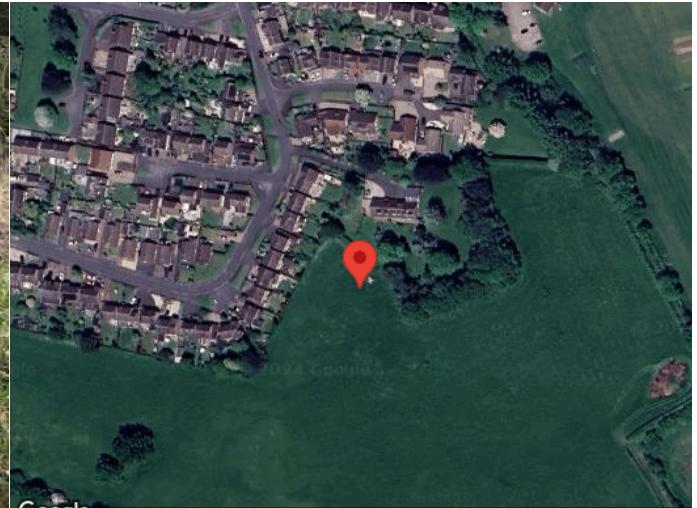
ID: A009 (15 Feb 2024)

Vegetation burning

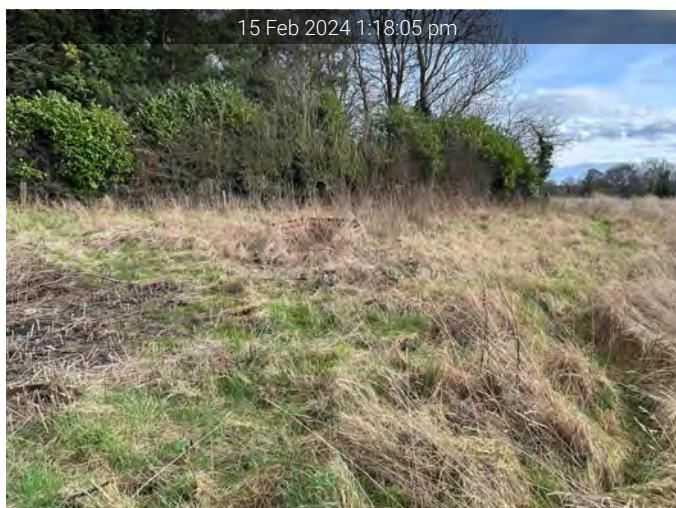
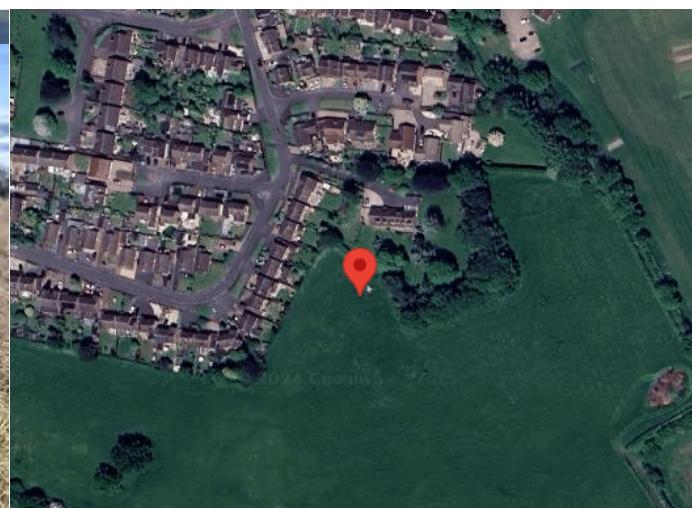
ID: A010 (15 Feb 2024)

Waste metal

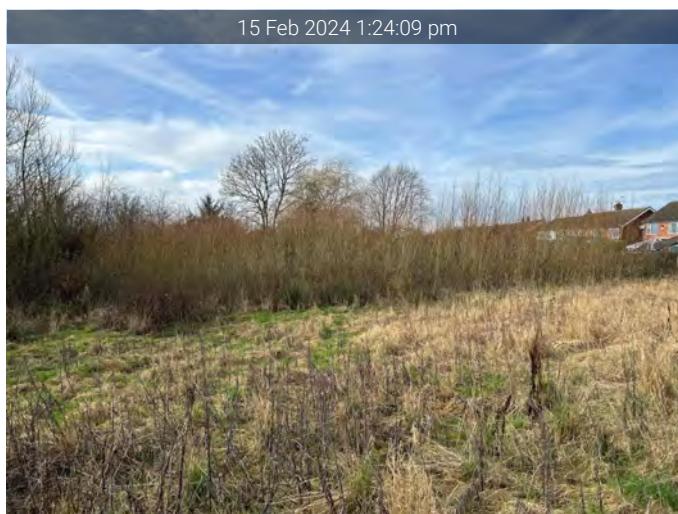
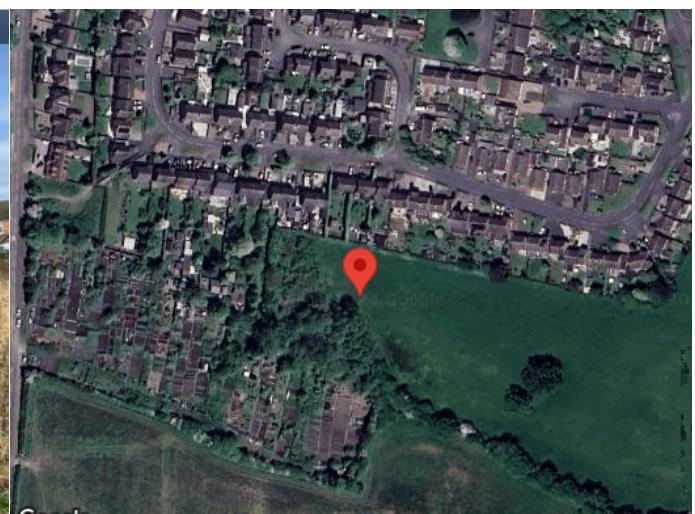
ID: A016 (15 Feb 2024)

Overgrown on western boundary

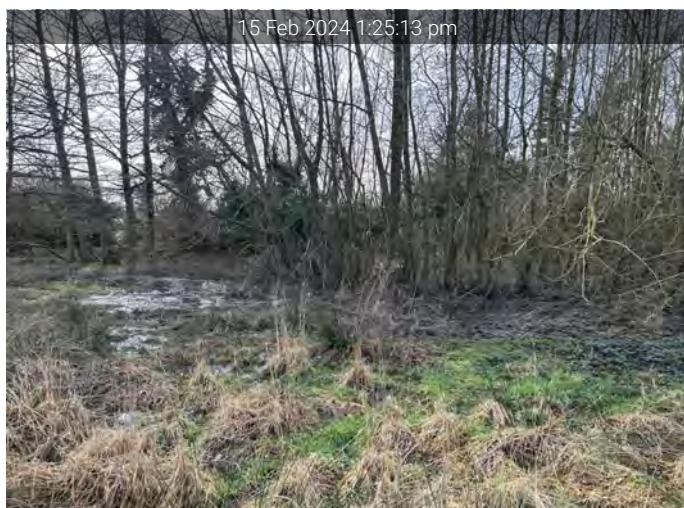
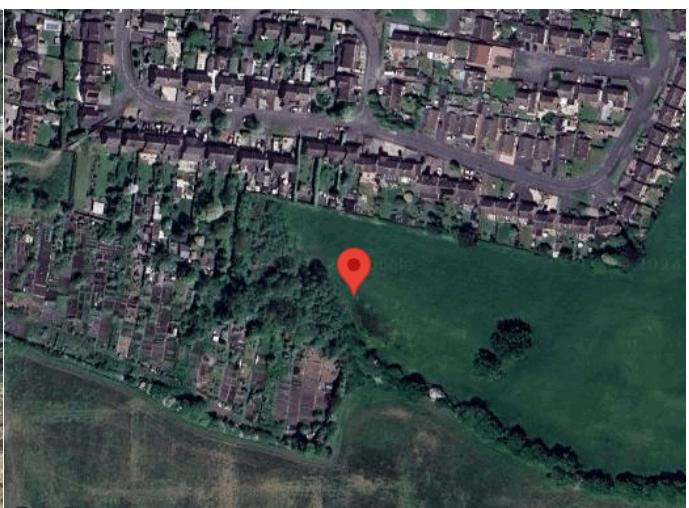
ID: A018 (15 Feb 2024)

Standing surface water, boggy soils in western portion

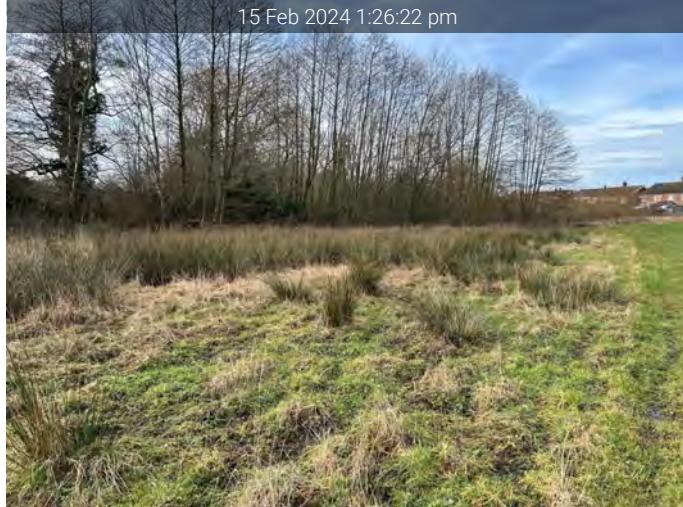
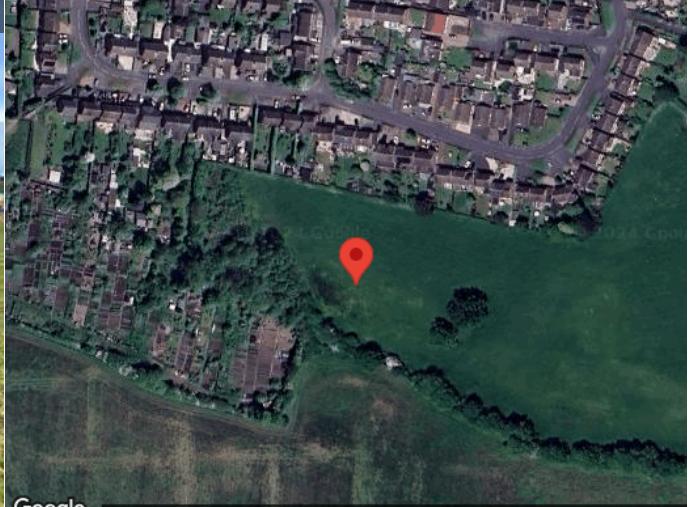
ID: A019 (15 Feb 2024)

Further swampy ground and reeds in west

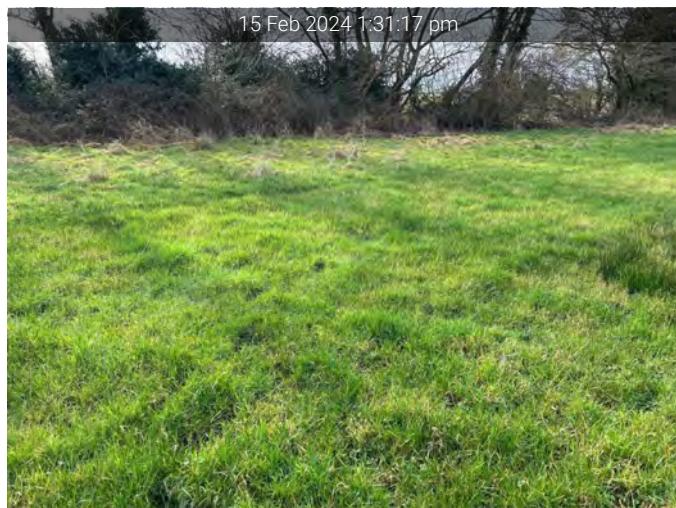
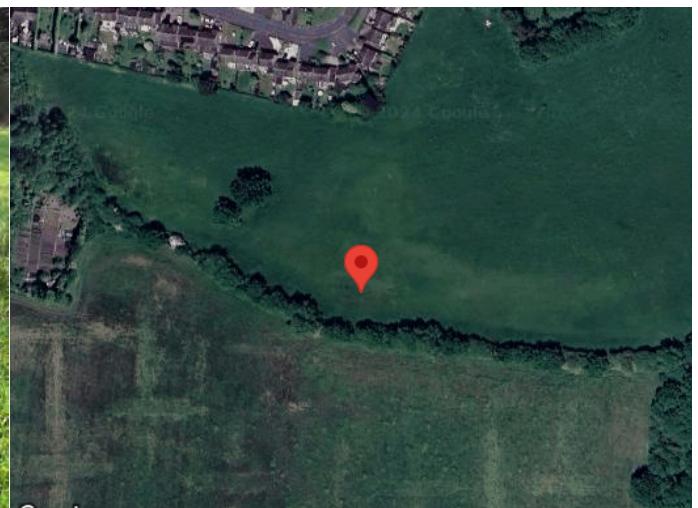
ID: A025 (15 Feb 2024)

Waterlogged soil

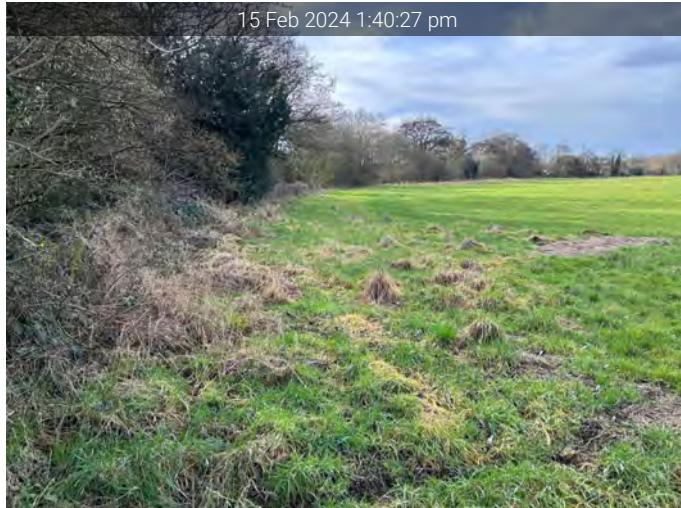
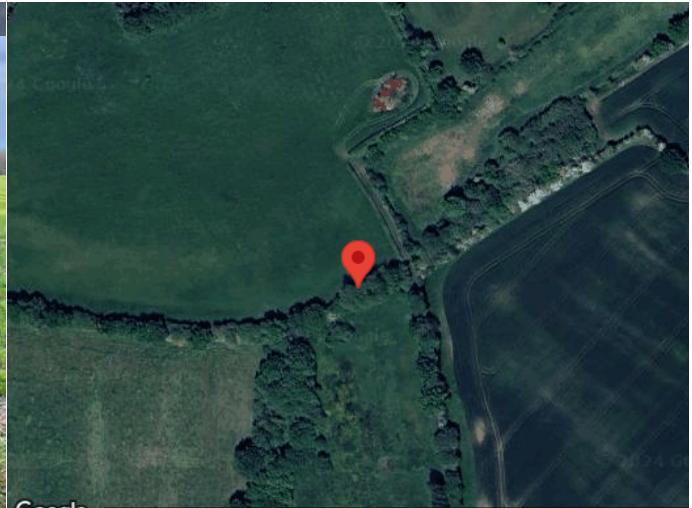
ID: A034 (15 Feb 2024)

Waterlogged soils
