Arboricultural Method Statement

Brascote Lane, Newbold Verdon

Report Reference: BG24.292

REV2 - September 2024

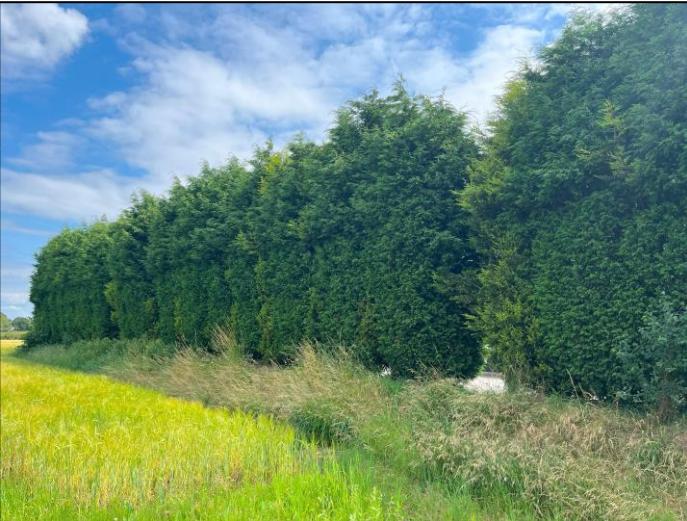
- 3.8.3 A small area of partial removal, approximately 5m in length, is required from G11, to facilitate the construction of the pedestrian access path to the adjacent property. G11 is a linear group of Leyland cypress which provide screening value against the adjacent property. A small, unmanaged gap is present within the group, and will require widening and partial removal to facilitate the footpath.

<p>G11, the linear line of Leyland cypress, providing screening value against the adjacent property.</p>

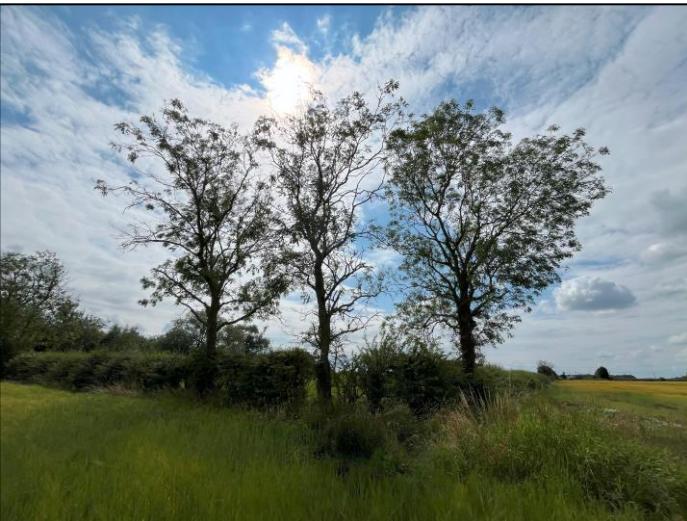
- 3.8.4 T6, T7, T23 – T25, and G10, are recommended for removal irrespective of development, due to their poor condition. T6, T7, T23 and T24 are Category U ash trees, while G10 is a Category C

group. They all show physiological decline and exhibit symptoms indicative of advanced ash dieback (including significant crown decline and deadwood). The ash trees have a significantly limited future potential and are recommended for removal. T25, a standing dead tree within the boundary hedgerow, is recommended for removal.

<p>G10, three ash trees exhibiting advanced symptoms of ash dieback, with limited future potential.</p>

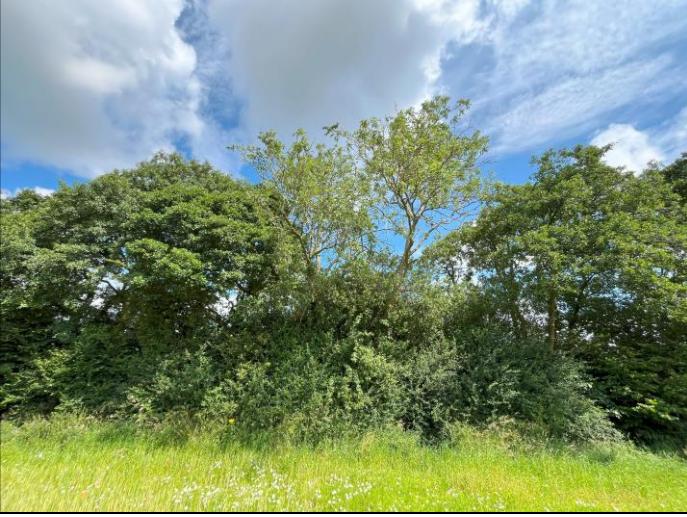
<p>T6, a Category U common ash within G2, exhibiting advanced symptoms of ash dieback.</p>

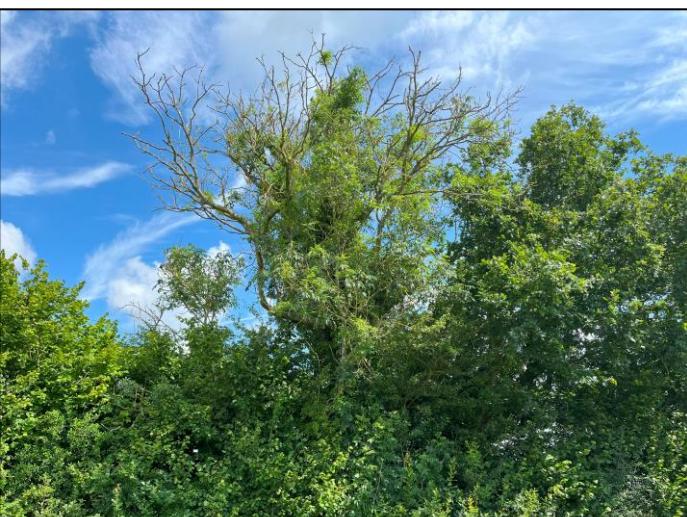
<p>T7, a Category U common ash, exhibiting advanced symptoms of ash dieback.</p>
