**BAT SCOPING SURVEY  
FOR THE PROPOSED ROOF ALTERATIONS INCLUDING  
ADJACENT ASH TREE  
OF  
WOODSIDE  
LITTLE LANE  
DESFORD  
LEICESTERSHIRE  
LE9 9GP**

August 2025

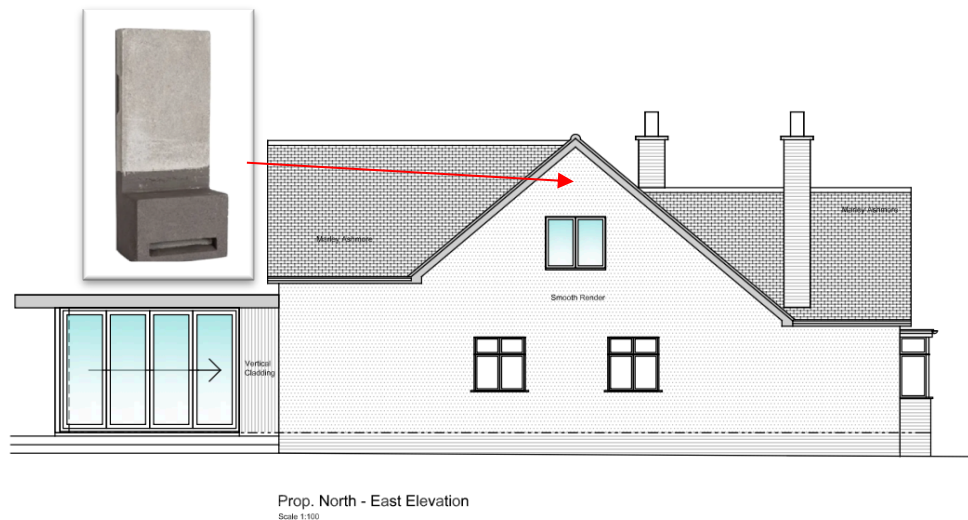
Given the sound construction of the roof, and maintenance of the dwelling it is unlikely that further bat activity surveys would inform further of use of the dwelling by bats. Both the dwelling and garages are deemed to have negligible bat roost potential.

It is recommended however that a bat brick be added to the fabric of the proposed northeast facing gable above the proposed new window, see Figure 1 below to enhance the site for bats. Vivara Pro UK Build-in WoodStone® Bat Box would be ideal for this site as it can be painted or rendered once fitted to match the proposed finish. See inset below.

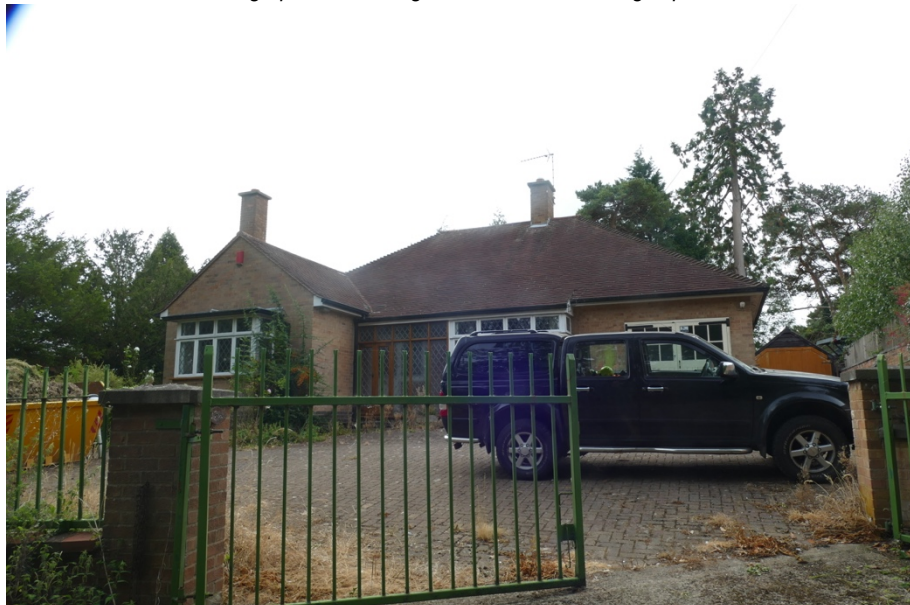
*Photograph 1 – dwelling, front, northwest facing aspect.*

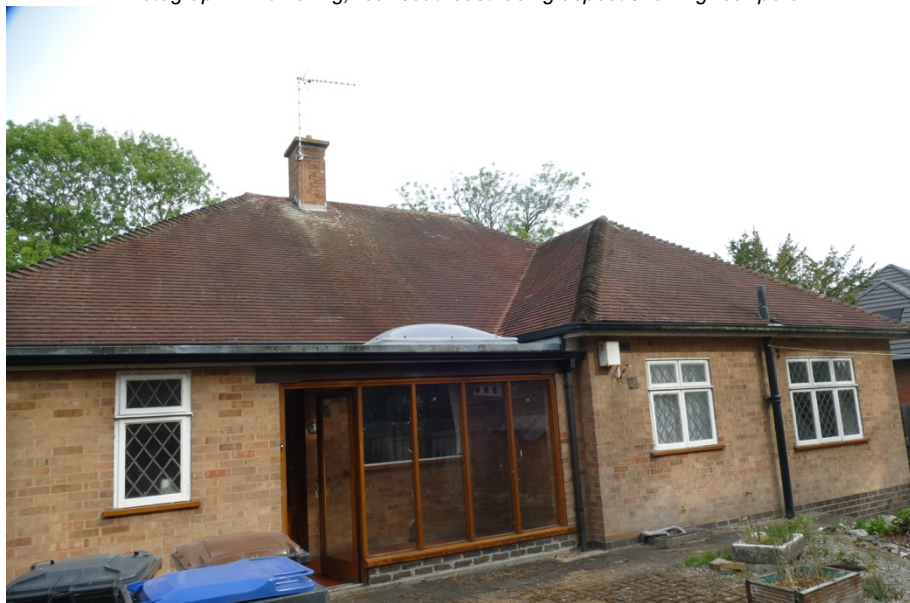
*Photograph 2 – dwelling, rear southeast facing aspect showing rear porch.*

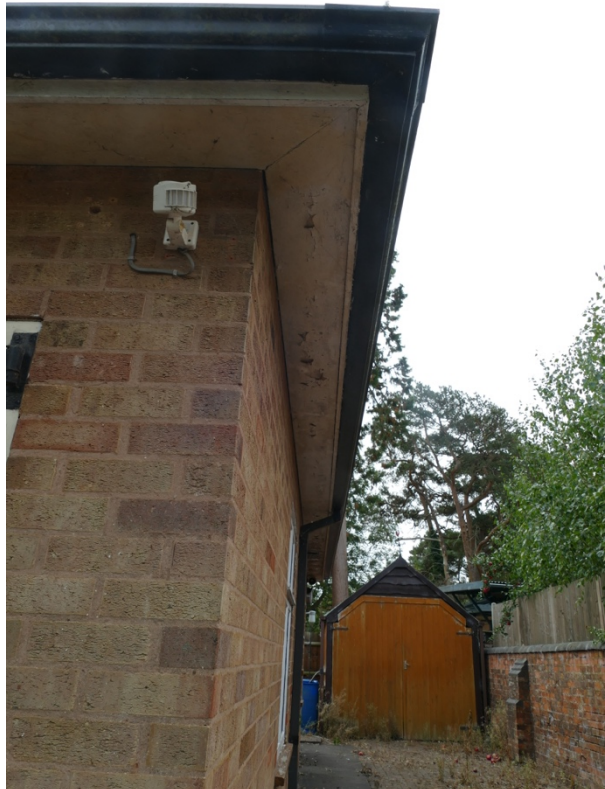
Photograph 3 – timber soffit detail and detached garage in the rear garden.

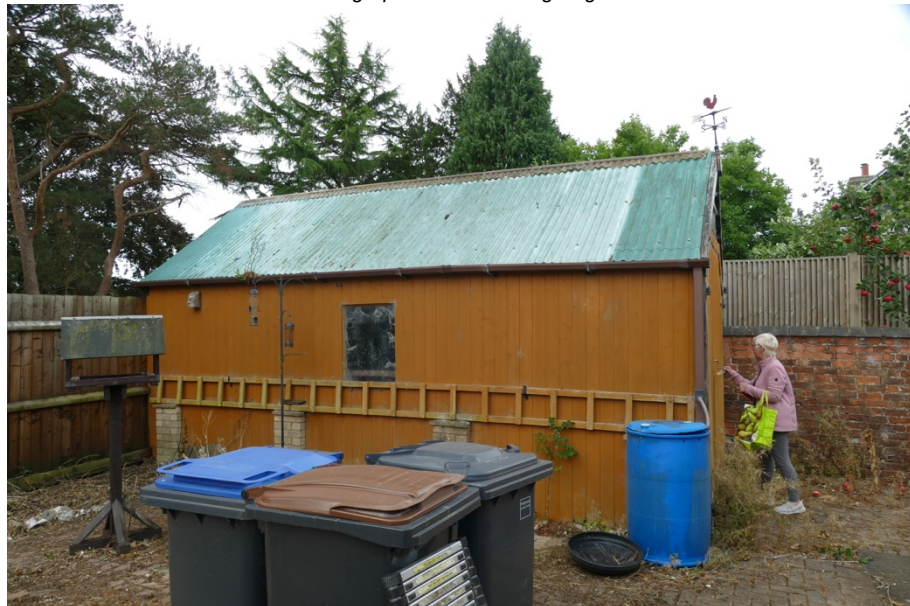
The bungalow's detached garage was of timber framed construction supported by low brick pillars. It had a corrugated steel roof.

Photograph 4 – detached garage .

No sign of use was found of the detached or integral garages by bats.

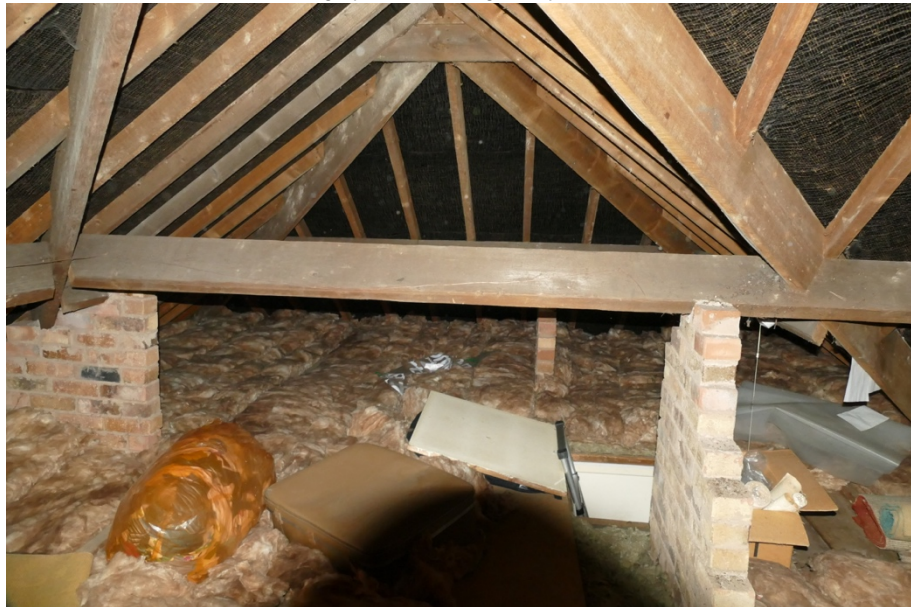
The roofspace was very large, complex, and of cut timber. The roofspace was heavily insulated with mineral wool.

Photograph 5 – dwelling roofspace detail.

No sign of bats was found during the search of the loft spaces and the construction and maintenance of the dwelling and garages did not provide access to bats.

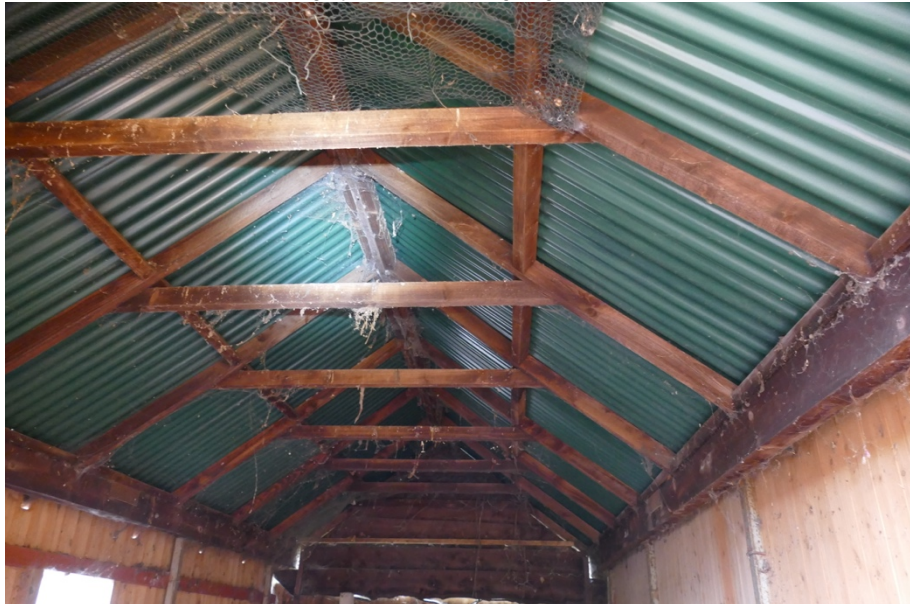
Photograph 6 – detached garage roof detail.

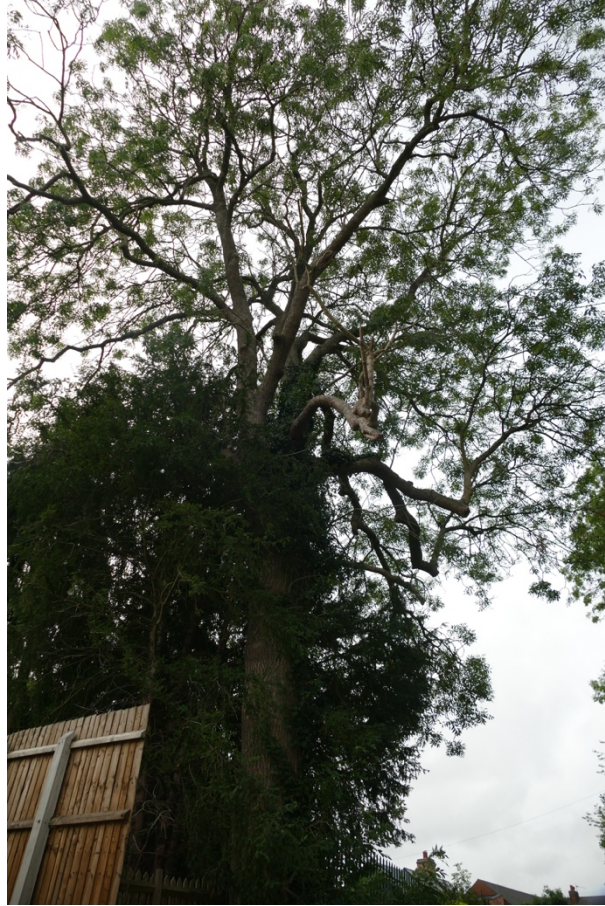
The ash tree was found to be semi-mature and lightly covered with ivy. No features such as rot holes or cracks and crevices were found during a ground level examination. The tree was deemed to have no daytime bat roost potential.

The ash tree T1 was found to lack any features suitable for daytime occupation by bats.

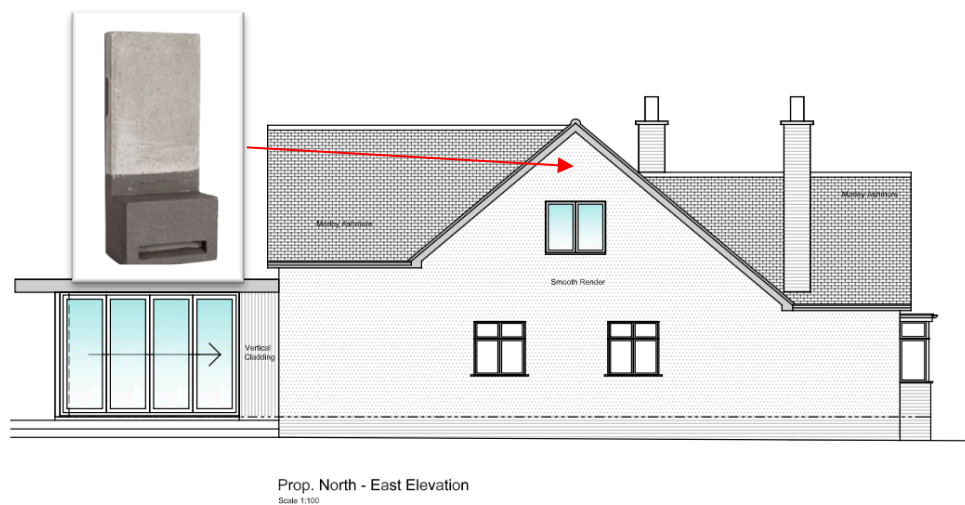
- 5.1.1 Given the sound construction of the dwelling, maintenance of the dwelling and detached garage, and the maintenance of both it is unlikely that further bat activity surveys would inform further of use of the dwelling by bats. This dwelling and garages were deemed to have negligible bat roost potential.

It is recommended however that a bat brick be added to the fabric of the proposed northeast facing gable above the proposed new window, see Figure 1 below to enhance the site for bats. Vivara Pro UK Build-in WoodStone® Bat Box would be Ideal for this site as it can be painted or rendered once fitted to match the proposed finish. See inset below.
