# **Pre-development Tree Survey BS5837:2012**

## **Convent Drive**

## **Stoke Golding**

April 2023, rev June 2024

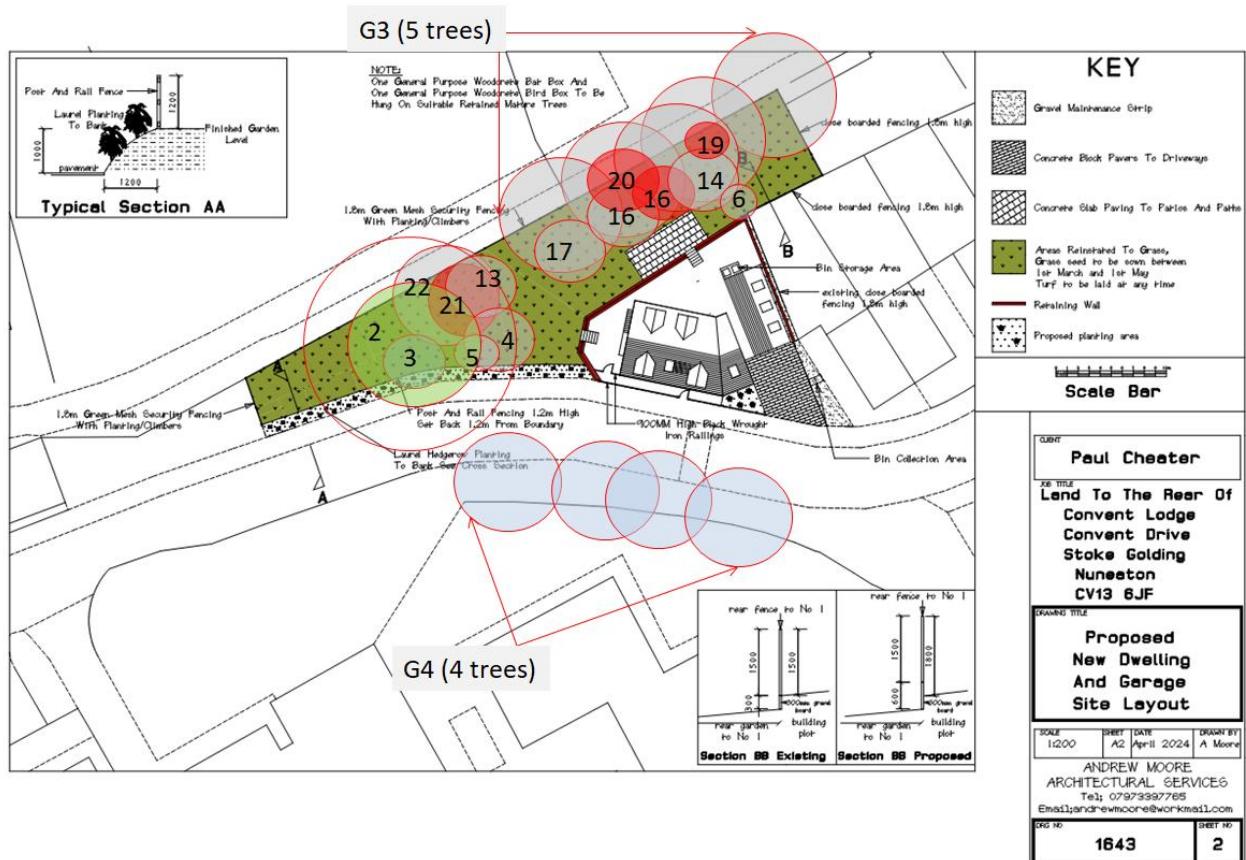
The plan below shows the trees of quality within the proposed development area and zone of influence. All other trees are of quality C and less

On the northern boundary are 5 Corsican pine, and south of the road 4 Common lime. Tree 2 is the Cedar, with a large nominal RPA. All trees shown on the plan above are to be retained as part of the development. No Root Protection Zones fall within the development area.

Any development within the area will need to take account of the tree roots. It is considered that a development could be situated within the site provided the nominal RPZs of Trees 2, and group 3 are entirely avoided. Group 4 RPAs do not extend onto the site and lie within the highway.

In addition, it is recommended that all retained trees, are protected during development by tree protection fencing as detailed below in section 4.1.4.

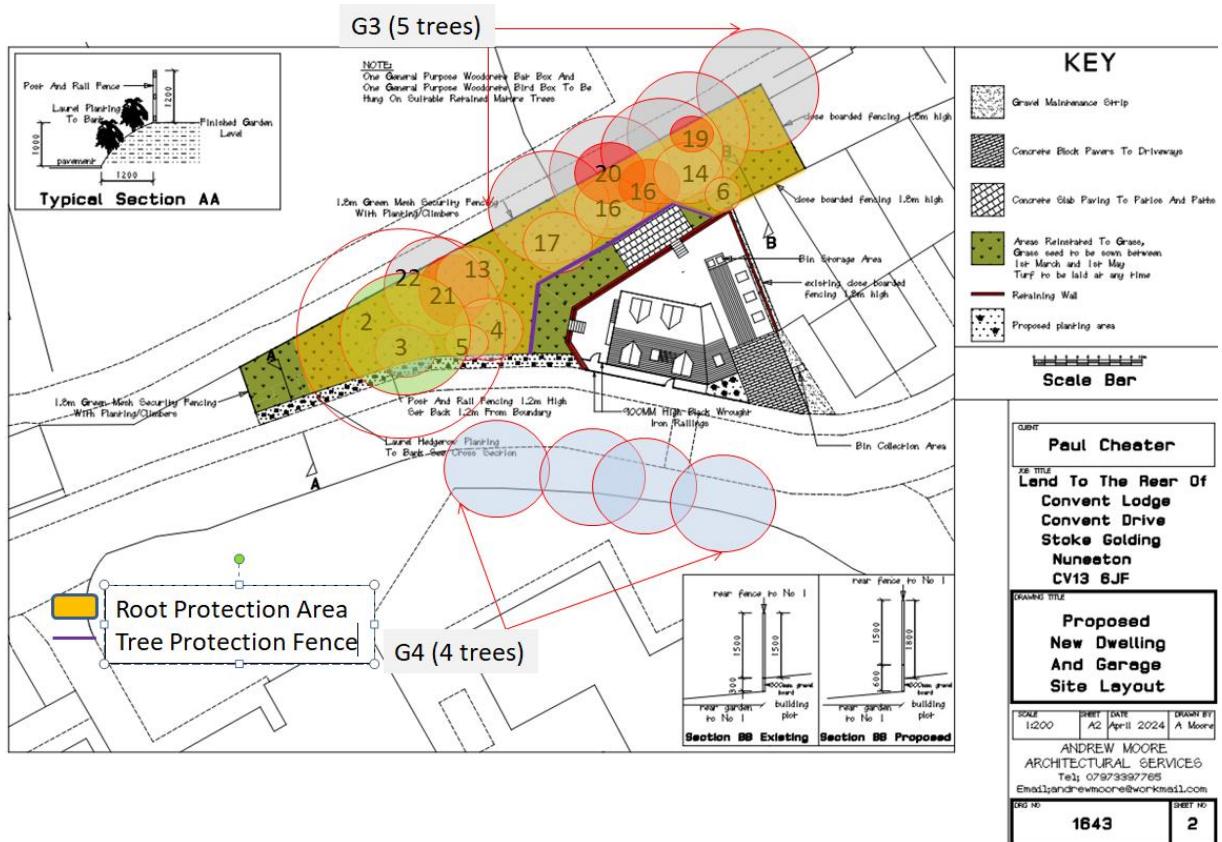
A single run of tree protection fencing covering all the nearby Root protection areas in full:

4.2.1 All trees that are being retained on site are to be protected by barriers and/or ground protection before any materials or machinery are brought onto the site, and before any demolition, development or stripping of soil commences. Where all activity can be excluded from the RPA, vertical barriers are to be erected to create a construction exclusion zone. The default barrier specification is to be in accordance with BS 5837:2012 'Trees in Relation to Design, Demolition and Construction - Recommendations' as illustrated in Figure 3 below.
