# ARBORICULTURAL ASSESSMENT

**Redrow Homes Limited**

**Land At Burbage Fields Farm Bullfurlong Lane  
Burbage**

**February 2025**

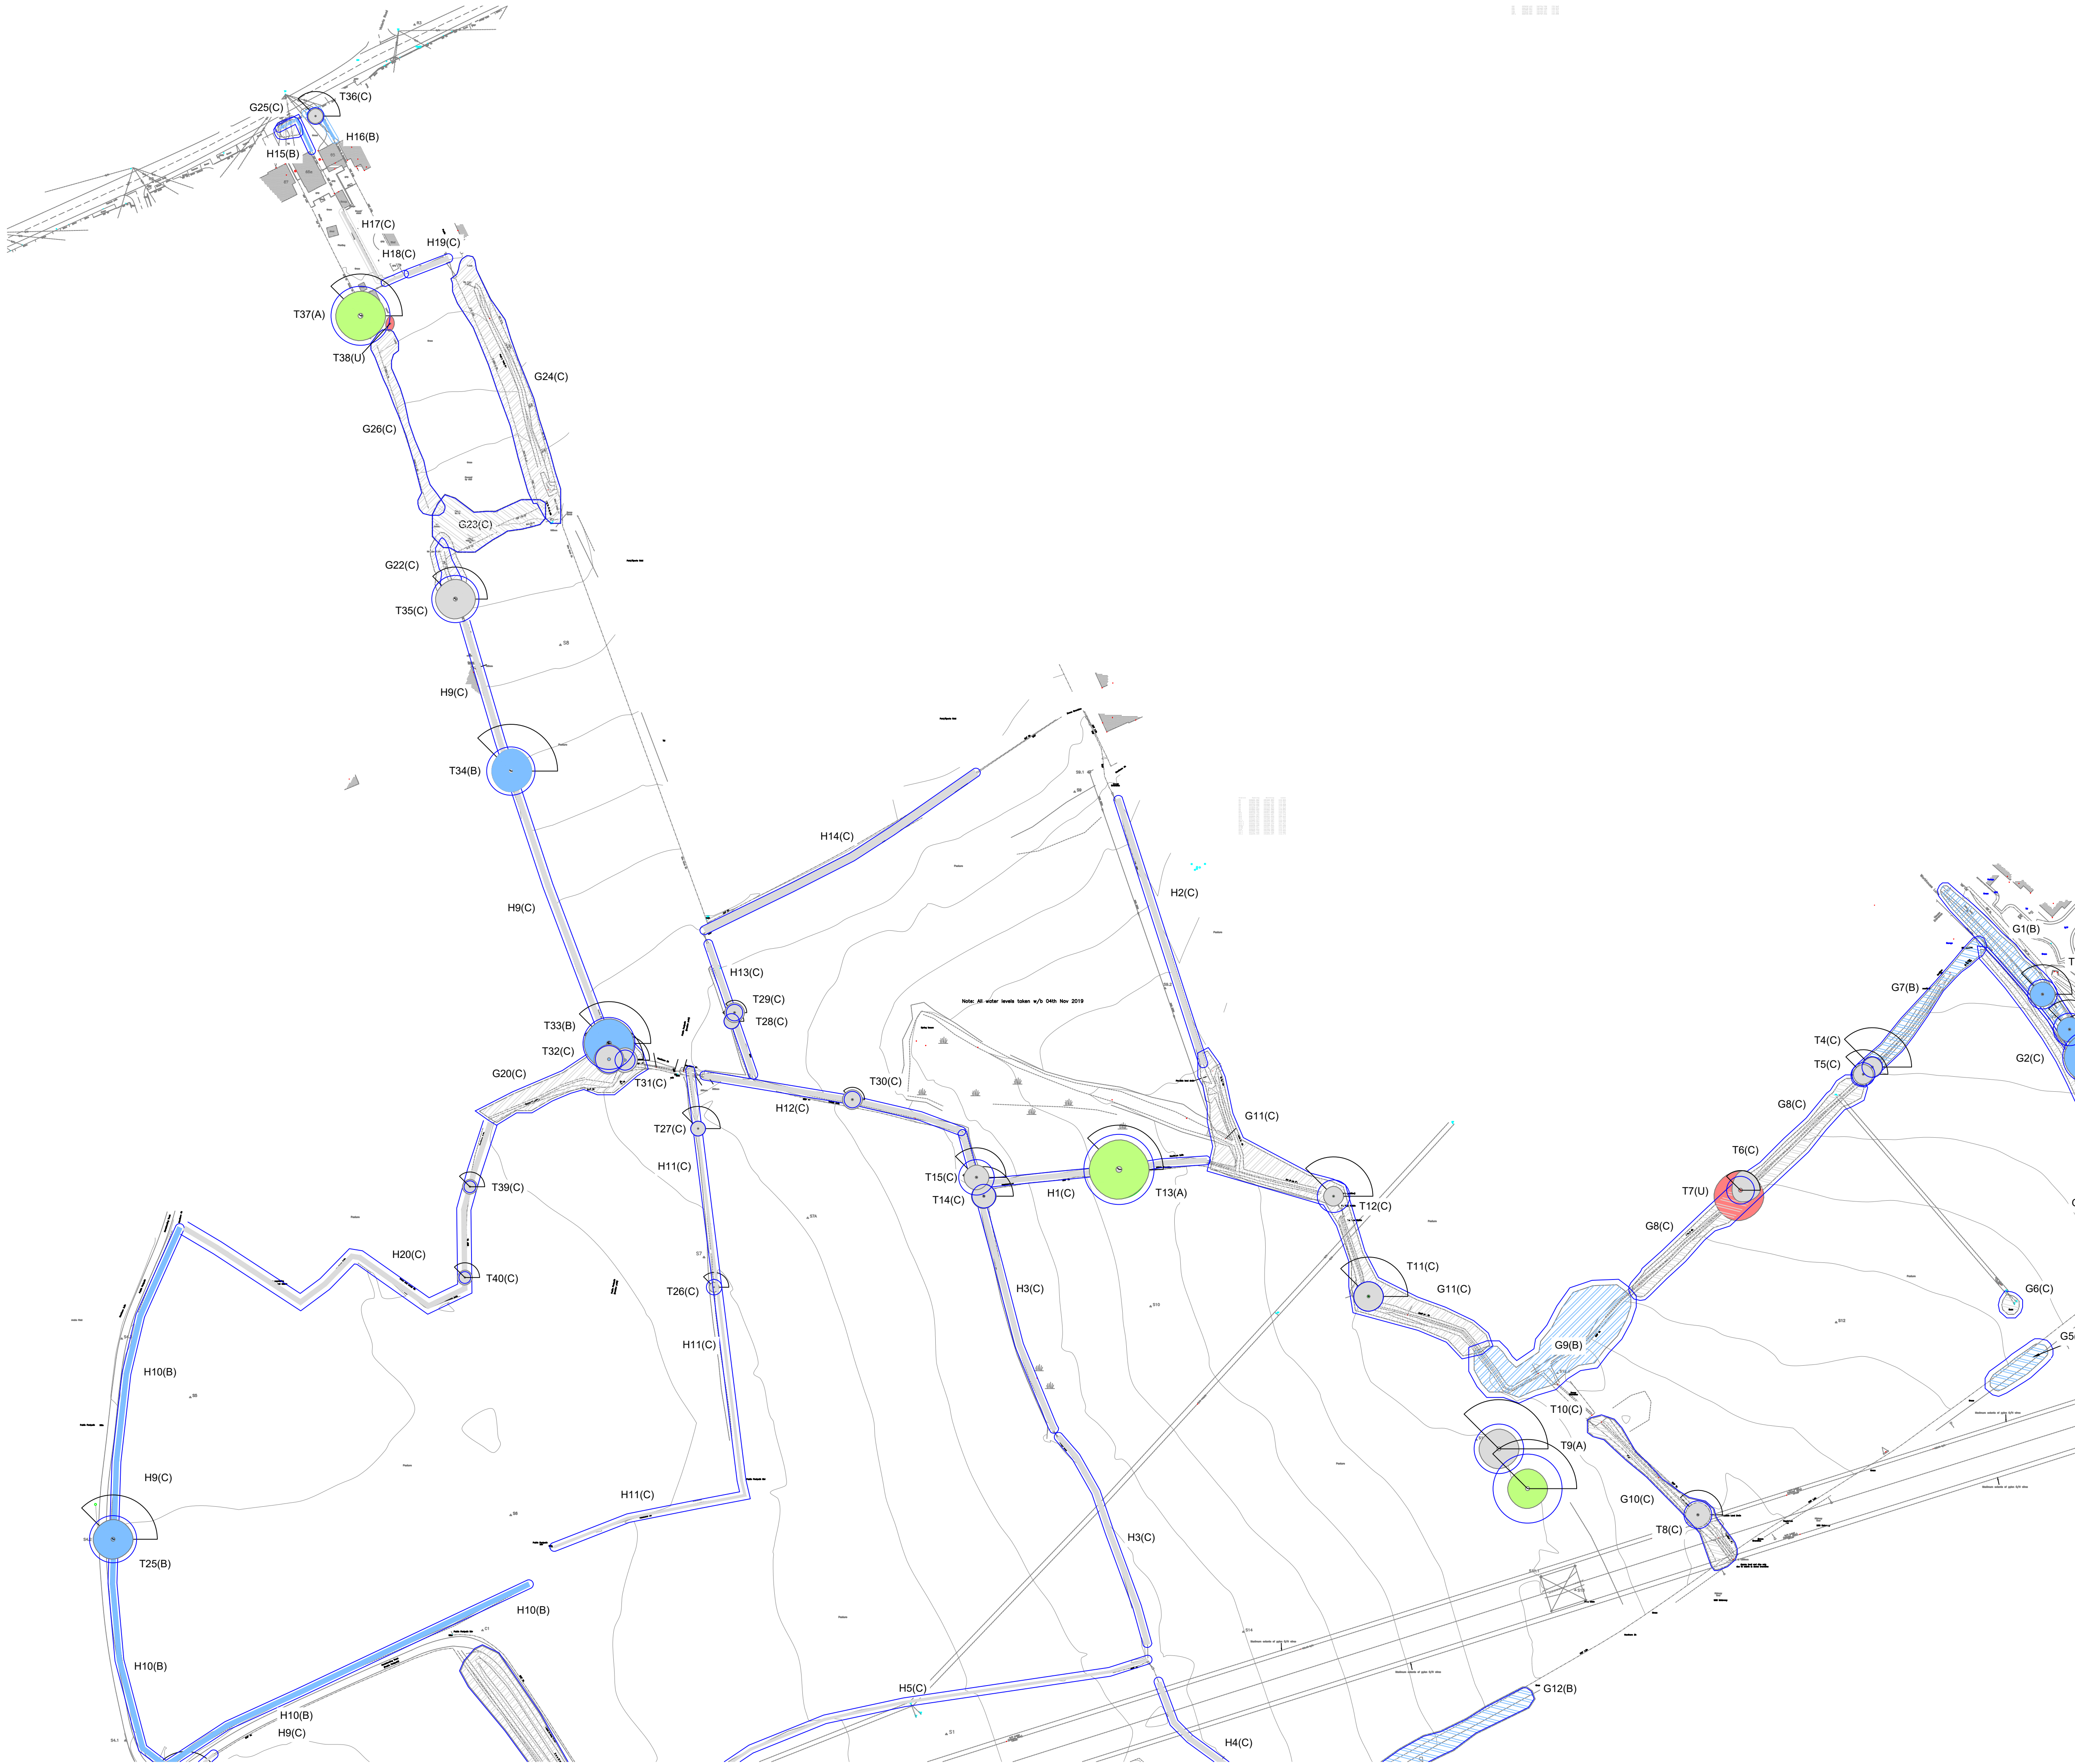
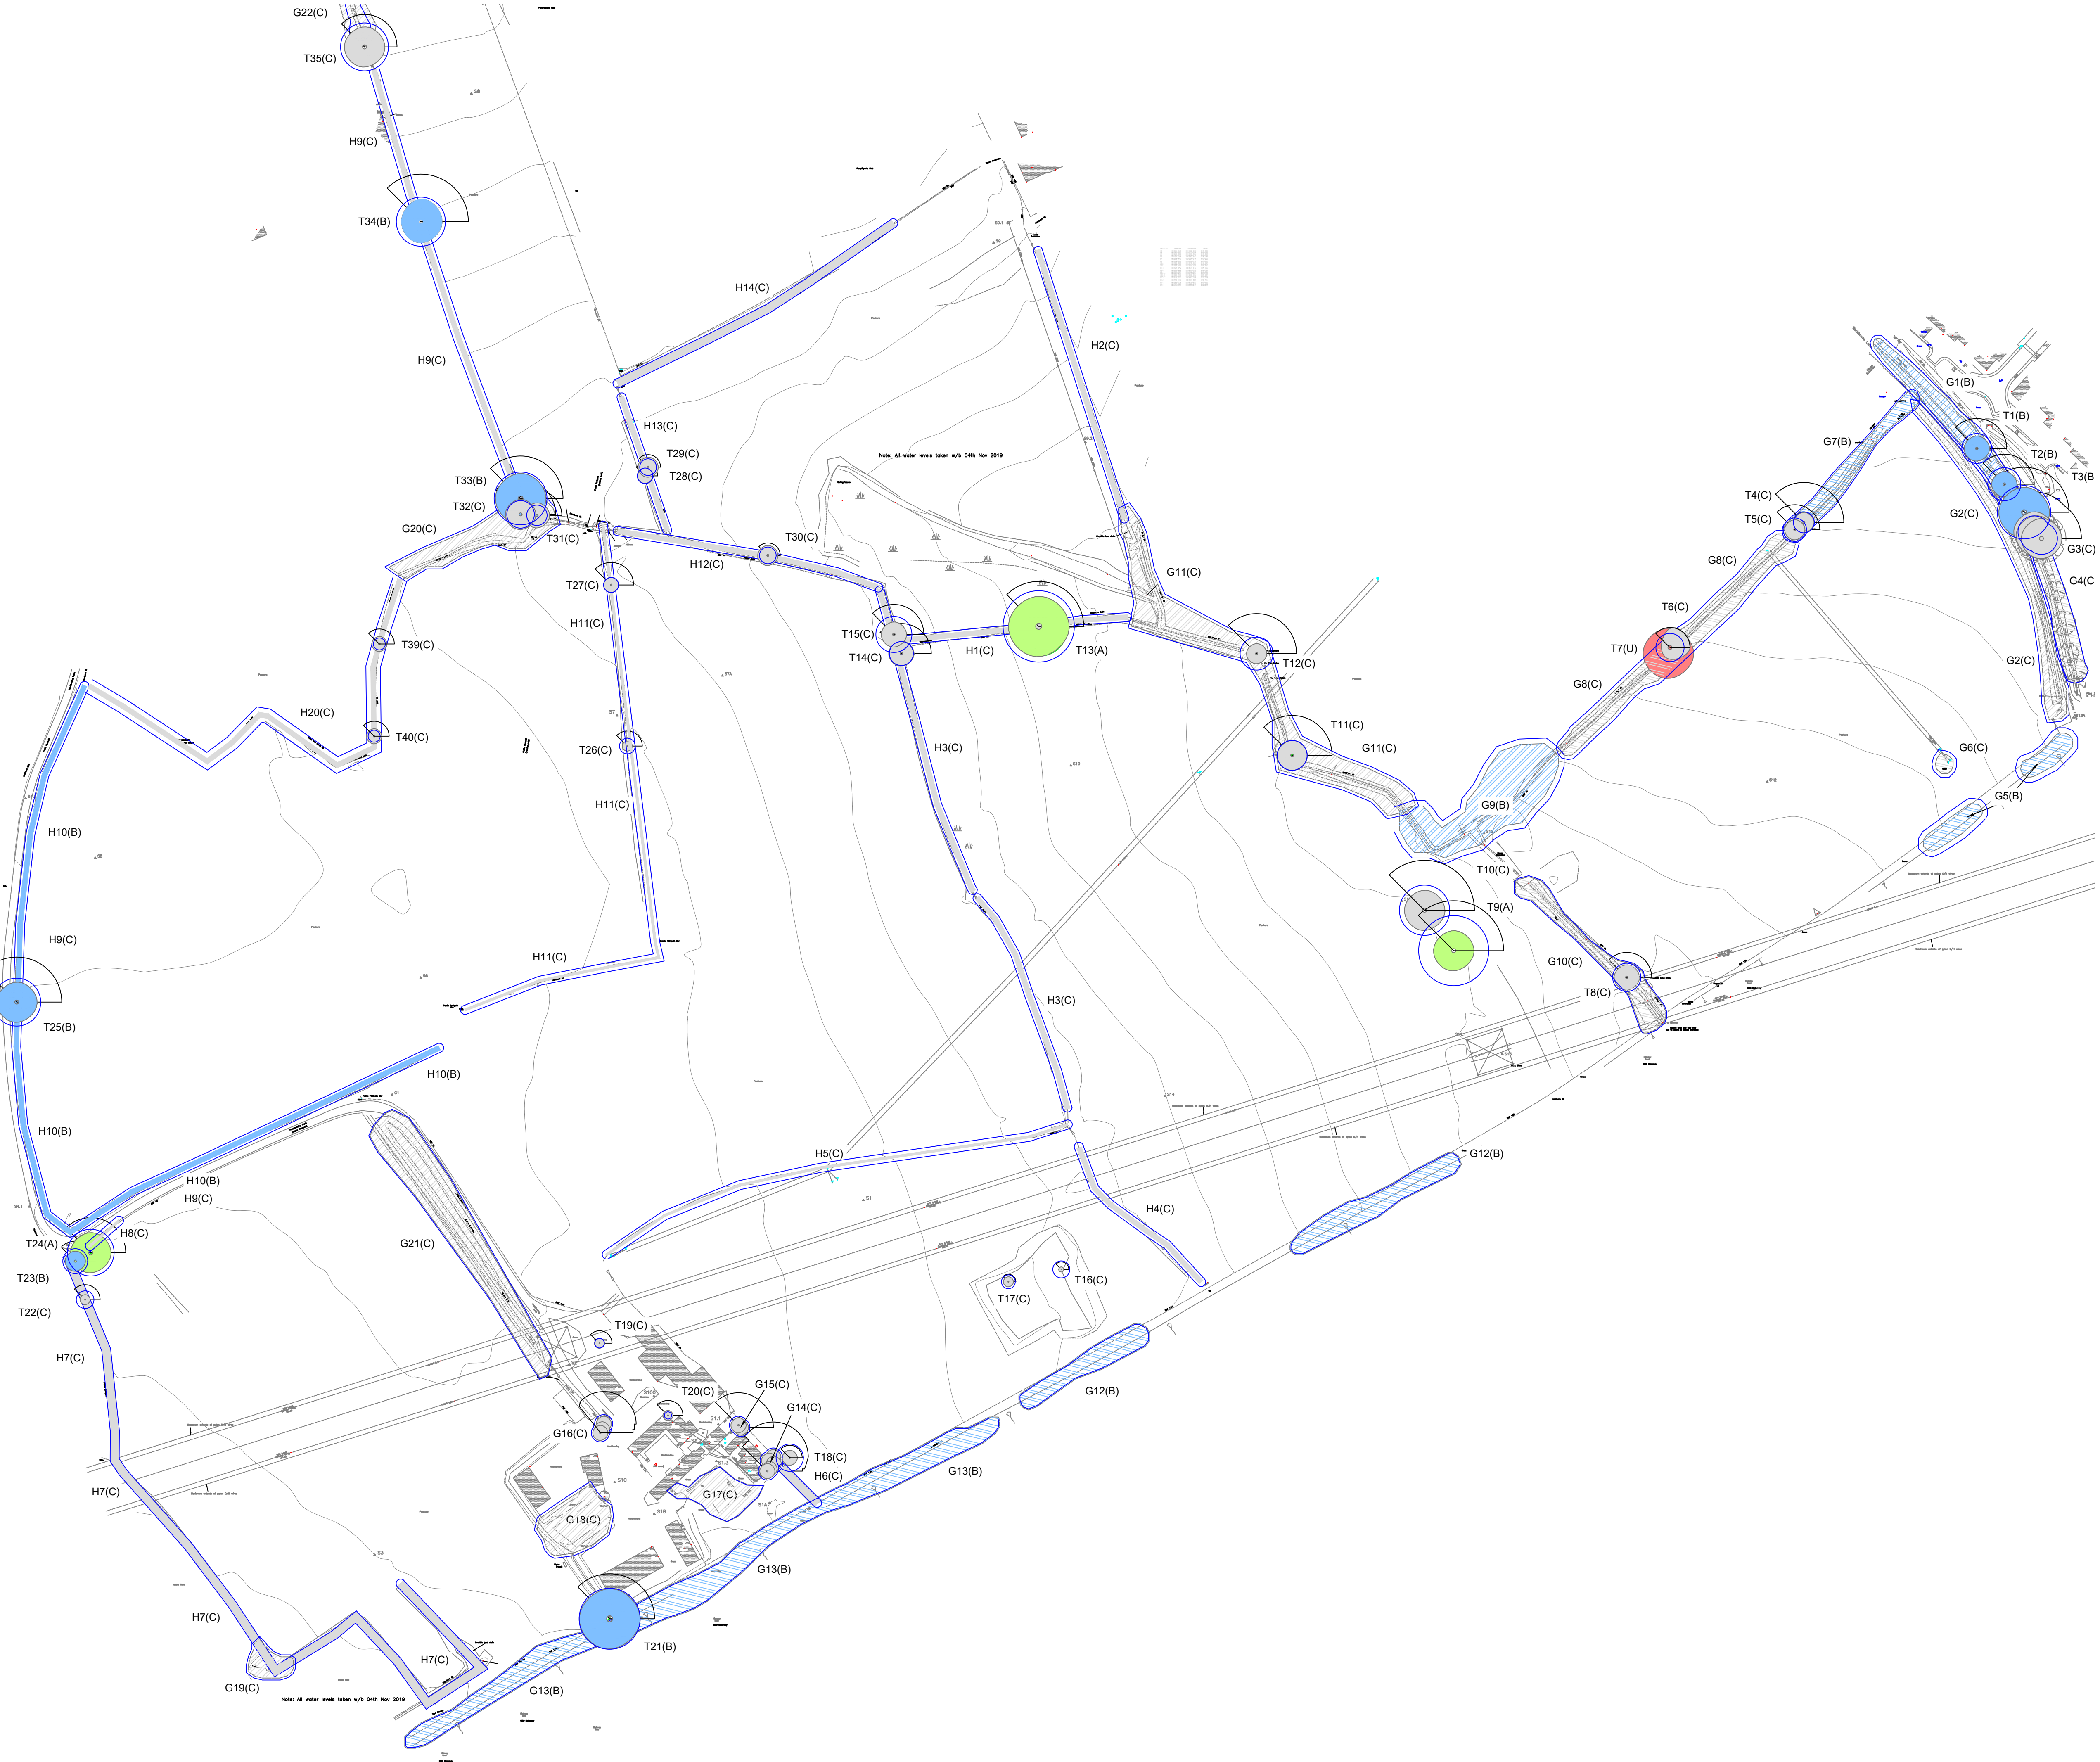
Tree Survey Plan (9685-T-11 & 12)

- 4.9 T7 and T38 were considered to be unsuitable for retention in their current condition and graded as category U accordingly. T38 was a mature specimen of apple *Malus domestica* in a visible state of decline. The crown had formed an asymmetrical form due to suppression from T37, a large specimen of oak directly to the west of this tree. It would be recommended that this tree is removed to prevent the risk of failure in the future. T7, a mature ash *Fraxinus excelsior* also graded as Category U due to its future potential, having recently had a major stem failure and the presence of *Inonotus hispidus* fungal fruiting bodies.

| Tree No | Species | Height | Stem Dia. | Crown Radius | Age Class | Overall Condition | Structural Condition | RPA | RPA Radius | BS5837 Cat |
|---|---|---|---|---|---|---|---|---|---|---|
| T7 | Ash<br>Fraxinus excelsior | 14 | 810 | 10 | M | P | Bark wounds noted<br>Basal cavity observed<br>Branch stubs evident<br>Broken branches evident<br>Dieback of the crown observed<br>Epicormic growth evident within the crown<br>Major dead wood evident in the crown (>75mm)<br>Minor dead wood evident in the crown (<75mm)<br>Sparse / thinning crown<br>Hollowing stem<br>Large failed stem on ground<br>Inonotus Hispidus present | N/A | N/A | U |

- 5.14 It would be necessary to remove T7 (Category U) due to its structural condition and due to the position of a turning head with close proximity of its stem. The loss of this category U tree should not have a detriment impact on the landscape as green cover on the norther boundary provided by G8 will still be present.

- 5.15 G8 would require management in the form of pruning back for clearance and T7 would require removal due to its condition. G8 was a dense, outgrown boundary group consisting of category C trees. This could be pruned back to the sites boundary to create clearance for construction works.
- 5.16 G22 and G26 to the north of the site and on the western boundary will require pruning to facilitate the installing of residential boundary fences. The exact position of stems is unclear and these works should be done to retain as much boundary vegetation as possible.
